Indian Point Unit No. 2
Results of Test Program Following
Modifications to Steam Generator Internals

August 30, 1974

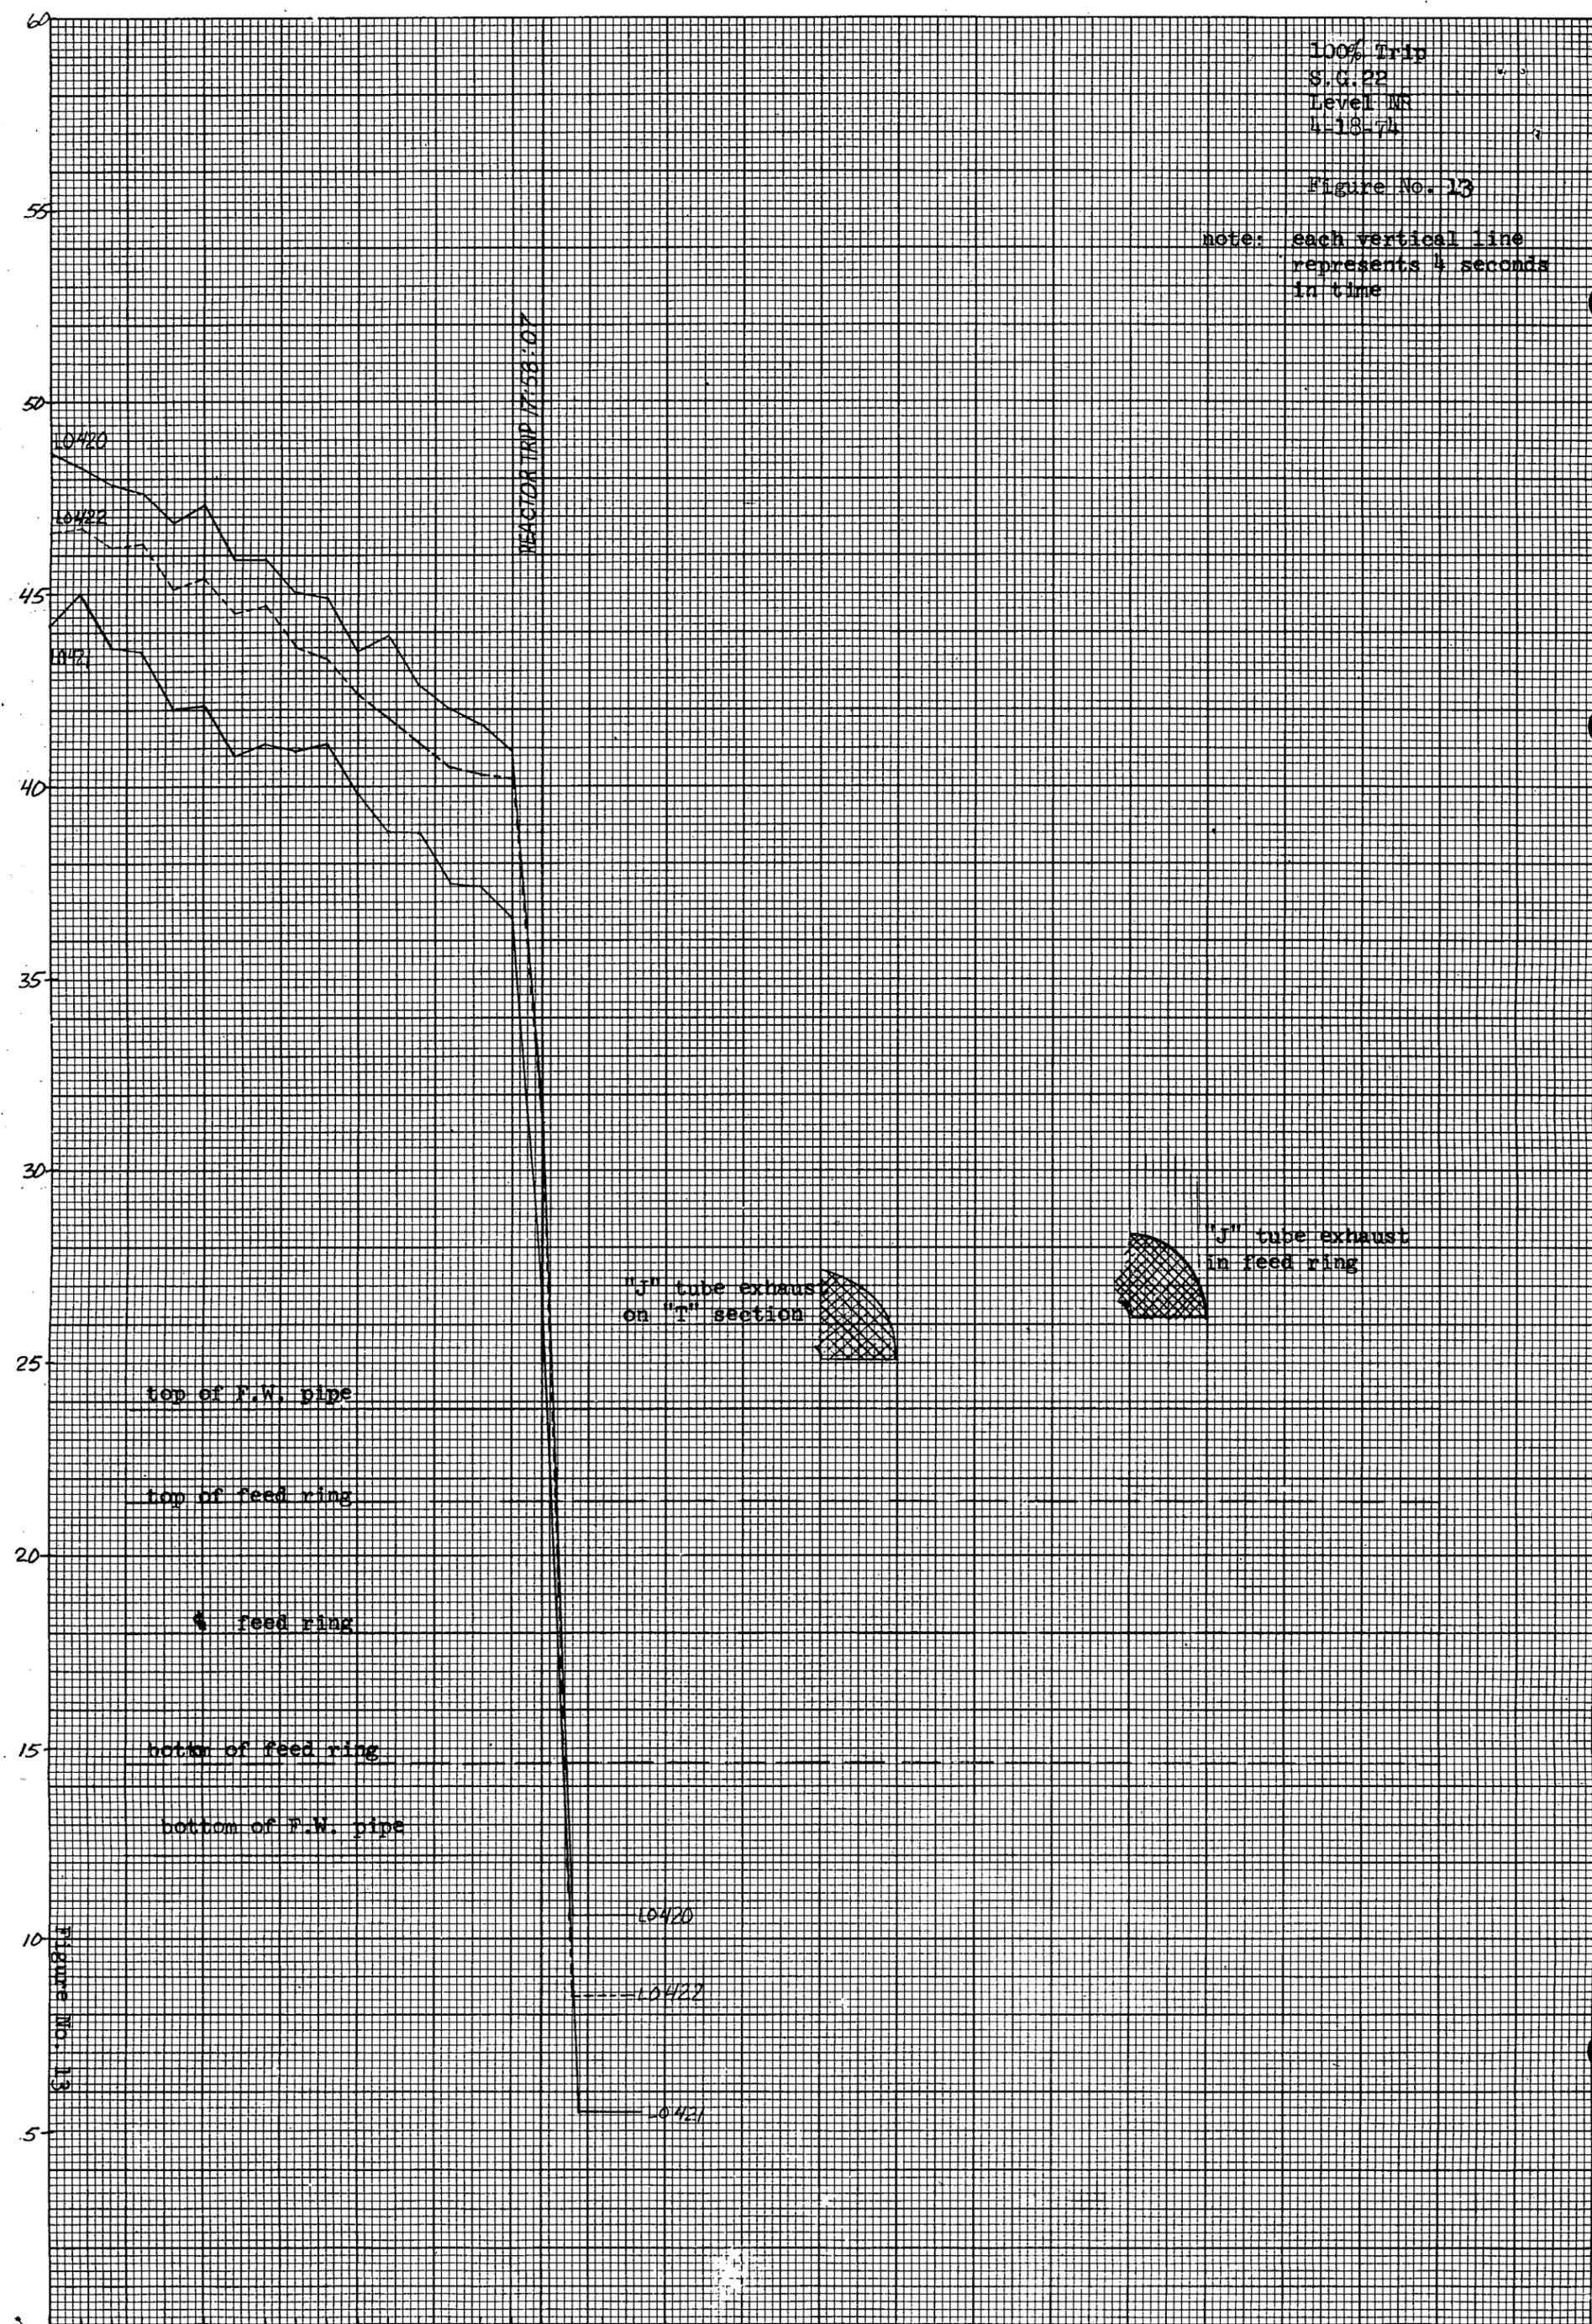
Figure No. 13

On April 18, 1974, the unit was being brought to full reactor power in preparation for scheduled physics tests at 100% power. Special test instrumentation was being monitored as the plant approached 100% power in preparation for a trip, and to observe any potential waterhammer shocks. The plant tripped unexpectedly at approximately 100% reactor power. There was no indication of any waterhammer shock either on special test instrumentation or from reports of observers outside containment. This test constituted the 100% trip test as described in Page 16 of the attachment to Reference 1, and the special test program was therefore considered to be successfully completed. The data for this test appear as Figures 11 and 12 for Steam Generator 21 and Figures 13 and 14 for Steam Generator 22.

100% Trip
S.G. 22
Level MR
4-18-74
