South Texas Project Electric Generating Station P.O. Box 289 Wadsworth, Texas 77483

South Texas Project  
Unit 2  
Docket No. STN 50-499  
Amended Request for Relief from ASME Boiler and Pressure Vessel Code  
Section XI Requirements for the Essential Cooling Water System  
(Relief Request RR-ENG-2-52) (TAC ME0899)

**SOUTH TEXAS PROJECT  
UNIT 2  
AMENDED REQUEST FOR RELIEF FROM ASME BOILER AND PRESSURE VESSEL CODE  
SECTION XI REQUIREMENTS FOR THE ESSENTIAL COOLING WATER SYSTEM  
(RELIEF REQUEST RR-ENG-2-52)**

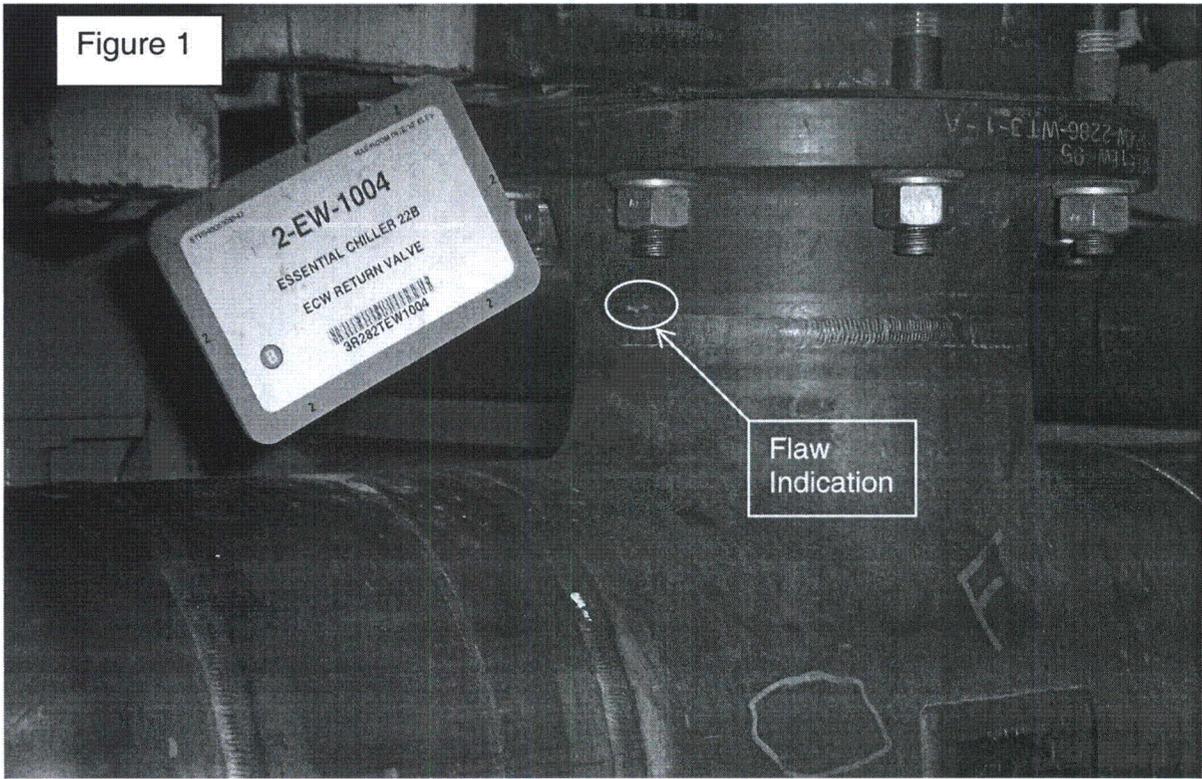
Figure 1

An indication of a through-wall flaw was found on the downstream flange of Essential Chiller 22B ECW return throttle valve 2-EW-1004. Leakage residue buildup in a line parallel to the circumferential weld was found at the weld on the downstream flange of the valve, with an underlying flaw of approximately 3/8-inch in length. The flaw appears to be a tight crack as leakage is not readily measurable. The attached pictures show the location (Figure 1) and the appearance (Figure 2) of the residue buildup. Nominal pipe diameter is 8 inches, with a pipe wall thickness of 0.322 inch.

The circumferential orientation of the flaw can be seen in Figures 1 and 2. The circumferential orientation is also stated in paragraph 1(d) of the original submittal.

Rework of the defect to restore the flange to its design condition was deferred until sufficient time was available. The flange was replaced in accordance with the ASME Code on April 24, 2009.
