Re Indian Point Unit No. 2
Docket No. 50-247
Facility Operating
License No. DPR-26

In accordance with the discussion held on November 27, 1973 with Mr. Brunner of your office, this letter is to provide you with supplemental information concerning the incident which occurred at Indian Point Unit No. 2 on November 13, 1973.

EFFECTS OF INCIDENT ON PLANT EQUIPMENT

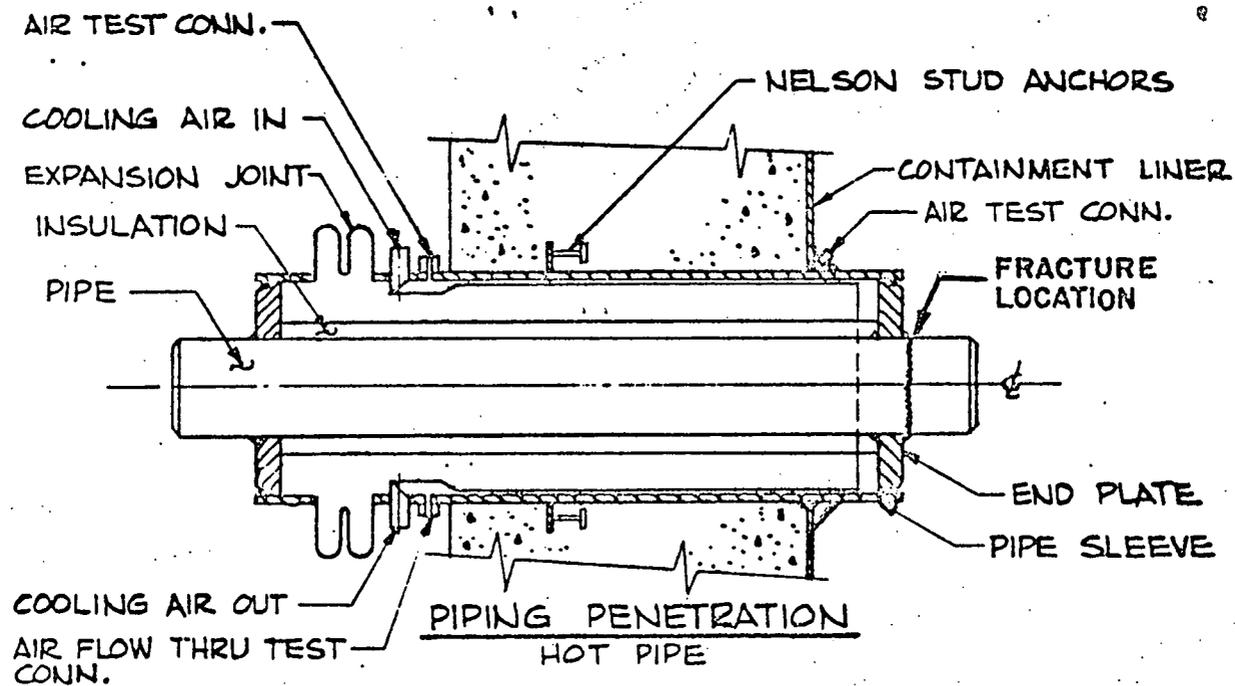
A visual inspection of the 18-inch diameter feedwater line inside containment indicated a fracture adjacent to a fillet weld between the feedwater line and the end plate which is welded into the penetration sleeve in the containment wall. The fracture extended approximately 180° around the pipe. The origin of the fracture was at the 3 to 4 o'clock position (from inside the containment when facing the containment wall). At the 3 to 4 o'clock location, the fracture was at the toe of the fillet weld. The fracture appeared to have propagated up to the 12 o'clock position, and down to the 6 o'clock position, and its path led away from the toe of the weld approximately 1/2 inch. Immediately above the 3 o'clock position, a short branch of the crack traveled along the toe of the weld.

The fractured portion of the pipe was offset from that portion remaining in the penetration so that at the 12 o'clock and at the 3 o'clock positions, it was raised 1/4 of an inch. The maximum measured width of the crack was 5/32 of an inch.

1. The failed section of feedwater piping has been removed and is being replaced with a new section of feedwater piping. The section to be replaced extends from the first elbow outside of containment, through the penetration, to near the first elbow inside containment (see Figure A attached to this report). In addition, the containment penetration end plates and expansion joint are being replaced. The undamaged containment penetration sleeve and penetration cooling coil will be retained.
2. As mentioned previously, the feedwater regulating valve in the feedwater line to Steam Generator No. 22 has been removed and sent to the vendor for inspection and maintenance as necessary.
3. All damaged or removed insulation will be replaced or repaired as necessary.
4. All piping supports and other components and/or structures removed for access will be reinstalled.
