January 11, 1978  
Re: Indian Point Unit No. 2  
Docket No. 50-247

INDIAN POINT UNIT NO. 2

STEAM GENERATOR INSPECTION PROGRAM

Planned for the  
Second Refueling Outage  
February 1978

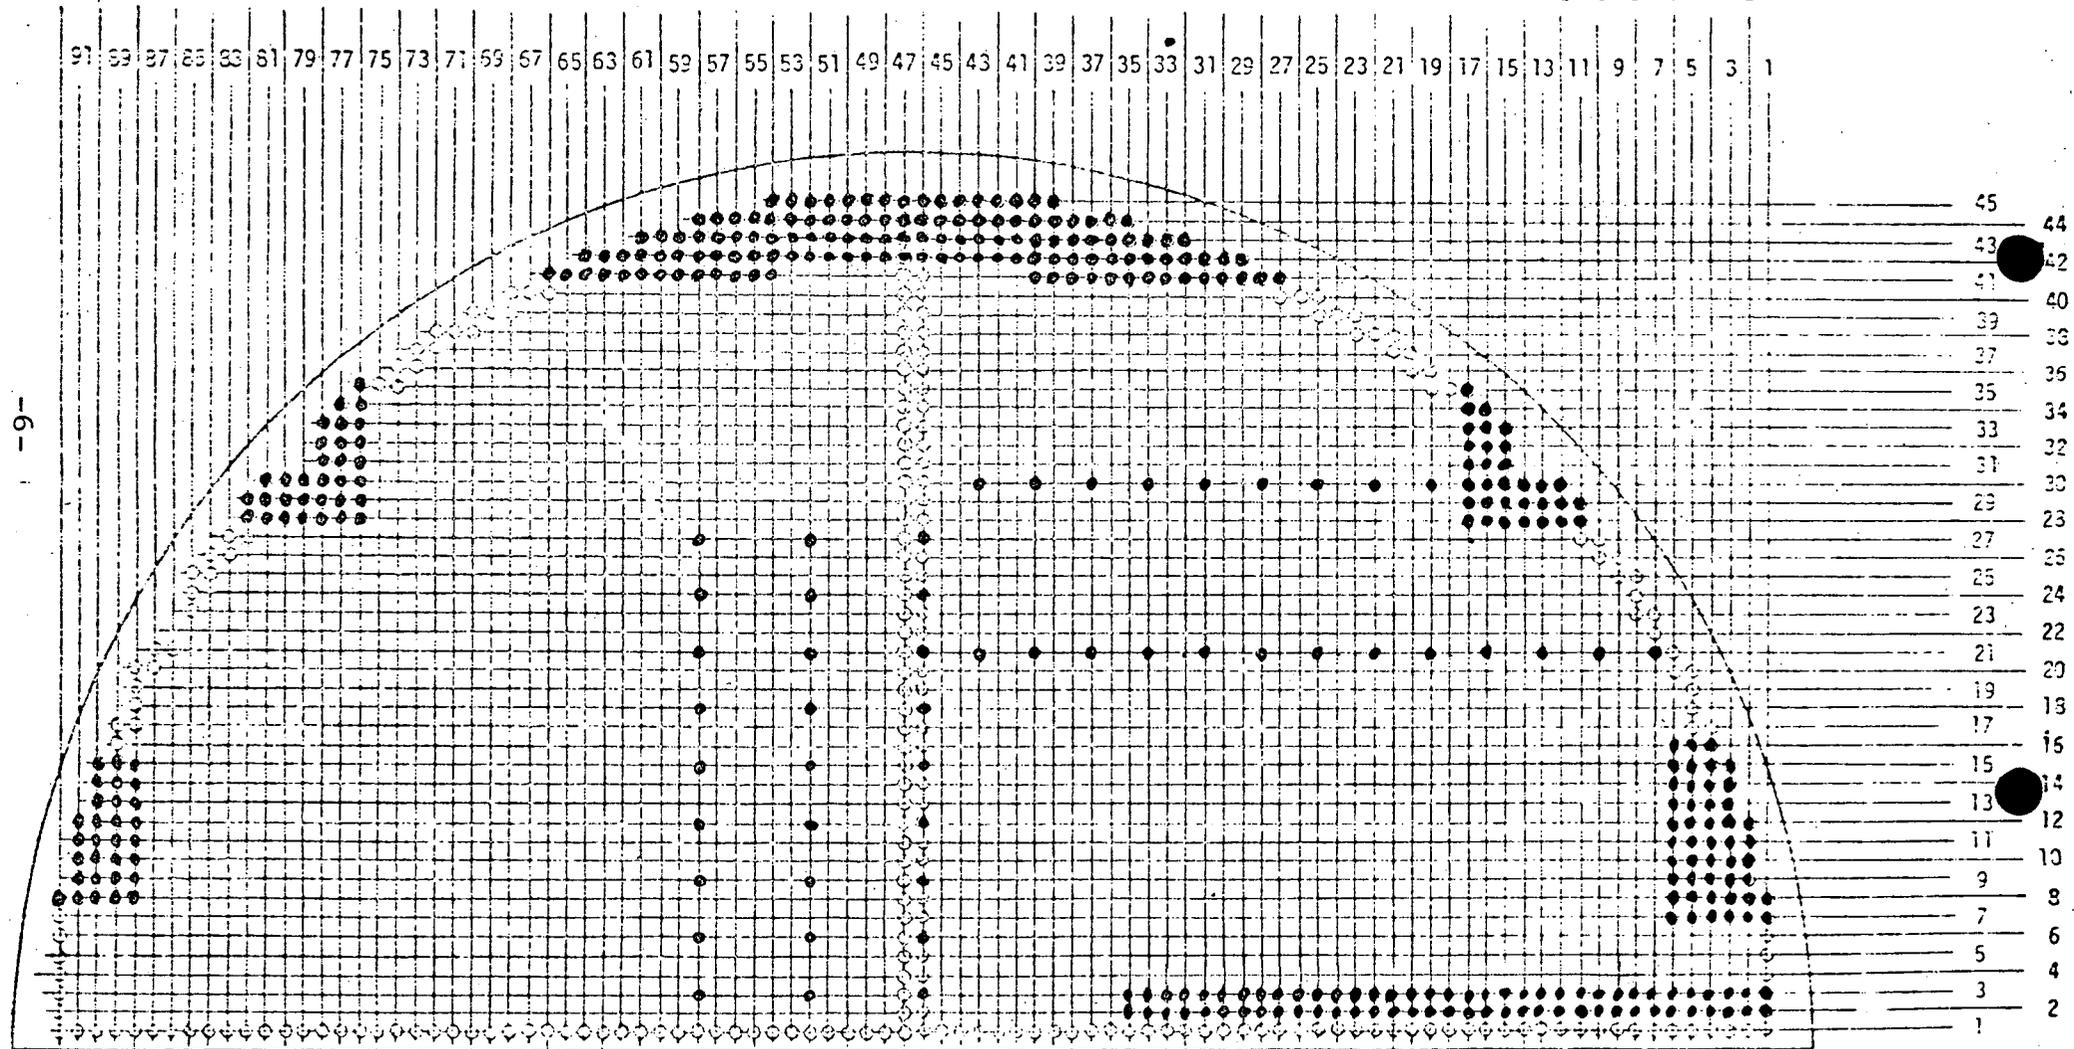
**FIGURE I : Locations of Tubes to be Eddy Current Tested for Dents (Hot Legs of Steam Generators 23 & 24)**

Locations of the hot leg tubes in Steam Generator 23 and 24 which will be eddy current inspected for dents are given in Table 1 and Figure 1. In addition 12% of the tubes in the hot leg of Steam Generator 23 and 6% of the tubes in the hot leg of Steam Generator 24 will be eddy current inspected for defects. To the extent practical, this shall include the length of tube from the point of entry in the steam generator hot leg water box, around the U-bend, and to the top tube support plate of the cold leg.\*
