Docket No. 50-247  
LER-80-006/99X-1

Consolidated Edison Co. of NY Inc.  
Indian Point Unit No. 2

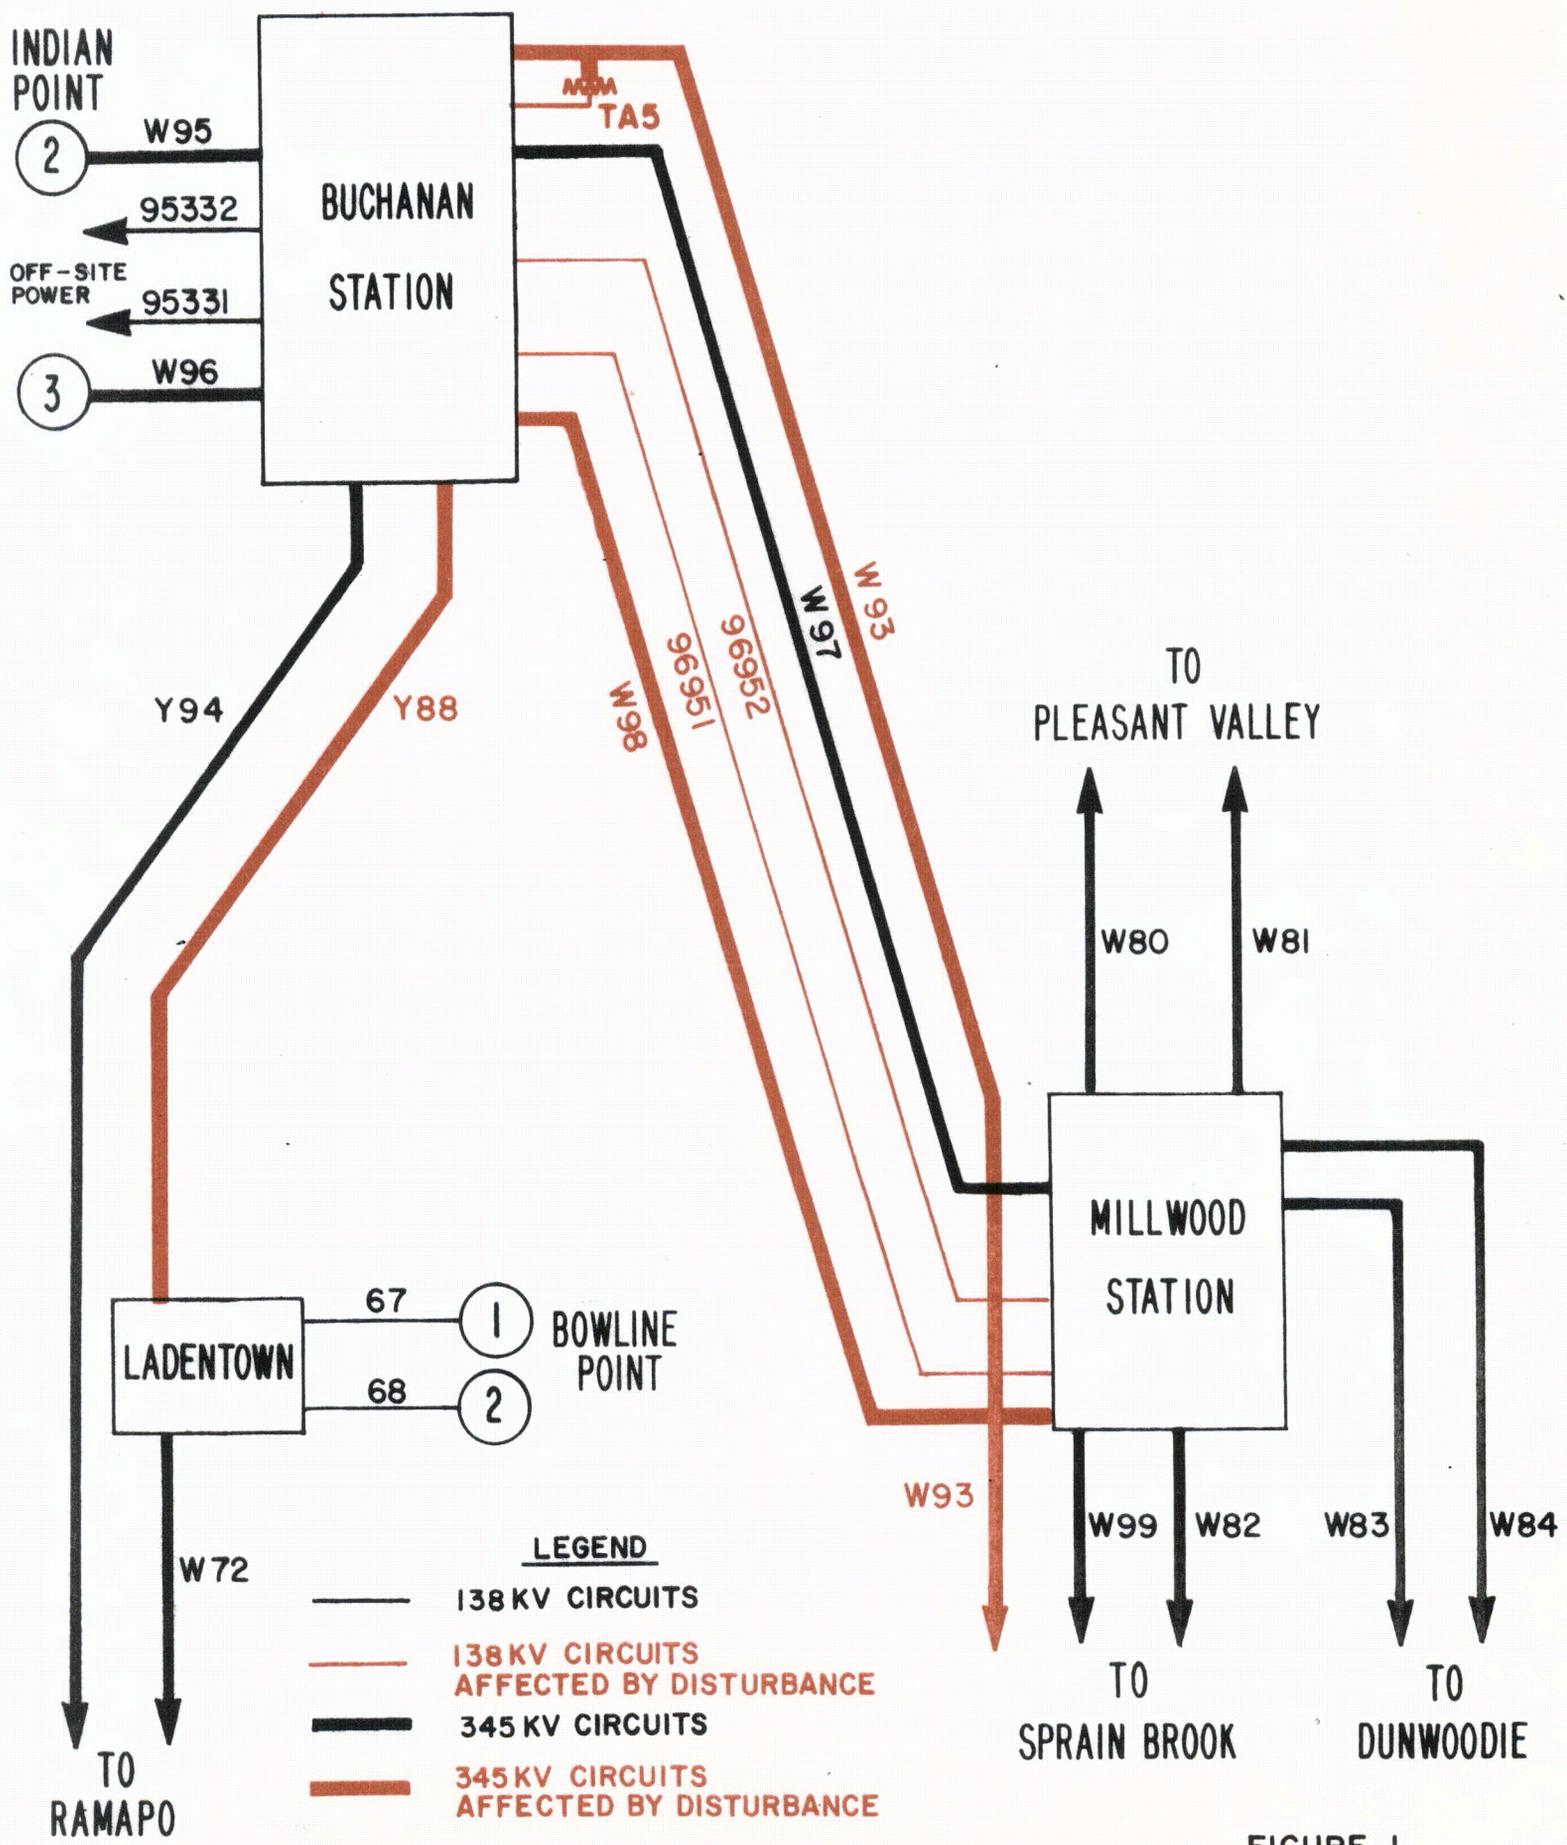
FIGURE I

Figure 1 is a diagram of a portion of the bulk power system showing the feeders supplying Buchanan which were affected by the lightning strike and related events.

● 345KV AND 138KV FEEDERS ●  
 AFFECTED BY JUNE 3, 1980  
 SYSTEM DISTURBANCE

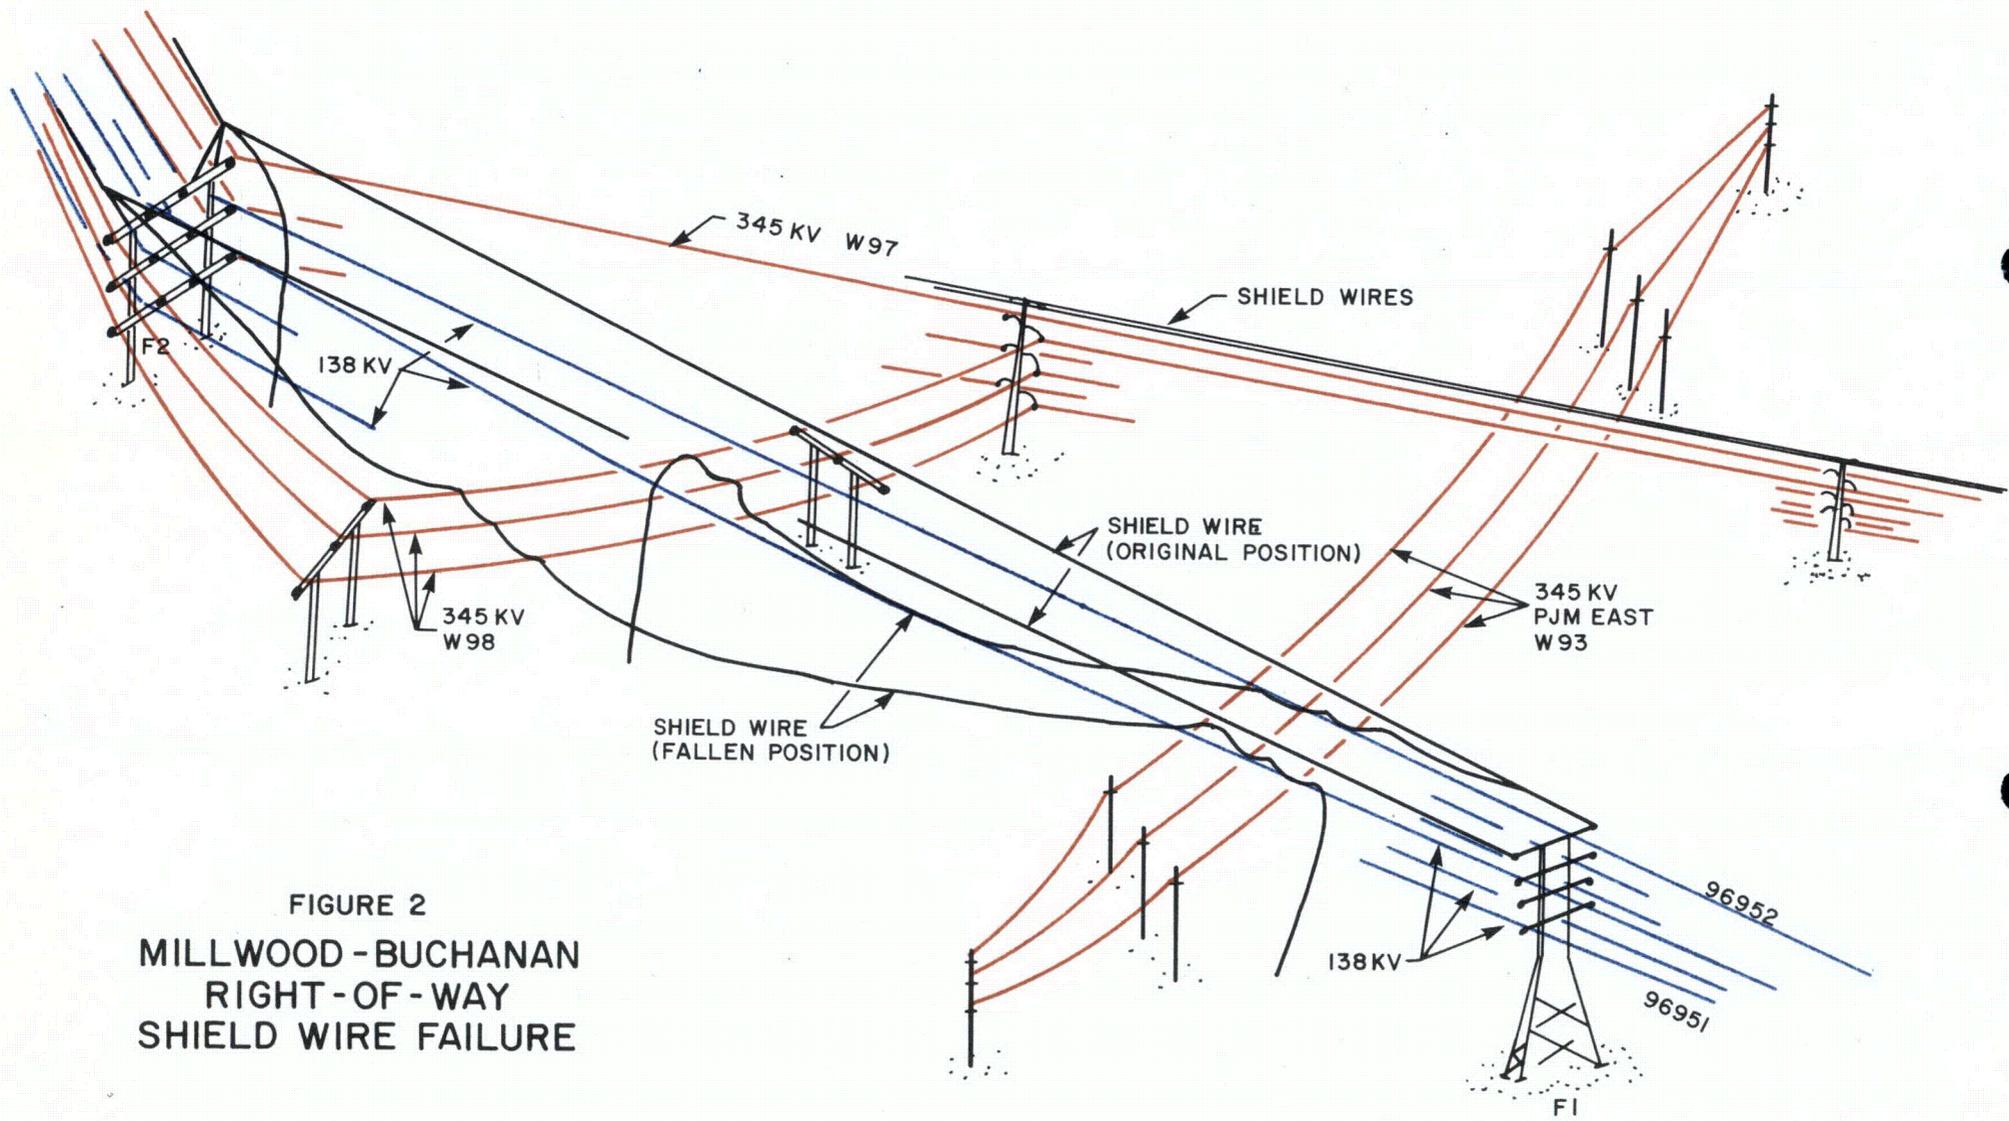
FIGURE 2  
 MILLWOOD - BUCHANAN  
 RIGHT-OF-WAY  
 SHIELD WIRE FAILURE

Figure 2 shows the physical arrangements of "rights-of-way" near Millwood Substation where the lightning strike occurred. It shows the tower configuration on these rights-of-way including the shield wires on the towers.

In the area just northwest of Millwood Substation, one 345 kV feeder crosses under two 138 kV feeders. A second 345 kV feeder crosses under not only these two 138 kV feeders, but also two 345 kV feeders. The feeders are all connected to Buchanan.

At 1454, lightning struck a tower just northwest of Millwood West Substation. A 138 kV feeder between Millwood and Buchanan Substations flashed over to ground and protective relays operated to open the circuit breakers. The breakers reclosed automatically but one of two shield wires burned through its connector and fell on the feeder causing a short circuit.

Subsequent investigation revealed that the shield wire became disconnected because the friction connector which attaches it to the tower failed due to thermo-mechanical deterioration.

The heavy surge of current resulting from the operations described above flowed through the downed shield wire and over the second shield wire. A splice on the second shield wire failed and the wire fell over another 138 kV feeder between Millwood and Buchanan Substations, short circuiting the feeder. Subsequent investigation revealed corrosion under the splice.

1. Install a jumper and bond to mechanically secure the shield wires at all locations with friction connectors.
2. Replace the friction splices on the shield wires with compression splices.
3. Disconnect Transformer TA-5 from 345 kV feeder W93 and re-connect to the north ring bus at Buchanan 345 kV Substation. This will provide a continuous supply of power in the event of a similar occurrence in the congested transmission line area.

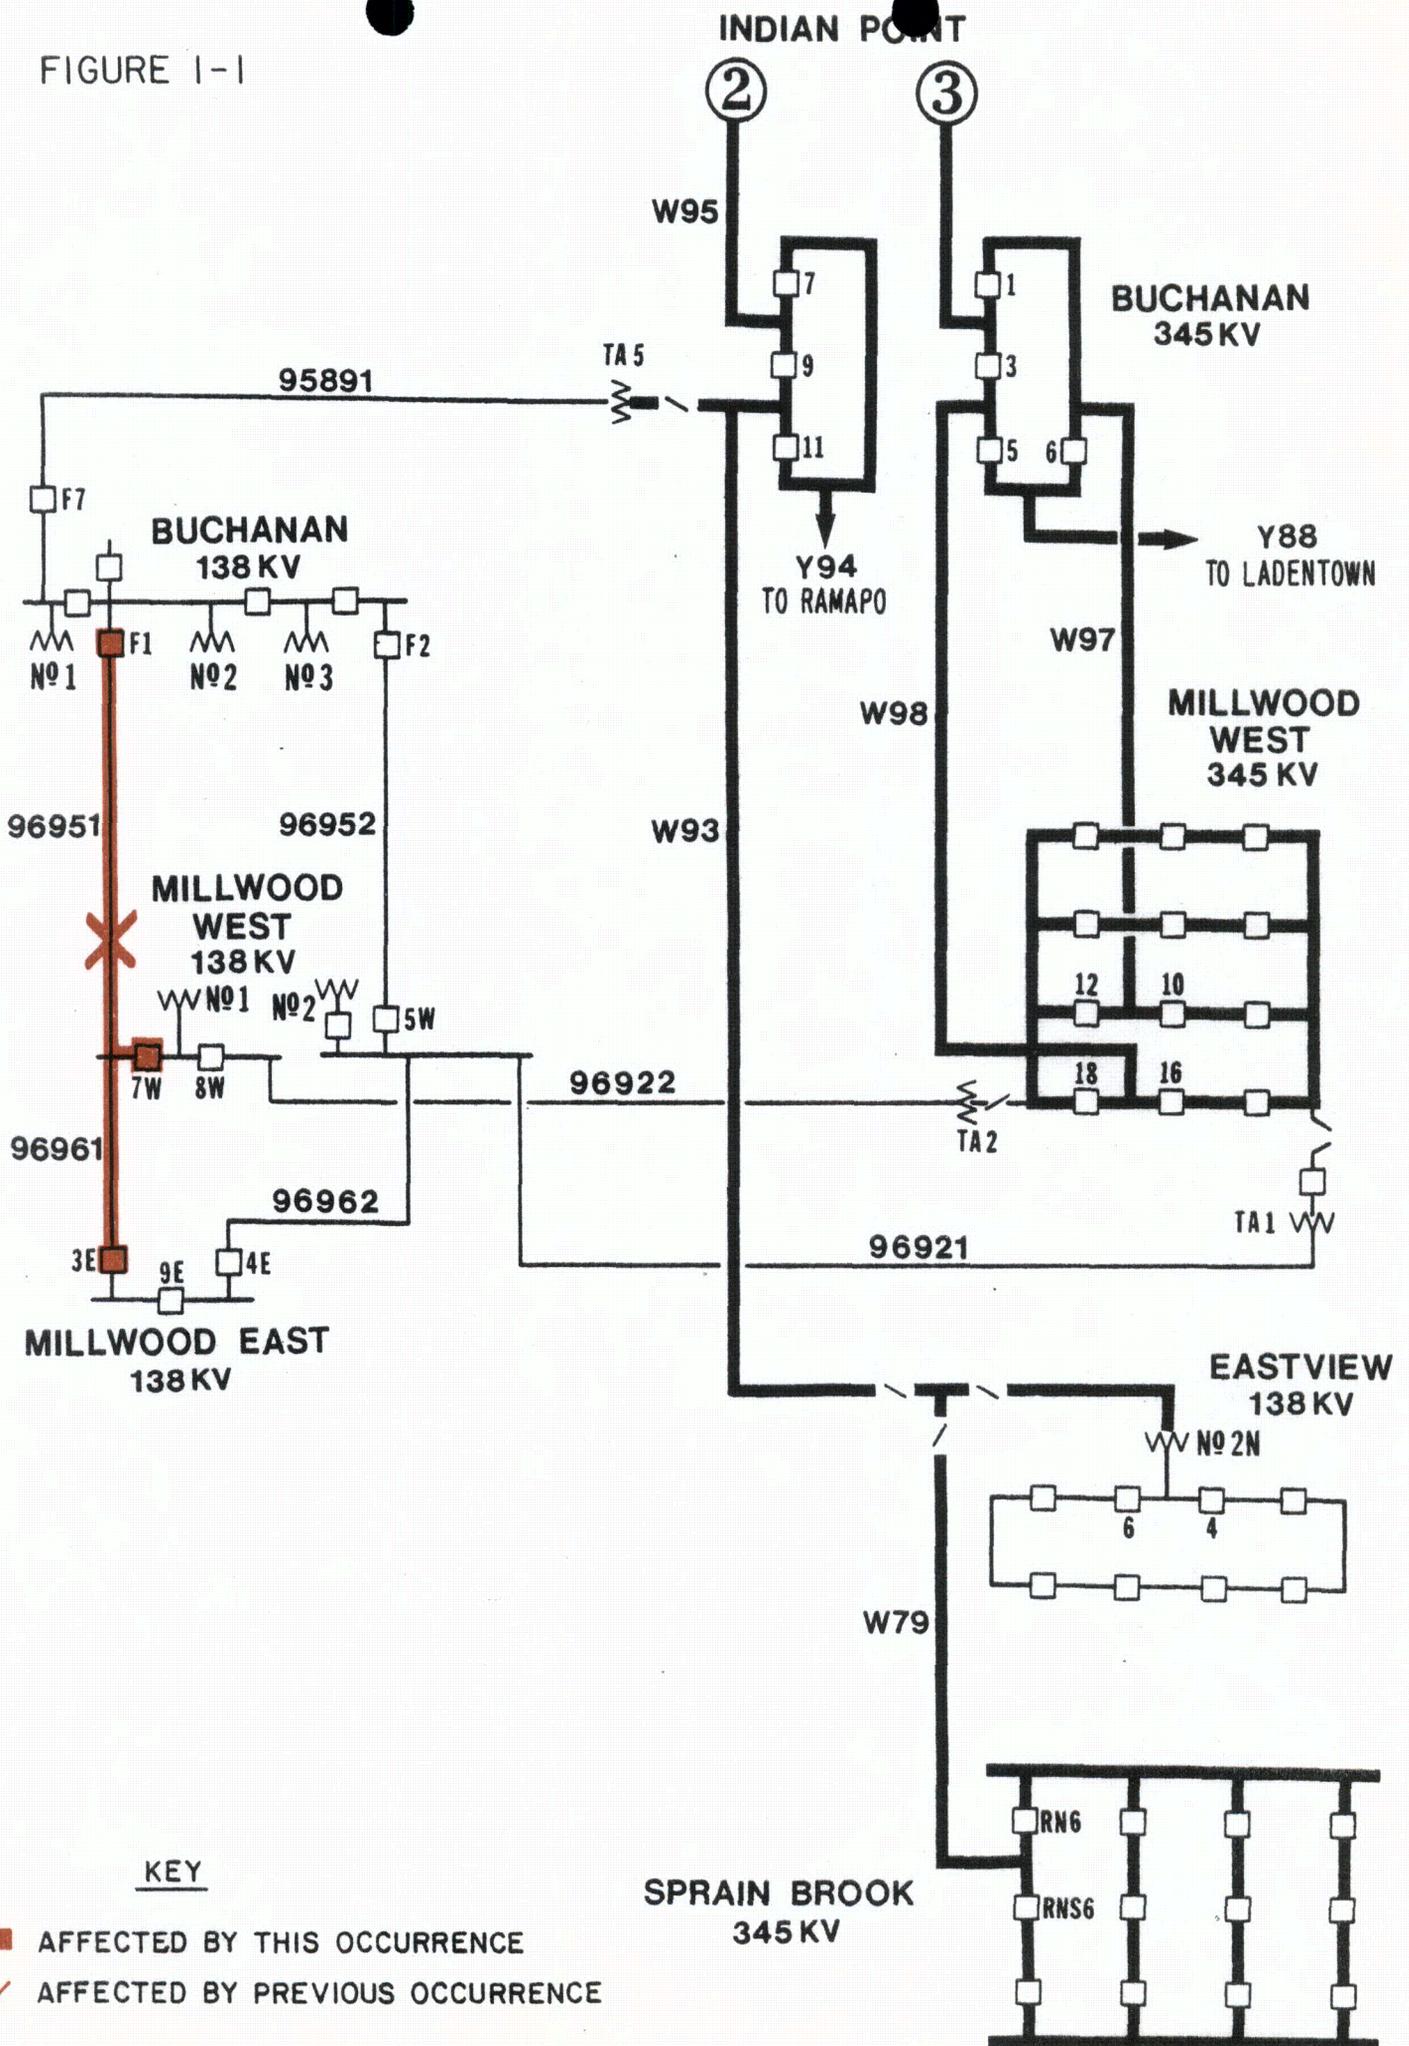
FIGURE I-1

14:54      138 kV Feeder 96951 between Millwood and Buchanan Substations flashed over C phase to ground as a result of a lightning strike. Protective relays operated within 6 cycles to automatically open circuit breakers at Millwood West (7W), Millwood East (3E) and Buchanan (F1) and deenergized the feeder. Before the fault arcing byproducts could completely deionize, breakers F1 and 3E reclosed automatically at 0 + 24 cycles and 0 + 27 cycles respectively, energizing the feeder and reestablishing the C phase fault. The breakers reopened. Breaker 7W at Millwood West reclosed automatically at 0 + 145.5 cycles and reenergized Feeder 96951. At 0 + 157 cycles Feeder 96951 experienced a B phase to ground fault as a result of a failed shield wire deadend on tower F-1 that caused the shield wire to fall onto the feeder. Breaker 7W at Millwood West automatically opened to deenergize the feeder.

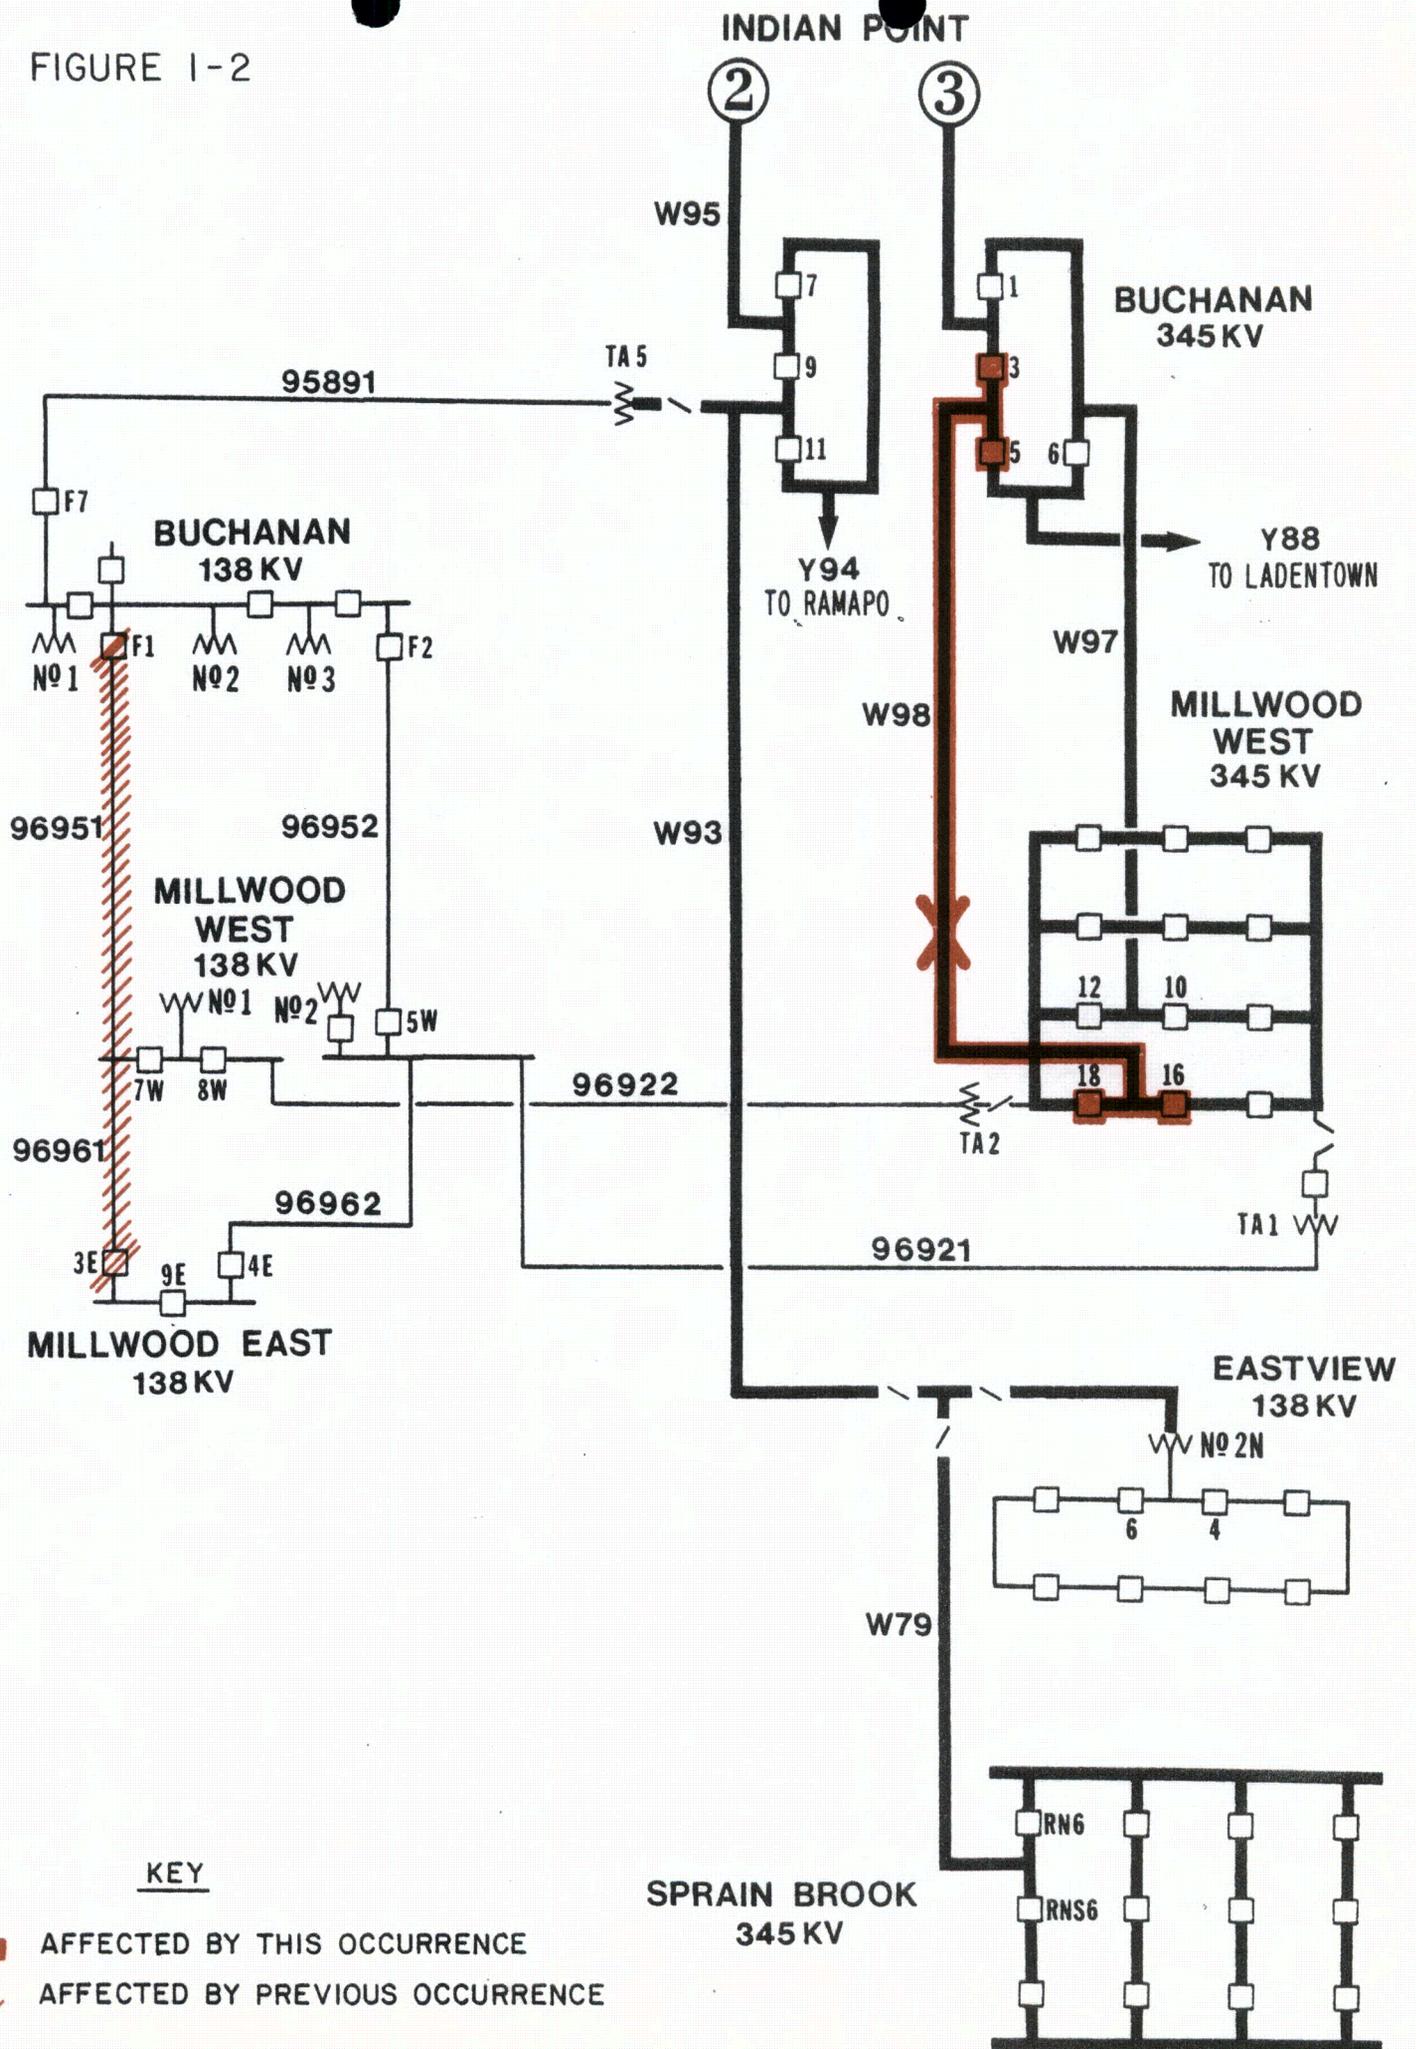
FIGURE 1-2

345 kV Feeder W98 experienced a C phase fault caused by the 96951 shield wire contacting the phase conductor. Protective relays automatically opened breakers at Buchanan (3 and 5) and Millwood West (16 and 18) to deenergize the feeder.

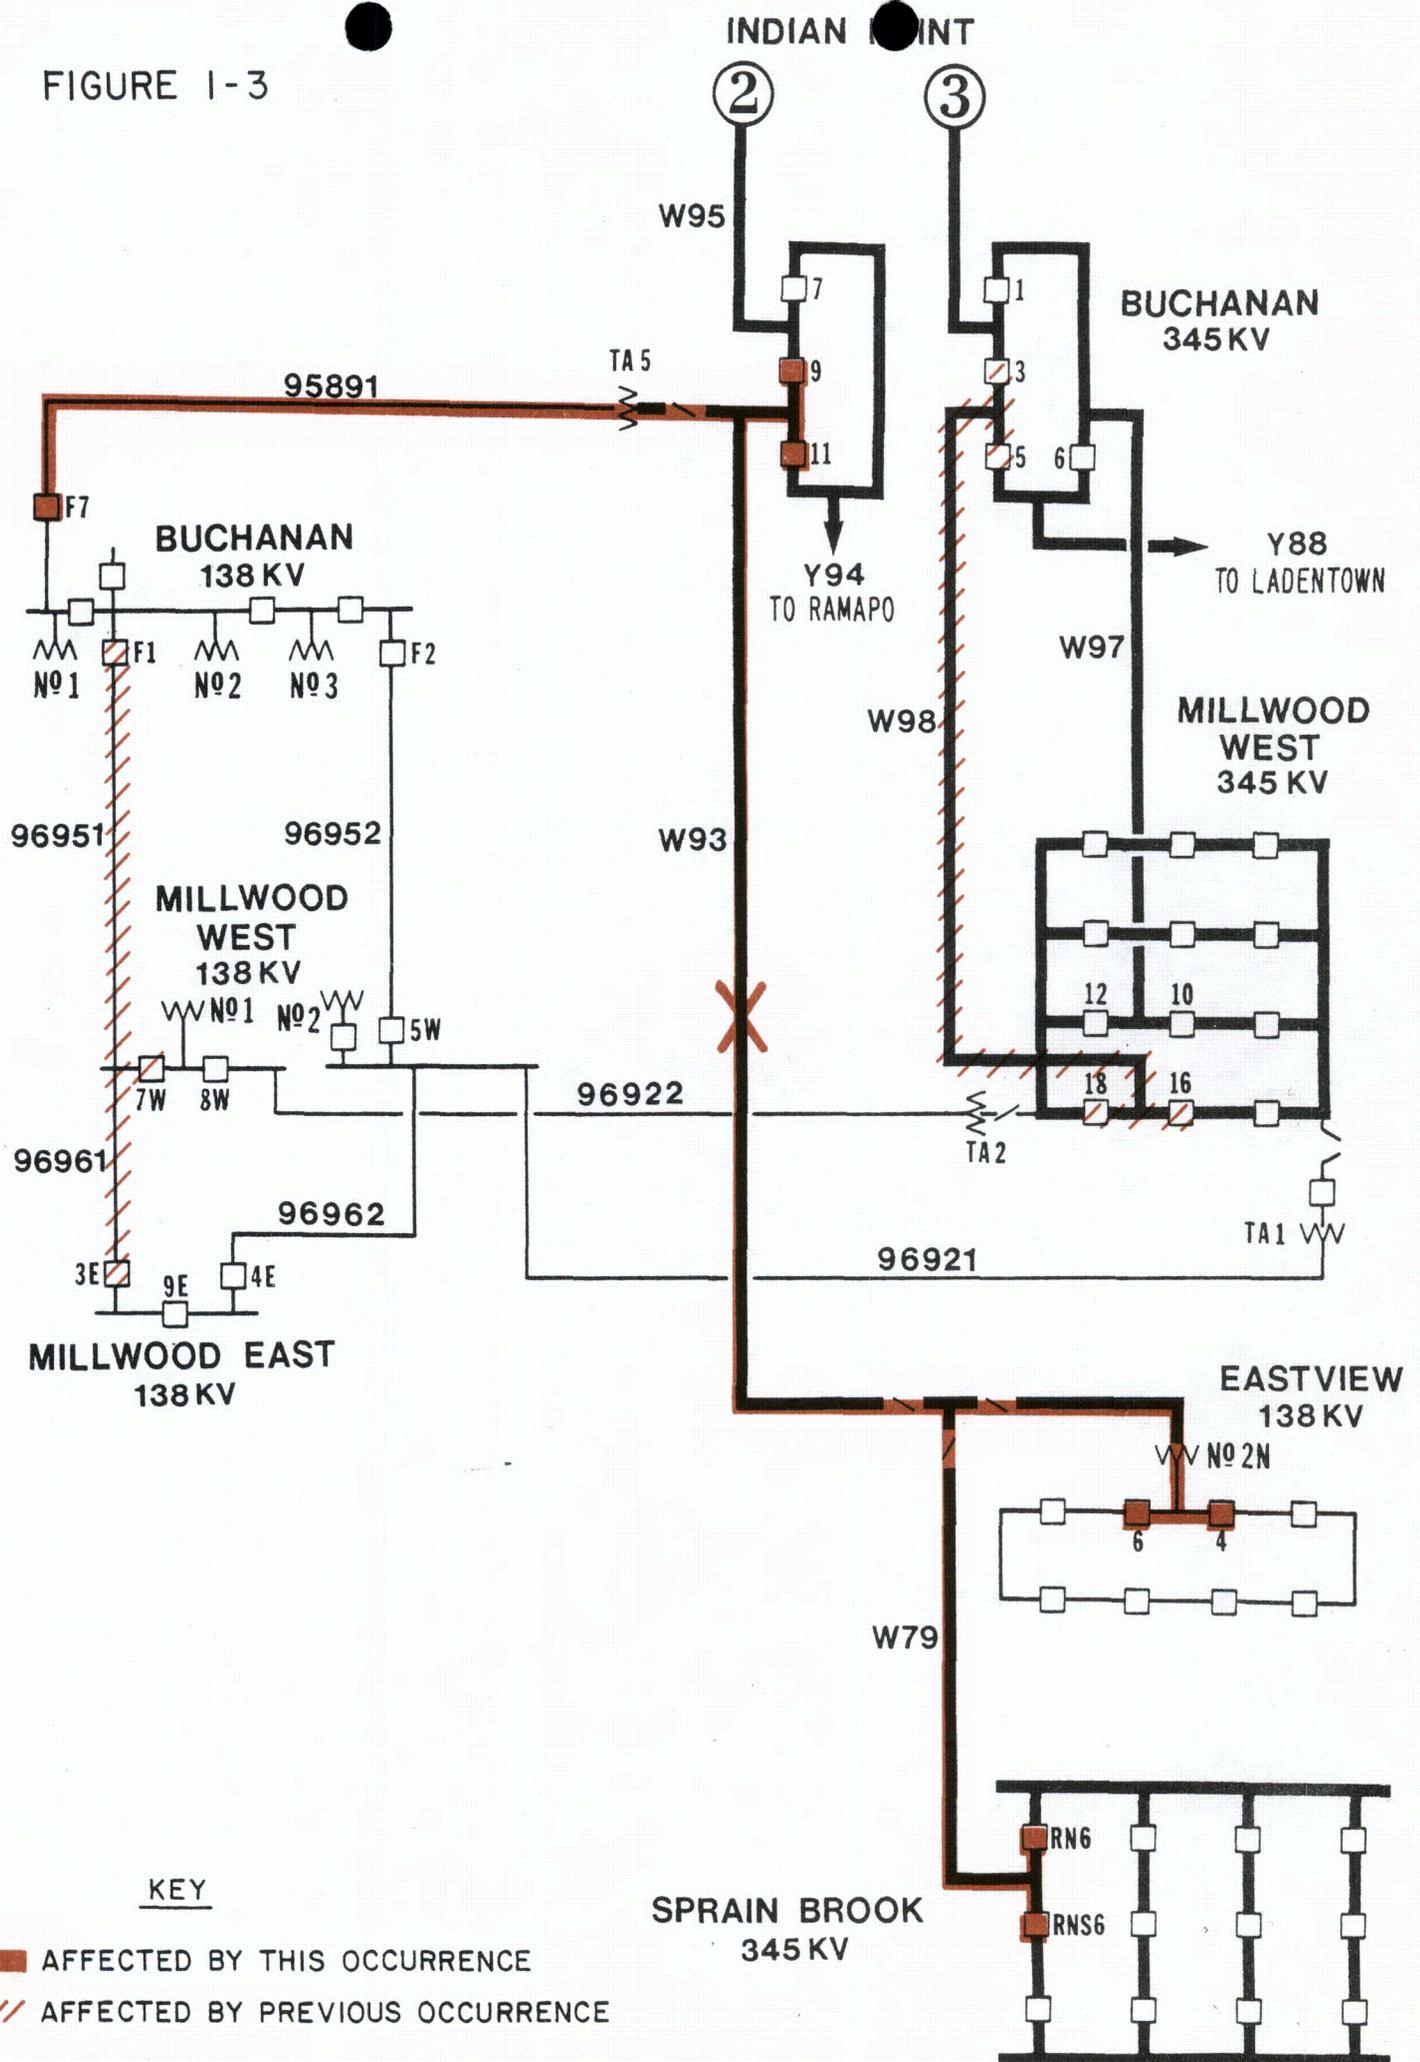
FIGURE 1-3

345 kV feeder W93/W79 experienced a B phase fault caused by the 96951 shield wire contacting the phase conductor. This quickly developed into a A-B ground fault before breakers at Buchanan (9, 11 and F7) and Sprain Brook (RN6 and RNS6) opened automatically. The shield wire fell across the three phases before the feeder was deenergized by breakers 4 and 6 at Eastview.

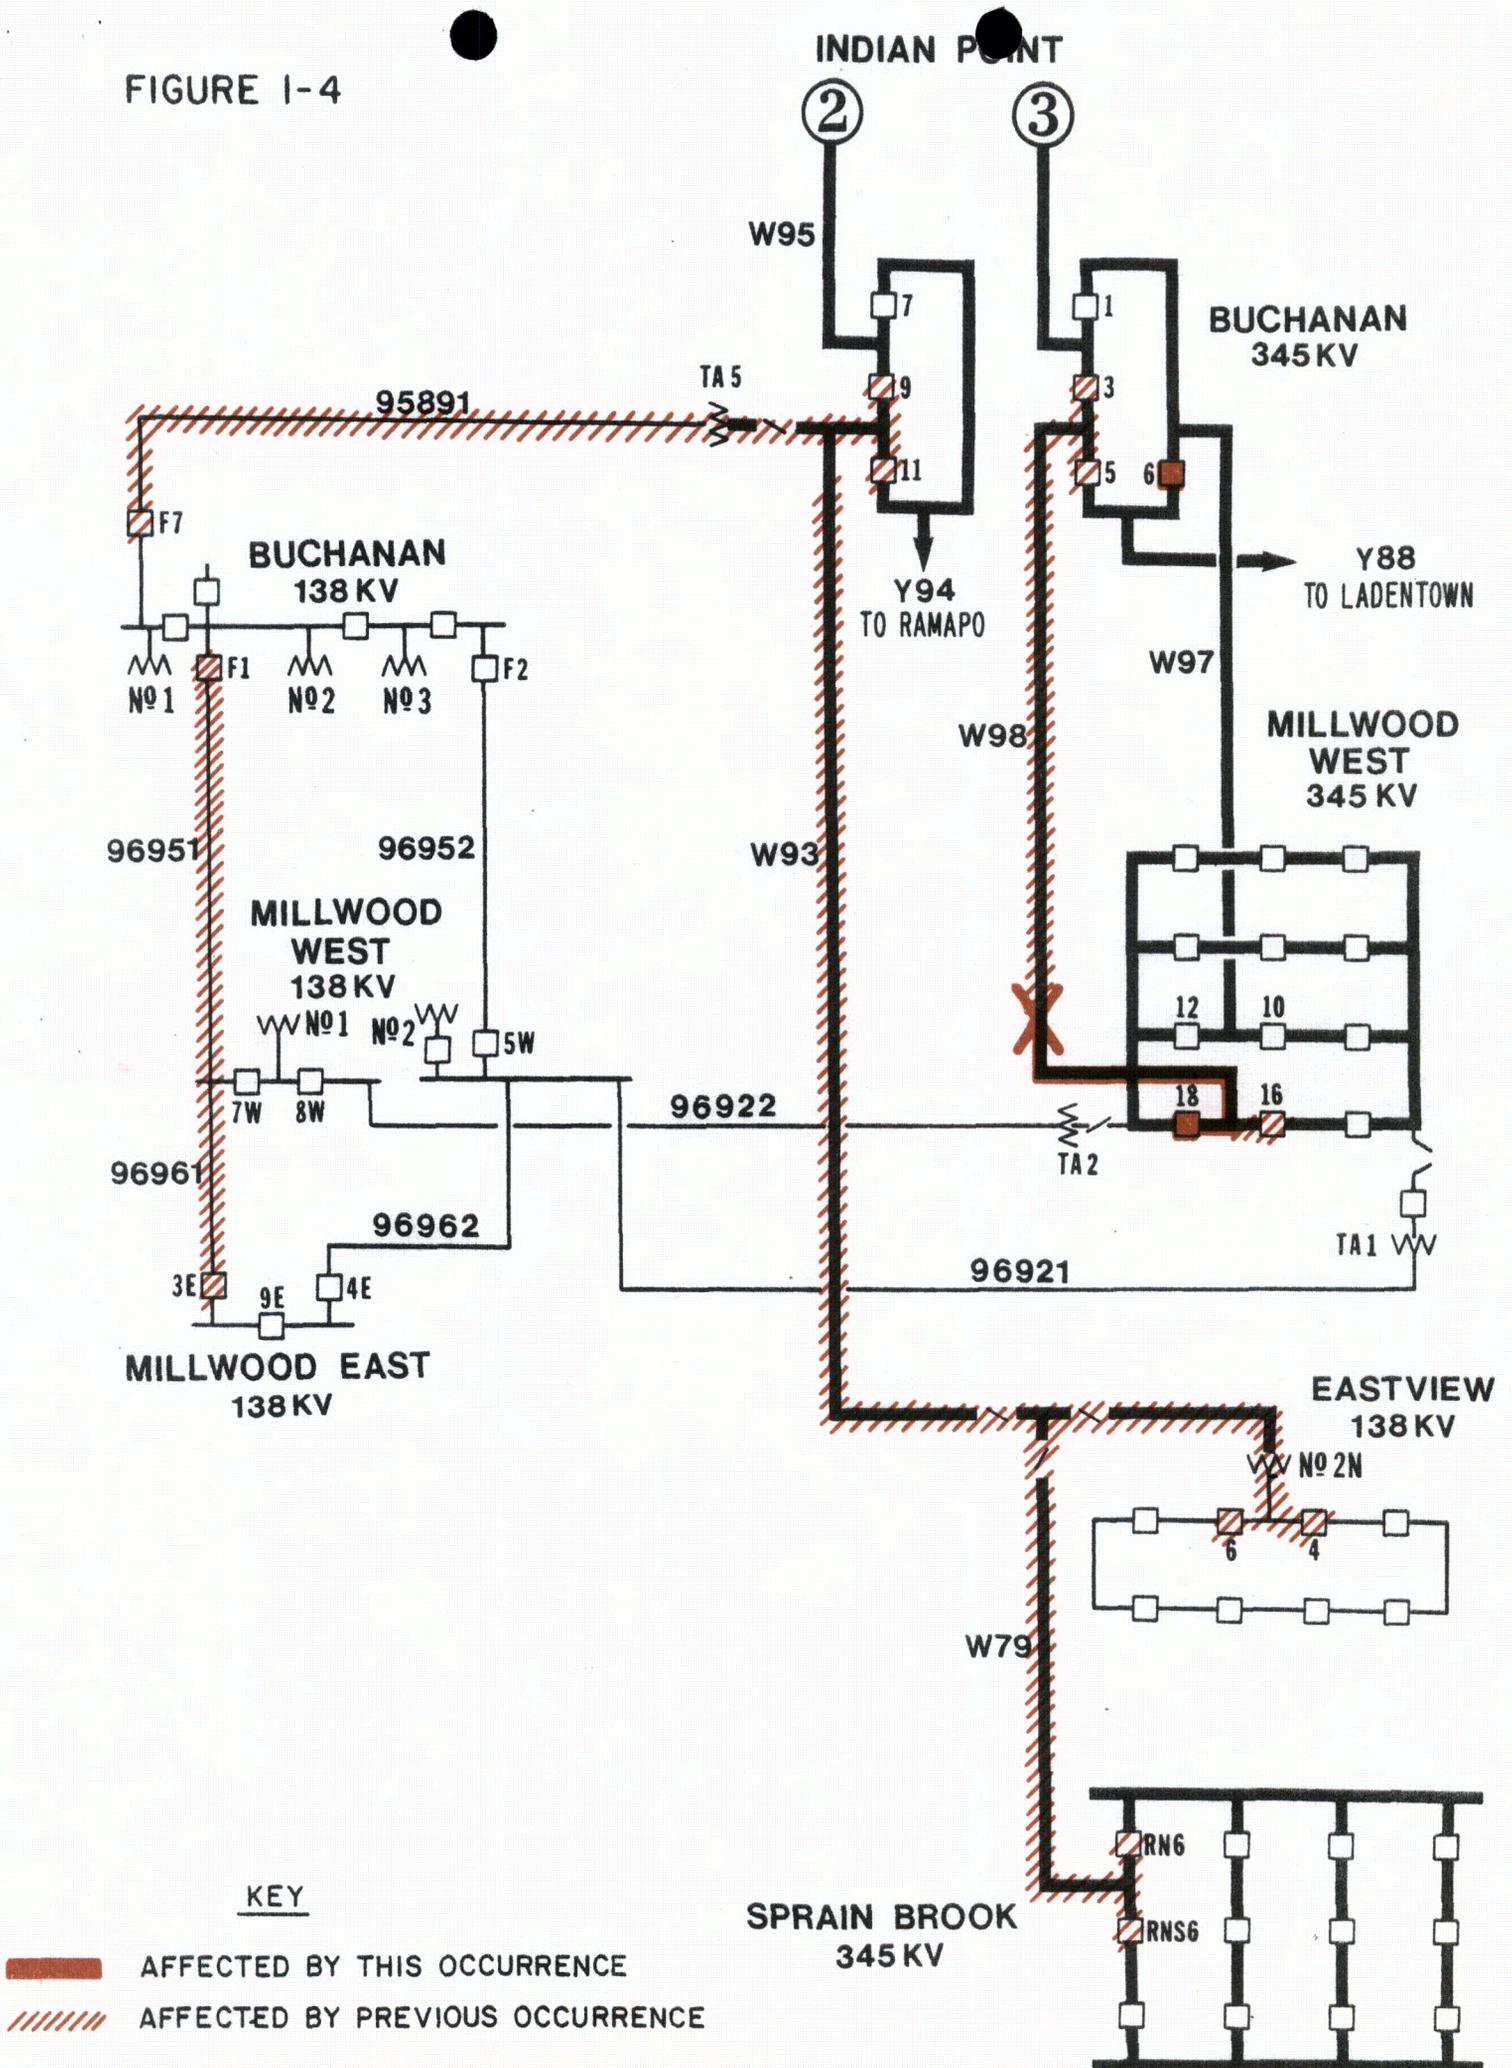
FIGURE I-4

Feeder W98 breaker 18 at Millwood reclosed into a three phase fault and reopened. Breaker 6 at Buchanan opened auto via misoperation of line relaying at Buchanan on Feeder Y88. No trouble has been found to date. Additional equipment is being connected to monitor the protective relay system.

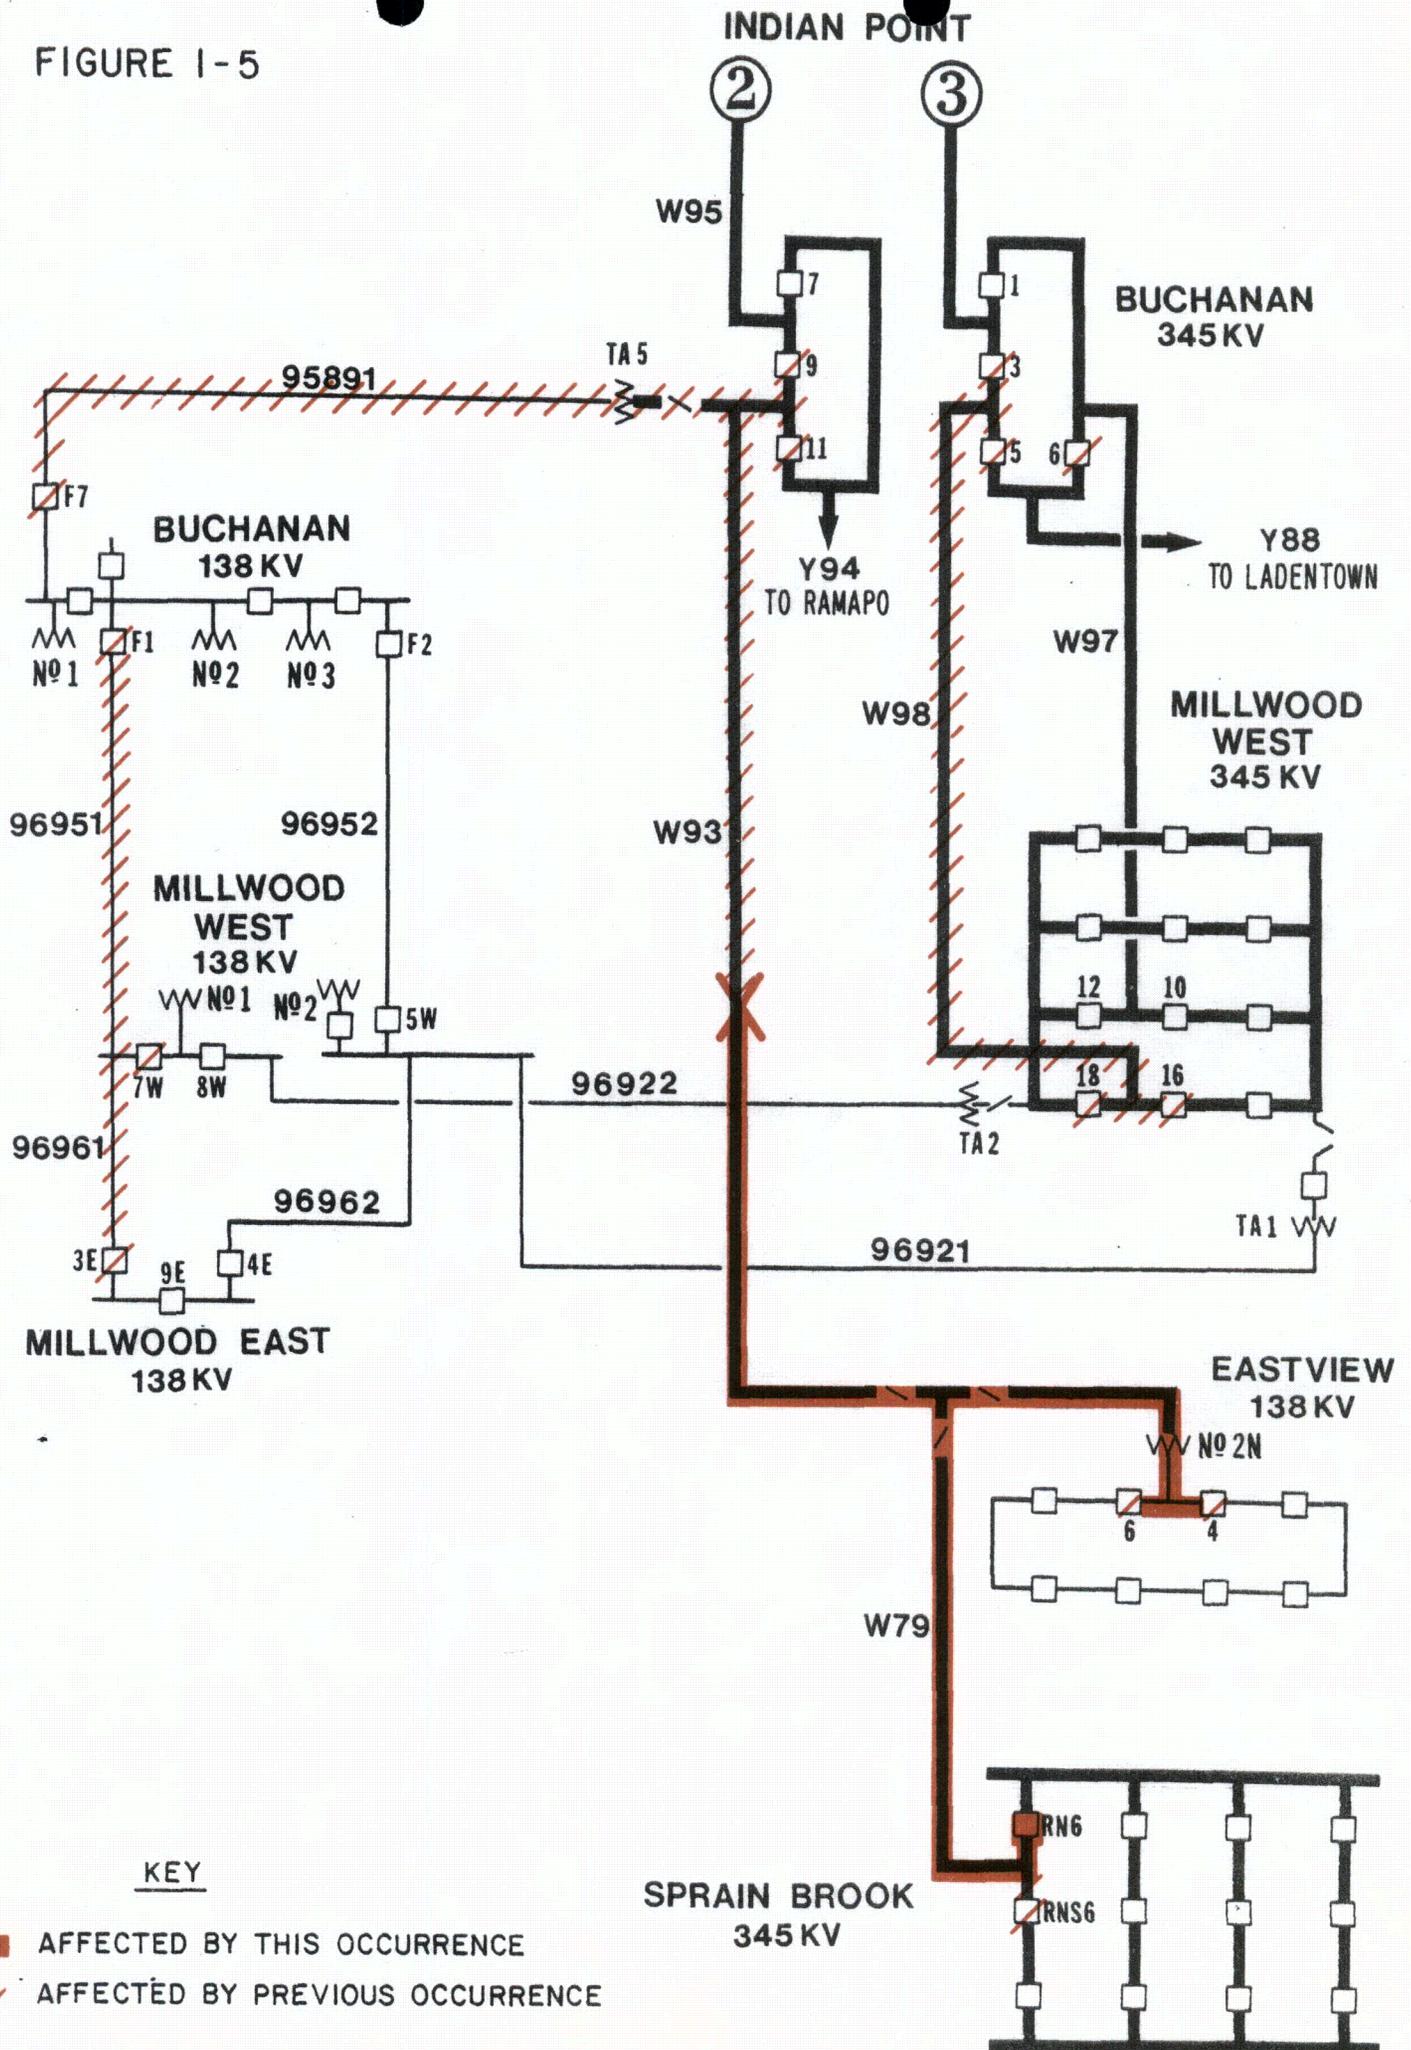
FIGURE I-5

Feeder W93/W79 breaker RN6 at Sprain Brook  
reclosed into a three phase fault and reopened.
