Docket No. 50-247  
LER-80-006/99X-1

Consolidated Edison Co. of NY Inc.  
Indian Point Unit No. 2

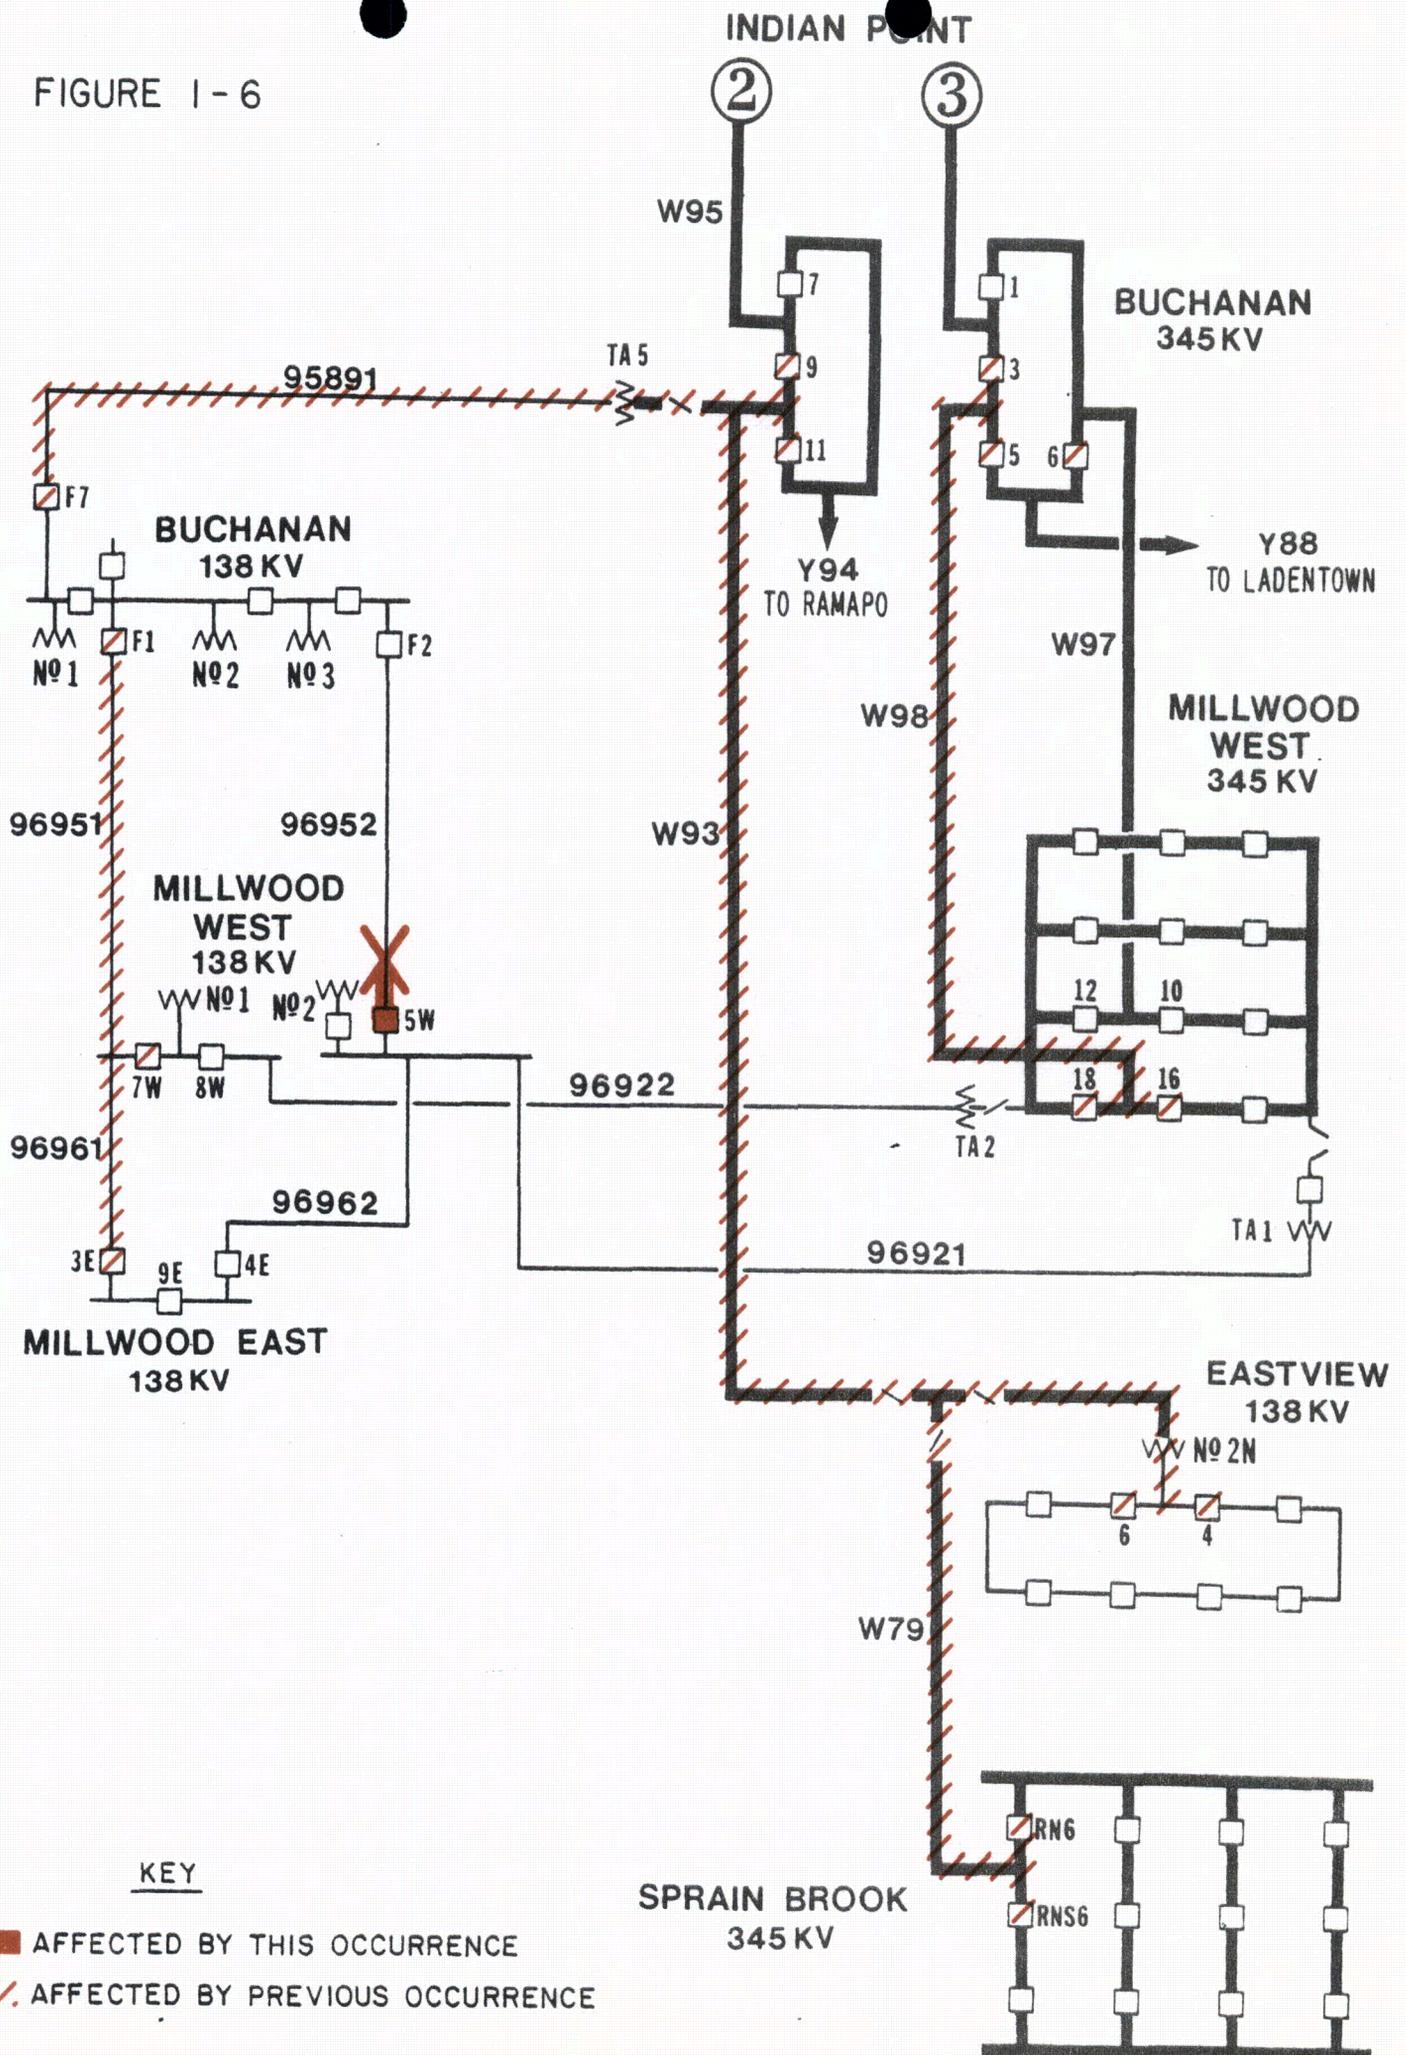
FIGURE 1-6

138 kV Feeder 96952 experienced a B phase fault initiated by a splice failure that caused its shield wire to fall into the feeder. Protective relays opened breaker 5W at Millwood. The Buchanan breaker F2 remained closed because the Buchanan bus had no source for ground current to trip the breaker. Breaker 5W reclosed and reopened.

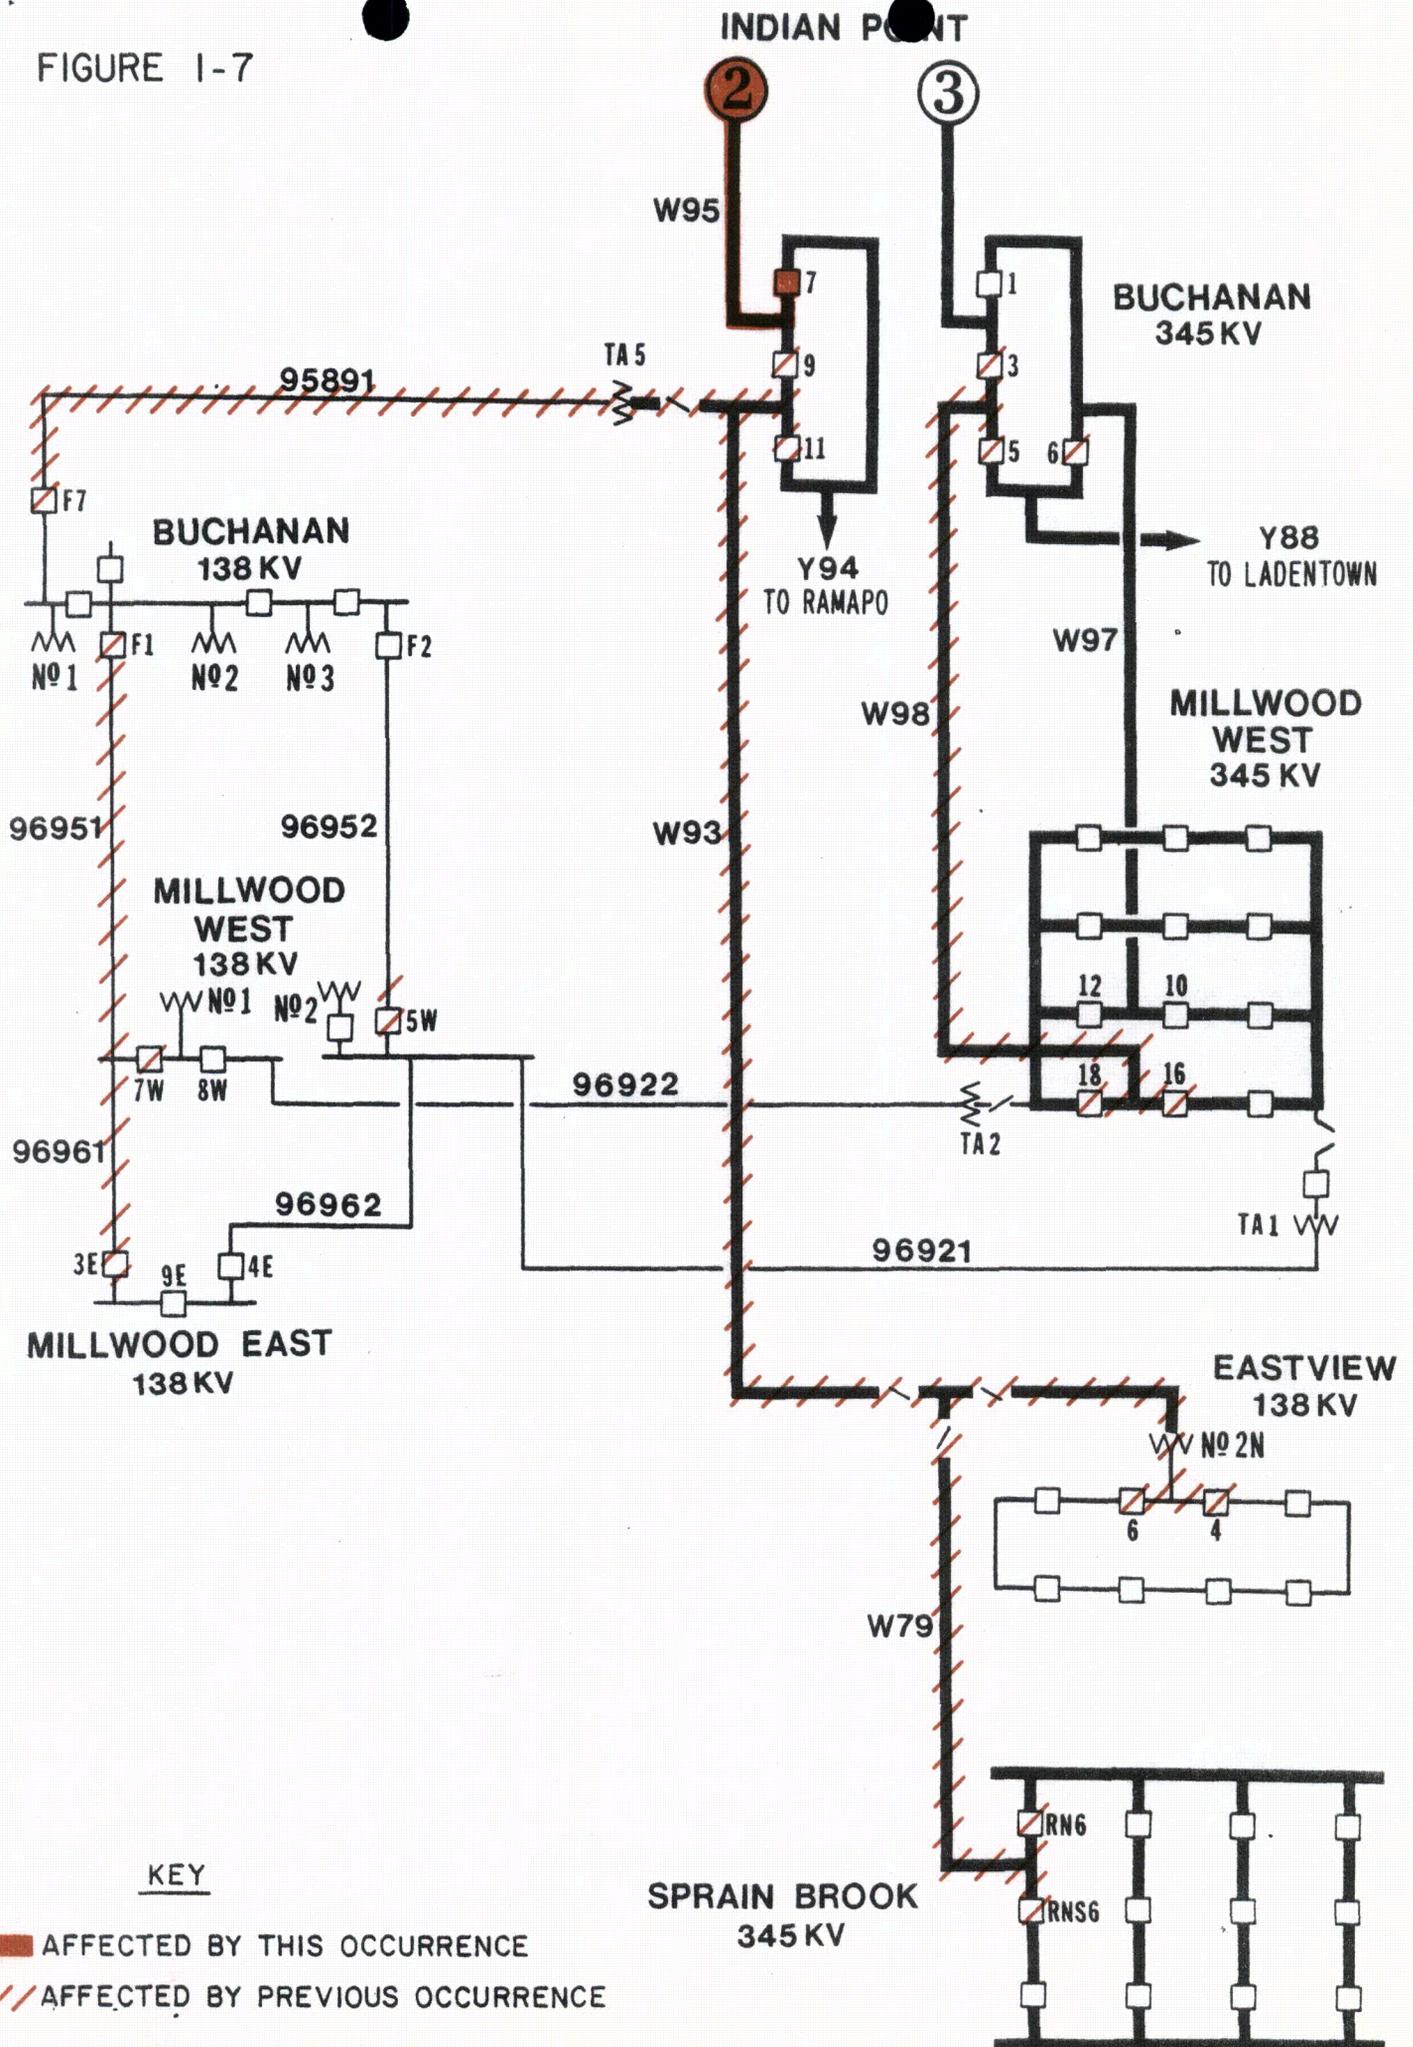
FIGURE 1-7

Operator tripped Indian Point #2 turbine. At sometime between the operator's action of manual turbine trip and the 30 second timing sequence, it was reported that the unit tripped as a result of a direct trip from the Buchanan Substation. Subsequent testing showed that the circuits were operating properly. Since it is possible that premature tripping may have occurred due to an auxiliary trip relay operating as a result of a battery surge, the auxiliary trip relay was de-sensitized to improve security against unwanted operation.

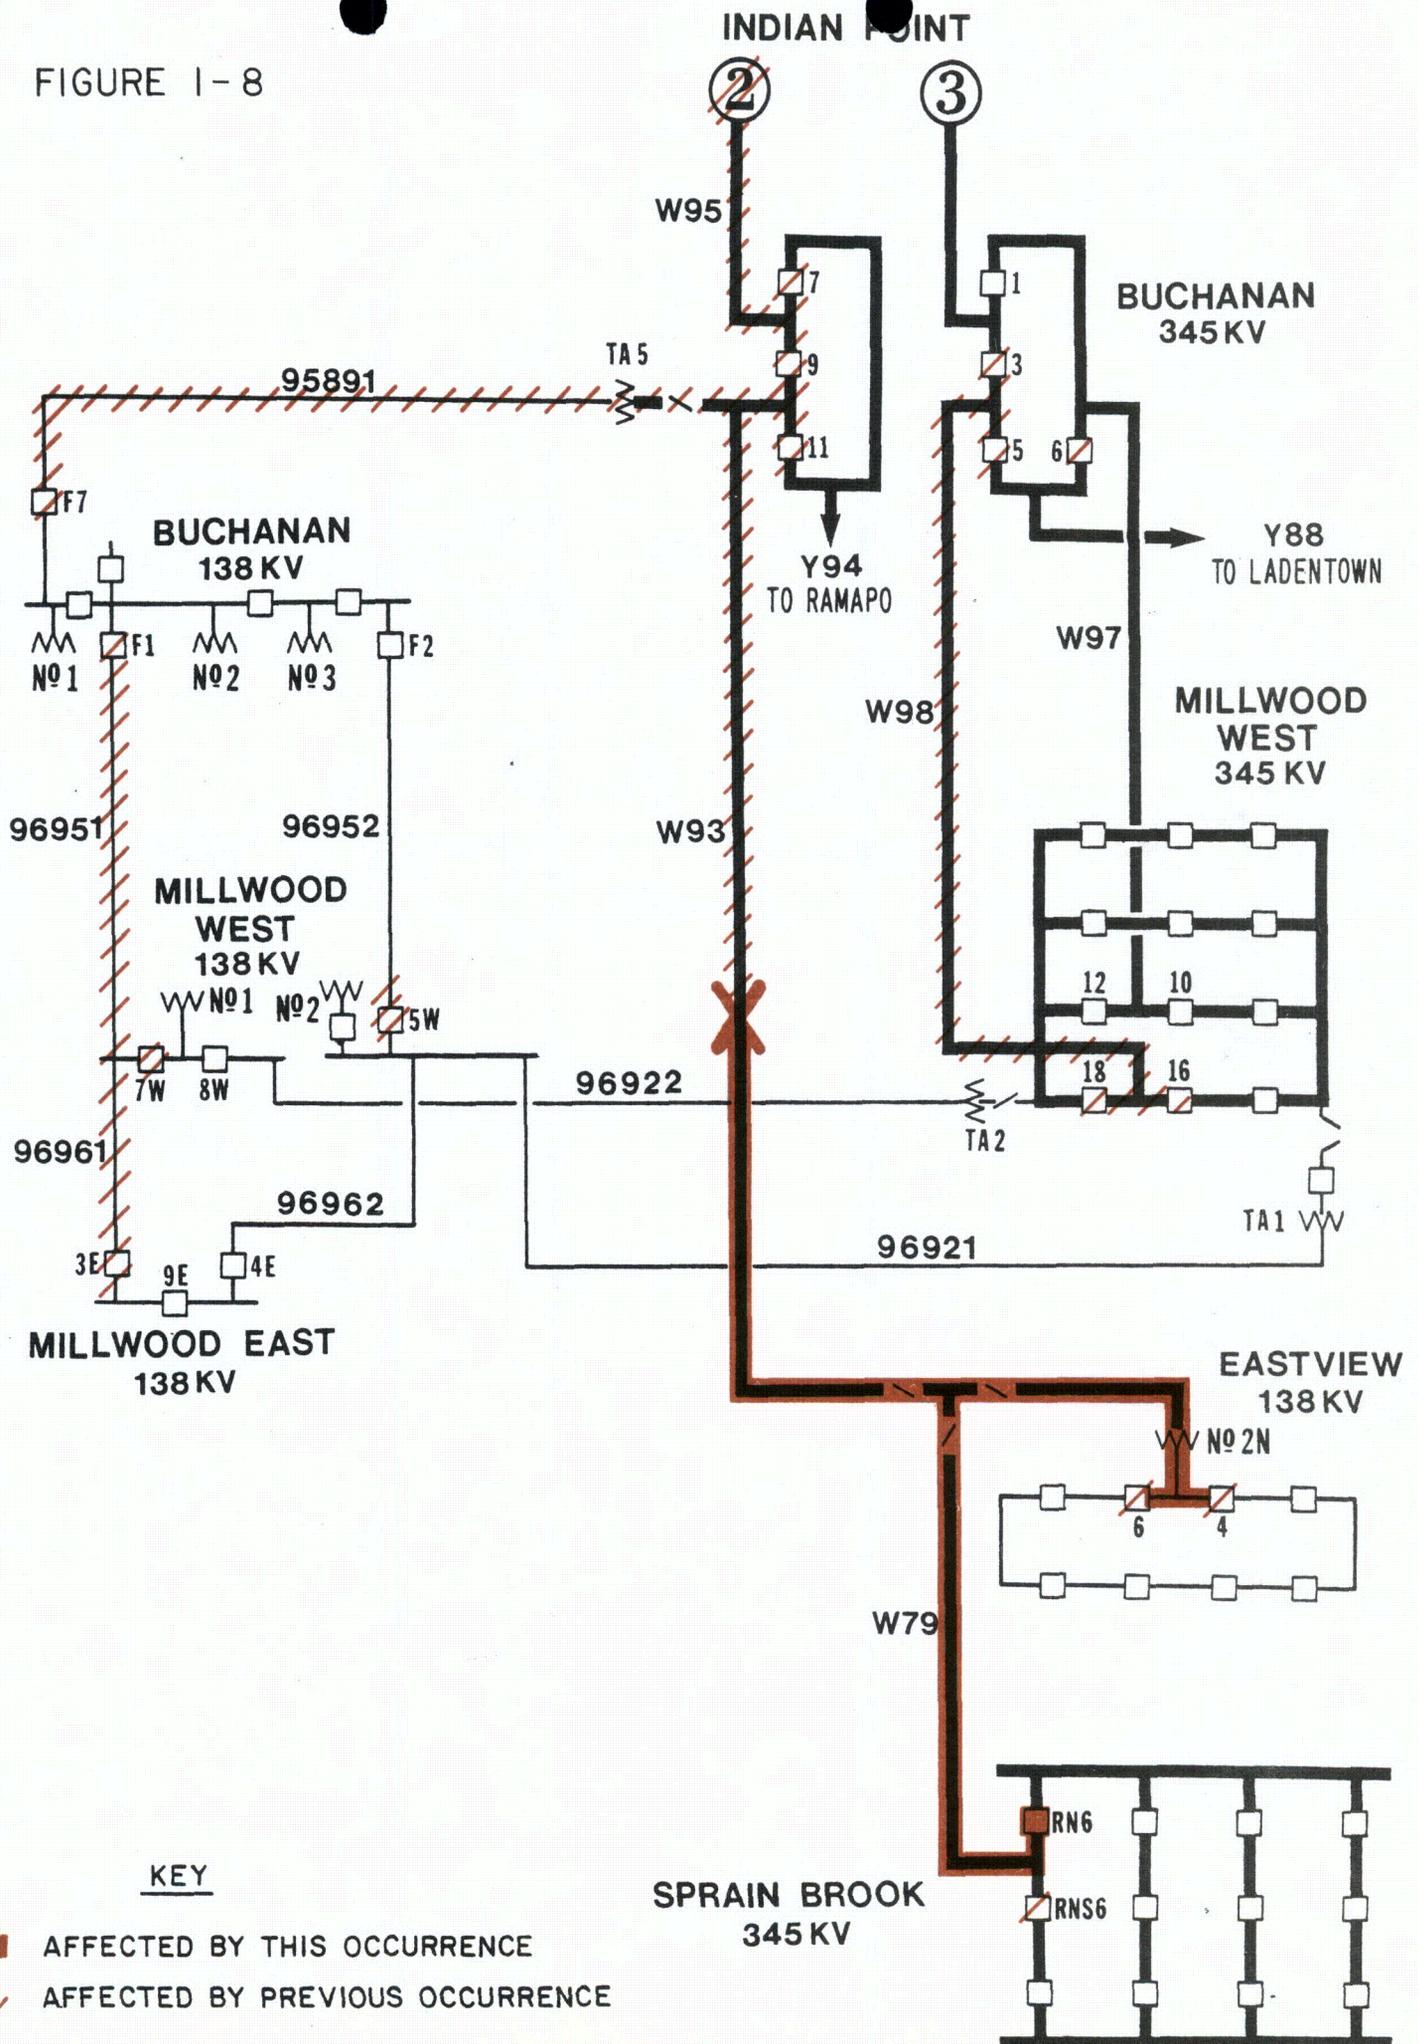
FIGURE 1-8

Operator closed breaker RN6 at Sprain Brook via supervisory in an attempt to reenergize feeder W93/W79. Breaker RN6 opened auto due to the three phase fault caused by the dropped shield wires.

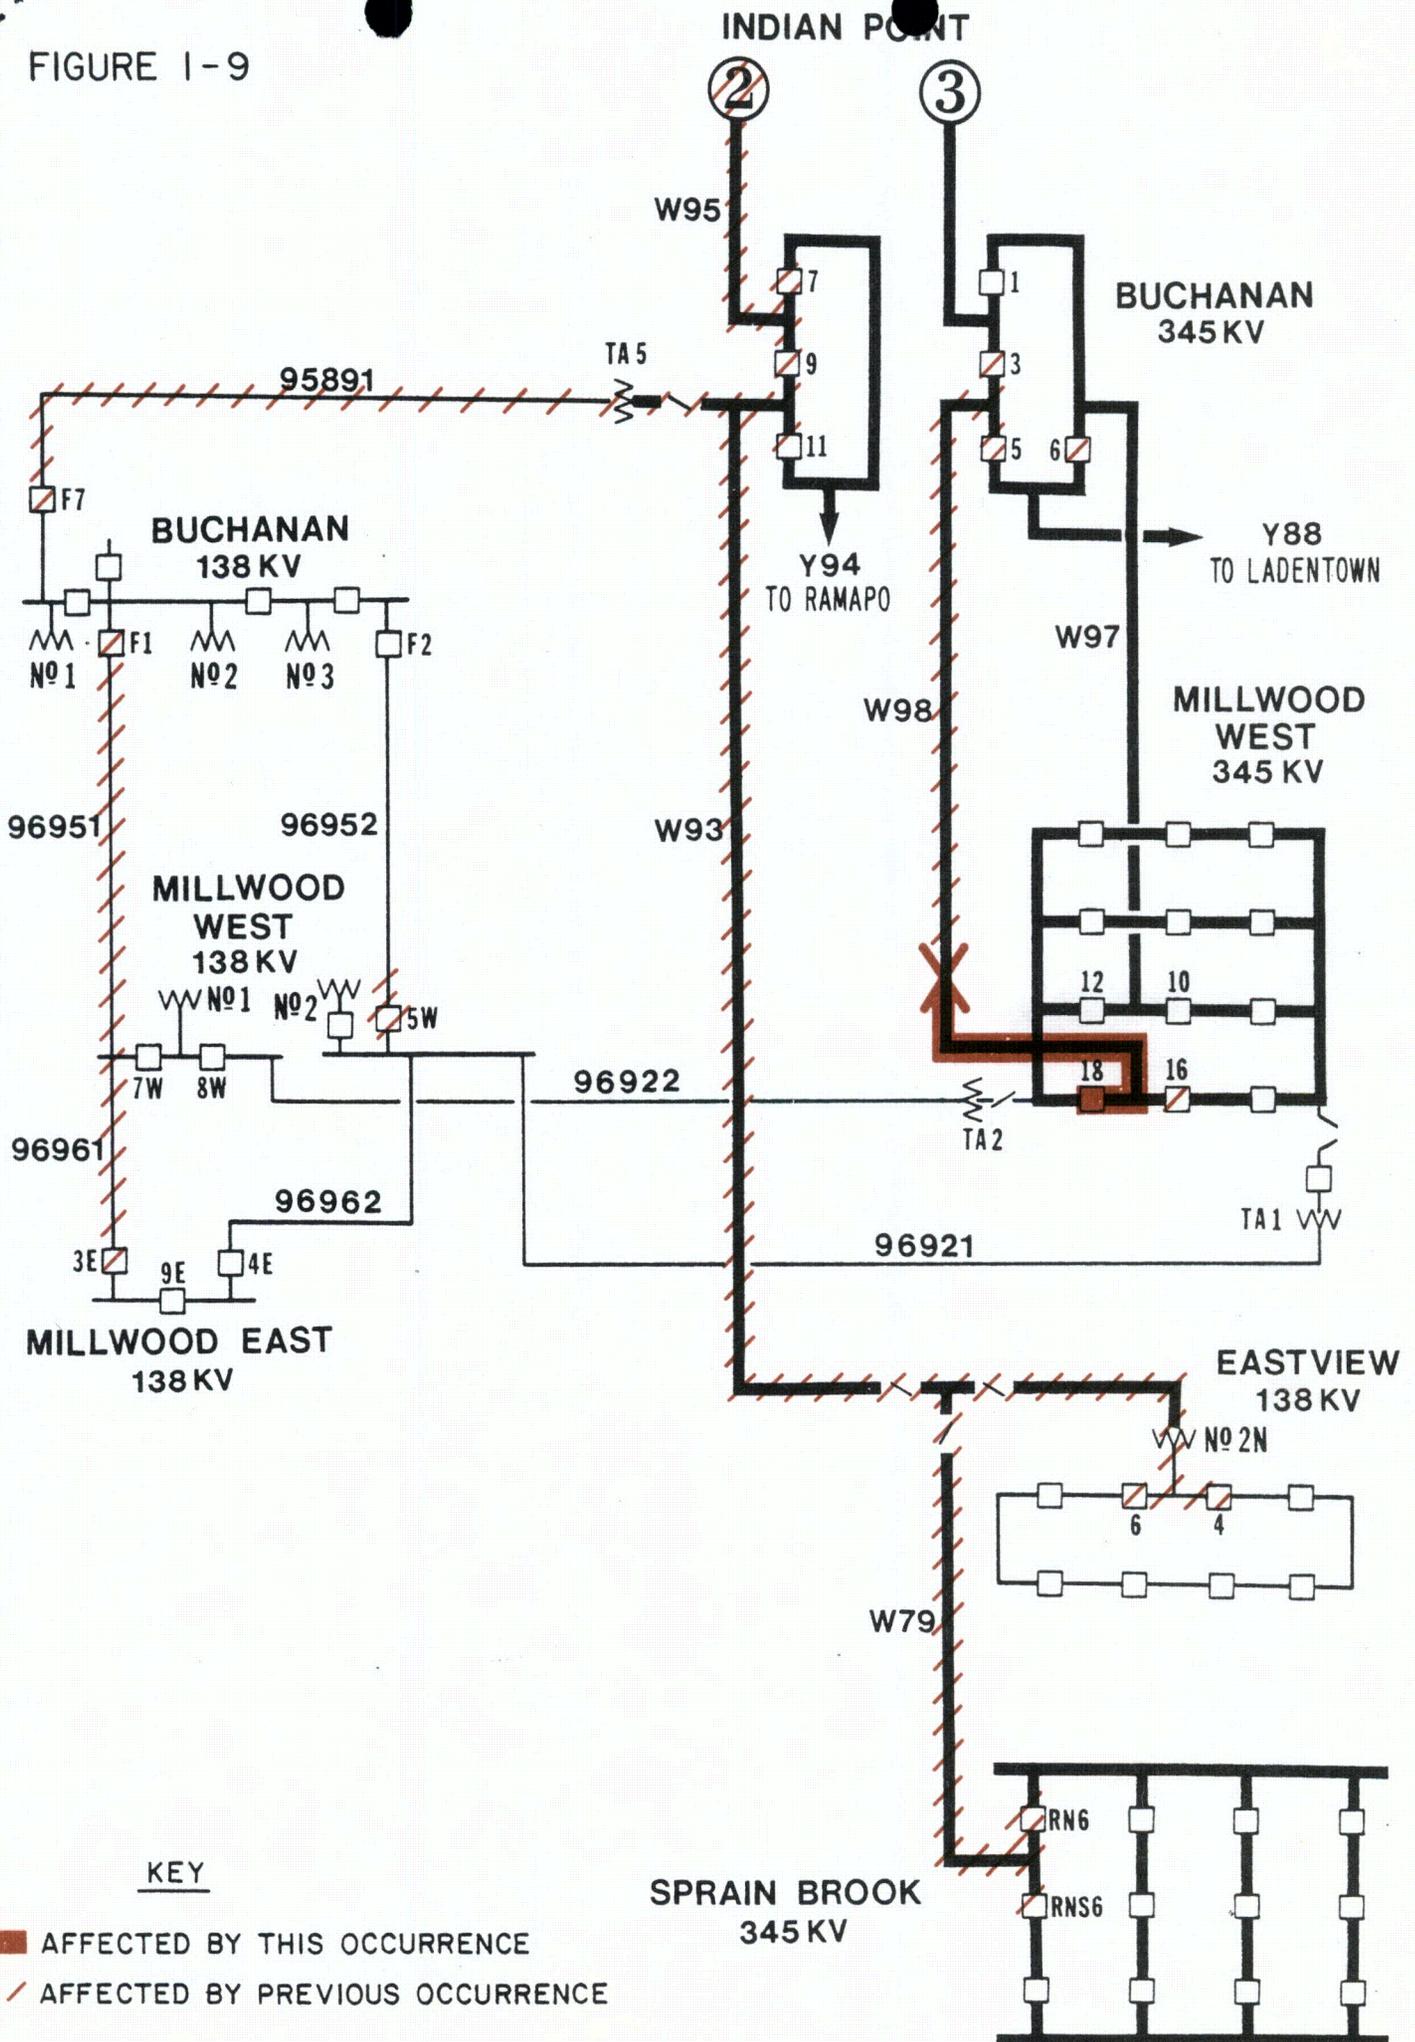
FIGURE 1-9

Operator closed breaker 18 at Millwood via supervisory in an attempt to reenergize Feeder W98. Breaker 18 opened auto to the three phase fault caused by the dropped shield wires across Feeder W98.

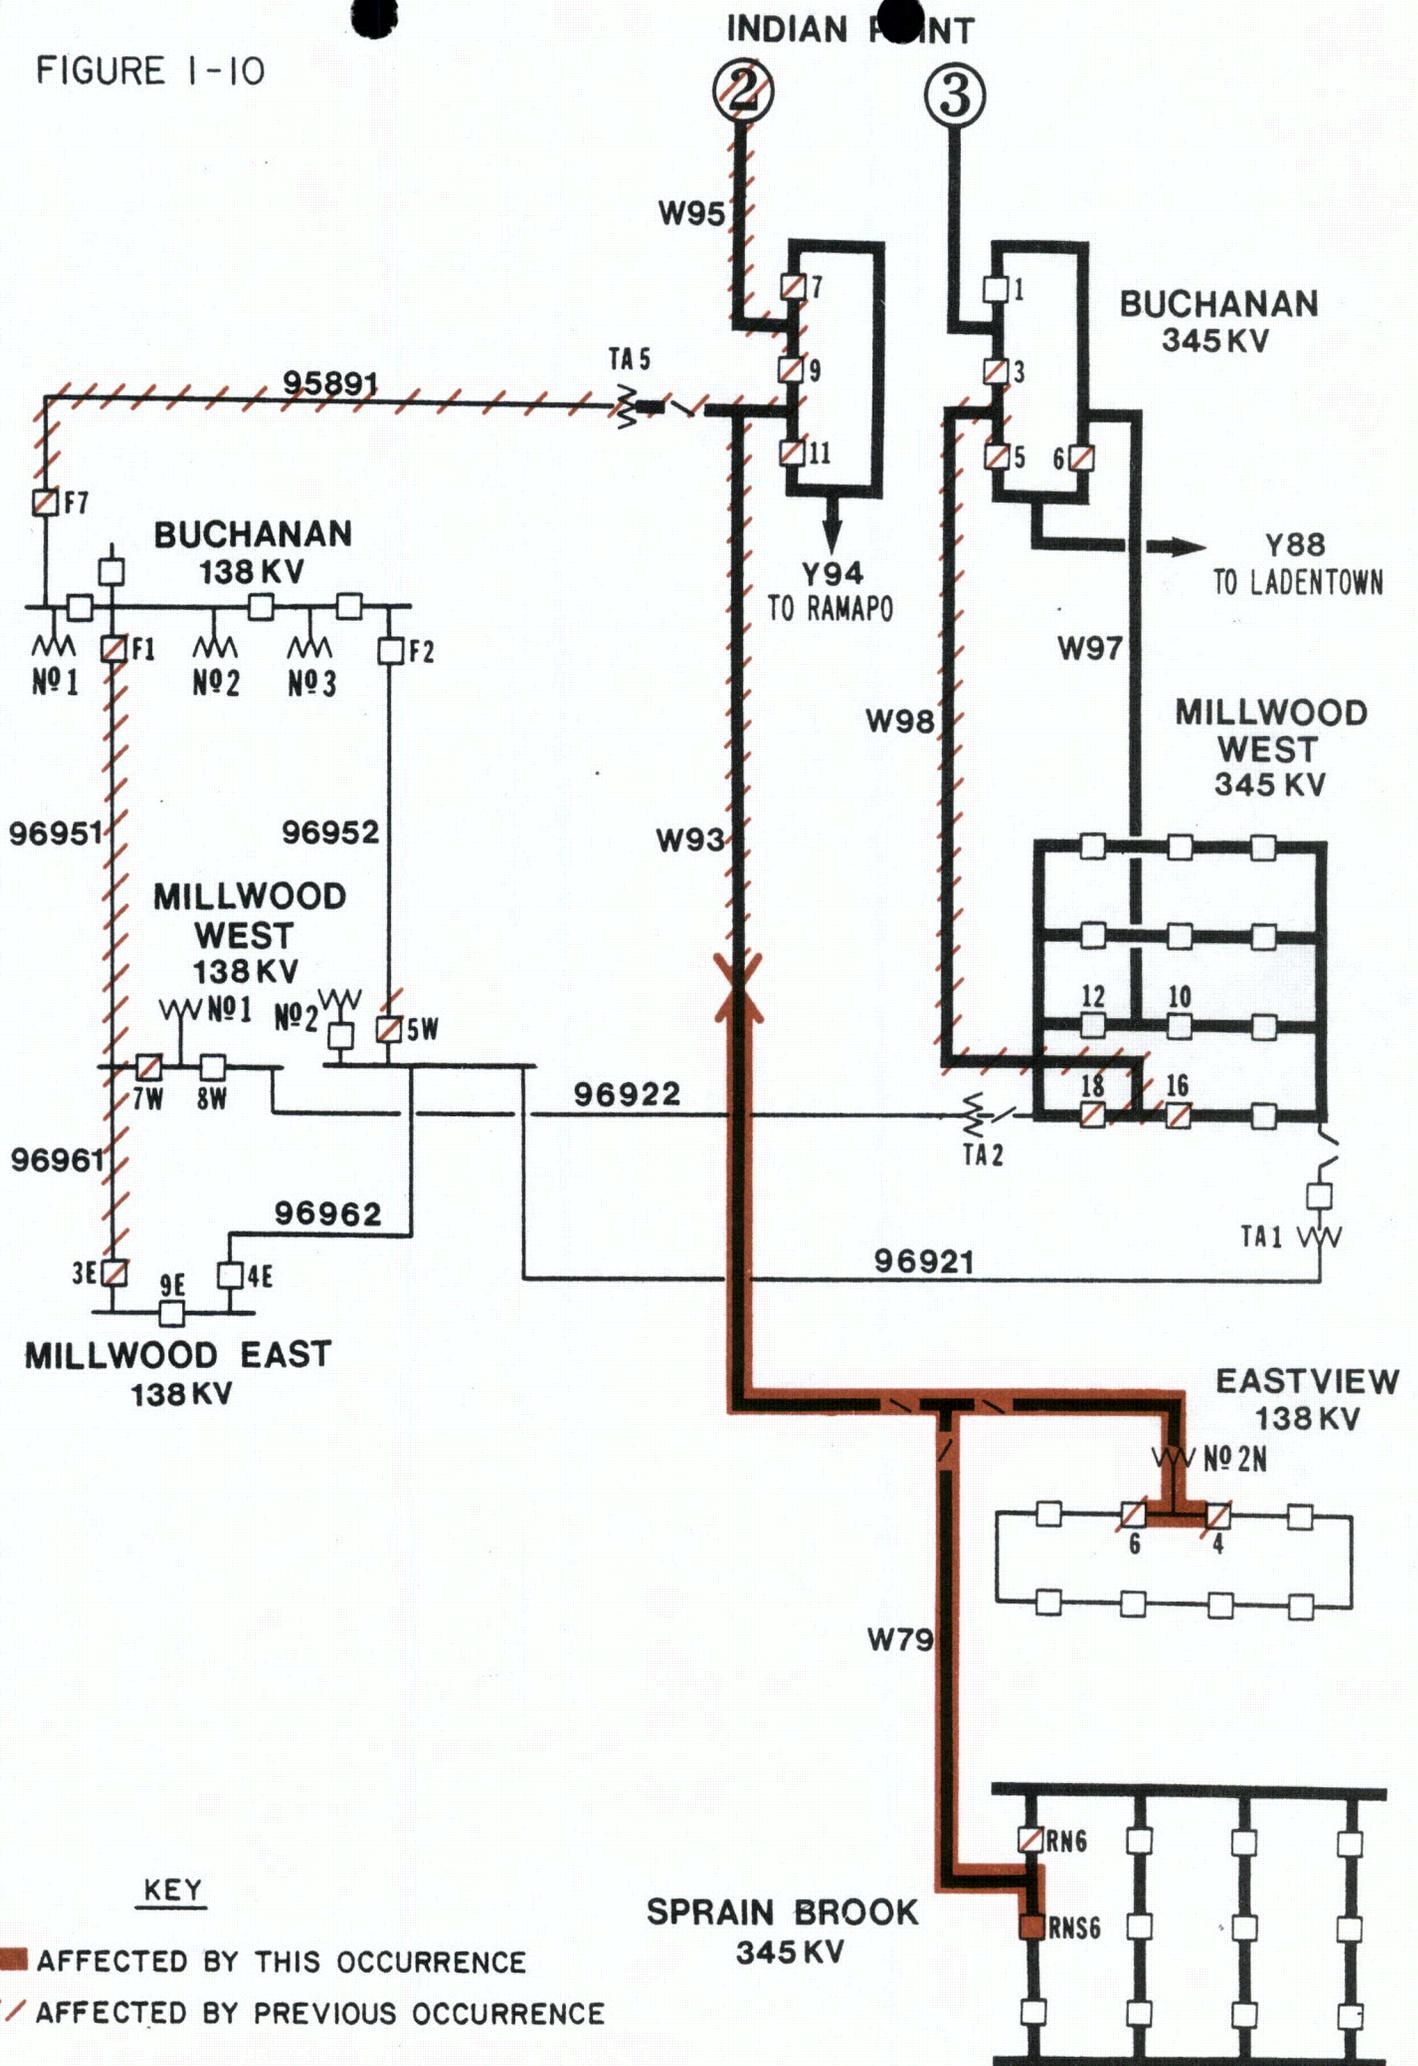
FIGURE I-10

14:58      Operator closed breaker RNS6 at Sprain Brook  
in an attempt to reenergize Feeder W93/W79.  
Breaker RNS6 opened auto due to the three  
phase fault caused by the dropped shield wires  
across Feeder W93.
