SUBJECT: CONSOLIDATED EDISON COMPANY, INDIAN POINT 2, DOCKET NO. 50-247  
INFORMAL REPORT ON THE CONTAINMENT BUILDING LINER PLATE BUCKLE IN THE  
VICINITY OF THE FUEL TRANSFER CANAL, DATED JANUARY, 1968

## PREFACE

## INTRODUCTION

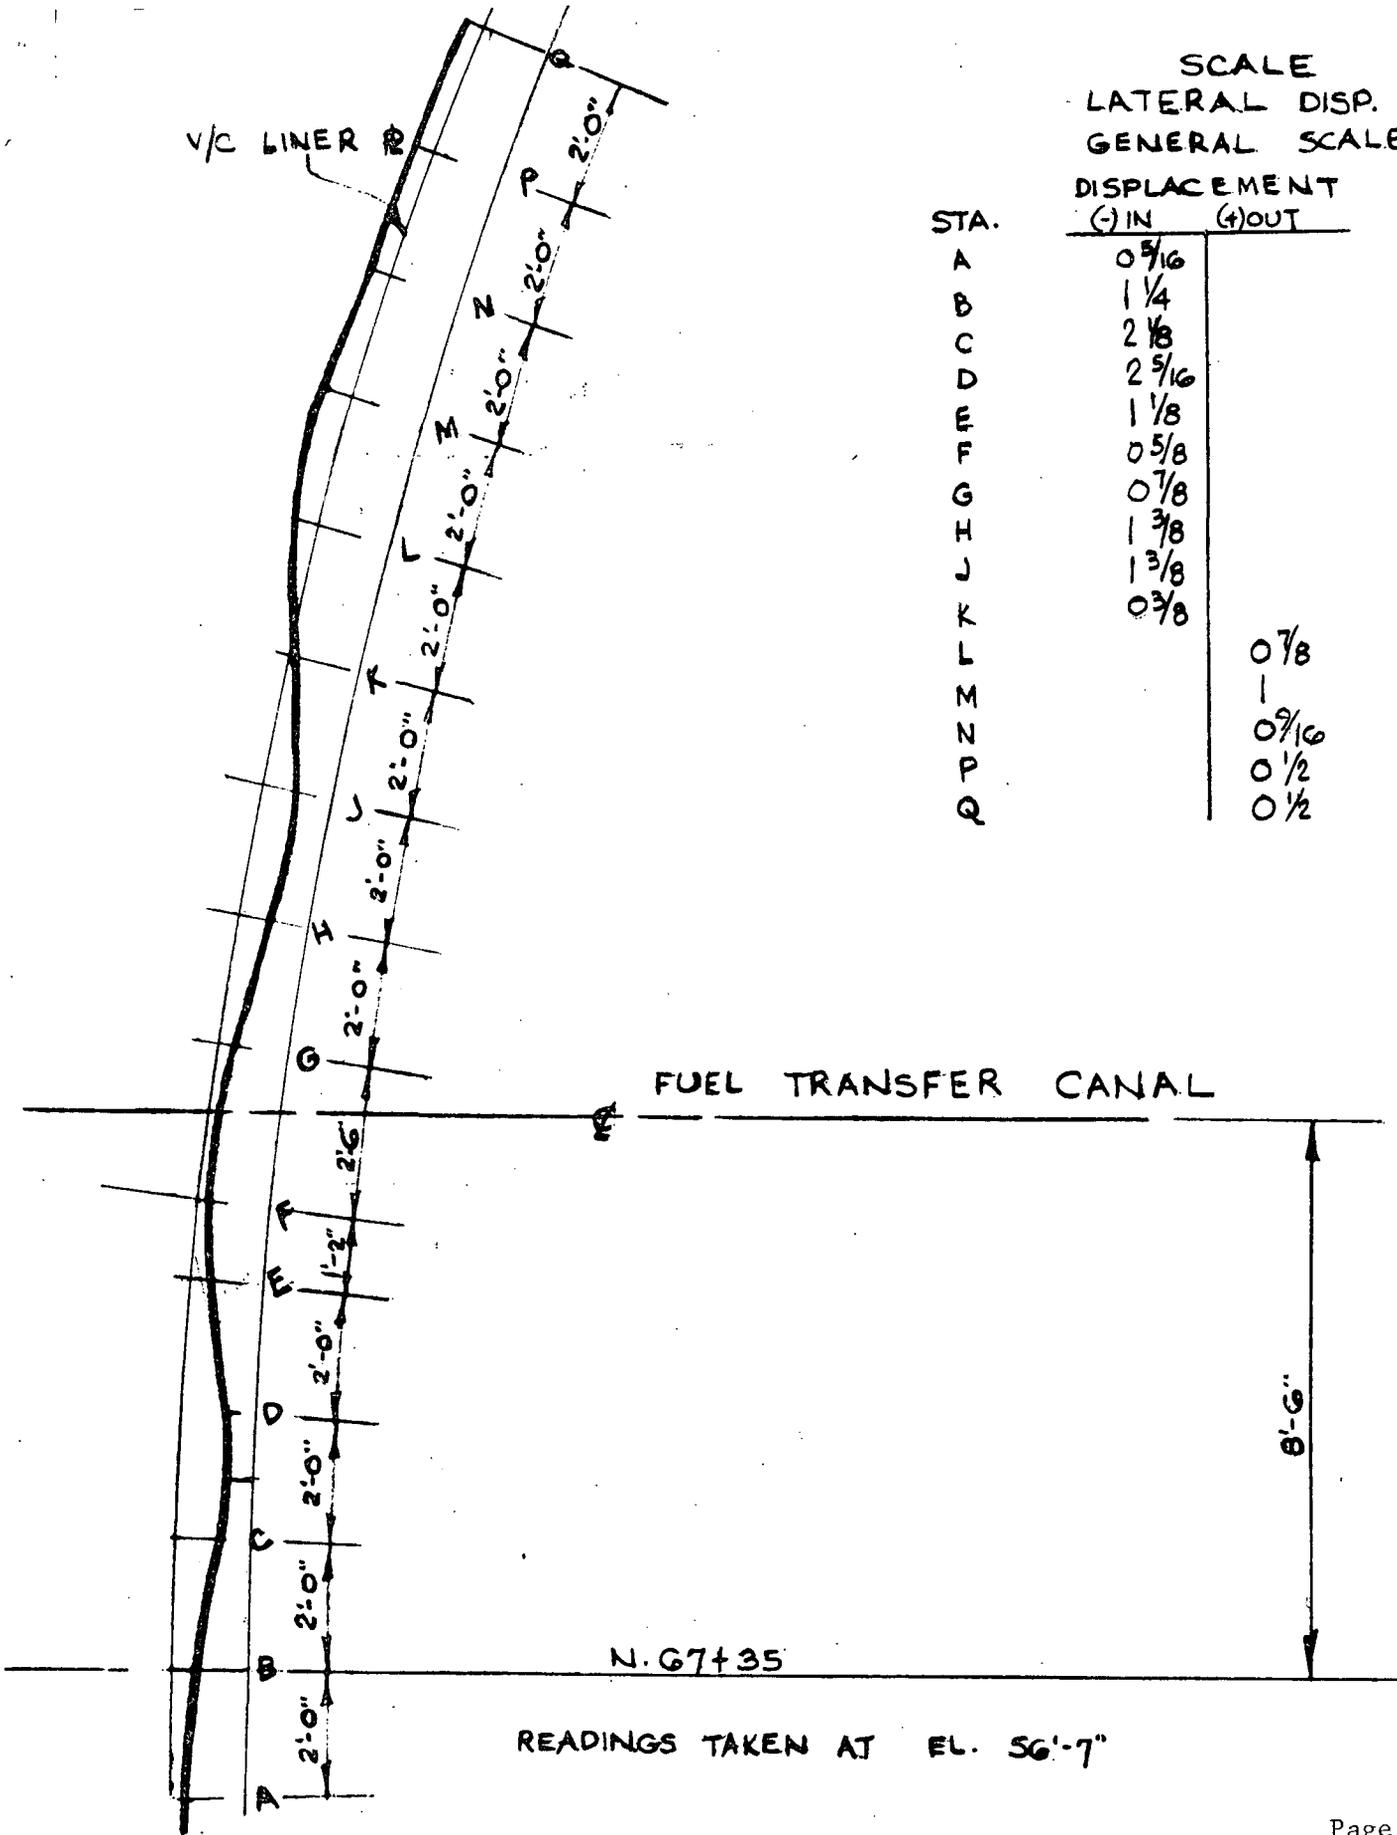
# FIGURE 2

Field measurements were taken at the buckled zone (elevations 56'-7" and 59'-7"). The measurements show the distance the liner had buckled from a normal position at various stations. This information is shown on the attached Figures 2 and 3. Figure 4 is a plot of this data in the form of a contour map of the buckled zone.

Specification 9321-01-225-3, Containment Building Liner, allows 2" tolerance for local buckling. From the above information, it is noted that points C and D at elevation 56'-7" were beyond the acceptable limits by 1/8" and 5/16", respectively.

STA.	DISPLACEMENT	
	( ) IN	( ) OUT
A	0 5/16	
B	1/4	
C	2 1/8	
D	2 5/16	
E	1 1/8	
F	0 5/8	
G	0 7/8	
H	1 3/8	
I	1 3/8	
J	0 3/8	
K		
L		0 7/8
M		1
N		0 9/16
O		0 1/2
P		0 1/2
Q		
R

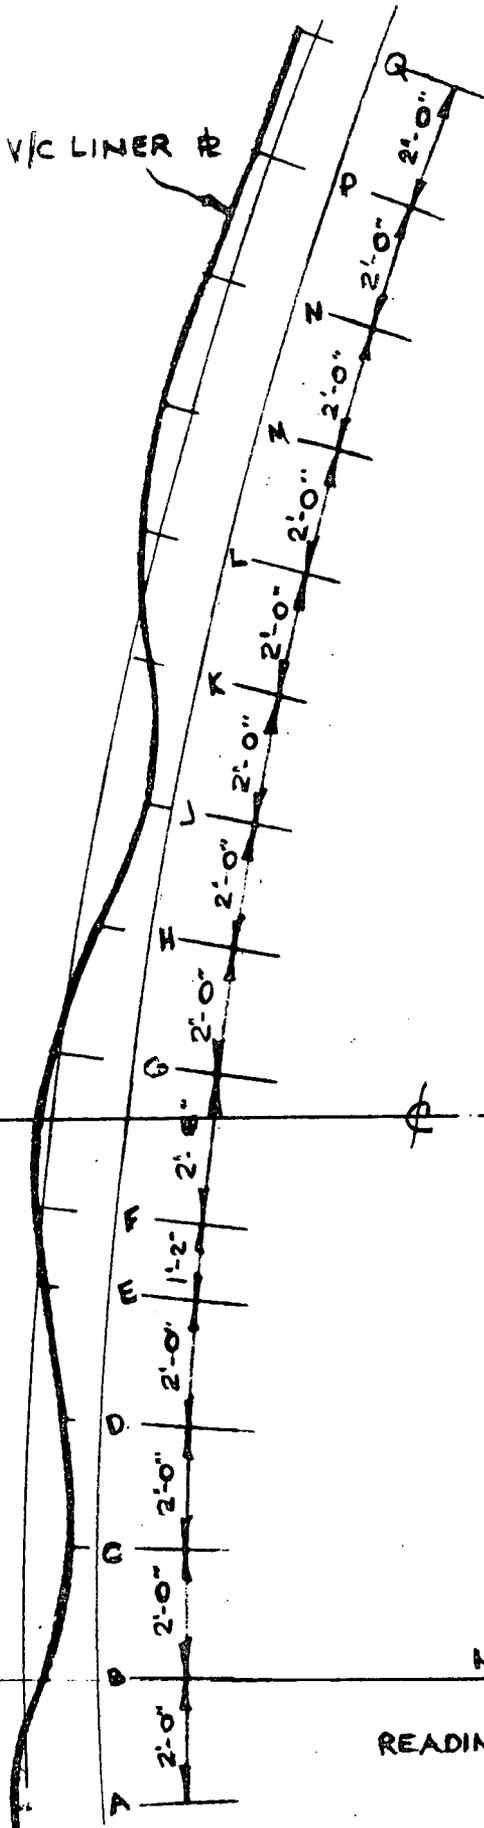
# FIGURE 3

STA.	DISPLACEMENT	
	(-) IN	(+) OUT
A		0/8
B		
C	1	
D	5/8	
E	0 7/8	
F		0/8
G		0/16
H	1/4	
I	15/16	
J		
K		
L		0 3/8
M		1 1/16
N		0 7/8
O		0 1/2
P		0 3/4

READINGS TAKEN AT EL. 59'-7"

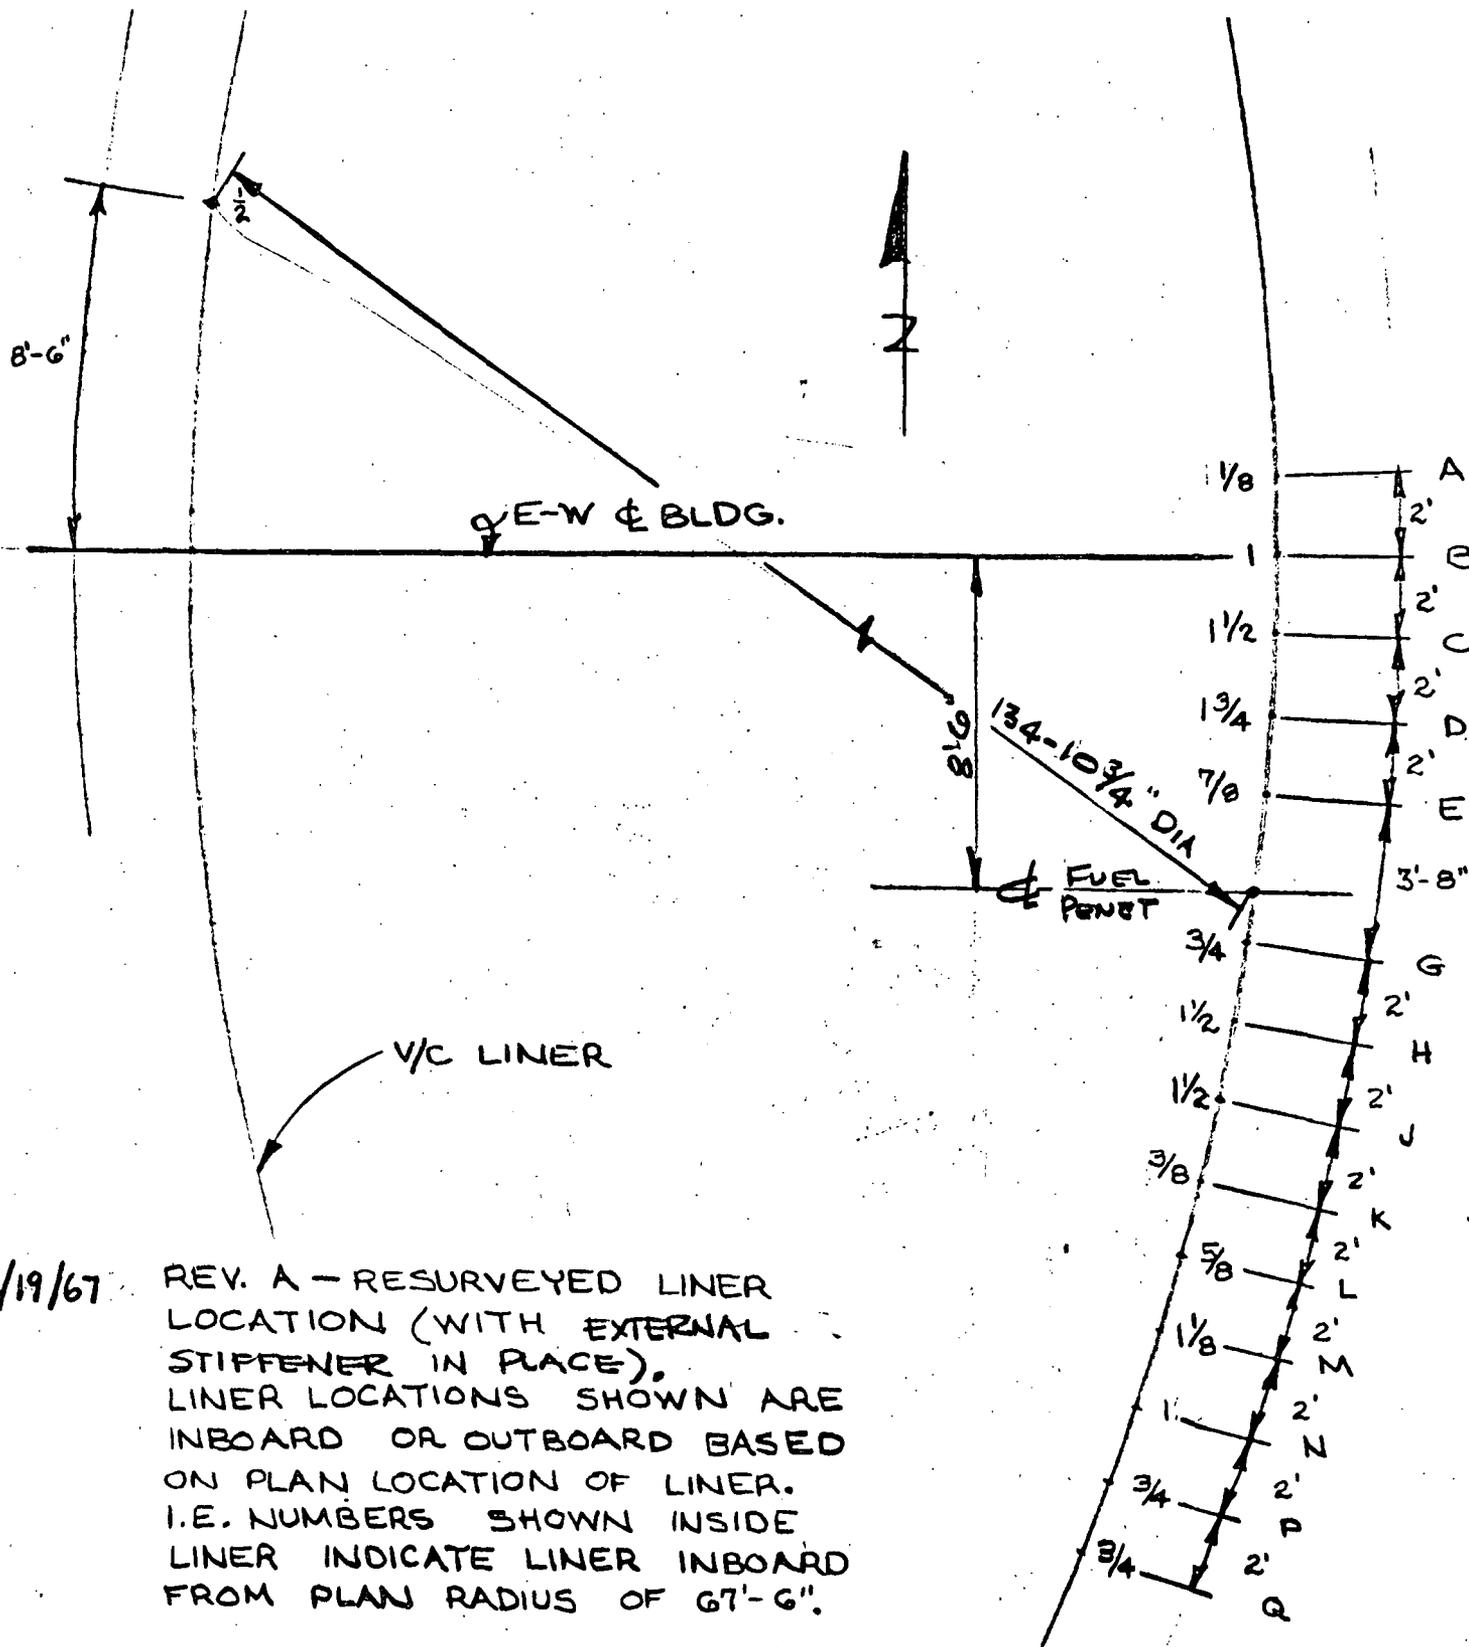
# FIGURE 7

Figures 7, 8 and 9 show the liner configuration after corrective action was taken. Figure 10 is a contour map of the buckled zone after corrections and in addition, all of the studs including the original installation and the additional studs are shown. At all points the liner is within the allowable tolerances.

12/19/67  
 REV. A - RESURVEYED LINER  
 LOCATION (WITH EXTERNAL  
 STIFFENER IN PLACE).  
 LINER LOCATIONS SHOWN ARE  
 INBOARD OR OUTBOARD BASED  
 ON PLAN LOCATION OF LINER.  
 I.E. NUMBERS SHOWN INSIDE  
 LINER INDICATE LINER INBOARD  
 FROM PLAN RADIUS OF 67'-6".

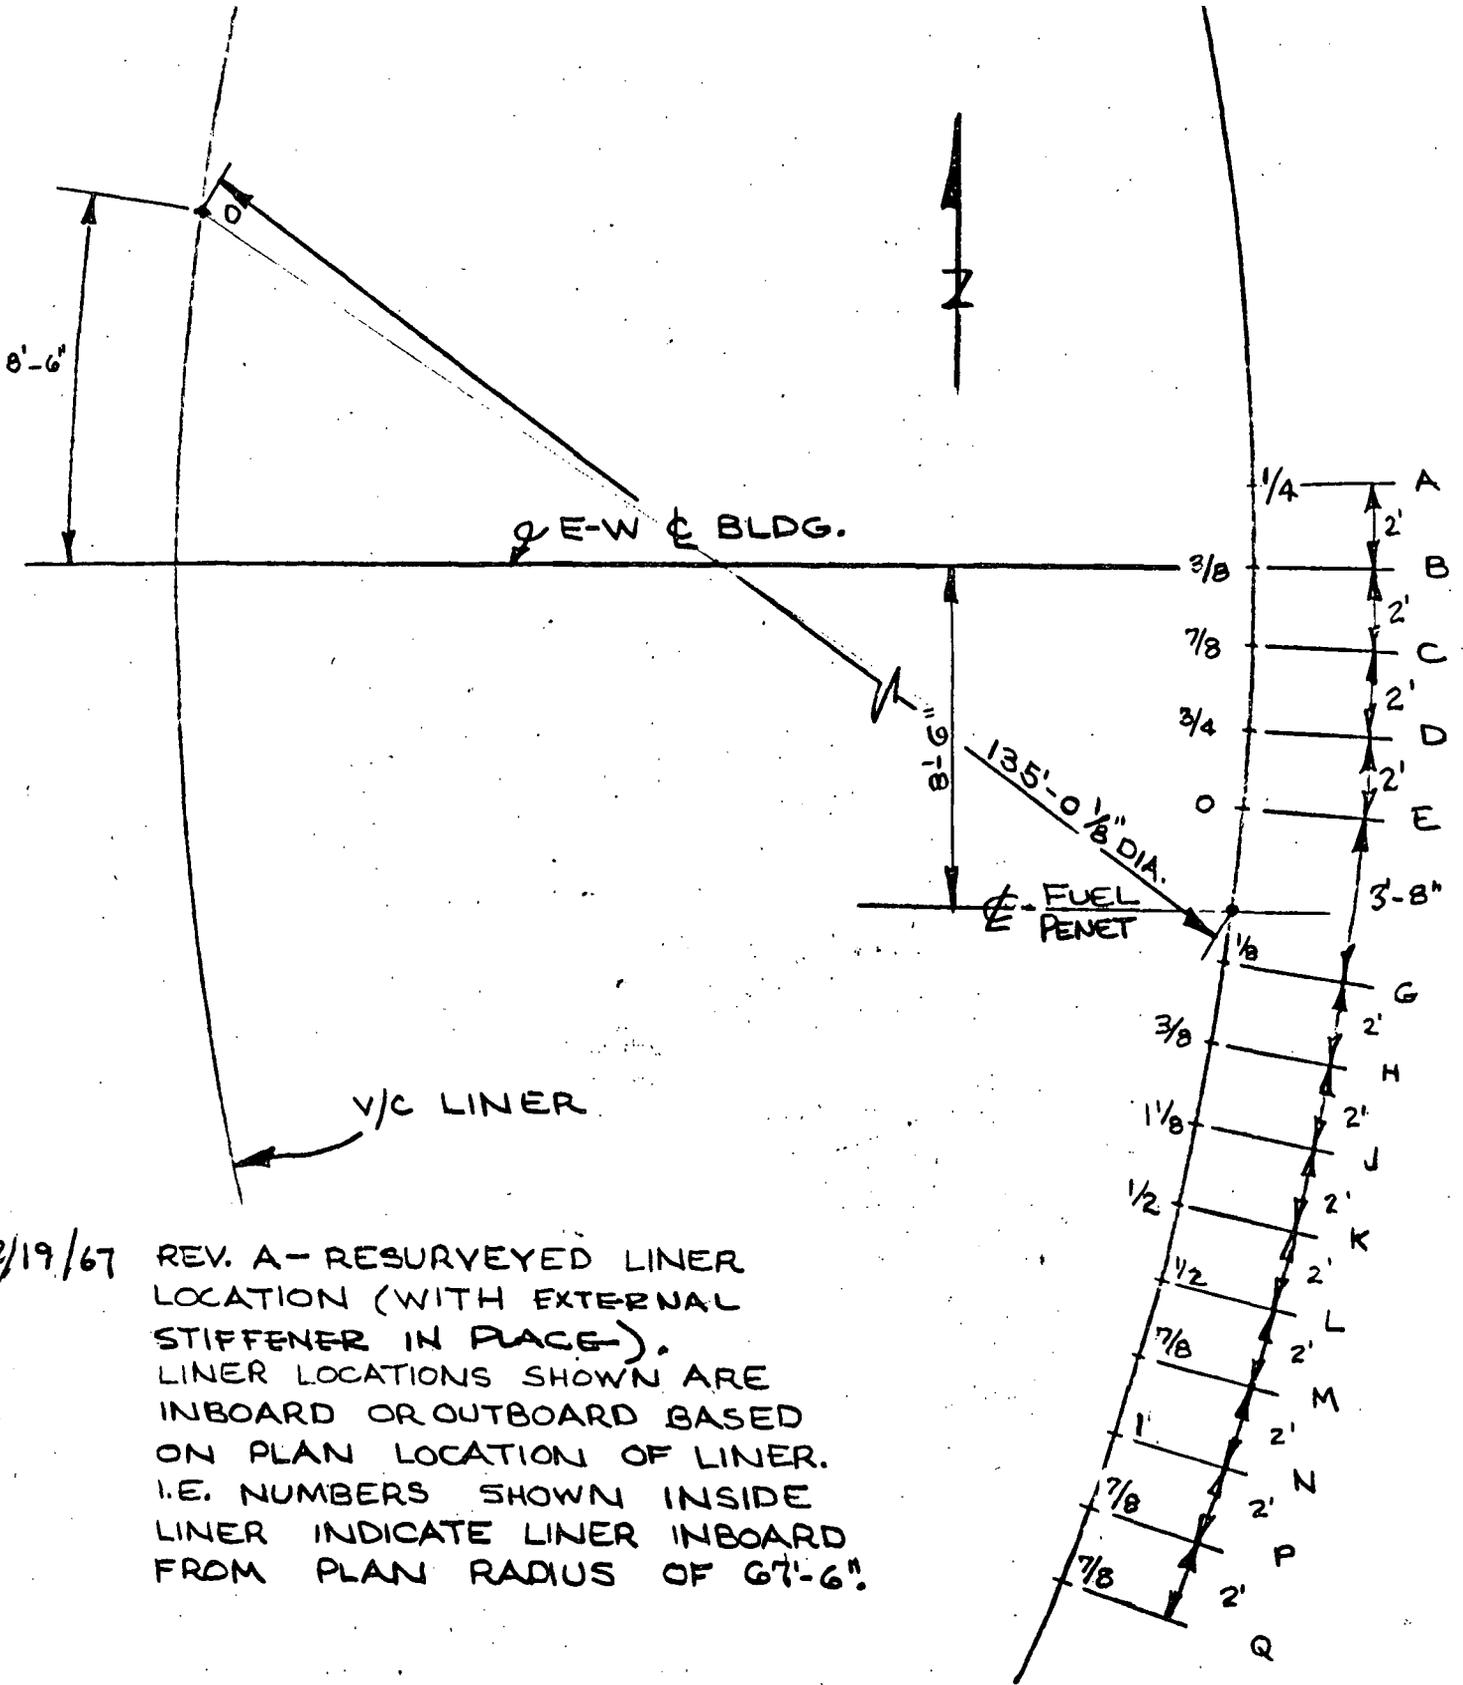
# FIGURE 9

12/19/67 REV. A - RESURVEYED LINER LOCATION (WITH EXTERNAL STIFFENER IN PLACE). LINER LOCATIONS SHOWN ARE INBOARD OR OUTBOARD BASED ON PLAN LOCATION OF LINER. I.E. NUMBERS SHOWN INSIDE LINER INDICATE LINER INBOARD FROM PLAN RADIUS OF 67'-6".
