UNITED STATES  
NUCLEAR REGULATORY COMMISSION  
OFFICE OF NUCLEAR REACTOR REGULATION  
OFFICE OF NUCLEAR MATERIAL SAFETY AND SAFEGUARDS  
OFFICE OF NEW REACTORS  
WASHINGTON, DC 20555-0001

NRC INFORMATION NOTICE 2010-07: WELDING DEFECTS IN REPLACEMENT STEAM GENERATORS

San Onofre Nuclear Generating Station (SONGS)  
Replacement Steam Generator Welding Defects

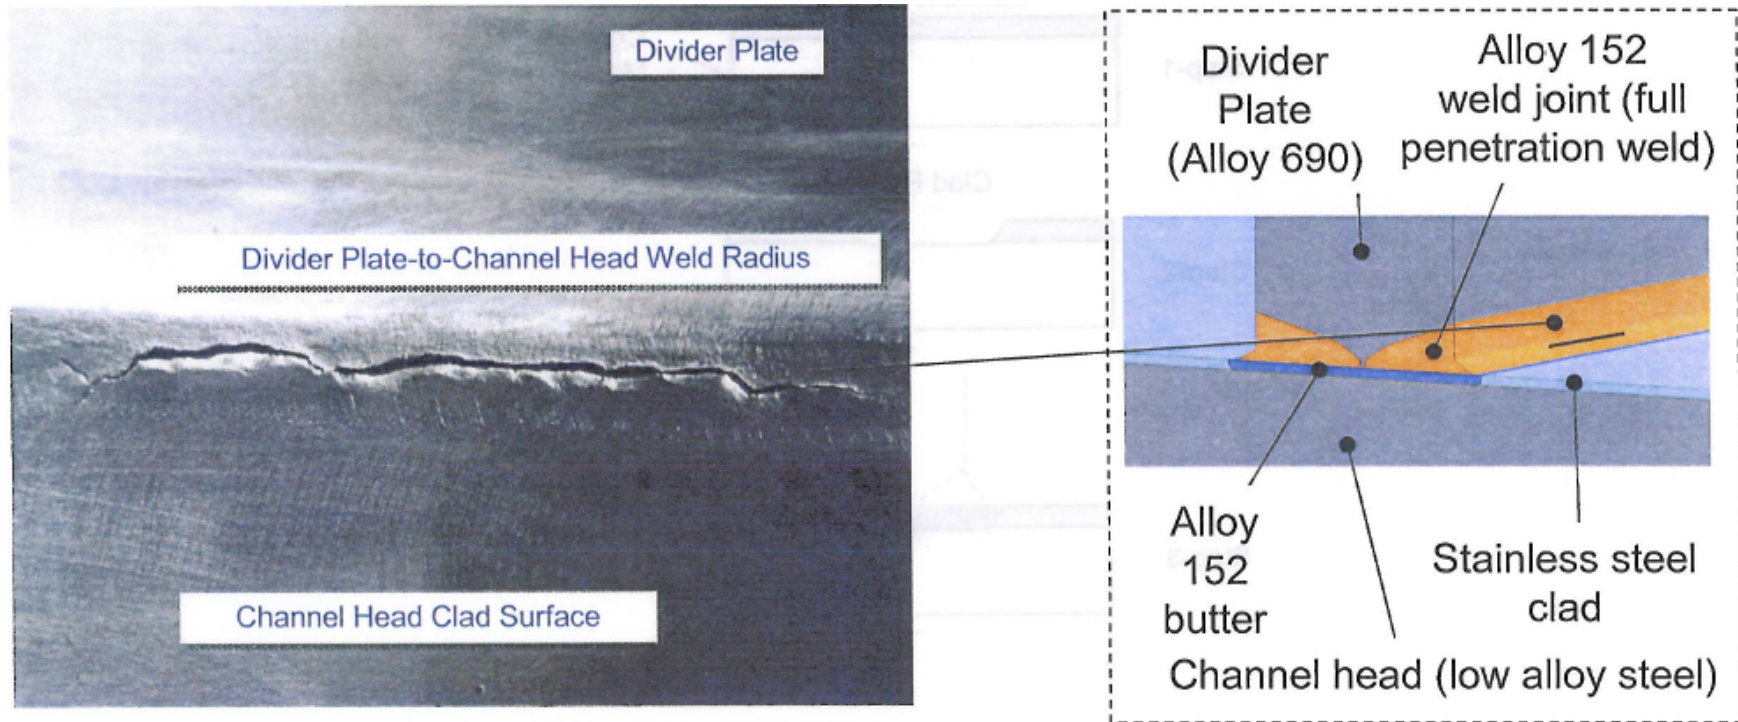
On March 18, 2009, MHI conducted a routine visual inspection after completion of the American Society of Mechanical Engineers Boiler and Pressure Vessel Code (ASME Code), Section III primary and secondary side hydrostatic pressure test on the SONGS Unit 3 "B" RSG and discovered a 5-inch long surface flaw (crack) in the dissimilar metal weld between the divider plate, made from Alloy 690, and the channel head, made from low-alloy steel (LAS). The flaw

formed between the LAS and the Alloy 152 butter. A photograph of flaw and a schematic diagram of the weld joint are shown in the enclosure.

SCE and MHI investigated the root cause of the cracking in the SONGS Unit 3 RSGs. SCE and MHI determined that the separation in the SONGS Unit 3 RSGs followed the fusion line between the Alloy 152 butter/stainless steel cladding and the LAS substrate. The weld joint was prepared by removing the stainless steel cladding from the RSG surface using air carbon-arc gouging (ACAG) and surface grinding to prepare for the deposition of Alloy 152 as a butter pass. The root cause of the separation was associated with the ACAG technique. The ACAG resulted in higher carbon content and areas of higher hardness in the vicinity of the fusion line between the butter pass and the LAS substrate. During subsequent surface preparation by grinding, MHI did not ensure that all of the surface carbonized material was removed. The regions of higher hardness and variations in surface conditions led to unfavorable metallurgical properties at the interface between the Alloy 152 butter and LAS substrate. Separation between the Alloy 152 butter and LAS was subsequently identified during the inspections following the primary side hydrostatic testing of the SONGS Unit 3 RSGs. The cladding in the SONGS Unit 2 RSGs was removed by machining without using ACAG. As a result, the RSGs for SONGS Unit 2 passed the ASME Code Section III secondary side hydrostatic pressure test without any inspection issues.

The welding defects identified at the fabrication facility on the RSGs for SONGS Unit 3 are unlike the weldability issues that are typically observed in the welding of nickel-based alloys. For the SONGS Unit 3 RSGs, surface preparation for the Alloy 152 butter was inadequate. Contamination from the ACAG, used to remove the stainless steel cladding, resulted in elevated hardness of the material adjacent to the fusion line that remained on the surface after the grinding step. When the butter pass was applied, the metallurgical bond between the LAS and Alloy 152 butter weld pass was not as strong as it should have been.

SONGS Unit 3 "B" Replacement Steam Generator  
Cold-Side Crack in Divider Plate-to-Channel Head Weld

Although all specific requirements or standards were met, this event illustrates that control over all aspects of welding ASME Code Class 1, 2, and 3 components can prevent welding defects like those found in the RSGs for SONGS Unit 3 from occurring.
