U. S. ATOMIC ENERGY COMMISSION
REGION I
DIVISION OF COMPLIANCE

Report of Inspection

CO Report No. 247/69-10

CONSOLIDATED EDISON COMPANY
Indian Point No. 2
License No. CPRR-21
Category B

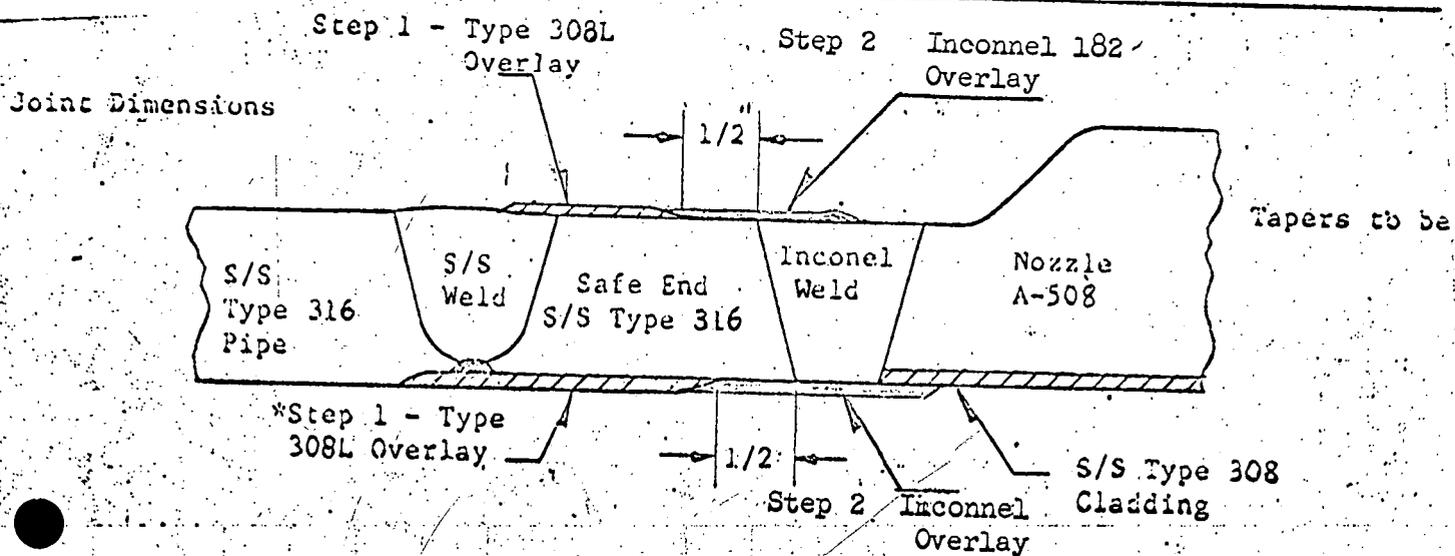
ATTACHMENT NO. 1

The inspector was informed that a weld overlay is scheduled to be applied to the eight reactor vessel nozzles, as is illustrated on Attachment No. 1 of this report. The nominal thickness of the overlay is to be 1/8 inch. Ultrasonic testing is to be performed prior to and after deposition of the overlay material. Welding procedures have been prepared by Westinghouse and will receive an evaluation by Con Ed Engineering. The procedures and welders are to be qualified to the requirements of ASME Section IX. The proposed procedures also include the following items:

1. Materials to be welded.
2. Type of electrodes to be employed.
3. Welding amperage requirements.
4. Minimum preheat temperature of 60° F.
5. Maximum interpass temperature of 300° F.
6. No peening is permitted.
7. Cleaning requirements.
8. Finishing requirements.
9. Final inspection requirements.
