The MacArthur Maze and Newhall Pass Fires and Their Implications for Spent Fuel Transport - 10536

Christopher S. Bajwa, Earl. P. Easton
U.S. Nuclear Regulatory Commission
Washington, DC 20555

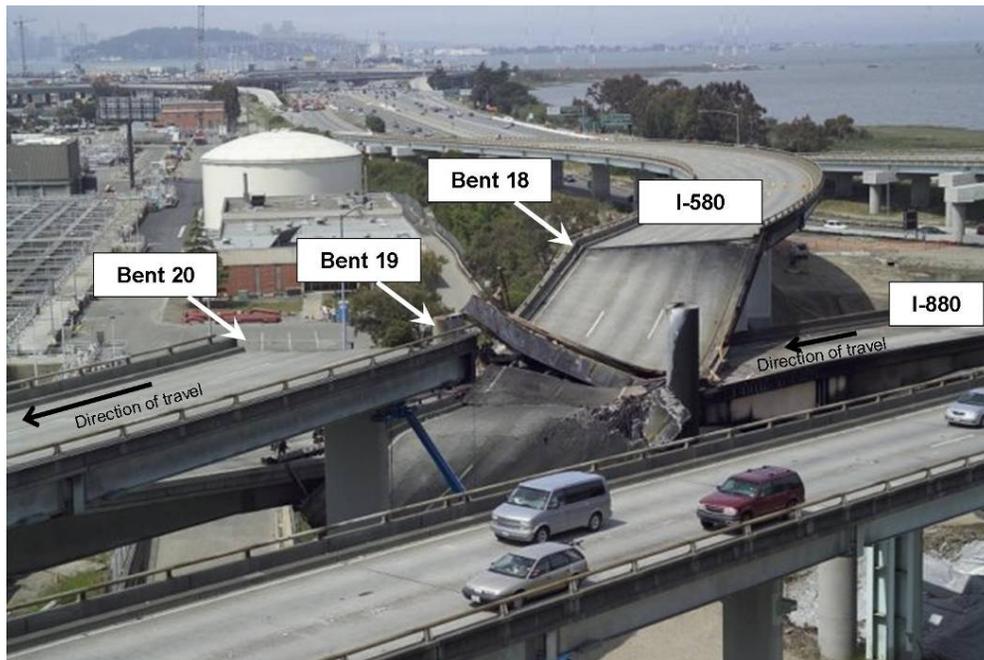
The main portion of the fire, fueled by the gasoline leaking from the tanker, spread along a section of the I-880 roadway. Some of the gasoline went through the scupper drain on I-880 and burned on the ground around an I-880 roadway support pillar. The fire on the I-880 roadway heated the steel girders on the underside of the of the I-580 overpass to temperatures where the steel strength was reduced and was insufficient to support the weight of the elevated roadway. The I-580 overpass collapsed onto the I-880 roadway about 17 minutes after the fire started, based on surveillance video taken from a water treatment plant adjacent to the highway interchange. An aerial photograph of the area with the accident site identified is shown in Figure 1 [2]. A photograph of the scene after the fire was extinguished is shown in Figure 2¹ [3].

Fig. 2. Postfire aerial view of the collapsed section of I-580 looking west. Picture from Caltrans <http://www.dot.ca.gov/dist4/photography/images/070429>.

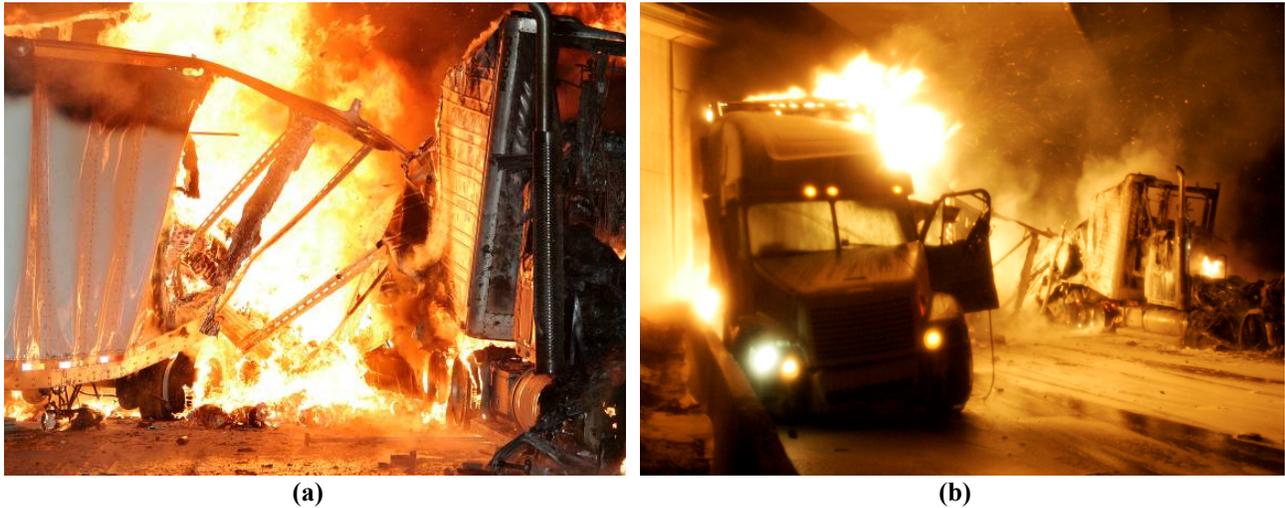
Fig. 3. Images of Commercial Vehicles on Fire Outside Tunnel Exit. Photos by Gene Blevins/LACOFD/Photo.

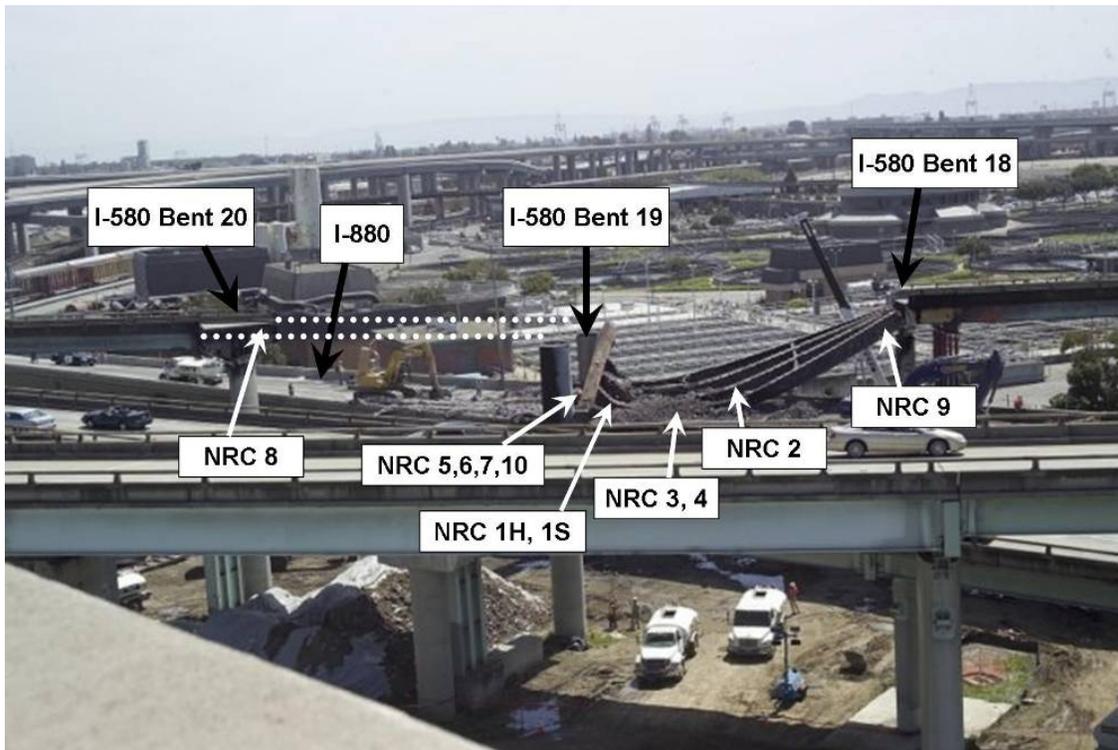
The approximate locations of the samples collected from the collapsed structure are shown in Figure 6 [3]. Table I provides a list and a brief description of the samples that the staff collected during a visit to the accident site in June, 2007.

Fig. 6. View of damage during demolition looking southwest. Bent 18, 19, and 20 and approximate locations of collected specimens are indicated. Dotted lines represent pre-accident overpass structure that was demolished and removed prior to this photograph. Original picture from Caltrans website <http://www.dot.ca.gov/dist4/photography/images/070430/index2.html>

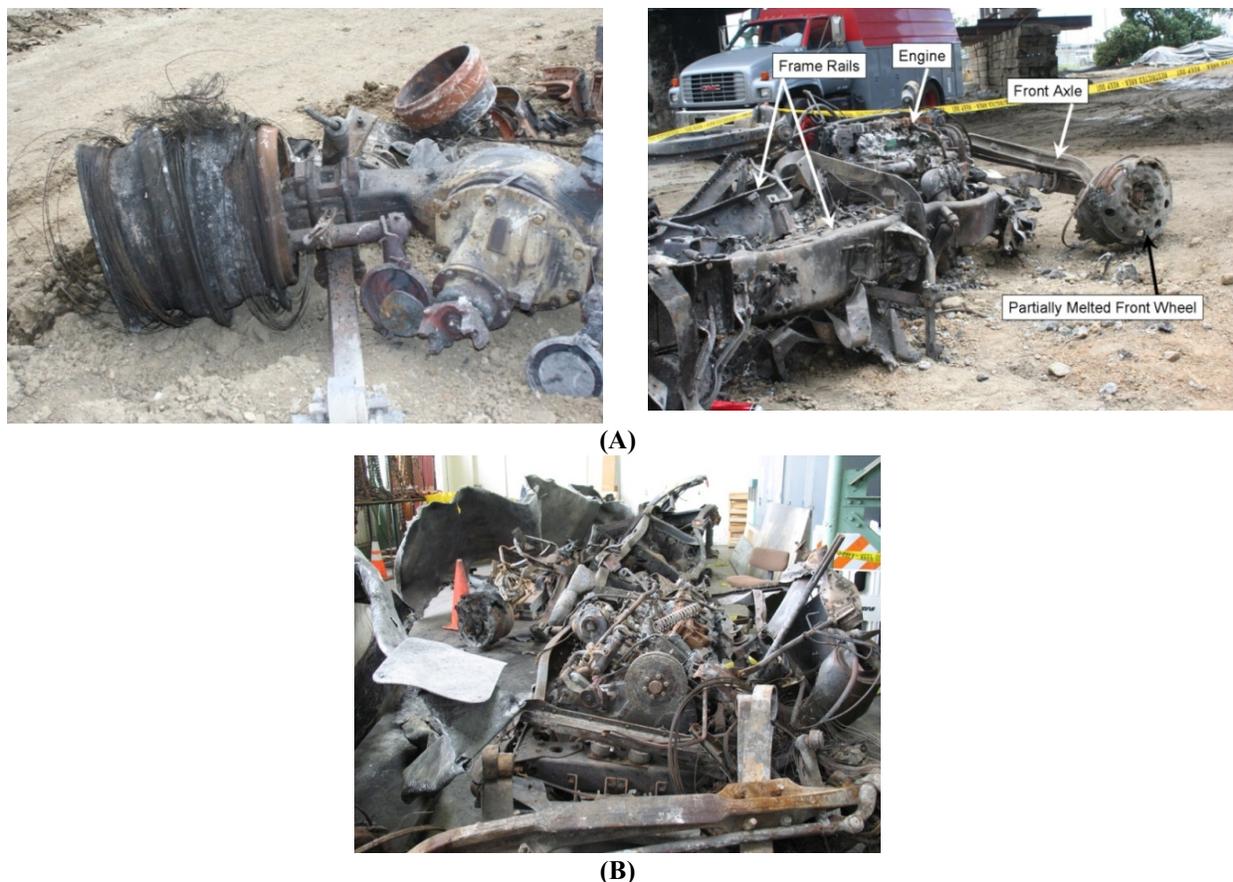
Fig. 7. Photographs of the tanker truck remains at the accident site (A) and at the Caltrans storage facility (B).

Based on the samples collected and the results of thermal exposures, the temperature of the I-580 overpass is estimated to range from 850°C [1,562°F] to approximately 1,000°C [1,832°F]. Near the truck, the maximum exposure temperature is estimated to be at least 720°C [1,328°F] and less than 930°C [1,706°F]. Results obtained from the analysis of the overpass and truck samples are consistent with modeling results, indicating the hottest gas temperatures during the fire were located above the I-880 roadway near the steel girders of the I-580 overpass. An extensive discussion of the materials analyses completed for the samples collected are provided in previous papers [4], as well as a NRC NUREG/CR series report [5].

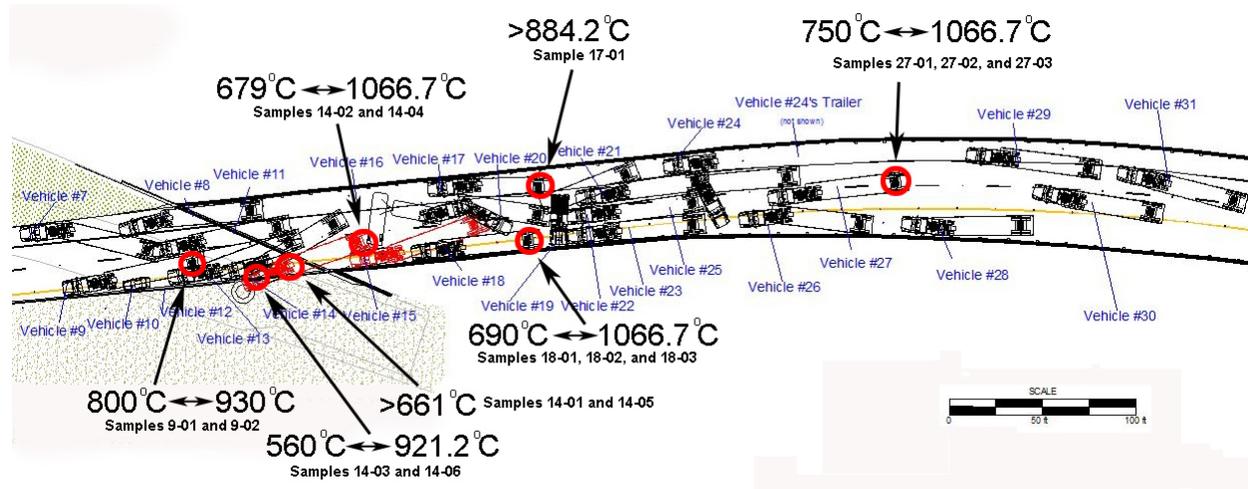
Figure 8. Section of Tunnel With Vehicles Accessed for Sample Recovery. (Image of Vehicle Location in the Tunnel Was Provided by CHP.)

Figure 8 shows that for the location of Truck 9, the results from the sample analysis indicated that the temperature ranged somewhere between 880 and 930 °C [1,472 and 1,706 °F]. The material analysis determined the lower bound by examining the hardness of graded bolts and melted aluminum. The upper-bound temperature for this vehicle was determined by an unmelted brass Schrader valve, which is located a few feet off the ground.

The temperature range predicted by the materials analysis for Truck 14's tractor was between 560 and 920 °C [1,040 and 1,690 °F]. The lower bound determined from the material analysis was based on melted aluminum from the grill of the tractor. This would be expected to be slightly above the 1.5 m [4.9 ft] level. The upper bound temperature

was determined from a brass clamp recovered from the engine compartment. This would be somewhere between 1.5 and 3.5 m [4.9 and 11.5 ft].

For the front end of Truck 14's trailer the materials analysis indicated that the temperature was greater than 660 °C [1,220 °F]. There was only a lower bound because melted aluminum was the only material recovered from that location. The temperature was determined in the materials analysis by examining a section of melted aluminum flooring.

For the backend of Truck 14's trailer the materials analysis indicated that the temperature was between 680 and 1,070 °C [1,256 and 1,958 °F]. The lower bound temperature was determined by melted aluminum wheels, which would be at the 1.5-m [4.9-ft] level. The upper bound temperature determined from the materials analysis came from examination of unmelted copper wiring.

The materials analysis indicated that the temperature range for Truck 17 was greater than 880 °C [1,616 °F]. The lower bound temperature from the materials analysis data was determined by a melted brass compression fitting ferrule.

Truck 18 was between 740 and 930 °C [1,364 and 1,706 °F]. The materials analysis of Truck 18 indicated that the temperature was between 690 and 1,060 °C [1,274 and 1,940 °F]. The lower bound of temperature for the materials analysis was determined by melted aluminum around the wheel level.

The last vehicle where the materials analyses results are reported is Truck 27. The materials analyses indicated that the temperature was at least 750 °C [1,382 °F] but did not reach 1,070 °C [1,958 °F]. The lower point on the materials analyses came from the hardness of a graded bolt. The bolt microstructure indicated it had been converted to pearlite; However, the upper-bound temperature from the materials analyses came from an unmelted plate on the axle.
