The MacArthur Maze and Newhall Pass Fires and Their Implications for Spent Fuel Transport - 10536

Christopher S. Bajwa, Earl. P. Easton
U.S. Nuclear Regulatory Commission
Washington, DC 20555

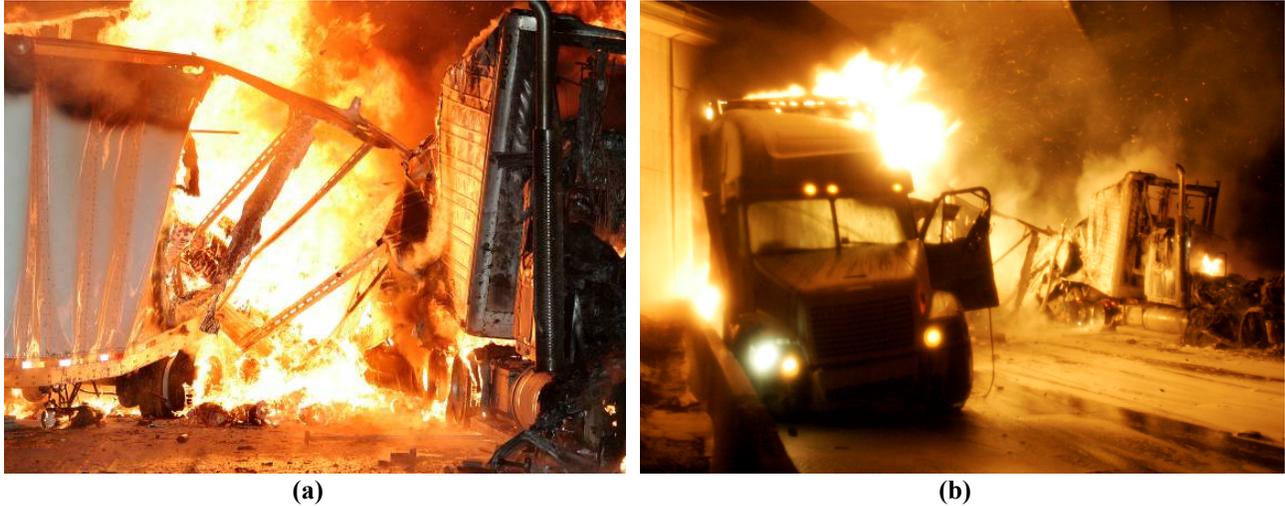
On October 12, 2007, a major fire occurred in the Newhall Pass tunnel near Santa Clarita, California at approximately 10:40 p.m. The Newhall Pass tunnel is part of the Interstate 5 southbound truck lane as it passes below Interstate 5 main lanes. The tunnel is a 165.8-m [544-ft] long reinforced concrete boxed girder, which was built in 1971. The tunnel fire was a result of a truck accident that led to a 34-vehicle pile-up in and around the Newhall Pass tunnel. One of the vehicles caught on fire and ignited the other vehicles in the tunnel. It was reported that the fire appeared to emanate from both ends of the tunnel within 15 minutes of its start (See Figure 3). An aerial map of Newhall Pass tunnel is shown in Figures 4 and 5.

Fig. 3. Images of Commercial Vehicles on Fire Outside Tunnel Exit. Photos by Gene Blevins/LACOFD/Photo.

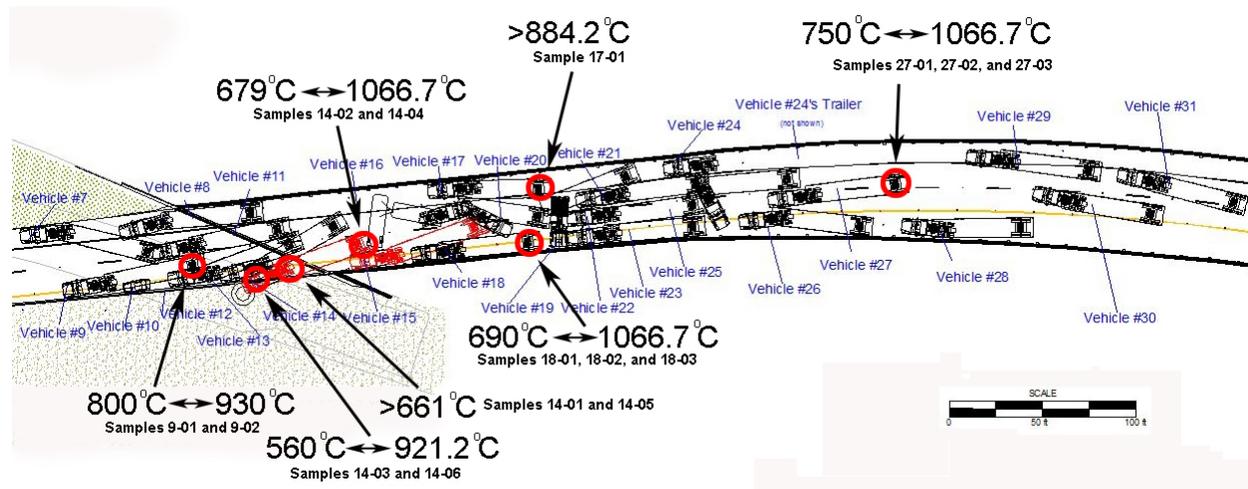
Figure 8 were obtained from the calorimetry analyses, visual inspections, and mechanical hardness measurements. Exposure temperatures were bracketed through the analysis of multiple substances obtained from adjacent locations. The temperature range provides bounds for the maximum temperature that was believed to have occurred in that location based on the materials analyses. The bounding temperature values were obtained by examining specimens that presented signs of incipient melting (only nonferrous metals) or changes in hardness values (only steel fasteners) due to the fire exposure.

Figure 8. Section of Tunnel With Vehicles Accessed for Sample Recovery. (Image of Vehicle Location in the Tunnel Was Provided by CHP.)

Figure 8 shows that for the location of Truck 9, the results from the sample analysis indicated that the temperature ranged somewhere between 880 and 930 °C [1,472 and 1,706 °F]. The material analysis determined the lower bound by examining the hardness of graded bolts and melted aluminum. The upper-bound temperature for this vehicle was determined by an unmelted brass Schrader valve, which is located a few feet off the ground.

The temperature range predicted by the materials analysis for Truck 14's tractor was between 560 and 920 °C [1,040 and 1,690 °F]. The lower bound determined from the material analysis was based on melted aluminum from the grill of the tractor. This would be expected to be slightly above the 1.5 m [4.9 ft] level. The upper bound temperature

was determined from a brass clamp recovered from the engine compartment. This would be somewhere between 1.5 and 3.5 m [4.9 and 11.5 ft].

For the front end of Truck 14's trailer the materials analysis indicated that the temperature was greater than 660 °C [1,220 °F]. There was only a lower bound because melted aluminum was the only material recovered from that location. The temperature was determined in the materials analysis by examining a section of melted aluminum flooring.

For the backend of Truck 14's trailer the materials analysis indicated that the temperature was between 680 and 1,070 °C [1,256 and 1,958 °F]. The lower bound temperature was determined by melted aluminum wheels, which would be at the 1.5-m [4.9-ft] level. The upper bound temperature determined from the materials analysis came from examination of unmelted copper wiring.

The materials analysis indicated that the temperature range for Truck 17 was greater than 880 °C [1,616 °F]. The lower bound temperature from the materials analysis data was determined by a melted brass compression fitting ferrule.

Truck 18 was between 740 and 930 °C [1,364 and 1,706 °F]. The materials analysis of Truck 18 indicated that the temperature was between 690 and 1,060 °C [1,274 and 1,940 °F]. The lower bound of temperature for the materials analysis was determined by melted aluminum around the wheel level.

The last vehicle where the materials analyses results are reported is Truck 27. The materials analyses indicated that the temperature was at least 750 °C [1,382 °F] but did not reach 1,070 °C [1,958 °F]. The lower point on the materials analyses came from the hardness of a graded bolt. The bolt microstructure indicated it had been converted to pearlite; However, the upper-bound temperature from the materials analyses came from an unmelted plate on the axle.
