U.S. NUCLEAR REGULATORY COMMISSION
OFFICE OF INSPECTION AND ENFORCEMENT

Report No. 50-247/80-19

Facility Name: Indian Point Nuclear Generating Station, Unit 2

Areas Investigated: Investigation of the circumstances leading to and the results of the Vapor Containment Floor and Reactor Vessel Pit flooding event on October 17, 1980. Areas examined included: Sequence of Events; Licensee Management Activities; Shift Technical Advisor; Reporting; Reactor Trip and Instrumentation Performance; Containment Sump Pumps and Level Instrumentation; Reactor Vessel Pit Sump Pumps; Leak Detection Instrumentation and Procedures; Fan Cooler Units; Reactor Vessel Pit Flooding; Flooding History; Reactor Vessel Integrity Following Immersion; Containment Paint and Insulation; Mirror Insulation; Steam Generator Blowdown Line Leaks and Supports; Corrosion Effects of River Water; Chloride Containment Survey; Non-Destructive Examinations; Quality Assurance and Quality Control Programs; and, System Descriptions. The investigation involved 1300 inspector hours onsite by one Section Chief, six inspectors, and two investigators.

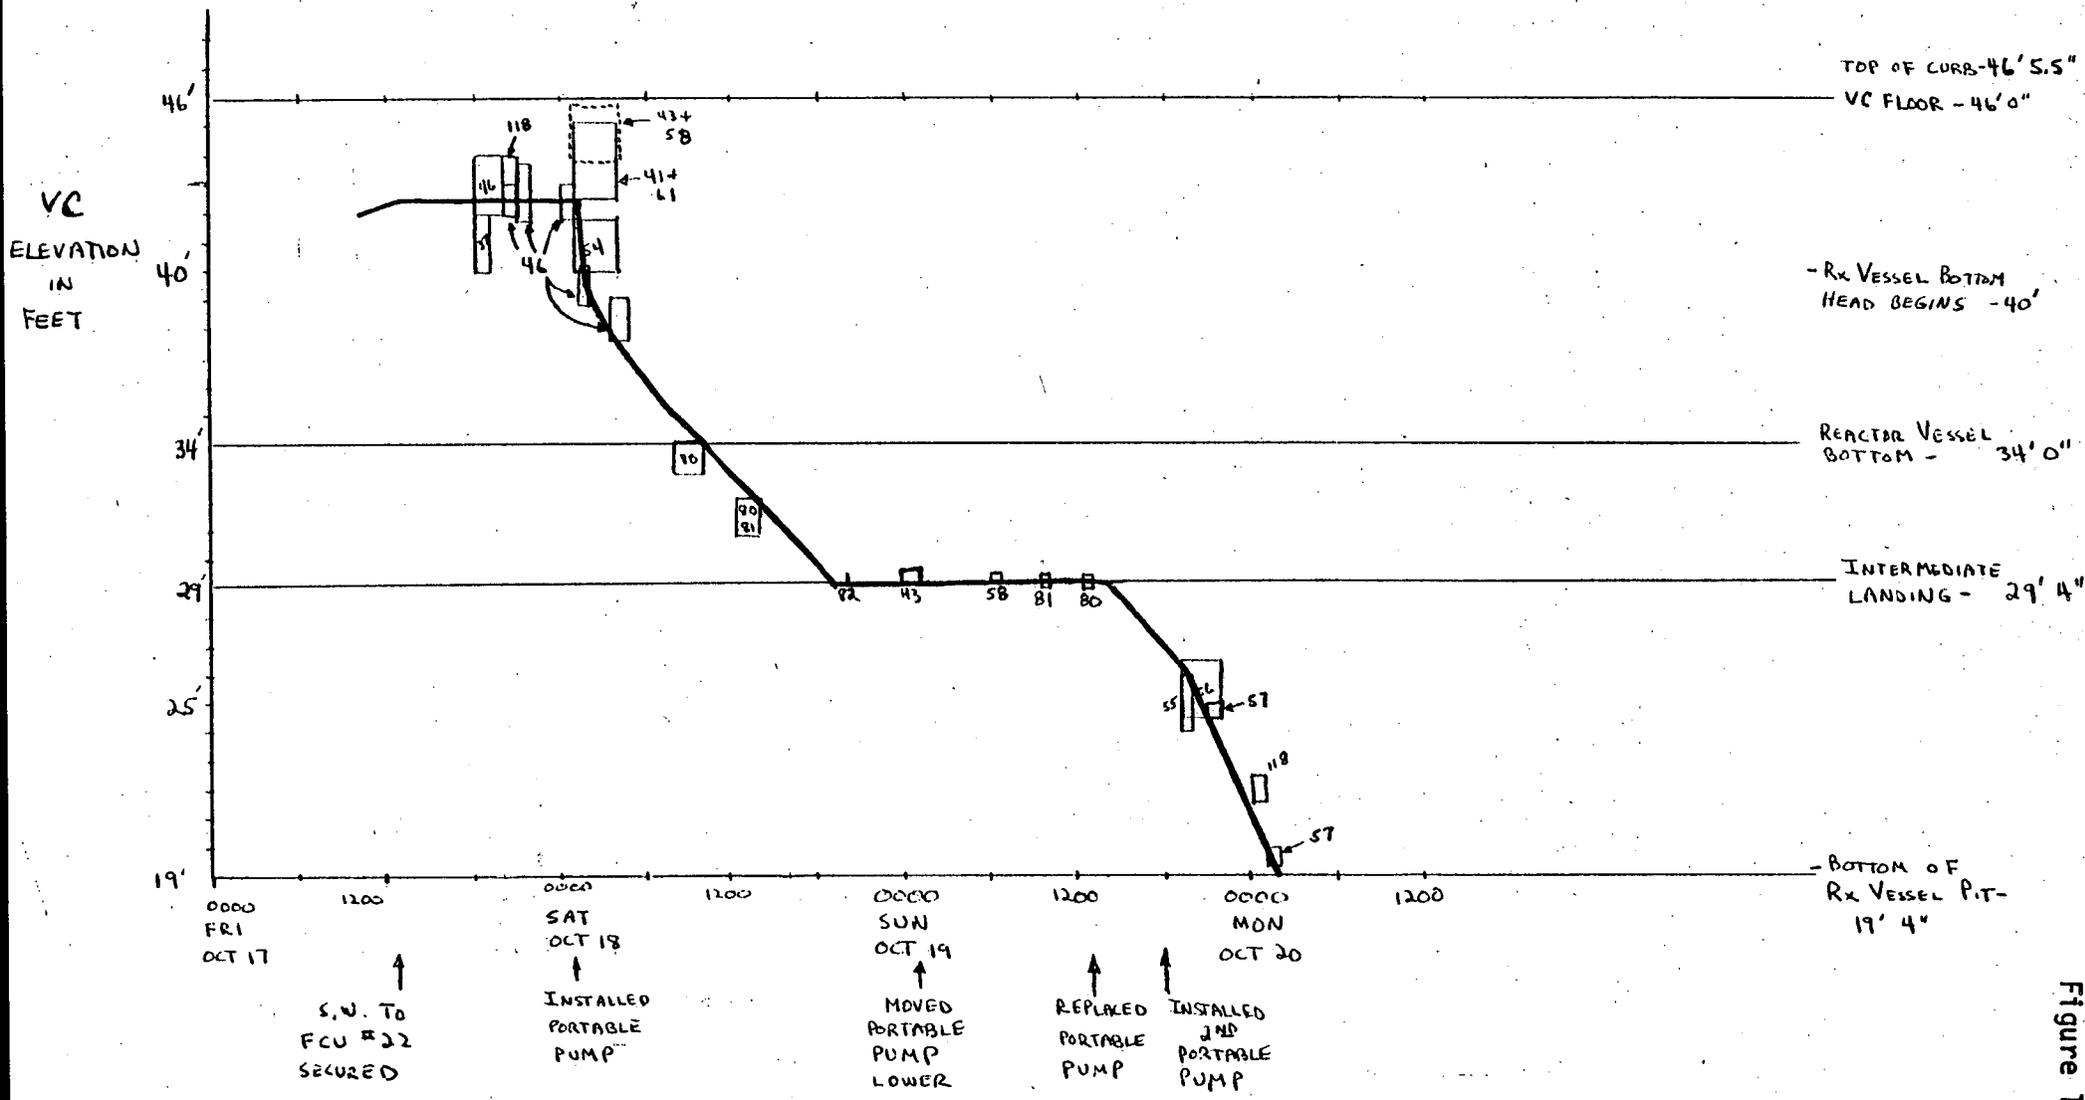
Figure 1

- (6) The discovery, during the evening of 10/17/80, that the Reactor Vessel Pit had been flooded to within four feet of the elevation 46 feet floor, was not documented by the licensee during the 10/17-20/80 weekend. This flooding elevation in the Pit corresponded to a water level on the outside of the Reactor Vessel itself of about 8½ feet. The submergence of the Reactor Vessel and the Incore Instrument Conduits in cold, high chlorides, River Water, while at normal operating temperatures of about 550°F, is a condition not considered in the safety analysis report or technical specifications and did require corrective measures, the removal of the water and boildown residue plus nondestructive examinations of the Reactor Vessel and the Conduits, to prevent the development of an unsafe condition. The licensee's failure to promptly report to NRC within 24 hours (by 10/18/80) the discovery of the flooded Reactor Vessel Pit is a noncompliance with T.S. 6.9.1.7.1.i.

PLOT OF BEST ESTIMATE OF WATER LEVEL IN REACTOR VESSEL PIT VERSUS TIME,
BASED ON ACTUAL WATER LEVEL OBSERVATIONS

Note: The rectangles around individual observations represent the uncertainty associated with that observation.

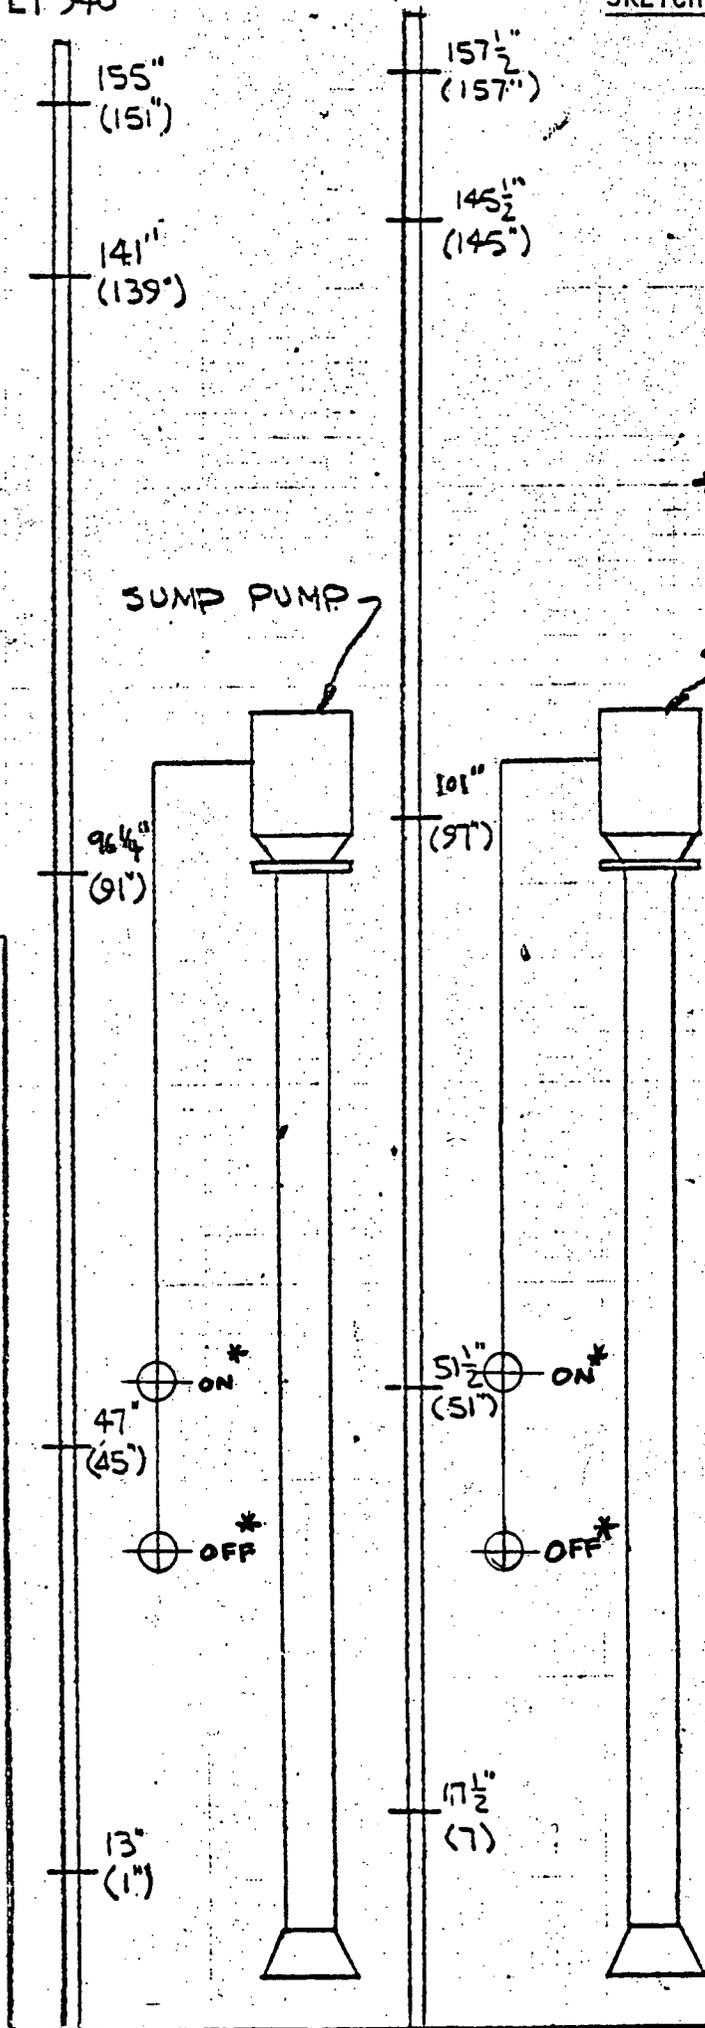
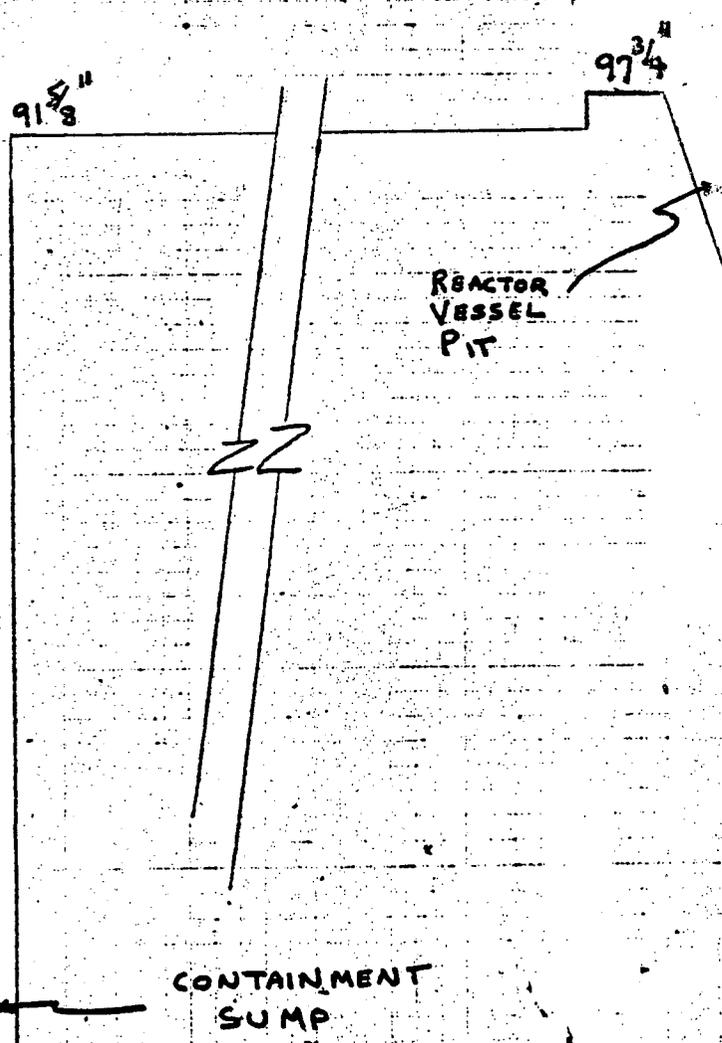
2. ALL MEASUREMENTS ARE REFERENCED FROM THE BOTTOM OF THE SUMP PIT

* 3. BEST ESTIMATE OF PUMP ACTUATION POINTS PRIOR TO 10/17/80.

EXISTING CONTAINMENT SUMP AND REACTOR CAVITY

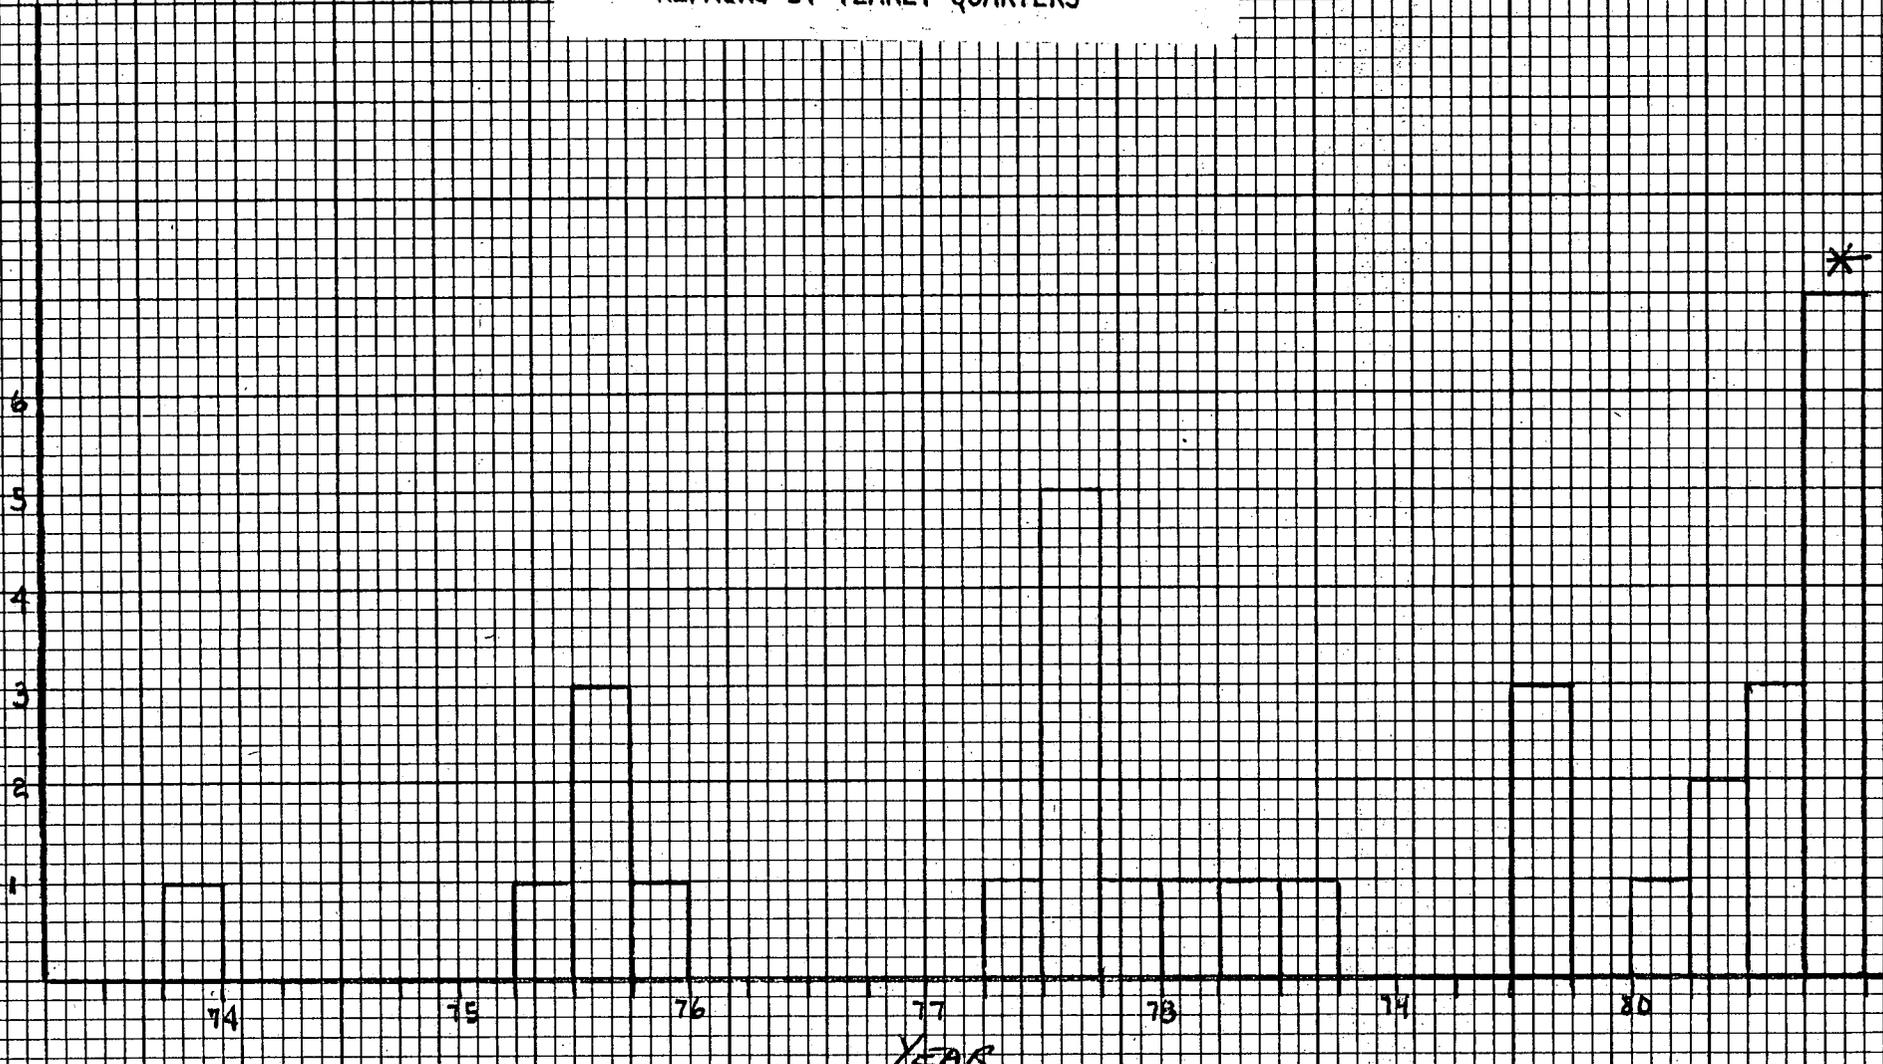
Figure 4

NRC SUMMARY
TOTAL NUMBER OF MWR'S ISSUED
FOR FAN COOLER UNIT AND RELATED
SERVICE WATER PIPING LEAK
REPAIRS BY YEARLY QUARTERS

* DATA PLOTTED INCLUDES POST EVENT REPAIRS
UP TO AND INCLUDING 10/26/80.

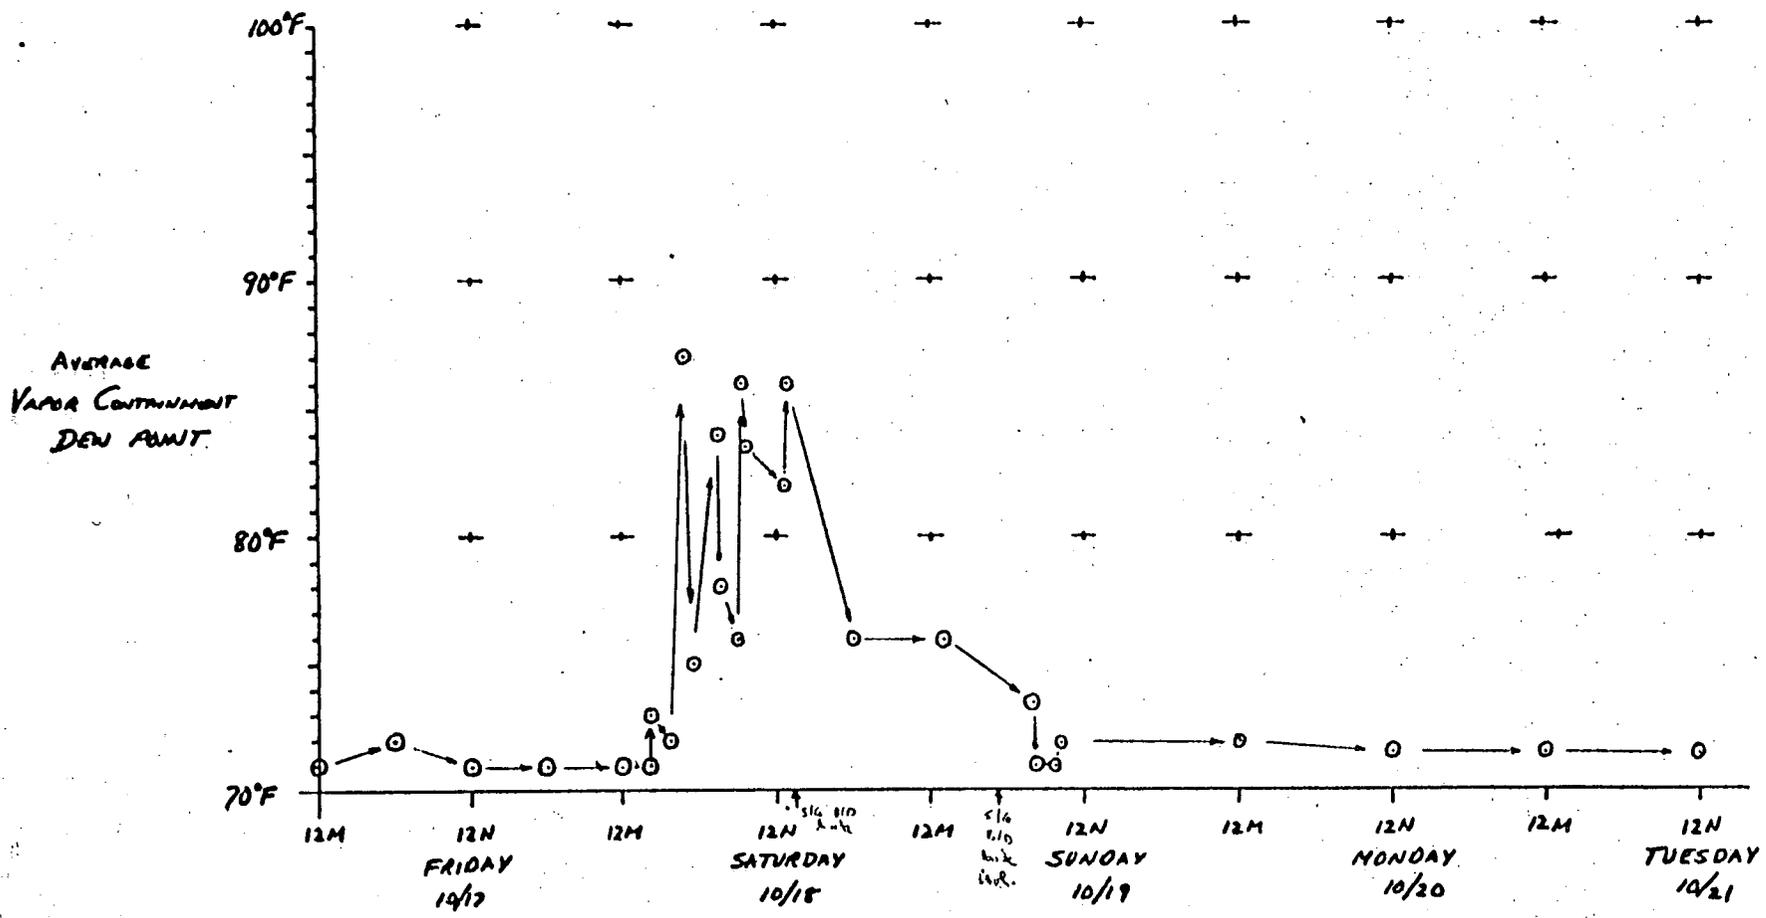
Figure 5

V.C. DEWPOINT TEMPERATURE VERSUS TIME
