Dresden Nuclear Power Station, Unit 2  
Renewed Facility Operating License No. DPR-19  
NRC Docket No. 50-237

**Subject:** Licensee Event Report 237/2009-005-00, "Unit 2 Reactor Recirculation Drain Line Pressure Boundary Leakage"

**4. TITLE**  
Unit 2 Reactor Recirculation Drain Line Pressure Boundary Leakage

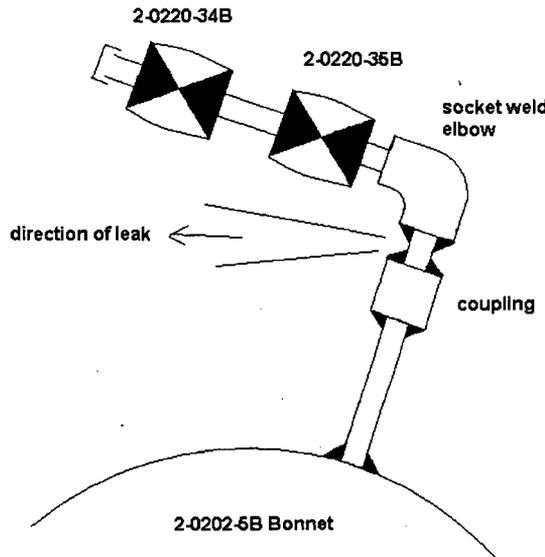
On 11/03/2009 at approximately 0445 hours plant personnel were performing a walkdown of the Unit 2 drywell. The walkdown was being performed as a part of the refueling outage activities. During the walkdown a leak was identified coming from the above seat drain line for the 2-0202-5B, 2B Reactor Recirculation Pump Discharge Valve [AD]. A steady stream of water was leaking from a 3/4 inch line between a coupling and a socket-welded elbow. The diameter of the water leak was approximately the size of a toothpick.

Jet pump plugs were installed and the 2B reactor recirculation loop was drained to accommodate repairs to the leaking line. Upon examination of the leaking component, it was identified that the through-wall leak was caused by a fatigue crack that initiated from the upper side of the pipe OD between the coupling and the elbow socket-weld toes.

Based on the examination of the failed component, two indications were identified. The larger circumferential indication extended 150 degrees. The through-wall portion extended approximately 85 degrees. The second indication was smaller and was not through-wall. Observing the fracture radial markings, the larger indication initiated from the outer diameter of the pipe. Microscopic examination revealed the cracking propagated in a non-branching transgranular manner, which was indicative of fatigue. The smaller indication initiated from the toe of the coupling weld.

The angled nature of the cracking near the origin indicated that the pipe was subjected to cyclic torsional loads, which would be consistent with cantilever loading induced by the weight of the two downstream valves. Likely causes of the cyclic loading include a known period when the 2B Reactor Recirculation pump experienced higher than normal vibrations or possibly a periodic resonance condition associated with intermediate pump operating speeds.

A review of the weld size from the failure report indicates that, while the weld meets minimum code requirements for a socket weld in this configuration, the proportions are such that it is susceptible to weld toe fatigue failure when subjected to a high vibration environment. Additionally, this type of geometry, with two welds nearly touching, is a stress intensifier. This configuration is seen as a contributing cause as it created a point of stress intensification.

The leaking above seat drain line was cut and capped. This arrangement results in a vibration tolerant configuration.
