Steam Generator Inspection Program and Results

July 1979 Inspection

Consolidated Edison Company of New York, Inc.

Indian Point Unit No. 2

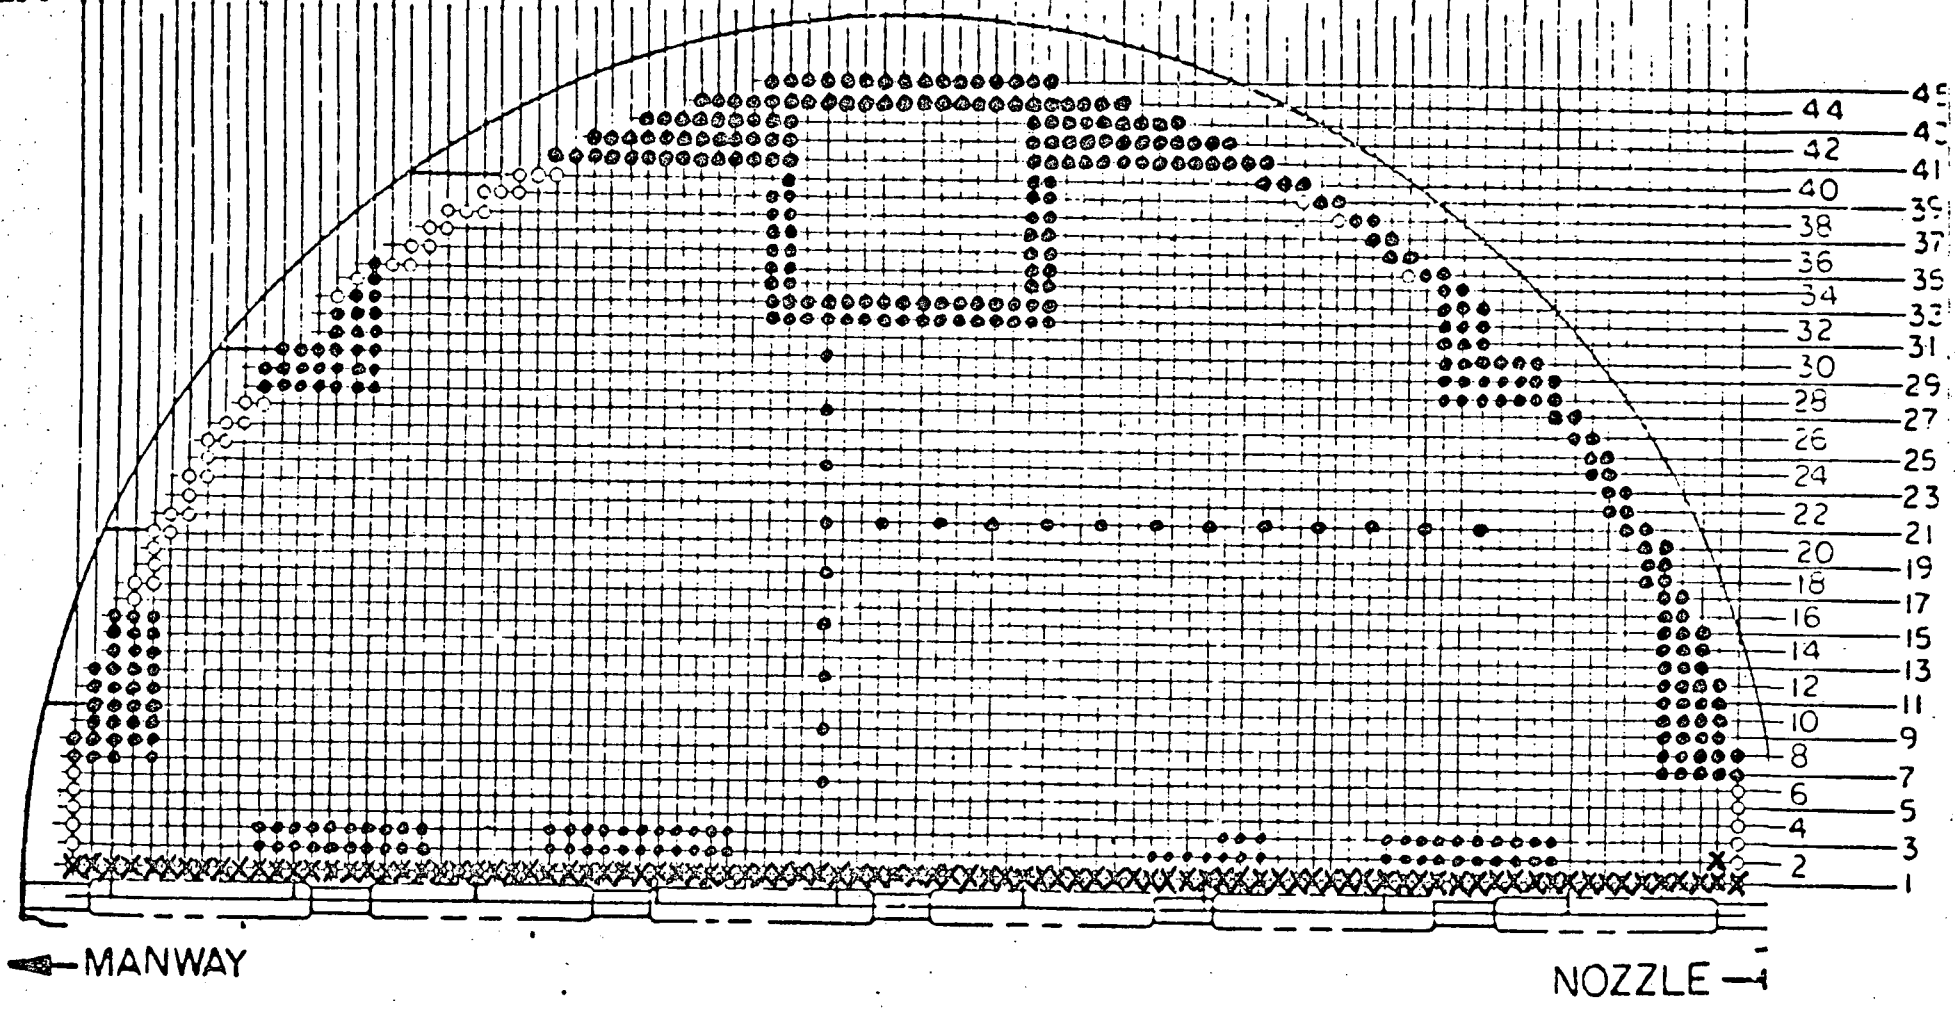
FIGURE 1

Steam Generator 21

July 1979 Inspection

● - Tubes inspected (429).

✕ - Tubes previously plugged.

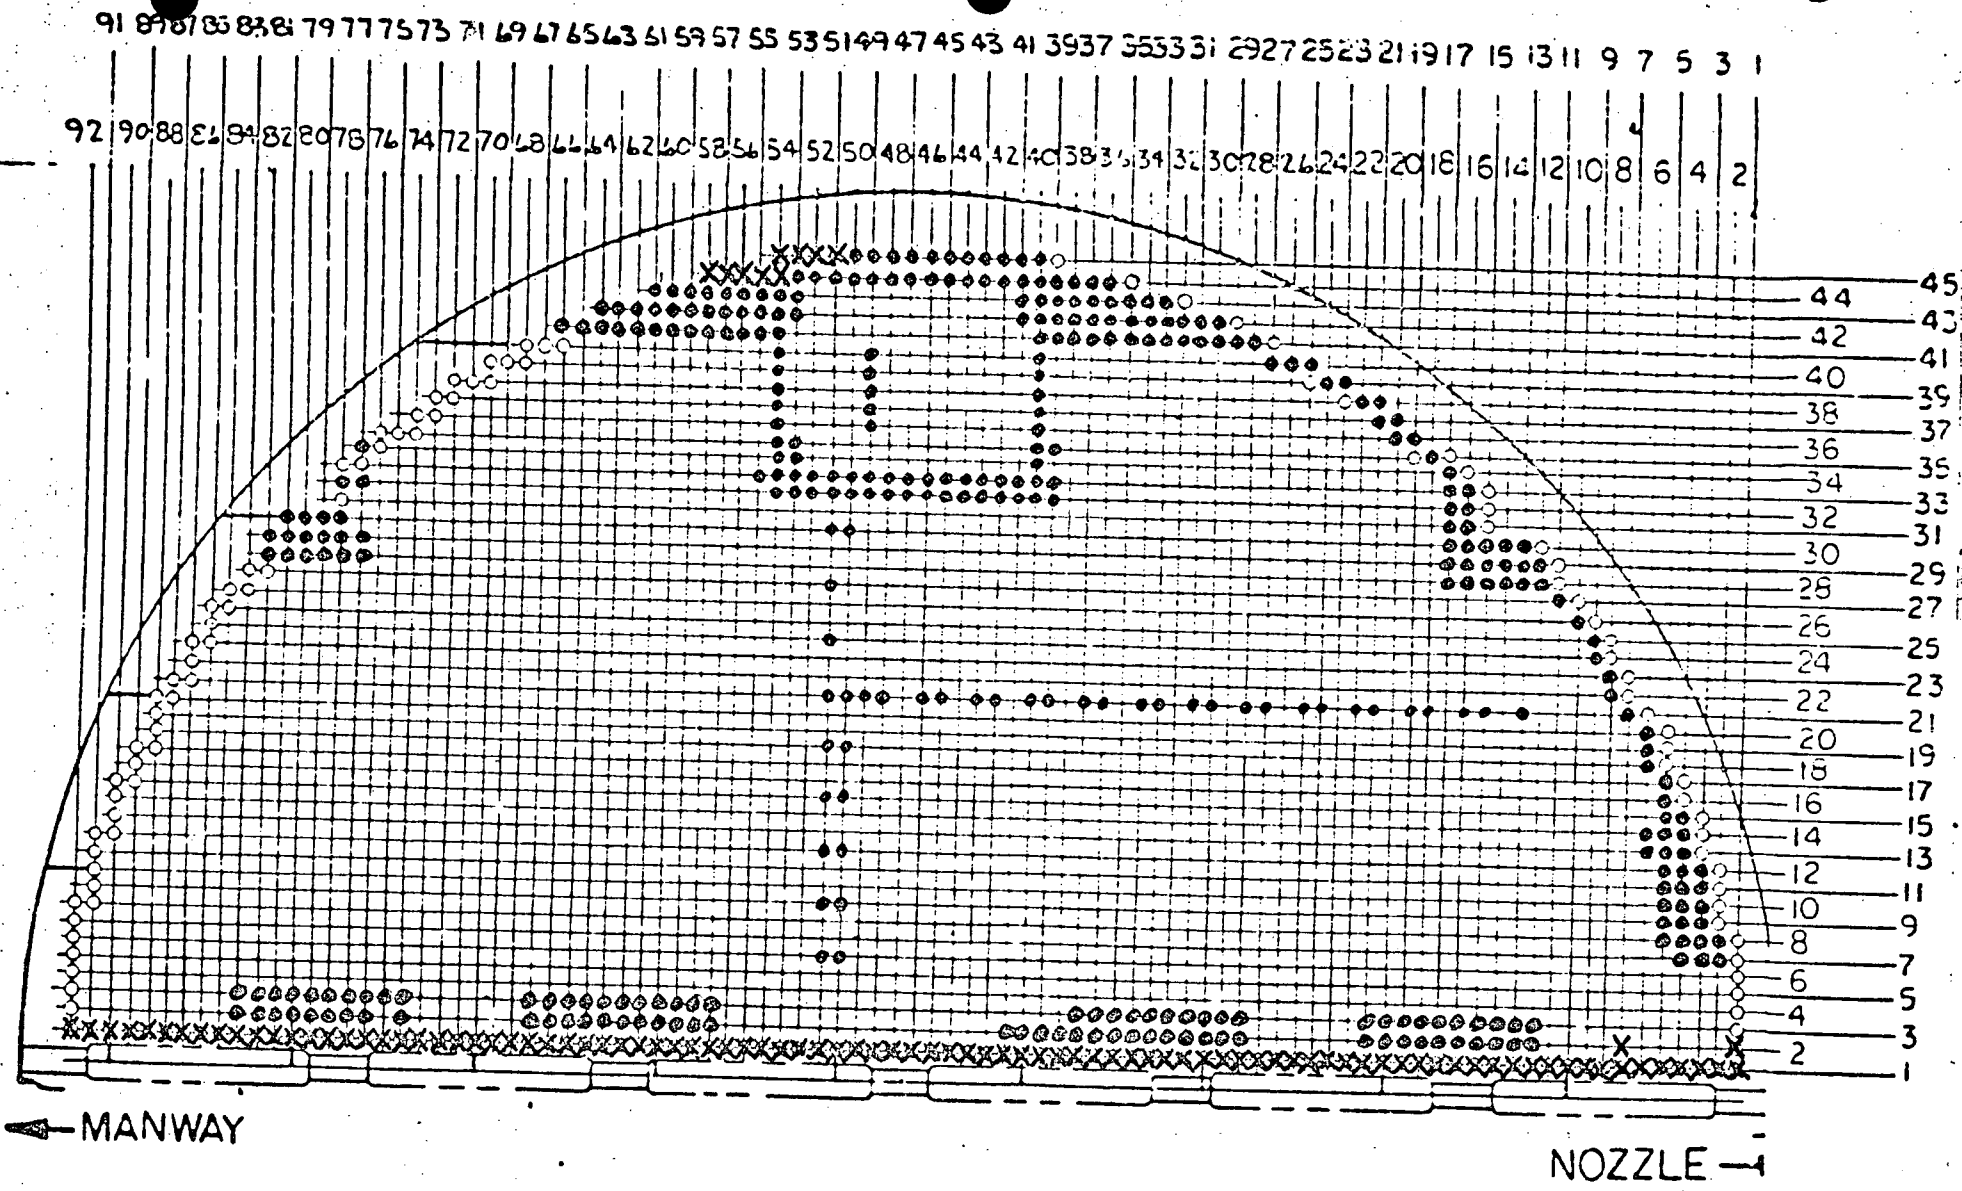
FIGURE 2

Steam Generator 22

July 1979 Inspection

● - Tubes inspected (375).

X - Tubes previously plugged.

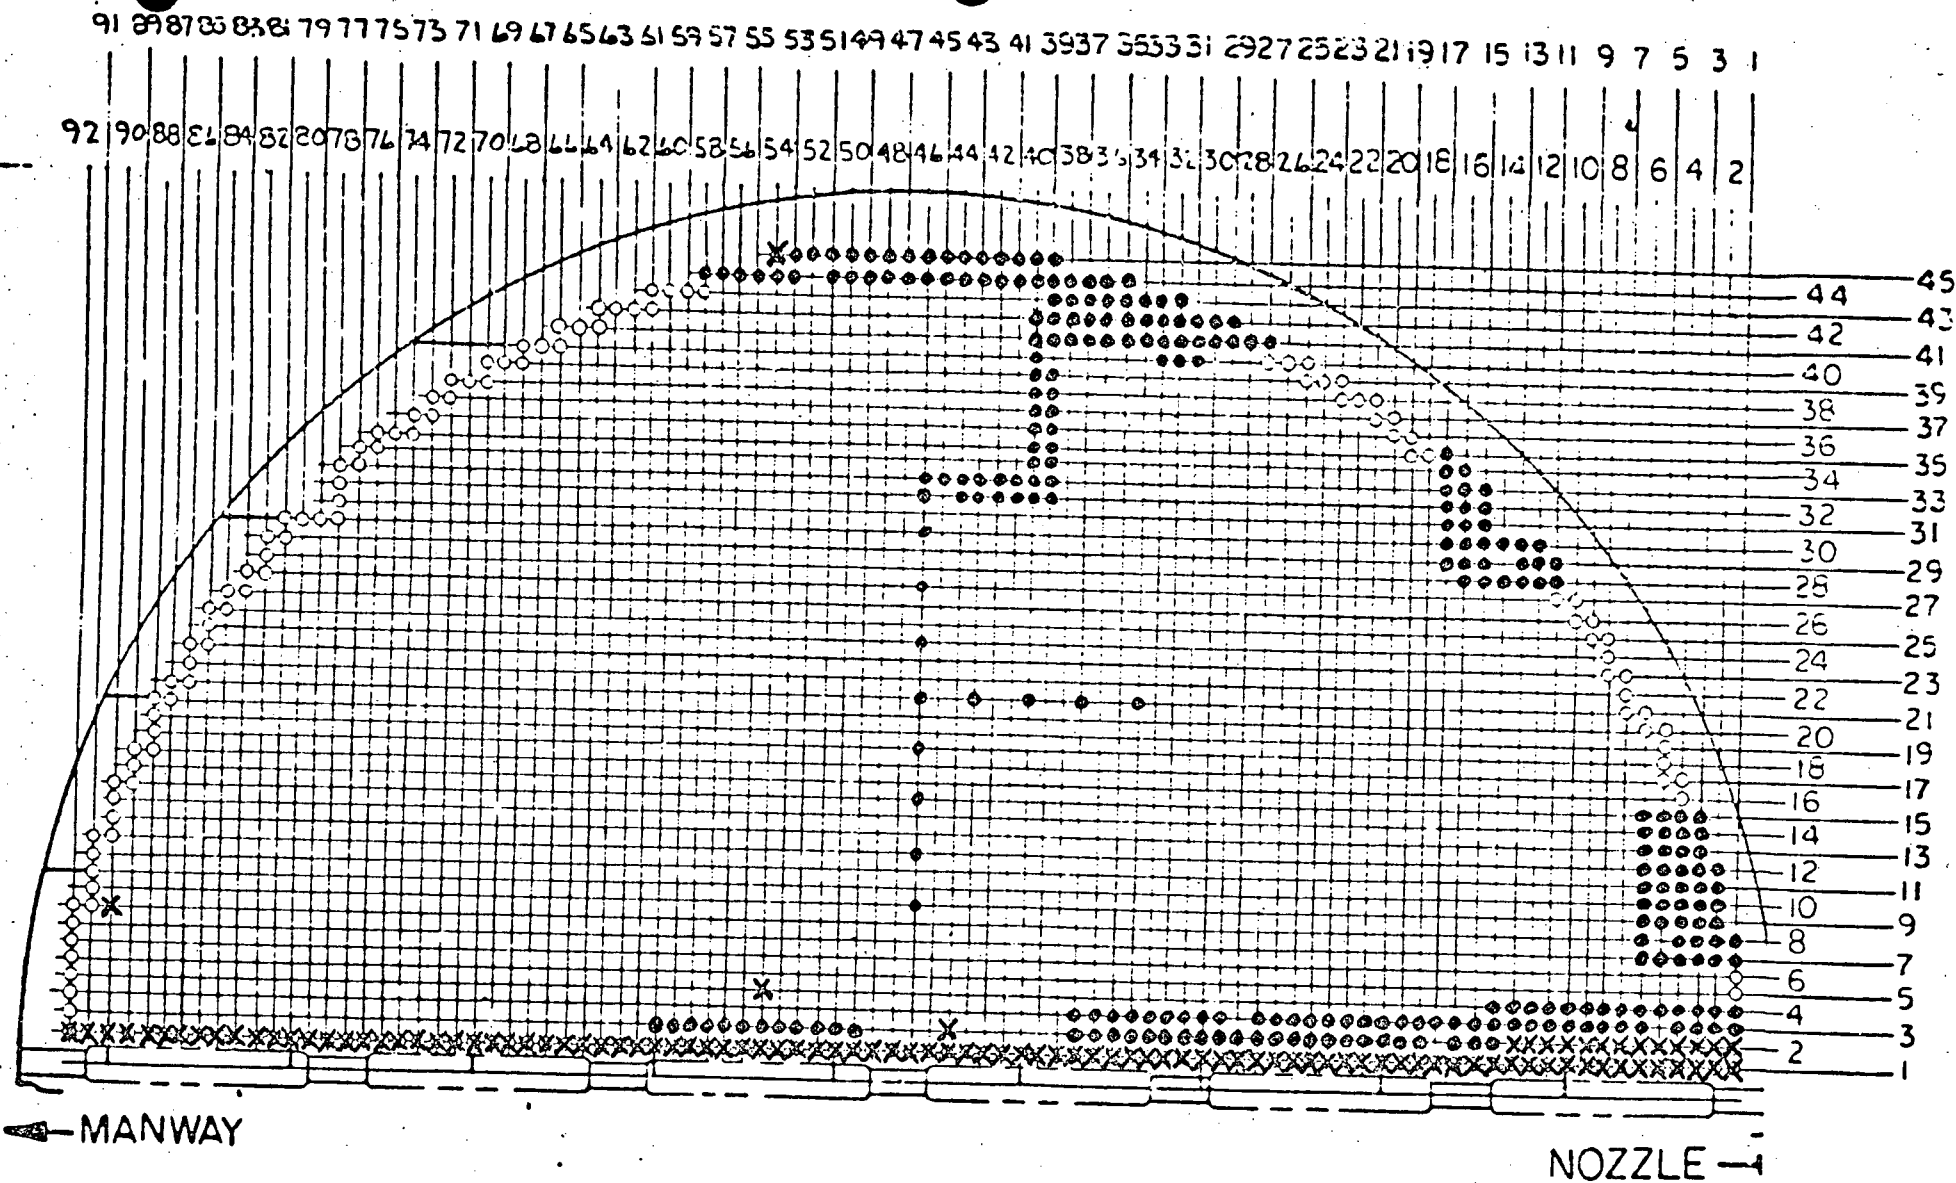
FIGURE 3

Steam Generator 23

July 1979 Inspection

● - Tubes inspected (272).

X - Tubes previously plugged.

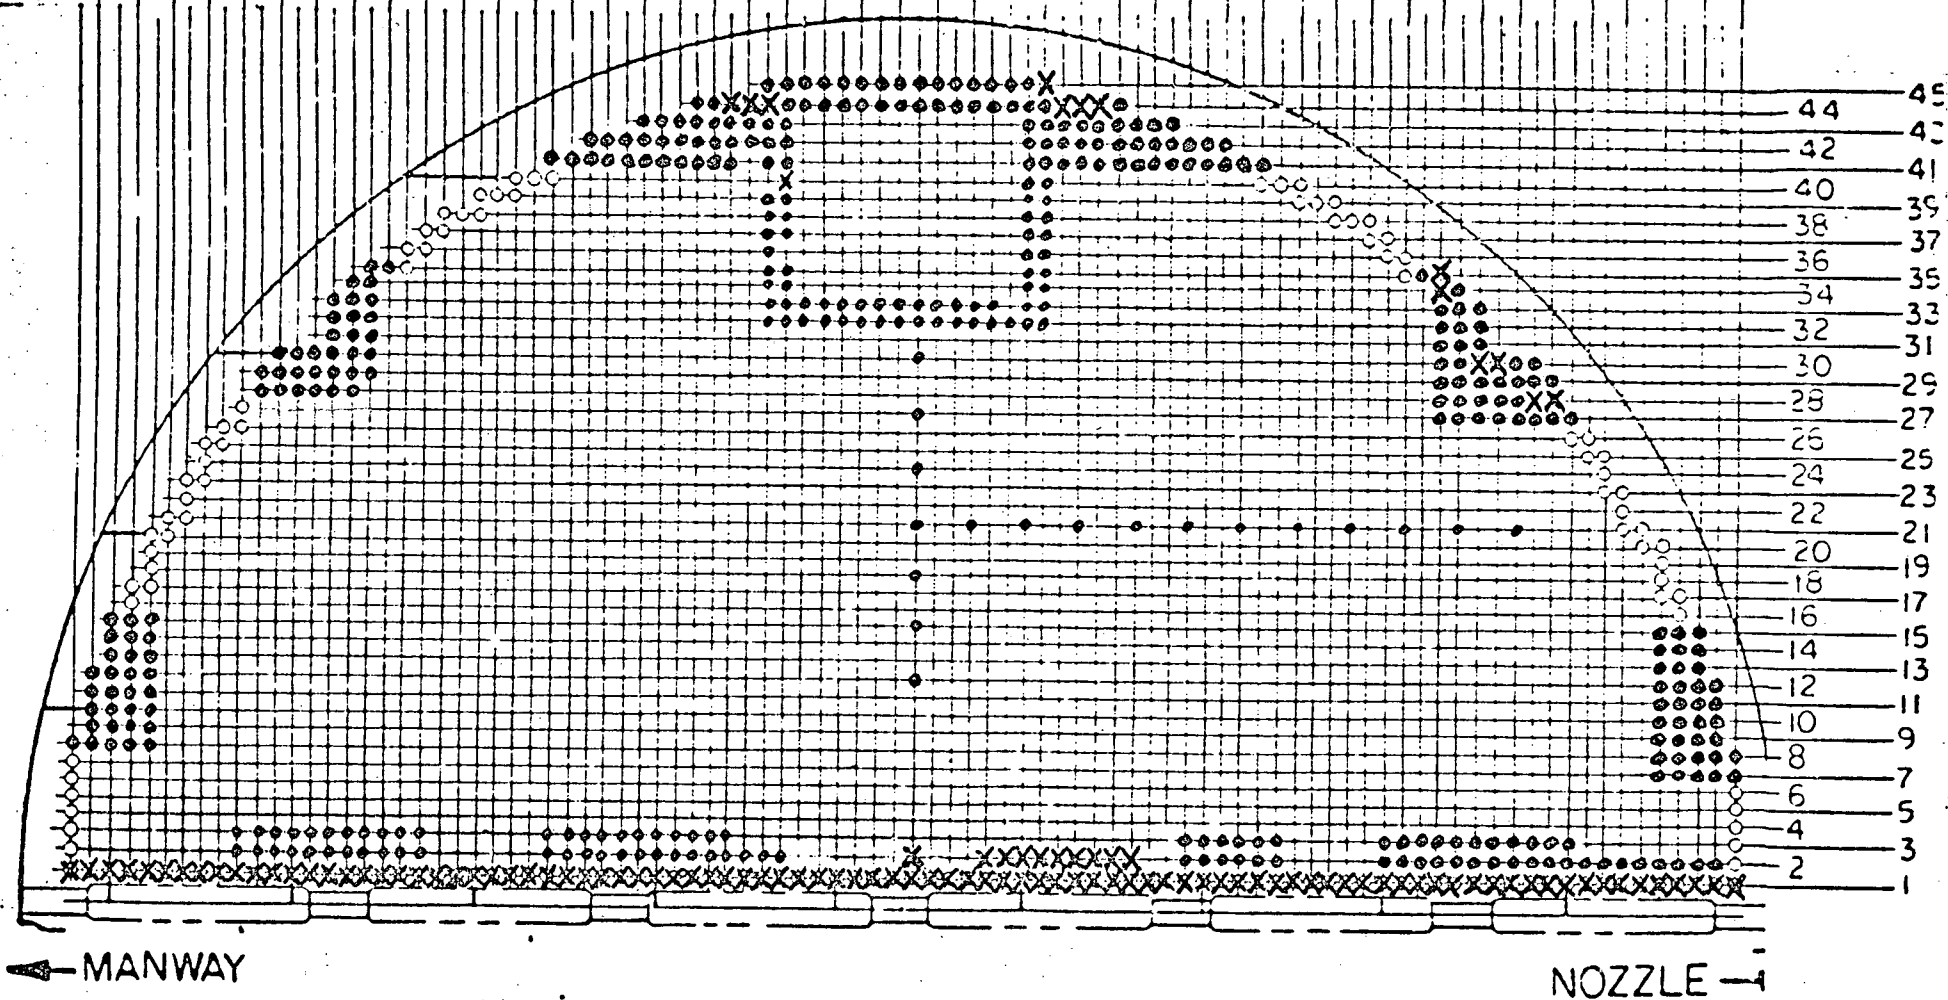
FIGURE 4

Steam Generator 24

July 1979 Inspection

● - Tubes inspected (396).

X - Tubes previously plugged.

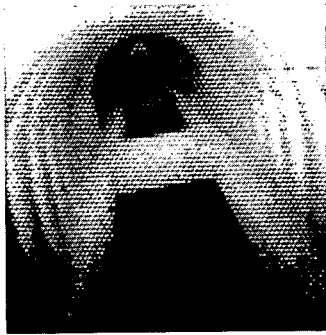
The inspections of this top support plate performed during this July 1979 inspection indicate that there has been no change in the flow slot width. The flow slots still show no discernible "hour-glassing". The photographs included in Attachment B to this report demonstrate this lack of "hour-glassing" and the similarity in the present condition with that observed during the previous inspections.

Top support plate with undeformed flow slots, as seen through a borescope.

Steam Generator 22, Indian Point 2.

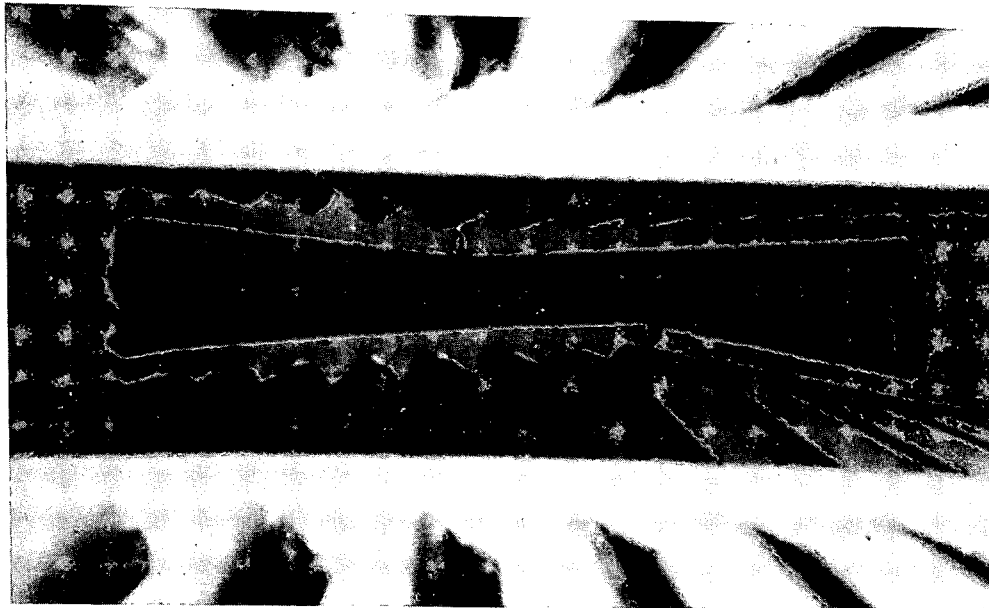
During the March 1978 steam generator inspection program, photographs revealed two cracks in the third flow slot from the manway side in the second tube support plate in Steam Generator 24. The cracks are in the ligaments between the flow slot and first row tube holes near the center of the flow slot. In addition, there was one crack in Steam Generator 23 in the second flow slot from the nozzle side in the third support plate. There is no indication as to when these cracks were formed, as the March 1978 inspection was the first time these areas were examined since the steam generators were fabricated.

Examination of these cracks during the July 1979 steam generator inspection program indicated that the three cracks appear to have opened slightly. In addition, a crack was observed in the third flow slot from the manway side in Steam Generator 22. This slot was not previously examined.

Cracked support plate.

Steam Generator 24, support plate 2  
Indian Point 2

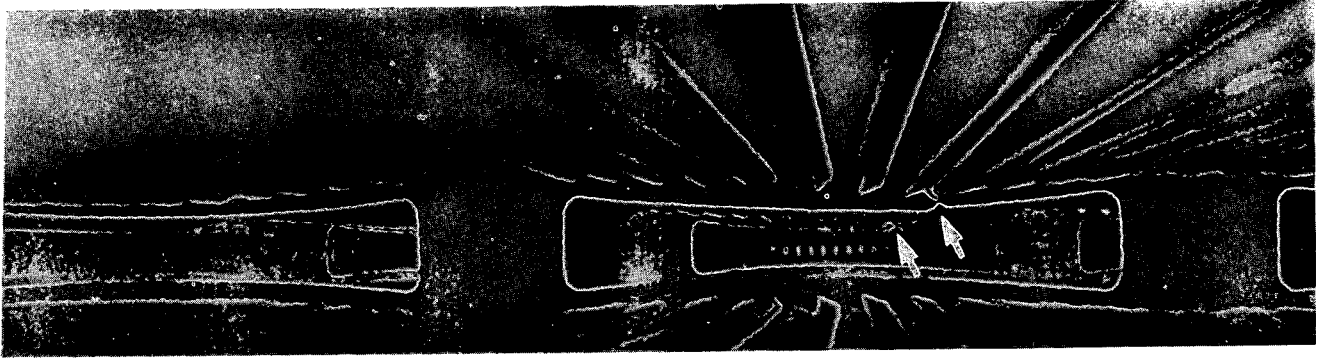
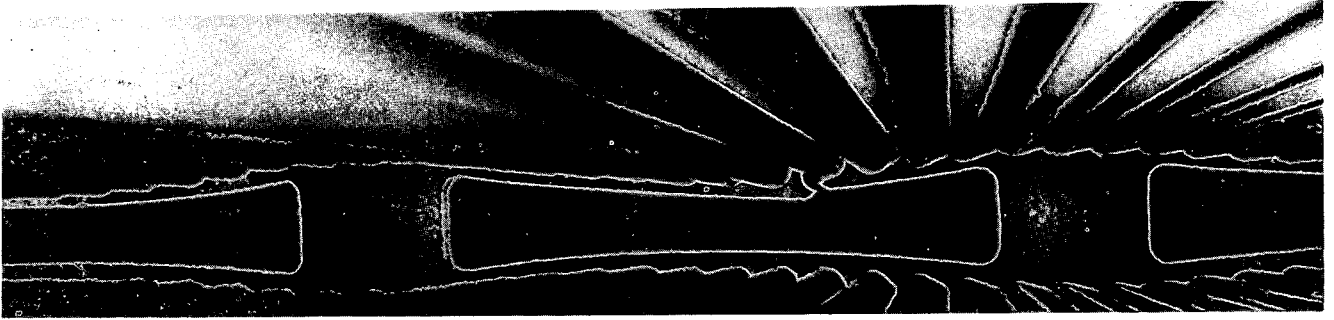
The photographs taken of the lower support plate flow slots during the March 1978 inspection indicated that some "hour-glassing" is apparent in lower flow slots in all four steam generators. For the support plates in Steam Generators 21 and 22 that were examined in April 1977 and again in March 1978, the "hour-glassing" appeared to be essentially unchanged.

Support plate showing flow slot hour glassing and cracking between the flow slot and the first row of tubes.

Steam Generator 23, support plates .3 and 4  
Indian Point 2.

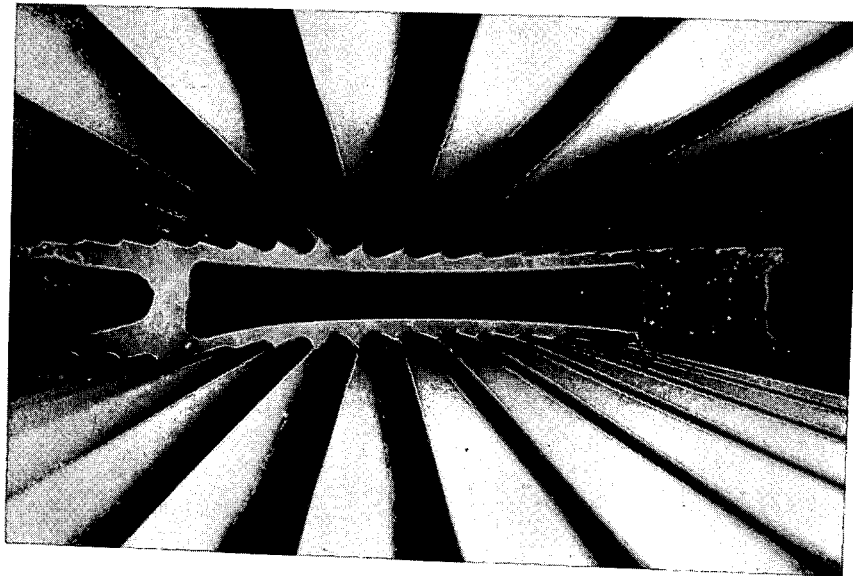
Cracked support plate

Steam Generator 22, support plate 1  
Indian Point 2

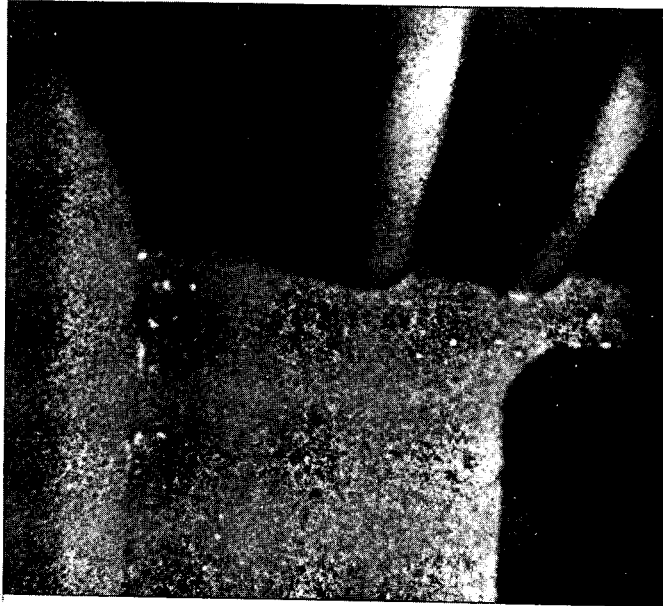
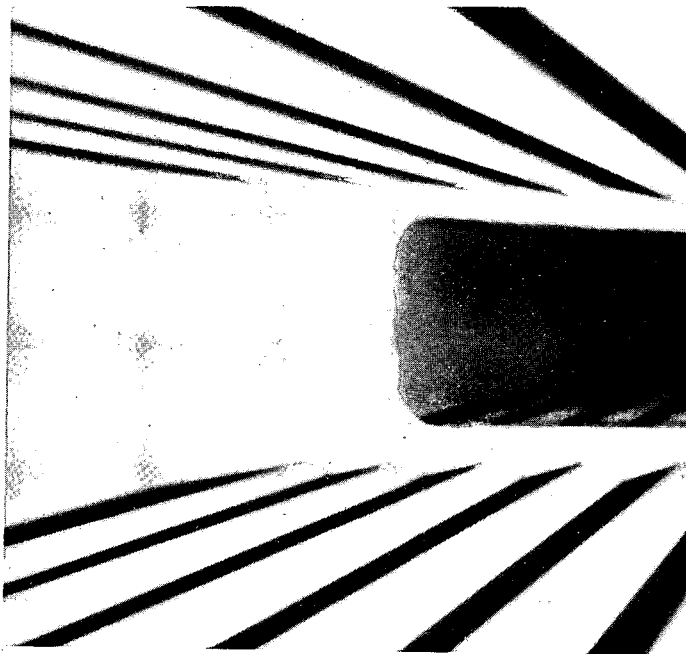
This area appears to be unchanged since the previous examination conducted during the March 1978 inspection. Furthermore, the outer surface of the wrapper was examined, and no evidence of bulging or distortion was found.

Wrapper and tube support plate

Steam Generator 24, Support plate 1, manway side  
Indian Point 2.
