WOLF CREEK

Subject: Docket No. 50-482: Licensee Event Report 2008-002-01, Technical Specification Allowed Outage Time Exceeded due to Room Cooler Leak

4. TITLE
Technical Specification Allowed Outage Time Exceeded due to Room Cooler Leak

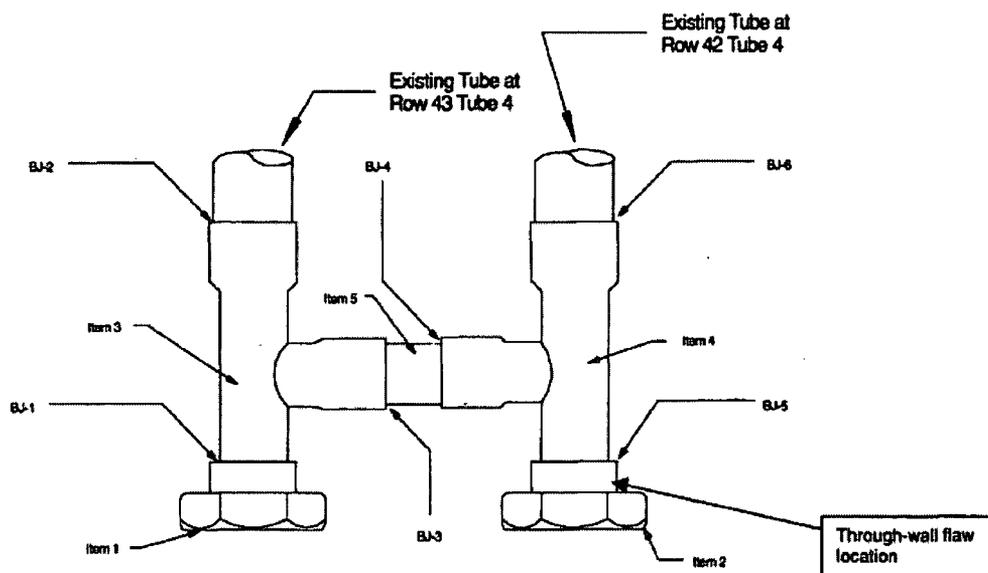
Room Cooler H-Bend Assembly

At 1420 hours on February 13, 2008, water was identified coming from the drip pan for the "A" Centrifugal Charging Pump (CCP) (EIS Code: P) room cooler. At 1550 hours, after the removal of the outer cover panel of the room cooler, a leak was identified on a room cooler H-bend assembly. The "A" CCP room cooler and "A" CCP were declared inoperable. TS 3.5.2, Condition A / Required Action A.1 was entered with a 72 hour Completion Time to restore the inoperable train ("A" CCP) to OPERABLE status. Additionally, Condition B / Required Action B.2 of TS 3.8.1 was entered with a Completion Time of 4 hours to declare the required feature(s) supported by the inoperable DG inoperable when its required redundant feature(s) is inoperable (i.e., 4 hours to declare the "B" CCP inoperable). When the "A" CCP was declared inoperable, entry into Condition B / Required Action B.2 of TS 3.8.1 was required as discussed in the TS Bases.

The H-Bend assembly arrangement is composed of two tees joined together (see sketch below), and a threaded nut on one end of each tee. All of this is brazed together into a solid unit. An end plug (not shown) threaded into each nut and sealed by an o-ring completes the assembly.

The "A" CCP room cooler is original installed plant equipment. The apparent degradation mechanism is flow-induced erosion in the H-Bend area. This failure mechanism has been seen on other room coolers that utilize H-Bends for connecting the circuits.

Flow erosion is a slow wear mechanism that degrades the H-Bends over a long period of time. This component has been in service for about 23 years and, other than maintenance outages, this component maintains continuous flow through the tubes. The continuous flow plus the length of service suggests that this is normal aging and not an accelerated degradation event.

The "A" CCP Room Cooler was isolated to repair the H-Bend leak. The repair activities replaced the defective H-Bend and returned the CCP Room Cooler to operable status.

The original room coolers included the use of H-Bend returns soldered to CuNi alloy tubes. The long-term plan to replace all CuNi coils with up-graded stainless steel components by the end of the first quarter of 2009 has been completed. The replacement room coolers have been re-designed which eliminated the H-bends and improved the tube material. The first of the new coils were installed in 1999.
