RE: Indian Point Unit No. 3
Docket No. 50-286
REGULATORY DOCKET FILE COPY

ENCLOSURE 1

STRUCTURAL INTEGRITY TEST
INDIAN POINT UNIT NO. 3

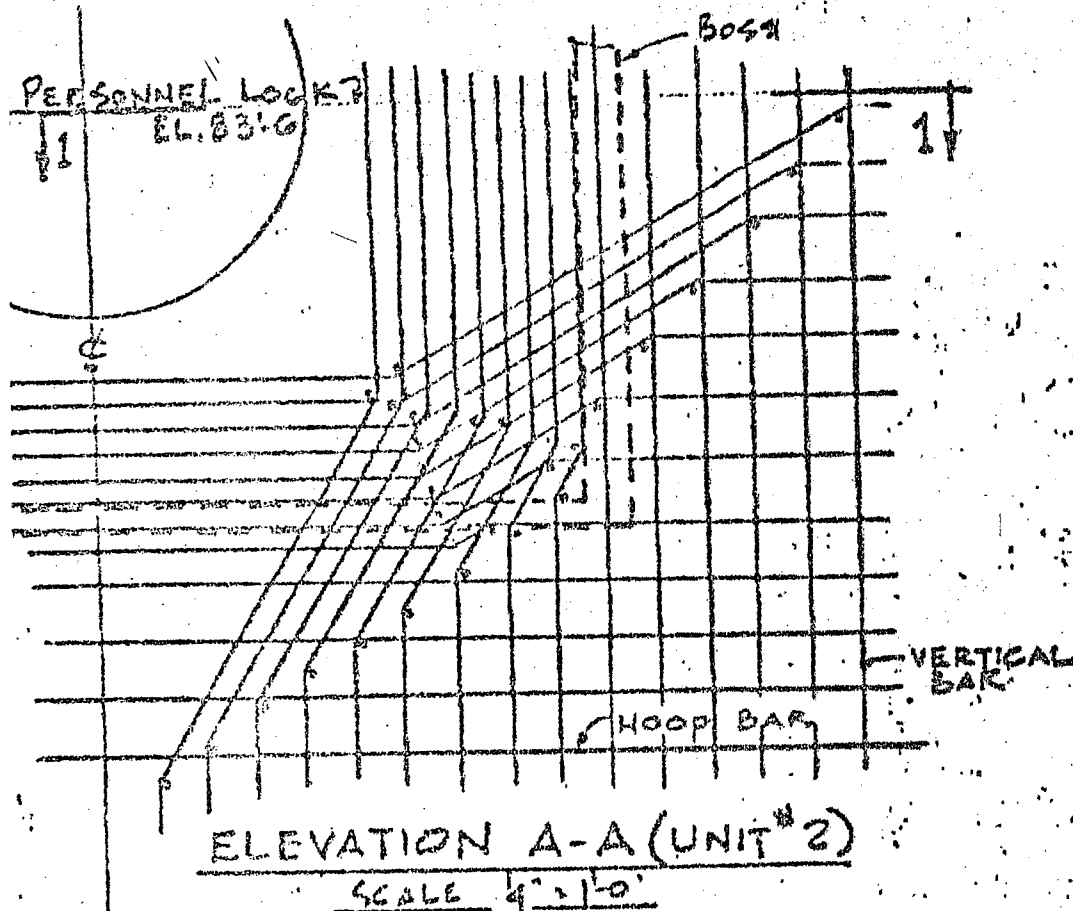
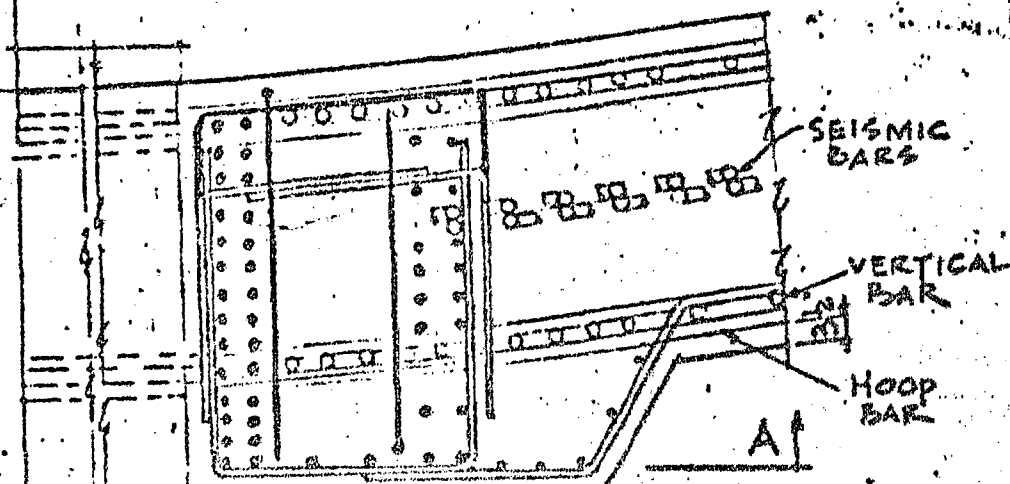
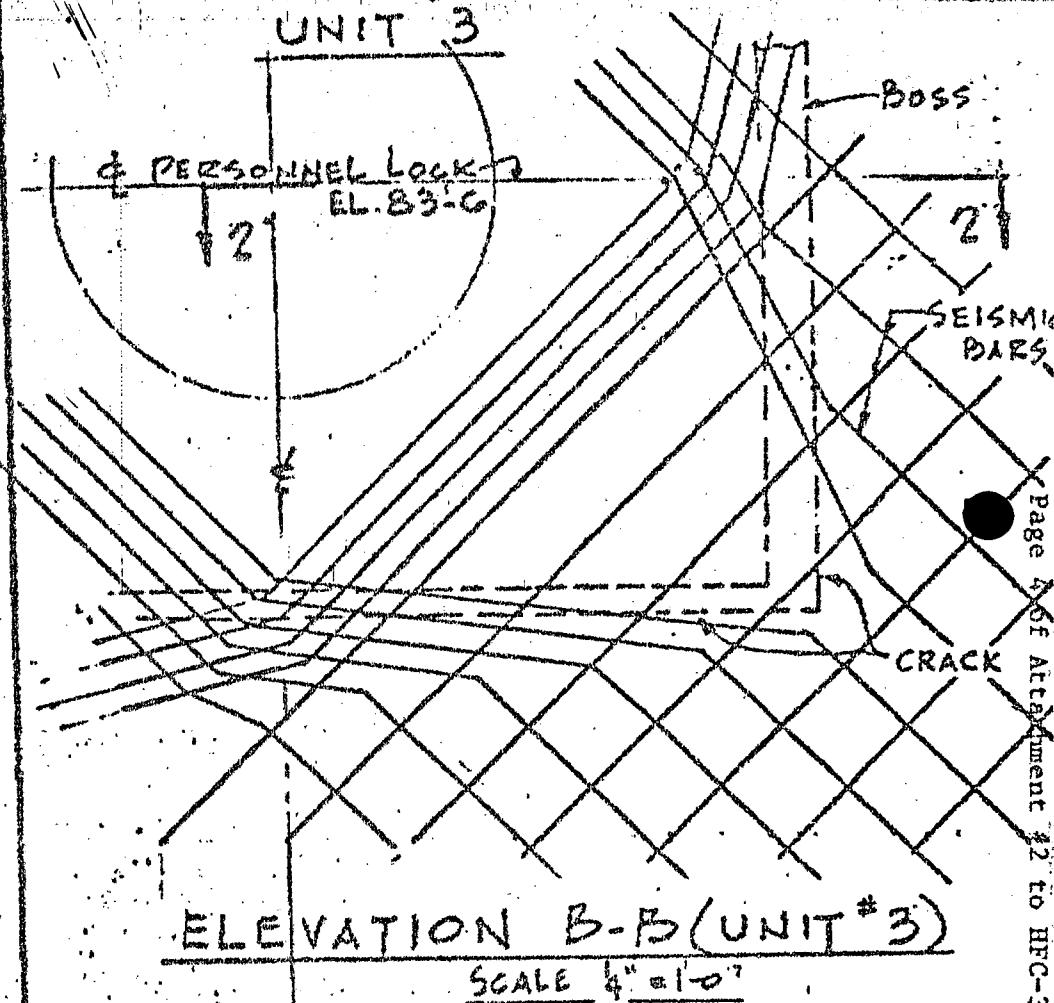
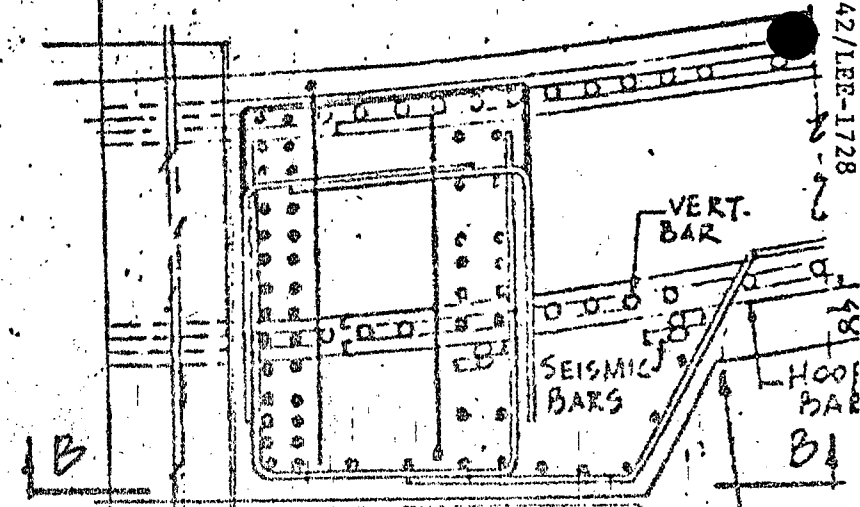
FIG. 2.1

The difference in rebar placement between Unit #2 and Unit #3 can be seen in the attached Fig. 2.1. For Unit #3 the outermost rebar is the seismic rebar. As shown in Figure 8 under Tab IX a large void is created when the seismic rebar bends around the opening. Figure 8 is the design drawing. It can be seen that a slight shift in seismic rebar location could cause a large void in seismic rebar at the lower left corner where the largest cracks occurred (see Figure 2.1). The first layer of rebar crossing the crack is thus the diagonal rebar in the orthogonal direction to the layer with the void in the crack area as shown in Figure 2.1 for Unit #3. Due to the 30" spacing of the rebar only one bar can potentially cross the crack area. In addition the horizontal rebars, which are most effective for vertical crack control are 8½" from the surface for Unit #3, since they are pushed further into the section by outside seismic rebar. For Unit #2, where the outside layer of rebar is the horizontal rebar which crosses the potential crack, the concrete cover is 3½". The differences in concrete cover between

Units #2 and #3 in Figure 2.1 comparatively illustrate the differences in rebar placement between Units #2 and #3 and provide an explanation why greater concrete cracking could be expected for Unit #3.

As stated in Item c) of Section IX the primary loads are carried by the rebar in this area; therefore the existence of concrete cracking is not a problem by itself. The concrete cracking is monitored during the test as an indicator of where rebar stresses may be high. Based on the many reasons why cracking is expected in this area as detailed in Section IX and the observation in Item f) of Section IX that the crack closed properly as pressure was reduced, the concrete cracking in this case does not indicate the presence of unacceptable rebar stresses.
