# LICENSEE EVENT REPORT

Docket No. 50-286  
LER-78-005/01T-0

Power Authority of the State of New York  
Indian Point No. 3  
Nuclear Power Plant

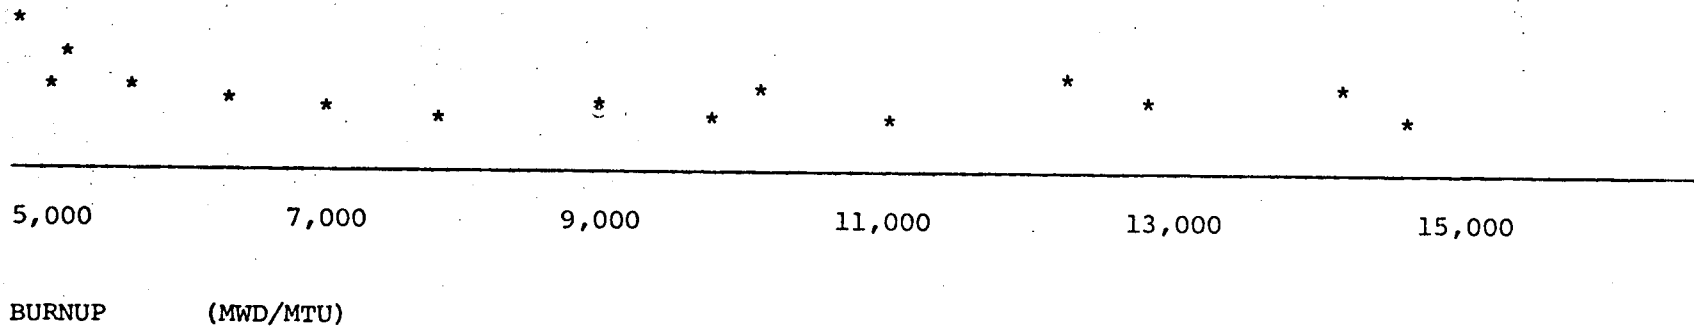
F T VS. CYCLE 1 BURNUP  
(Measurements at 91% Rated Power)

The attached figure illustrates the  $F_{QT}$  trend as a function of actual Cycle 1 burnup. It is seen that the  $F_{QT}$  has steadily decreased with burnup. Compared to the 100% and 91% rated power technical specifications limit on  $F_{QT}$  of 2.32 and 2.55 respectively, the current measured value of  $F_{QT}$  is 1.7.
