Docket No. 50-286

IE Circular No. 79-24
Date: November 26, 1979
Page 1 of 3

PROPER INSTALLATION AND CALIBRATION OF CORE SPRAY PIPE BREAK DETECTION EQUIPMENT
ON BWRs

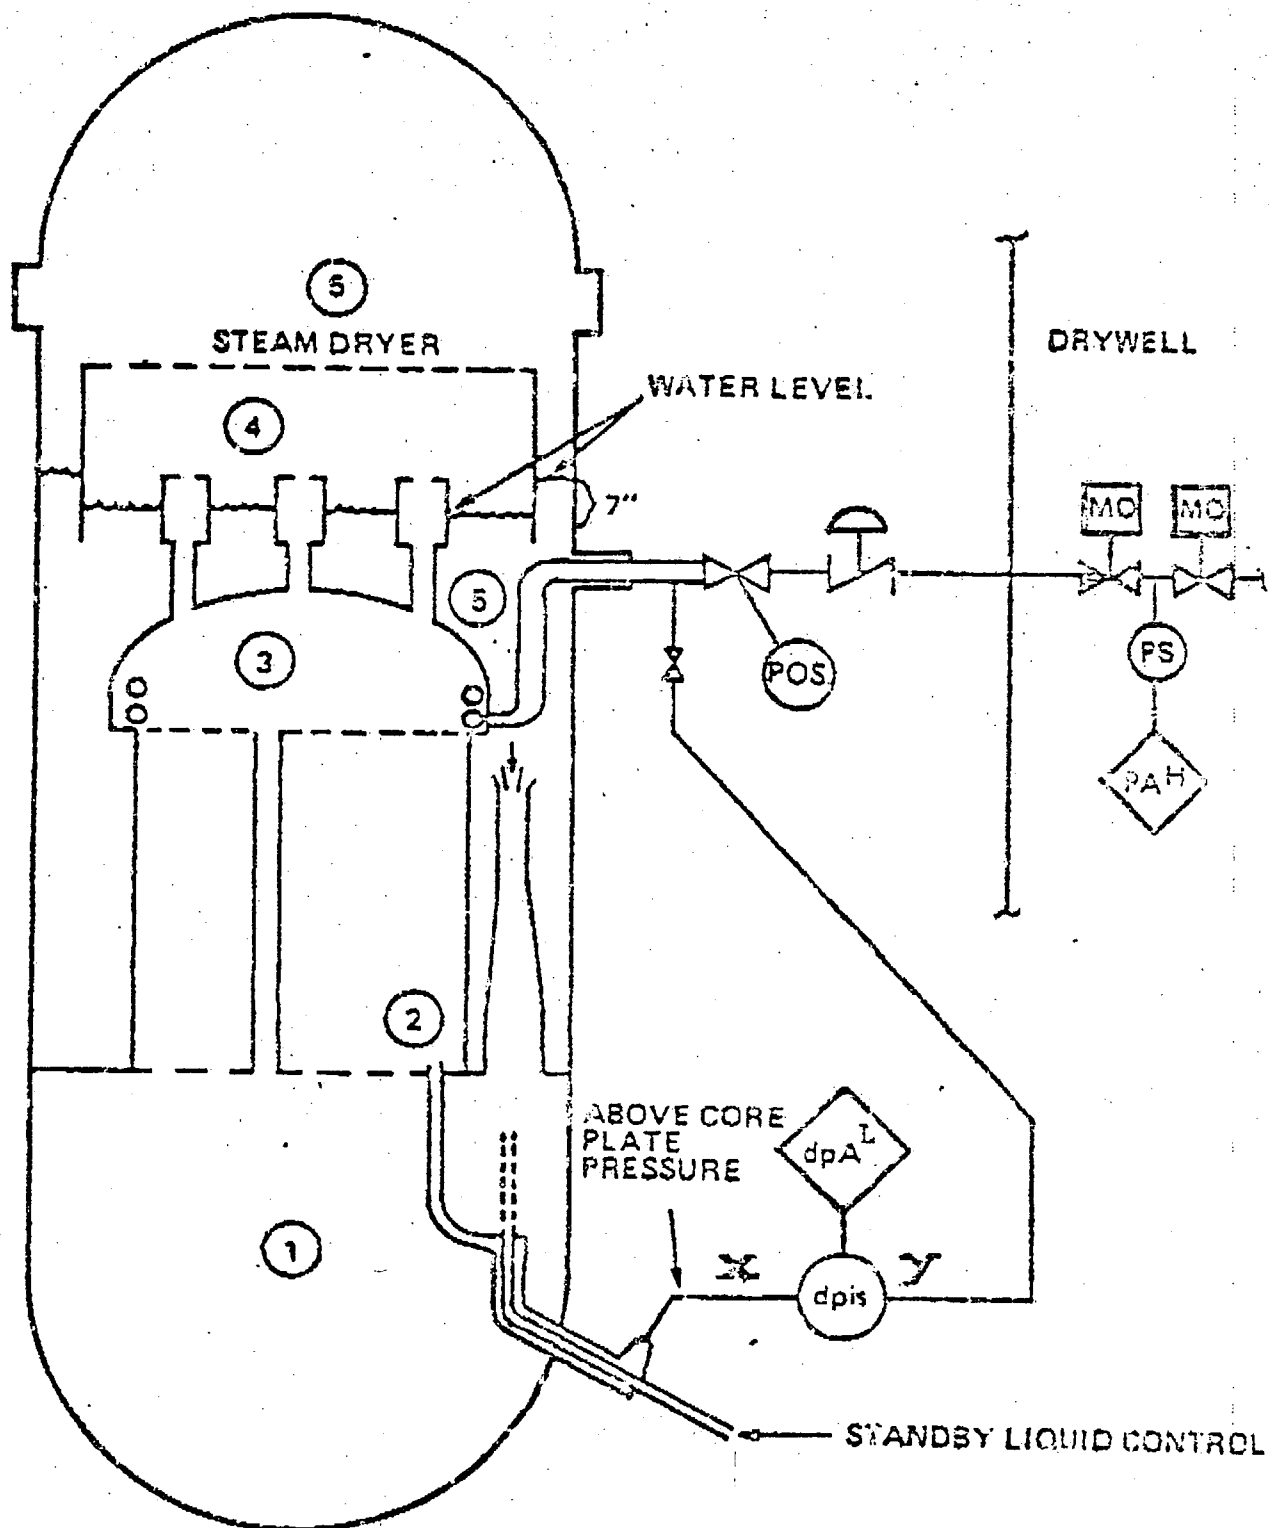
Figure 1 Core Spray System Pipe Break Detection Instrumentation

The licensee's investigation of the downscale deflection revealed that the original piping arrangement and calibration did not adequately take into account the effect of density changes of the water in the pressure leg connections. The original installation had the high pressure side of the dp instrument (see attached Figure 1) connected to the reference leg in the vessel (Figure 1 Connection X) and the low pressure side to the core spray piping outside the vessel but inside the drywell (Figure 1 Connection Y). With the piping intact, this arrangement senses the pressure difference between bottom and top of core. With a break in CS piping in the annulus area the instrument then senses the additional pressure drop across the separators (dp \approx 7 psi additional) and dryers (dp \approx 7-inches water). This installation was in accordance with GE design requirements.

Also in accordance with GE instructions the calibration of the dp instrument was performed with the reactor in the cold condition and the alarm was set to trip at 5 psid increasing. Because of this cold calibration the dp instrument then indicated full downscale negative during operation. This negative dp was due to the heat up of the reference leg (Figure 1 Connection X) which caused the fluid density to decrease as the plant reached hot conditions. The magnitude of this dp was determined to be about 3.5 psid following completion of the modification discussed below.

Adding the 3.5 psi downscale deflection to the 5 psi alarm setpoint results in a total required deflection of 8.5 psi to initiate the alarm at the setpoint. Since the total dp available across the separators and dryer is only 7 psi

(1.5 psi less than the total required deflection), the alarm would not be actuated by a CS pipe break in the annulus. Therefore, the original installation, including calibration procedure, was deficient.

To correct the problem, Iowa Electric modified the installation by interchanging the pressure leg connections and resetting the alarm to trip at 2 psid decreasing. In this orientation it was found that going from cold to hot produced a 3.5 psid positive deflection. The technical specifications were changed to reflect the revised alarm setpoint.

- "1. BWR operators, who have differential pressure (ΔP) instrumentation which reads only positive values, interchange their core spray line break instrument connections so that the high side connection is to the core spray sparger sensing line and the low side connection is to the above the core plate sensing line. This instrumentation should be calibrated for a zero ΔP reading during cold shutdown; it will then give a positive ΔP reading during normal rated power operation and a pegged zero reading for a line break indication during normal rated power operation.

Also, when this change is made, the recommended alarm setpoint (on decreasing ΔP) setting is 0.5 ± 0.25 PSID; and for those plants that have a value in their technical specifications, > 0 PSID is recommended as a limit.
