U.S. NUCLEAR REGULATORY COMMISSION
REGION I

Report No. 50-286/89-09

Facility Name: Indian Point Nuclear Generating Station, Unit 3

Inspection Summary: Routine unannounced inspection on April 3-7 and April 18-21, 1989 (Report No. 50-286/89-08)

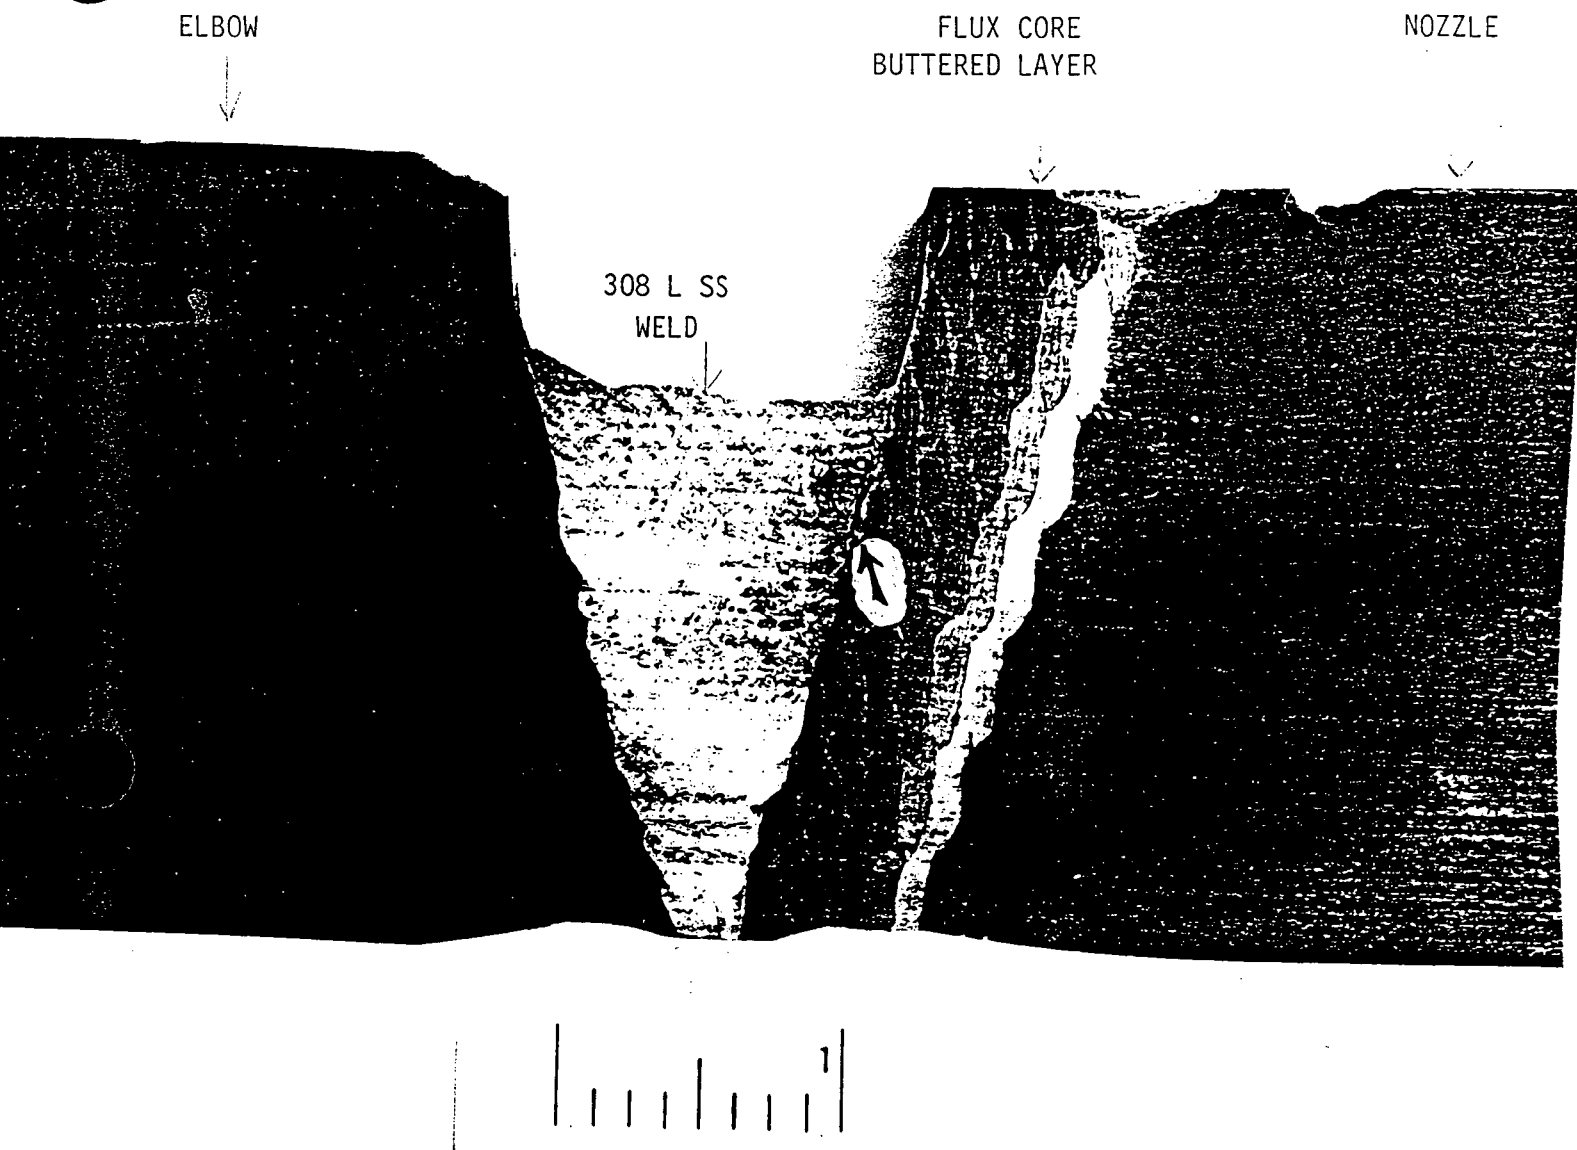
On April 3, 1989 the inspectors met with the licensee's principal engineering and welding personnel and were informed that the licensee was not able to consistently produce sound welds in the JAP mockups even though welding was performed under tight supervision by PCI (Power Cutting Incorporated), a subcontractor to Bechtel. As experienced with the steam generator replacement at D.C. Cook Unit 2, where identical materials were employed, the licensee experienced difficulties in the flux core stainless buttered nozzle end preps when "tie-ing in" the adjacent weld beads. The replacement SG's at both sites were fabricated by the same manufacturer. The difficulty was found to be due to lack of fusion that occurred in the middle 1/3 of the thickness, above the change in joint bevel. The licensee presented to the inspector a metallurgical report, prepared by Lucius Pitkin Laboratories, showing the lack of fusion in a mockup cut from JAP-3 that was readily found by radiography. Macroscopic and microscopic examination of sections cut from the mockup showed that the lack of fusion occurred at the interface between the TIG deposited type 308L stainless weld metal and the flux core type 308L stainless buttered layer as shown in the photograph in Figure 1. The report also included the results of Energy Dispersive Spectroscopy (EDS) which revealed significant quantities of calcium, silicon, and a lesser amount of aluminum in the defect, all of which were considered

to be impurities (oxides) generally found in weld fluxes. It was concluded that in all likelihood, these impurities in the weld metal contributed to the lack of fusion. As the result of this experience with the JAP mockups and the experience at D.C. Cook the licensee elected to butter ("seal") the as delivered nozzle weld end preps with three layers of "clean" type 308L stainless weld metal using the automatic TIG process prior to making the nozzle to elbow weld. The licensee proceeded to weld JAP 4 mockup utilizing three layers of TIG deposited 308 L. Radiography and metallographic sectioning, as shown in Figure 2, revealed a sound joint free of defects. (See Figure 2). In addition, the safe end weld joint bevel was modified from 30°, 15°, and 5° to 30° and 19°. The inspector reviewed the documentation covering the TIG buttering operation and found no reported problems except as discussed in Allegation No. RI-89-A-0031 page 6.

Figure 1 - Shows cross sectional of transverse macrosection cut from JAP-3 simulated nozzle-elbow mockup. Arrow depicts lack of fusion defect along fusion line between weld and flux core buttered layer.
