TECHNICAL REPORT ON STEAM GENERATOR CHANNEL HEAD CLADDING
INDIAN POINT UNIT NO. 3

PREPARED BY Samuel Rothstein
Samuel Rothstein
Senior Engineer

DATE September 19, 1975

Consolidated Edison Co. of N.Y., Inc.
4 Irving Place
New York, N.Y. 10003

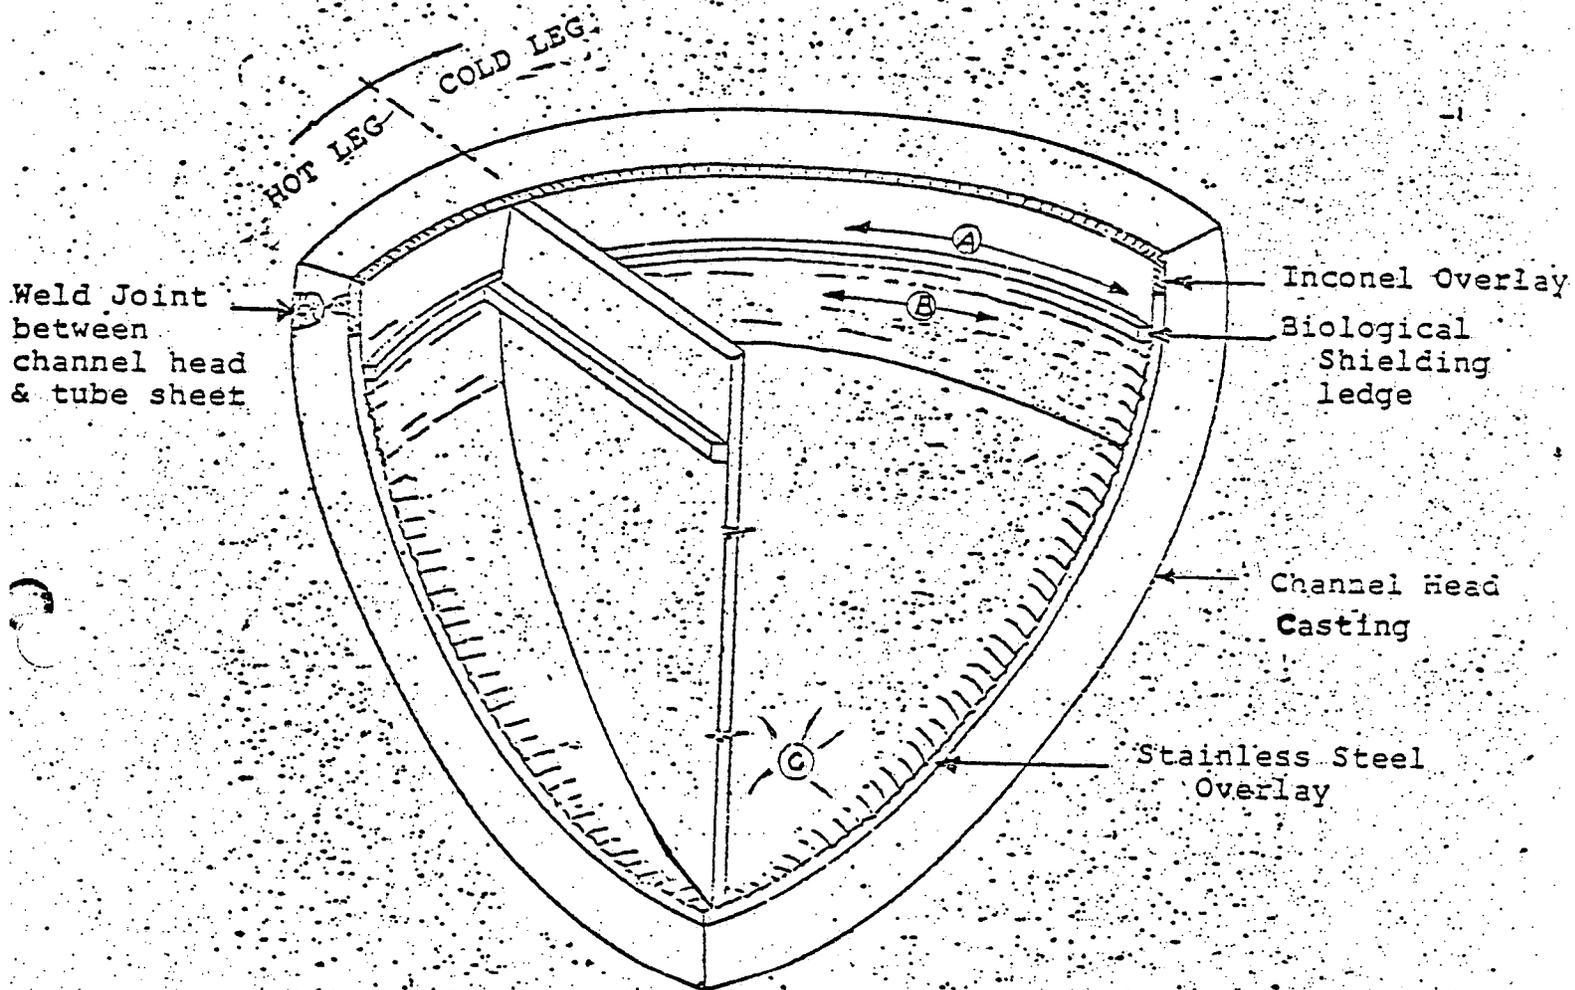
Because of the previous history of the steam generators' exposure to sea water, it was decided to liquid penetrant examine all primary clad surfaces in each steam generator. This examination detected indications on the cladding of each channel head varying in degree and location. The frequency of indications was highest at the area just above and below the biological shielding ledge. Liquid penetrant indications were detected in isolated areas in each steam generator, with only a minor portion (estimated 5%) of all clad surfaces being affected.

A-- Areas above shielding ledge

B - Areas below shielding ledge

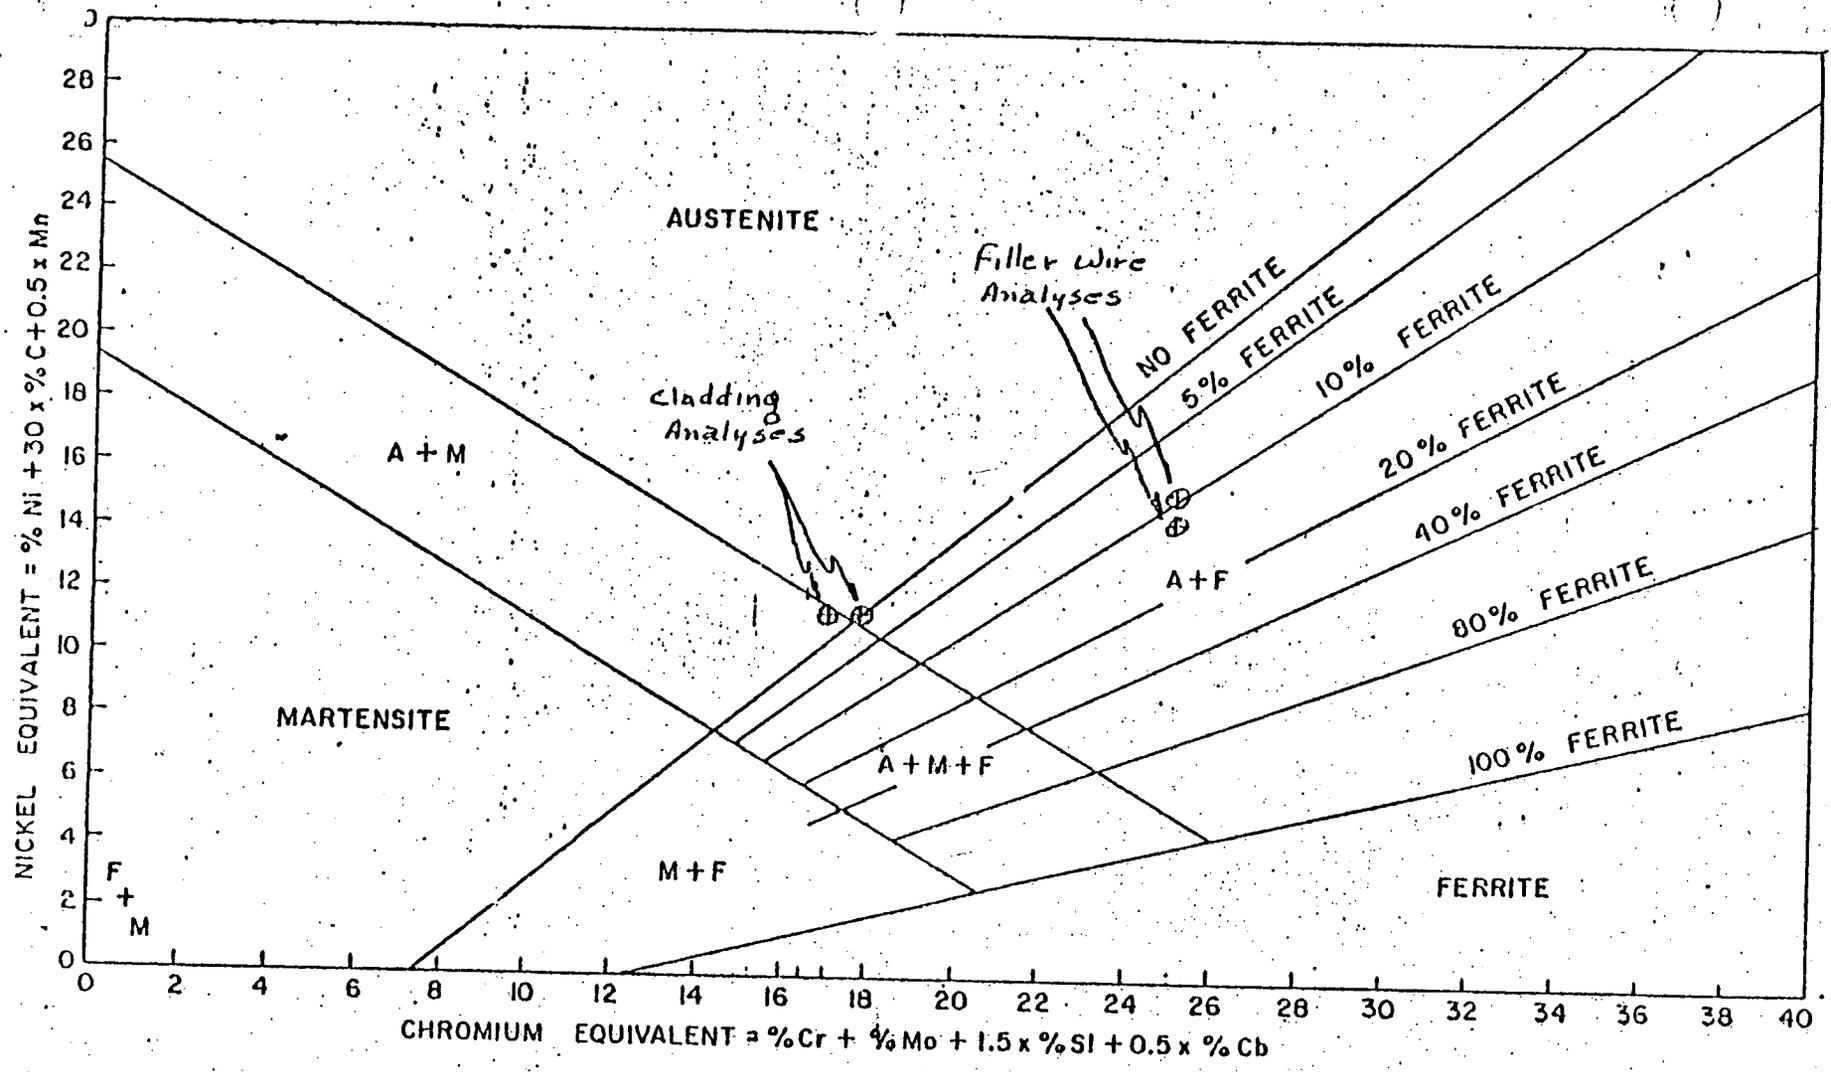
FIG. 5-1 SHAEFFLER DIAGRAM

Referring to the Schaeffler constitutional diagram, Figure 5-1, it is apparent that the cladding falls into a region where austenite, ferrite and martensite may be present. Local variation in alloy content of the cladding plus variations in the cooling rate and the reheat temperature of the heat affected zone of each deposited bead account for the wide variation in ferrite content noted in magnagage readings, as well as the variation in structure noted in the boat samples. Small differences in unit heat input resulting from changes in weld parameters such as arc voltage, distance between arc and base metal, and rate of travel would result in variations in the chemical composition and consequently in the metallurgical structure of the cladding. Areas low in ferrite would be subject to microfissuring; high ferrite would be reasonably ductile. Variations in martensite content would also result in variations in hardness and ductility.

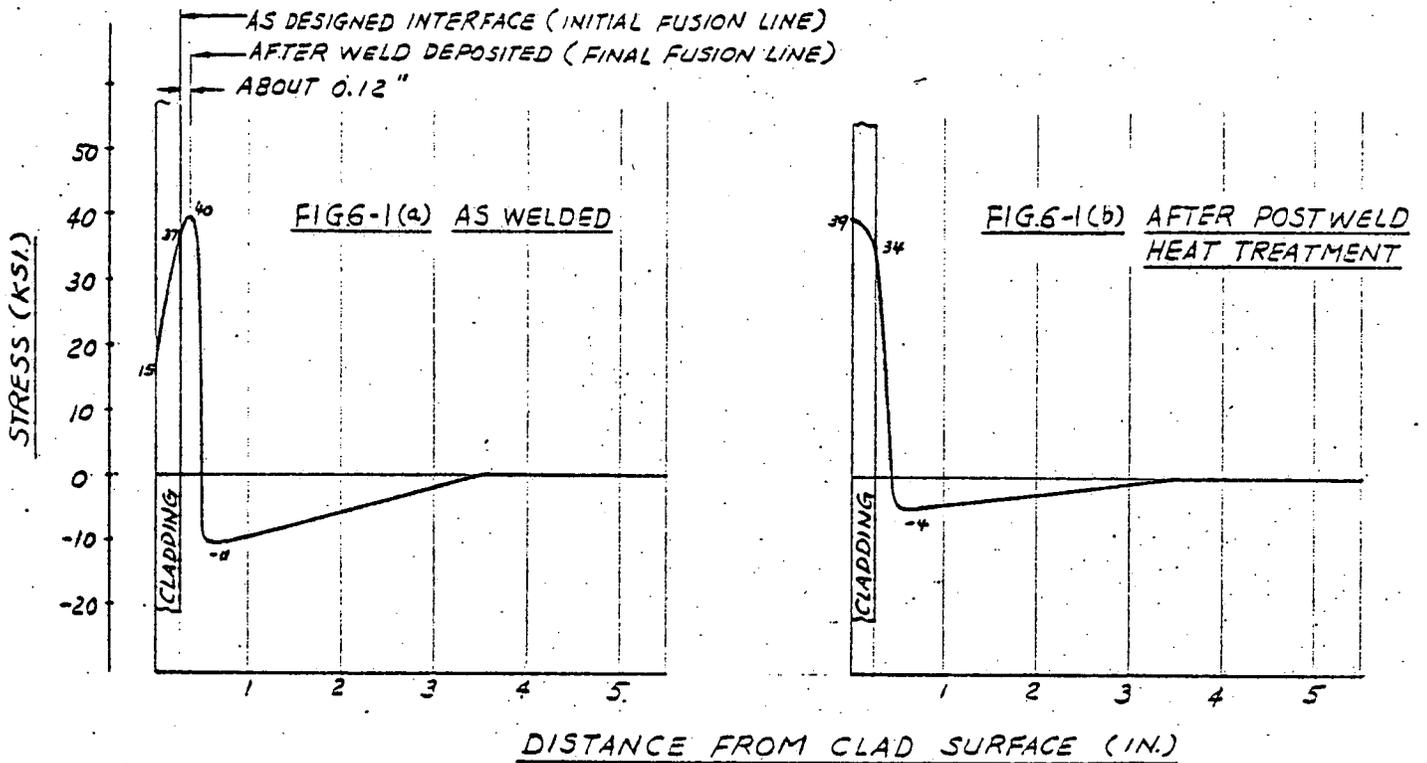
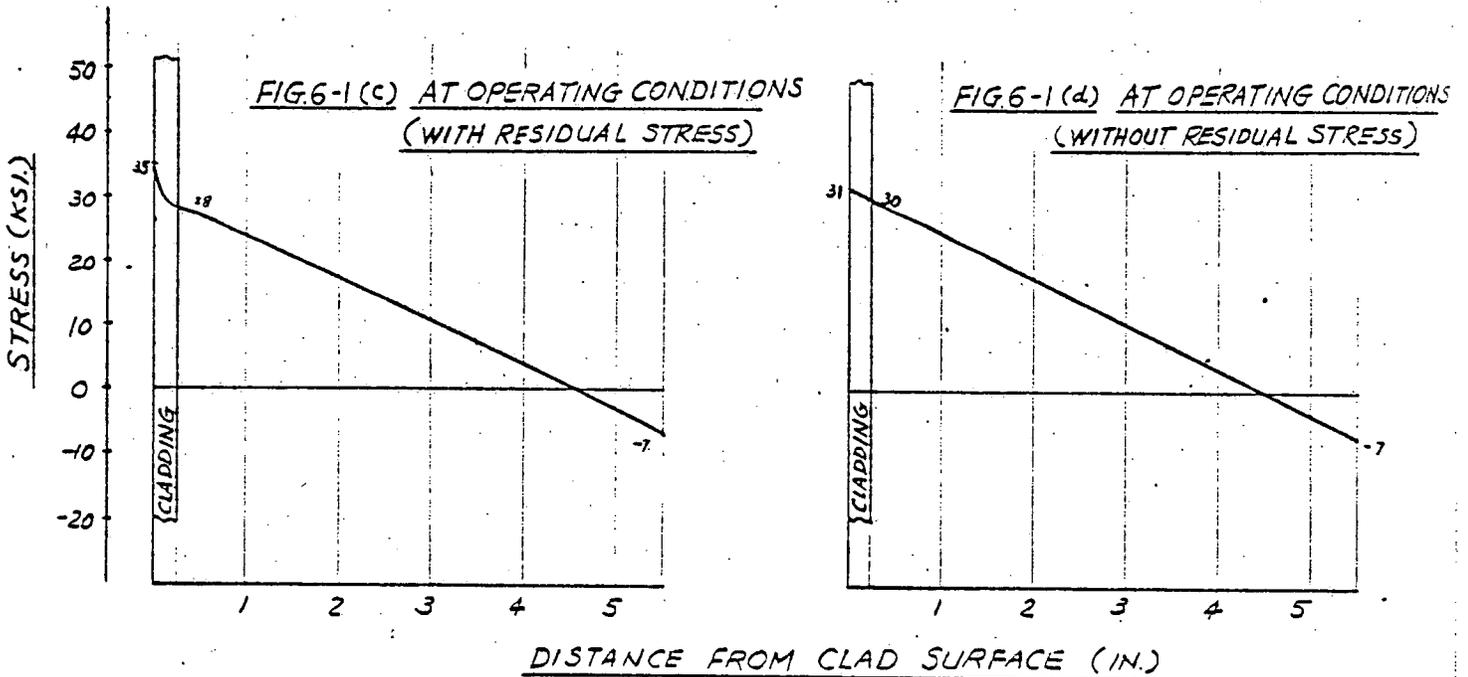
FIG.6-1 PREDICTED STRESS DISTRIBUTION IN THE CLADDED CHANNEL WALL

Postweld heat treatment does not erase the residual stresses in the clad region, as shown in Fig. 6-1 (b). This is again due to the large difference in thermal-expansion coefficients between the austenitic stainless steel cladding and the ferritic base metal. The differential shrinkage at room temperature (resulting from cooling down from the stress relief heat treatment temperature of 1100F) between these two metals is large enough to drive the entire cladding region to very high tensile stress. The major portion of the base metal remains in insignificantly low compressive stress.

At operating temperature, a significant portion of the residual stress resulting from postweld heat treatment is relieved due to the now favorable difference in thermal-expansion between the two metals. The stress distribution shown in Fig. 6-1 (c) is for the channel weld region approximately 3.5" below the tubesheet. Service pressure stresses result in very high discontinuity pressure bending stress due to the interaction between the very thick tubesheet and the thinner channel wall. These stresses are maximum in the axial direction. The maximum residual stresses occur in the hoop direction along the direction of the cladding deposition. For conservatism, these two stresses are combined to obtain the curve in Fig. 6-1 (c). This can be compared to the calculated stress distribution neglecting the residual stresses due to the cladding, as shown in Fig. 6-1 (d).

It is apparent that during service, the residual stresses and difference in thermal expansion serve to reduce the peak pressure stress at the surface of the base metal. This reduces the probability of propagation of discontinuities into the base metal.
