MEMO REPORT CI-1052

EXAMINATION OF A BOAT SAMPLE SUPPLIED BY GE
I&SE NUCLEAR PLANT SERVICES

G. G. Gould

June 23, 1982

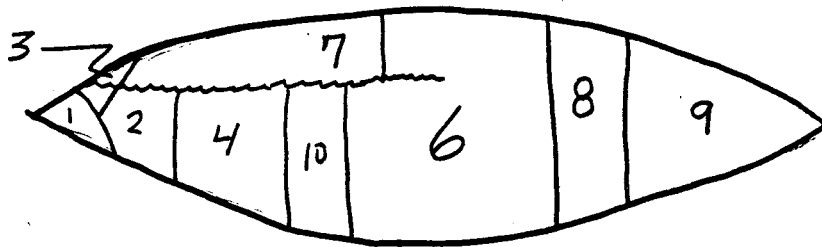
A boat sample was removed in the proximity of a weld on the steam generator at Indian Point. The boat sample had been cut up prior to being sent to the Turbine Technology Laboratory and the following sketch shows the original sample, the slices made, and identifies the pieces by number.

We received pieces #3, 6, 7, 9 and 10.

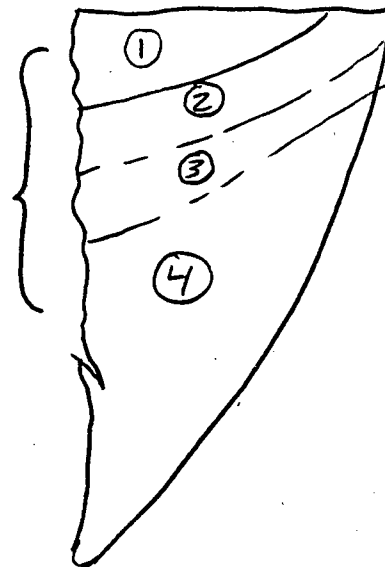
ZONES

<u>Location</u>	<u>Knoop Hardness</u>
Zone 1 (Weld)	257 258
Zone 2 HAZ	405 408 376
Zone 3 HAZ	289 278 289
Zone 4 Base Metal	244 246 239

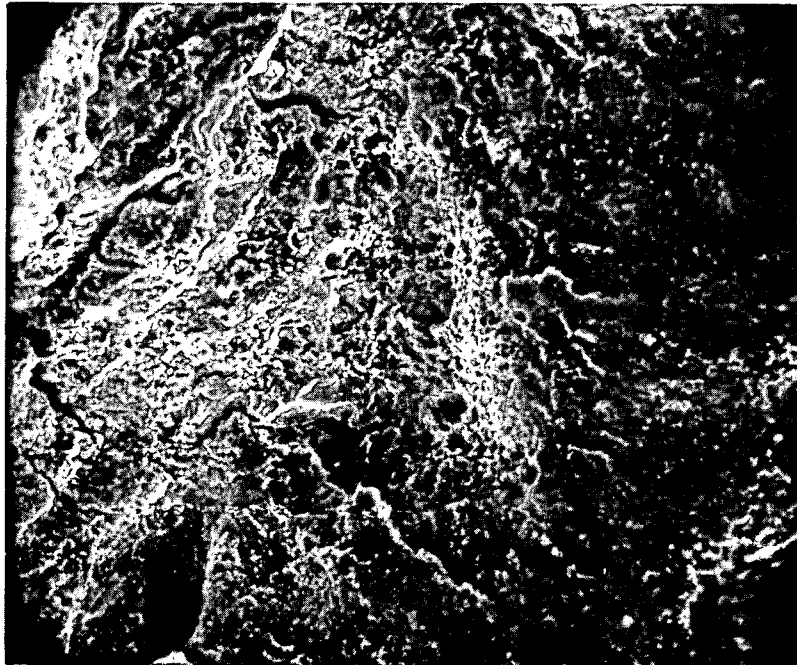
The SEM photographs showed insufficient detail to determine whether the primary crack was intergranular or transgranular. The SEM photographs do reveal extensive secondary cracking, much of which seems nearly parallel the original crack surface, i.e. it branches at a small angle.

FIGURE 1. SEM of primary fracture surface after some ultrasonic cleaning. Note secondary cracks.

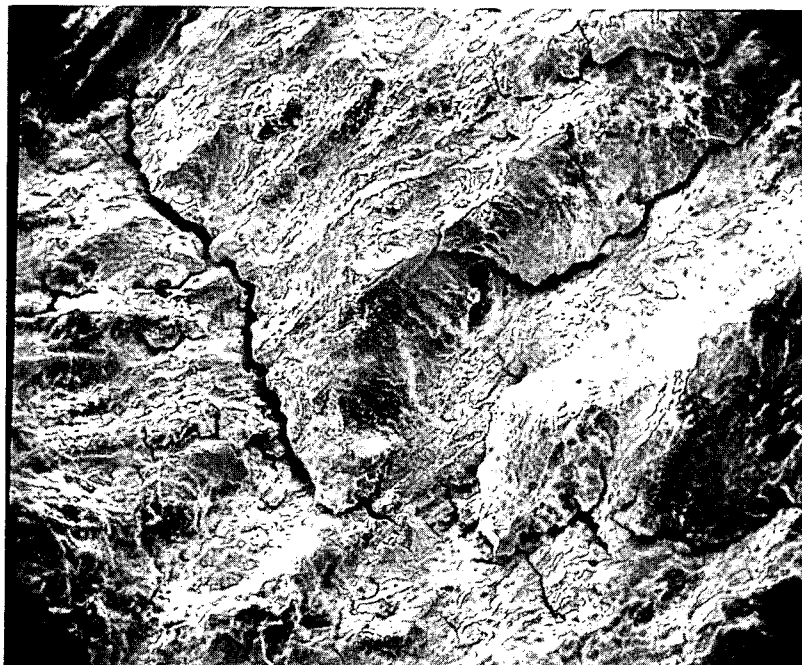
FIGURE 2. SEM of primary fracture surface after some ultrasonic cleaning. Note the secondary cracks.

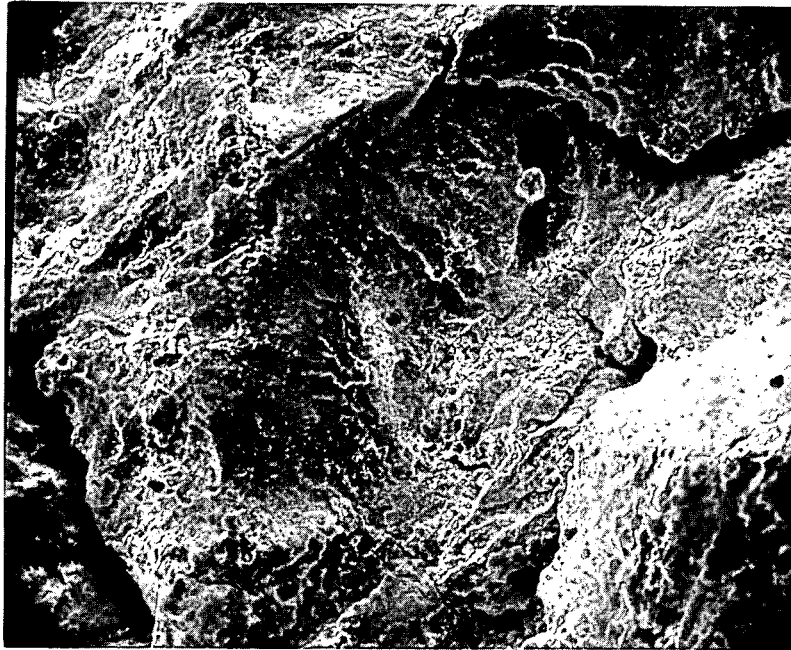
FIGURE 3. SEM of primary fracture surface after some ultrasonic cleaning. Note the secondary cracks.
Mag 500X

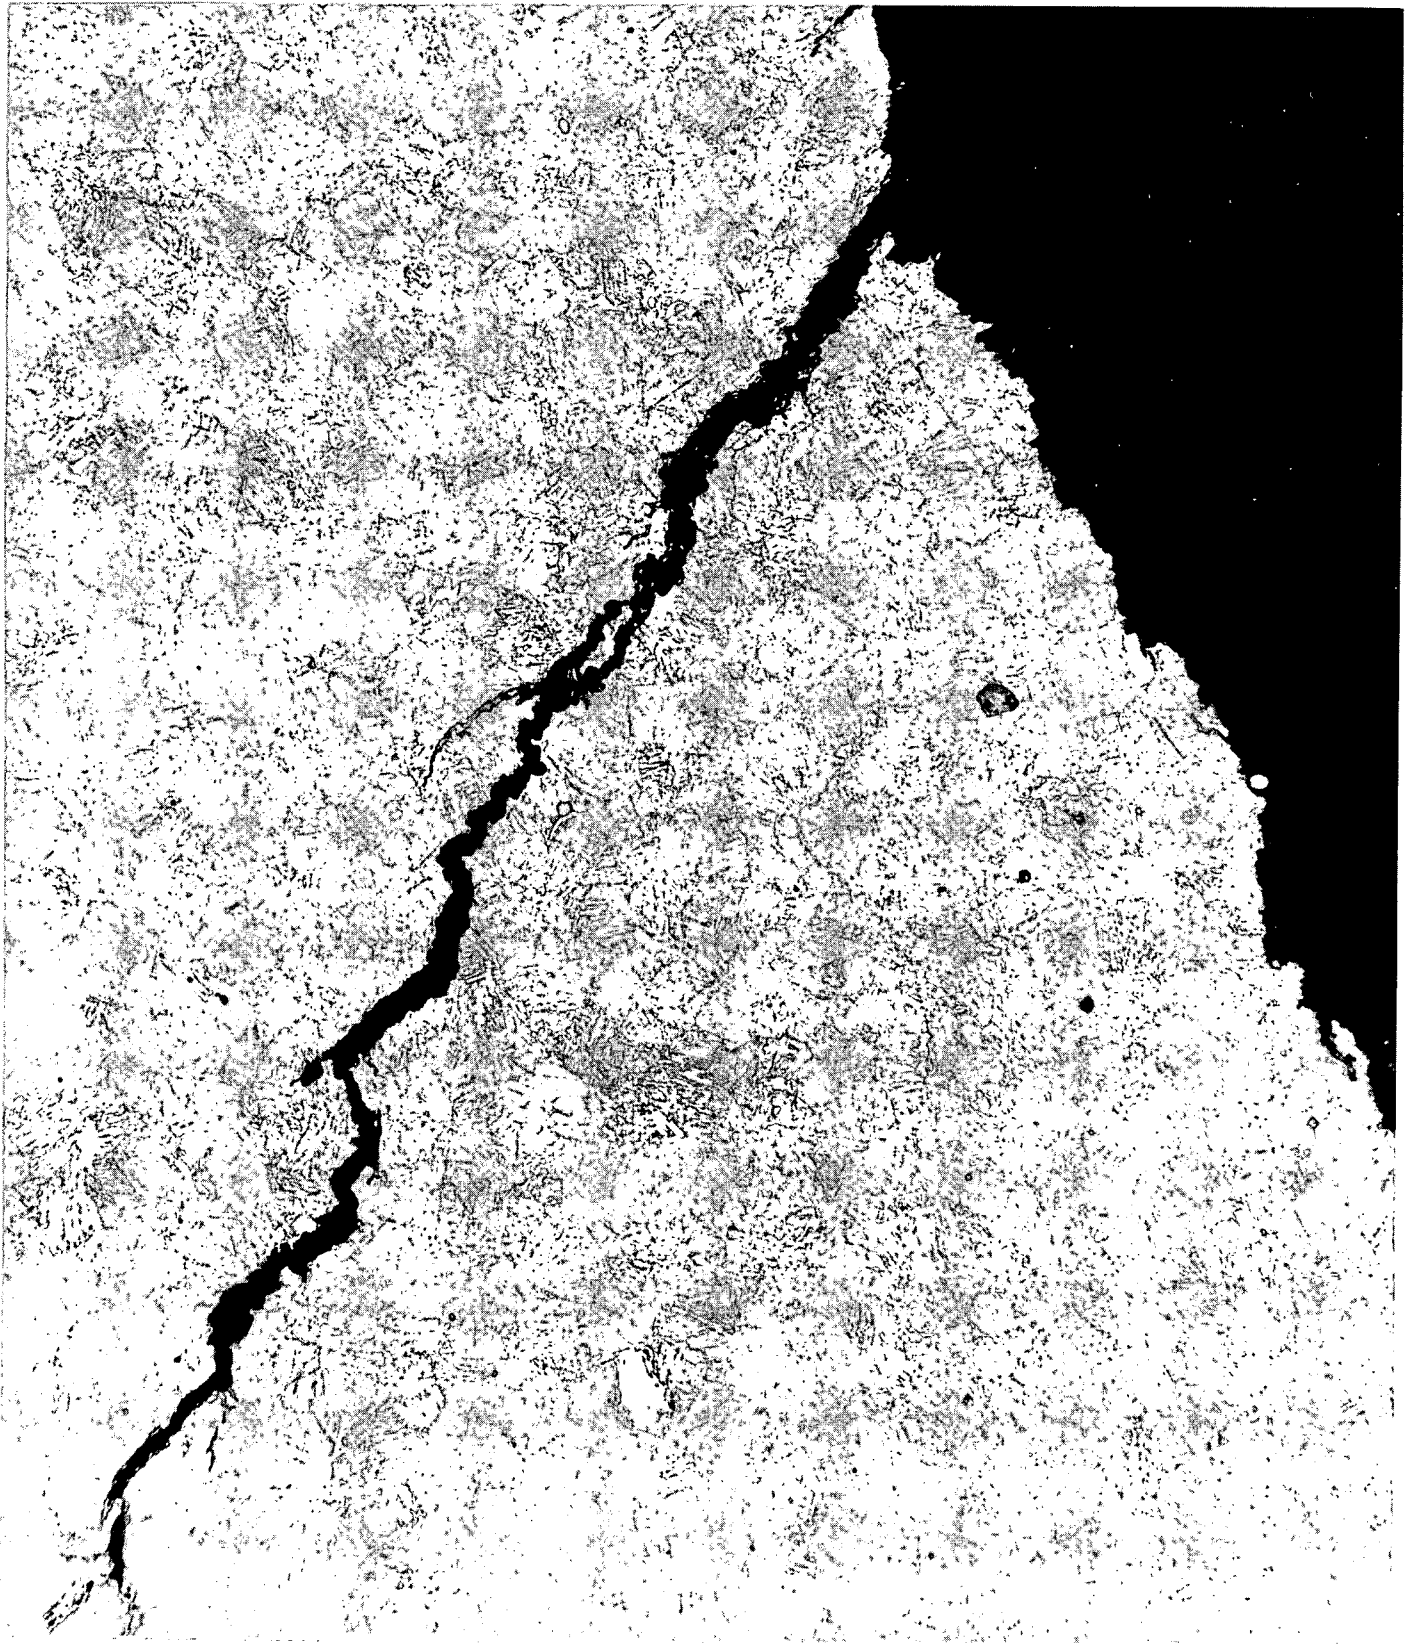
The optical metallography shown in Figures 4-7 shows secondary cracks,

some with oxide and some with none. Resolution of the crack path is not simple in these micrographs but the secondary crack propagation is transgranular.

FIGURE 4. Secondary crack in Specimen 6A. Etchant 2% Nital.

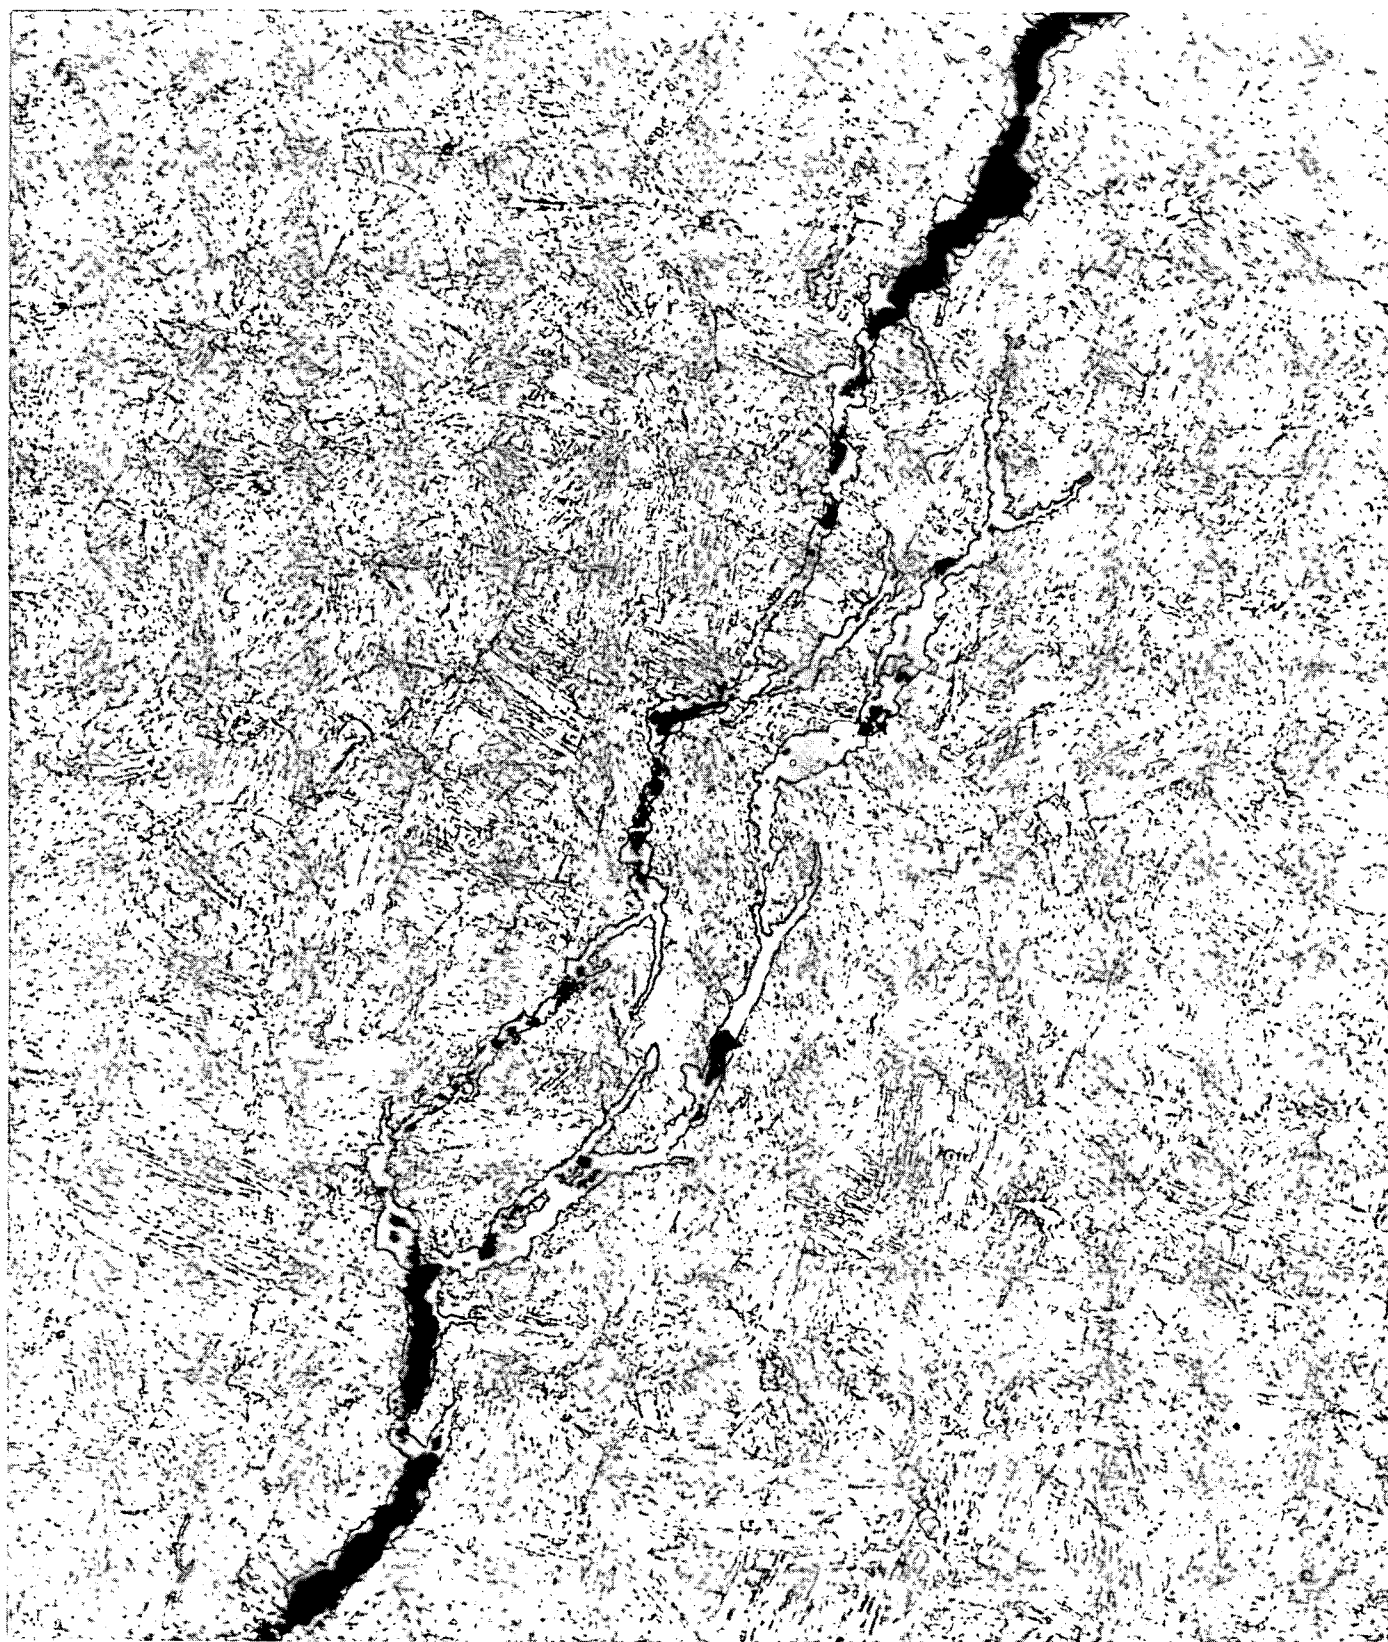
FIGURE 5. Secondary crack in Specimen 6A. Oxide Filled. Etchant 2% Nital.
Mag 500X
Neg. #2-2175F-2

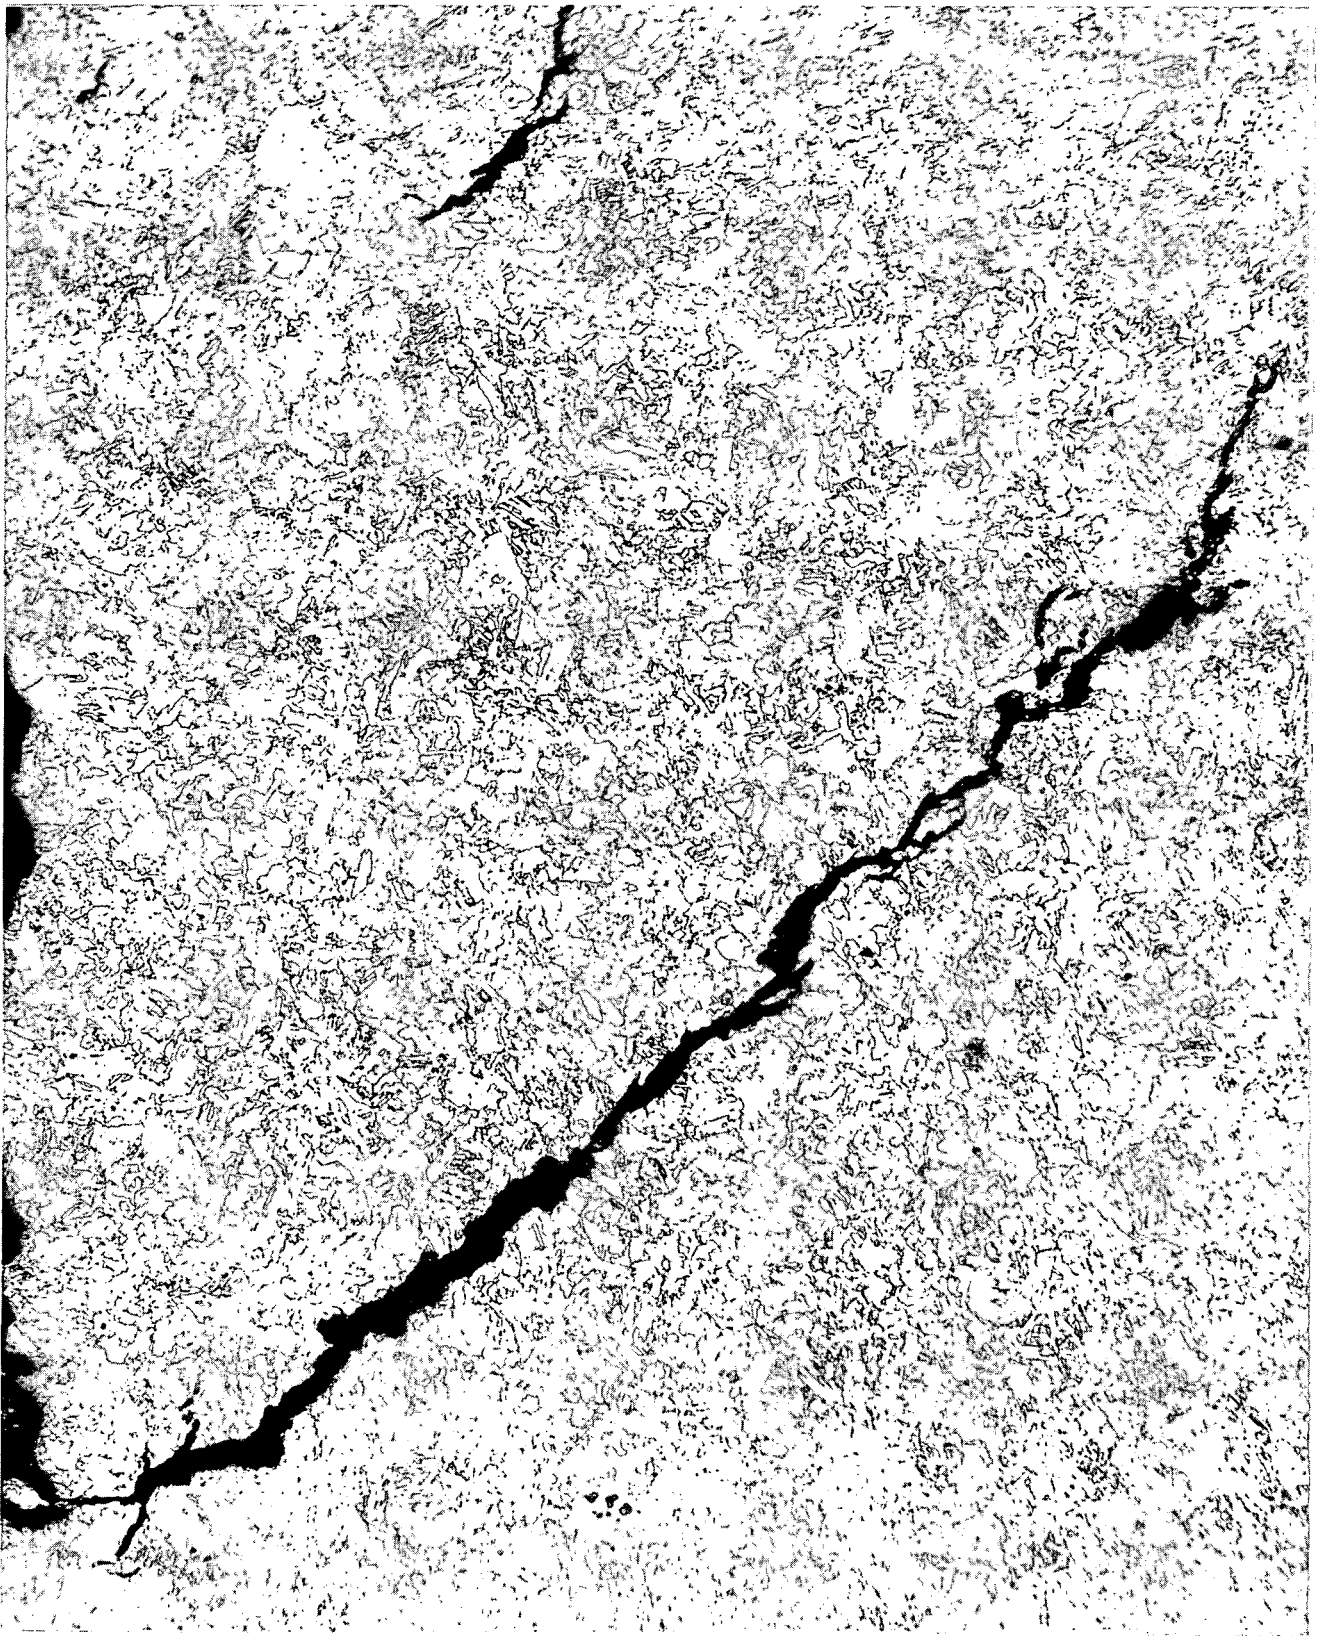
FIGURE 6. Secondary crack from Specimen 6B. Etchant 2% Nital.
Mag 200X
Neg. #2-2175F-4

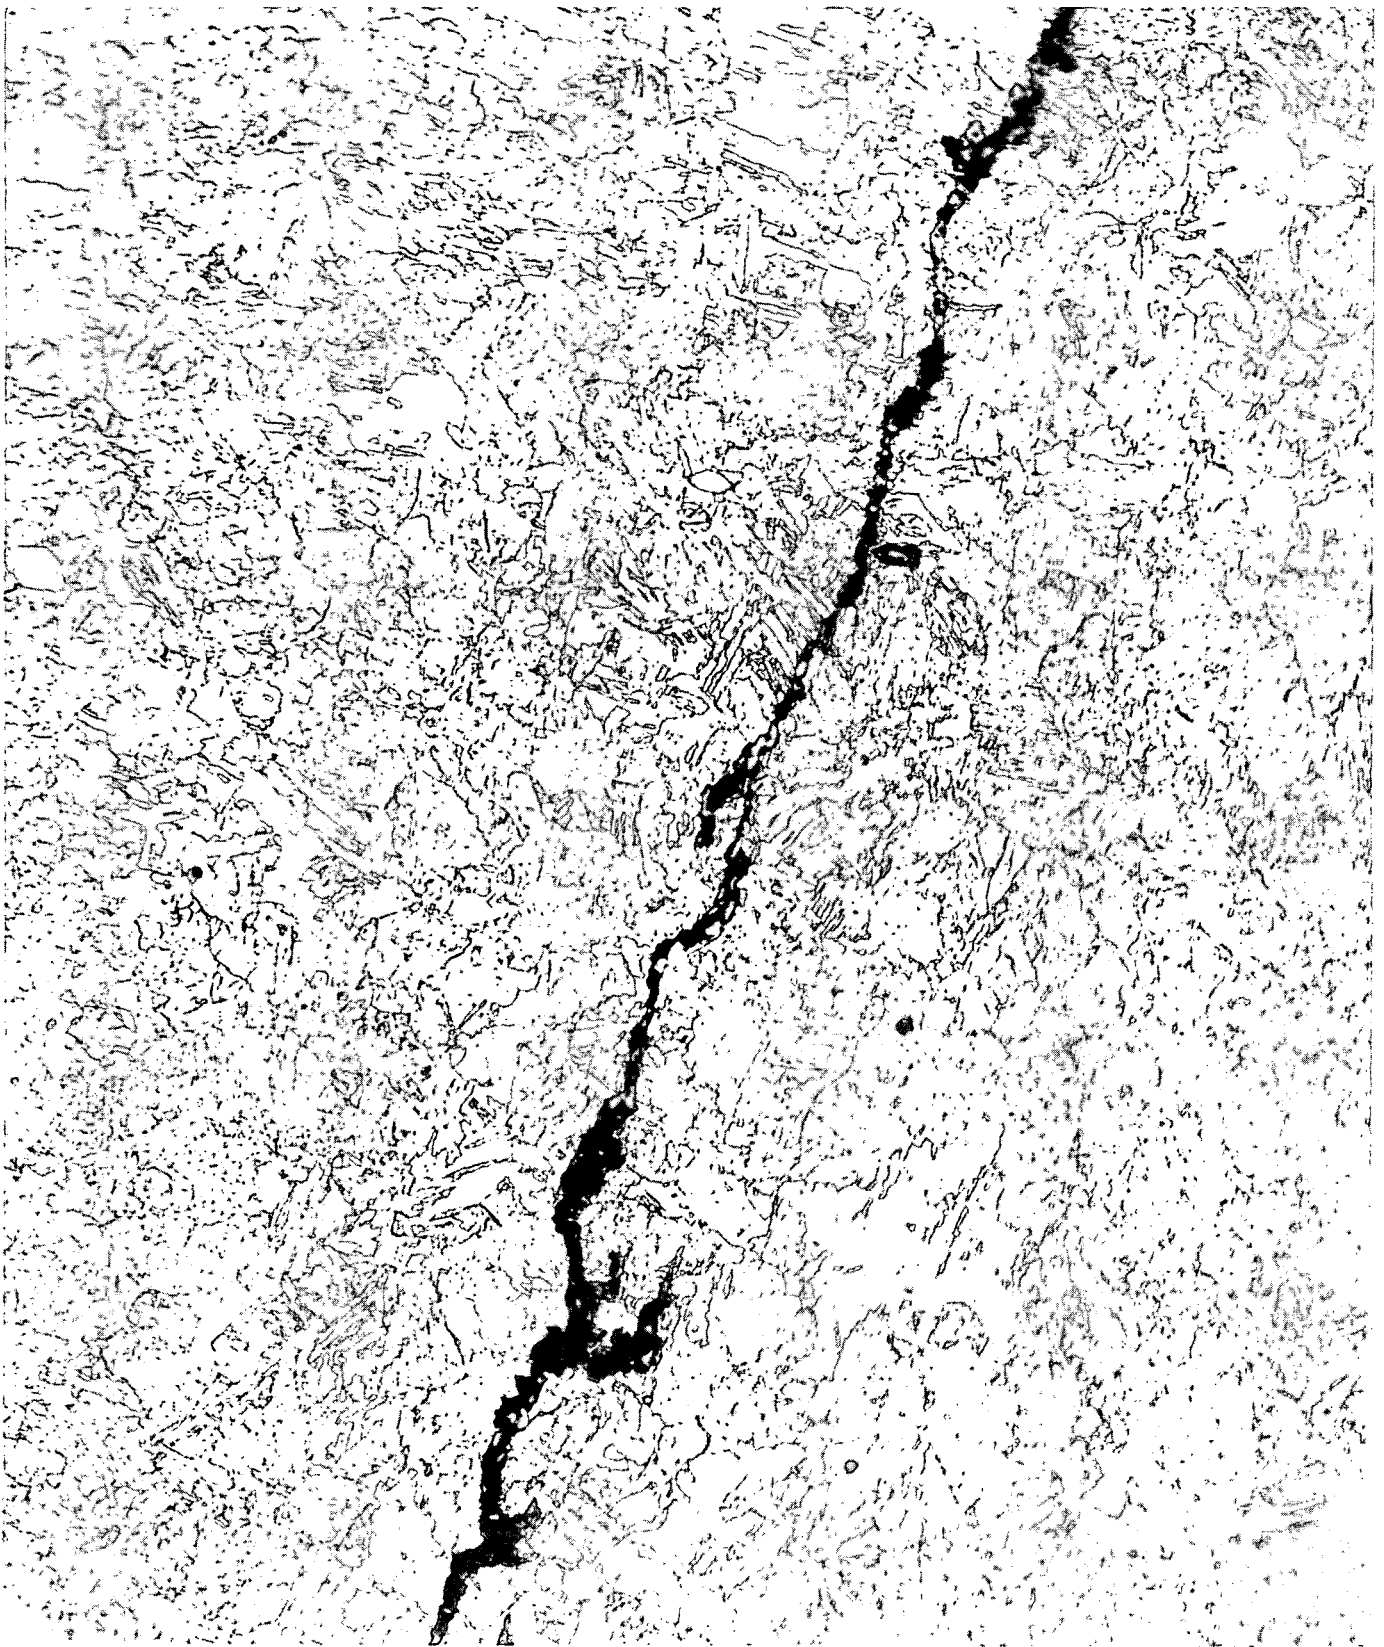
FIGURE 7. Secondary crack in Specimen 6B. Etchant 2% Nital.
Mag 500X
Neg. #2-2175-3

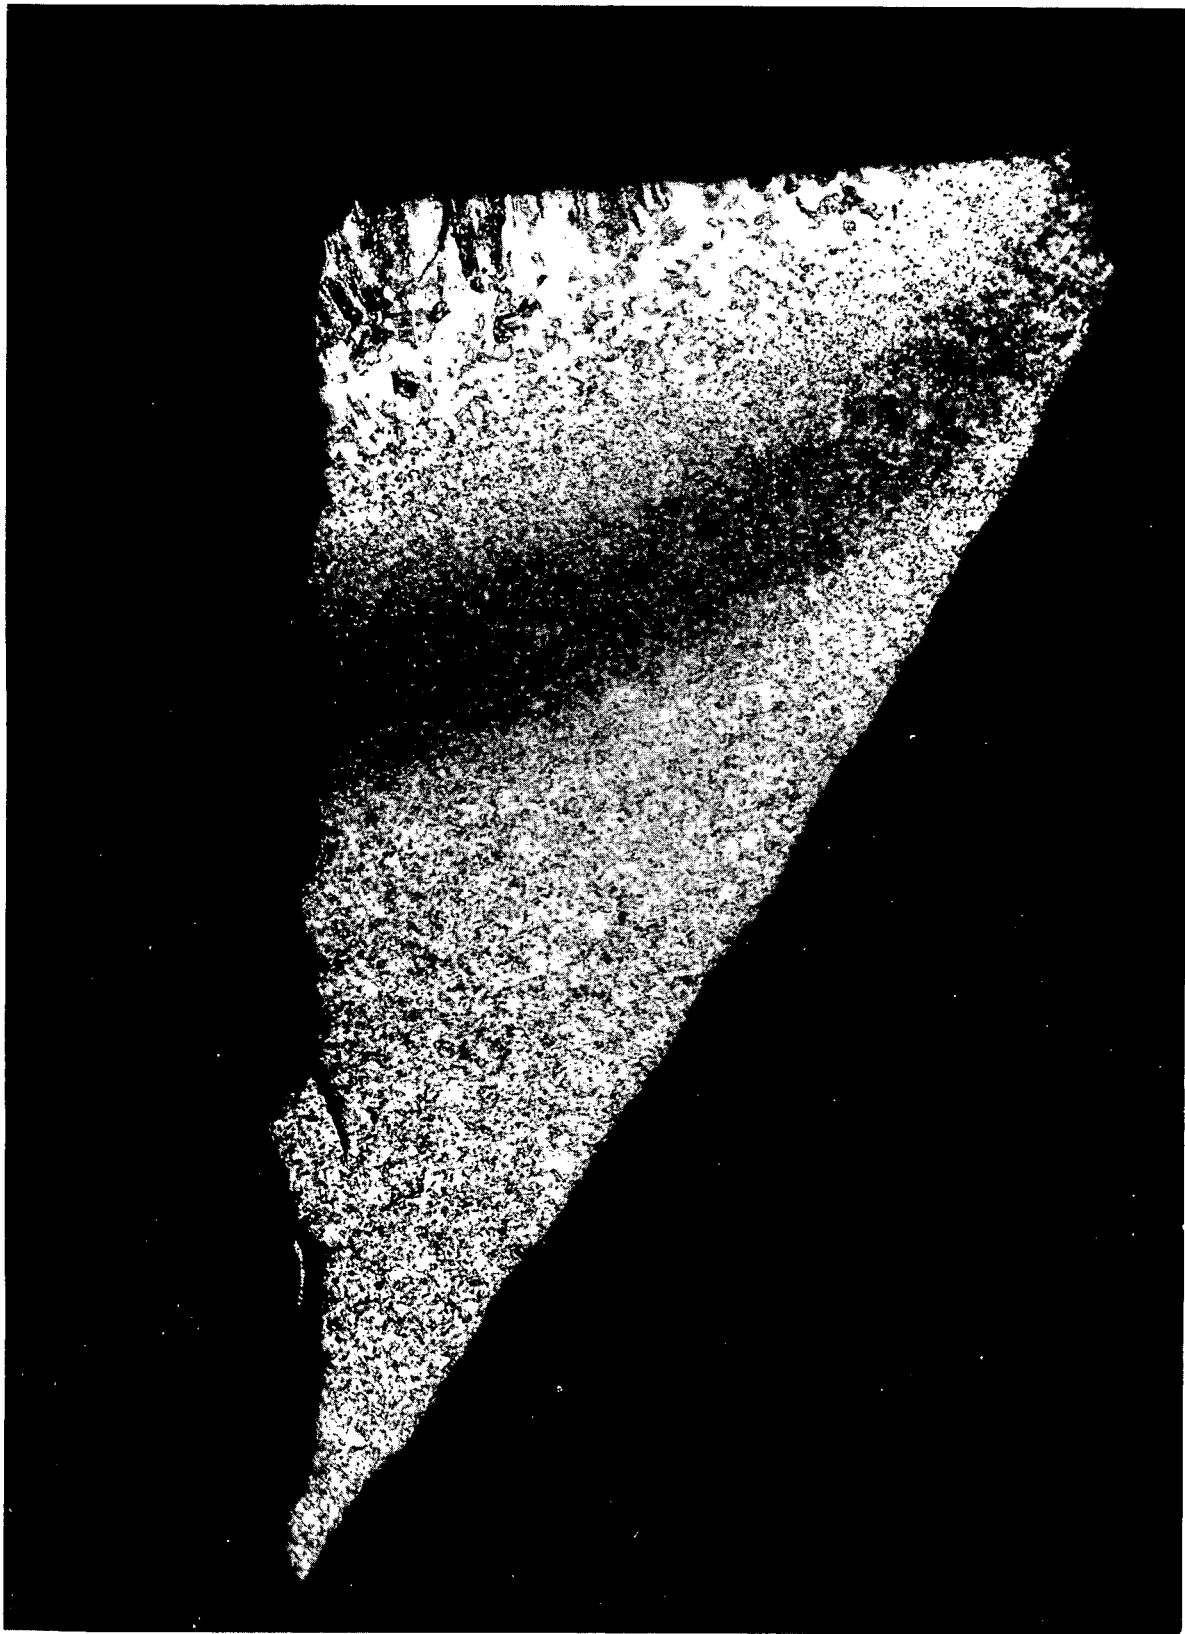
The sample shown in Figure 8 (Sample 7) was used in a hardness survey where the hardness of each of the four "zones" shown in Figure 8 was measured. The hardness results are shown in Table 1, along with a sketch showing the zones, contains the Knoop hardness values.

FIGURE 8. Boat sample 7 showing primary crack, secondary crack and weld, HA2 and base metal. Etchant 2% Nital.

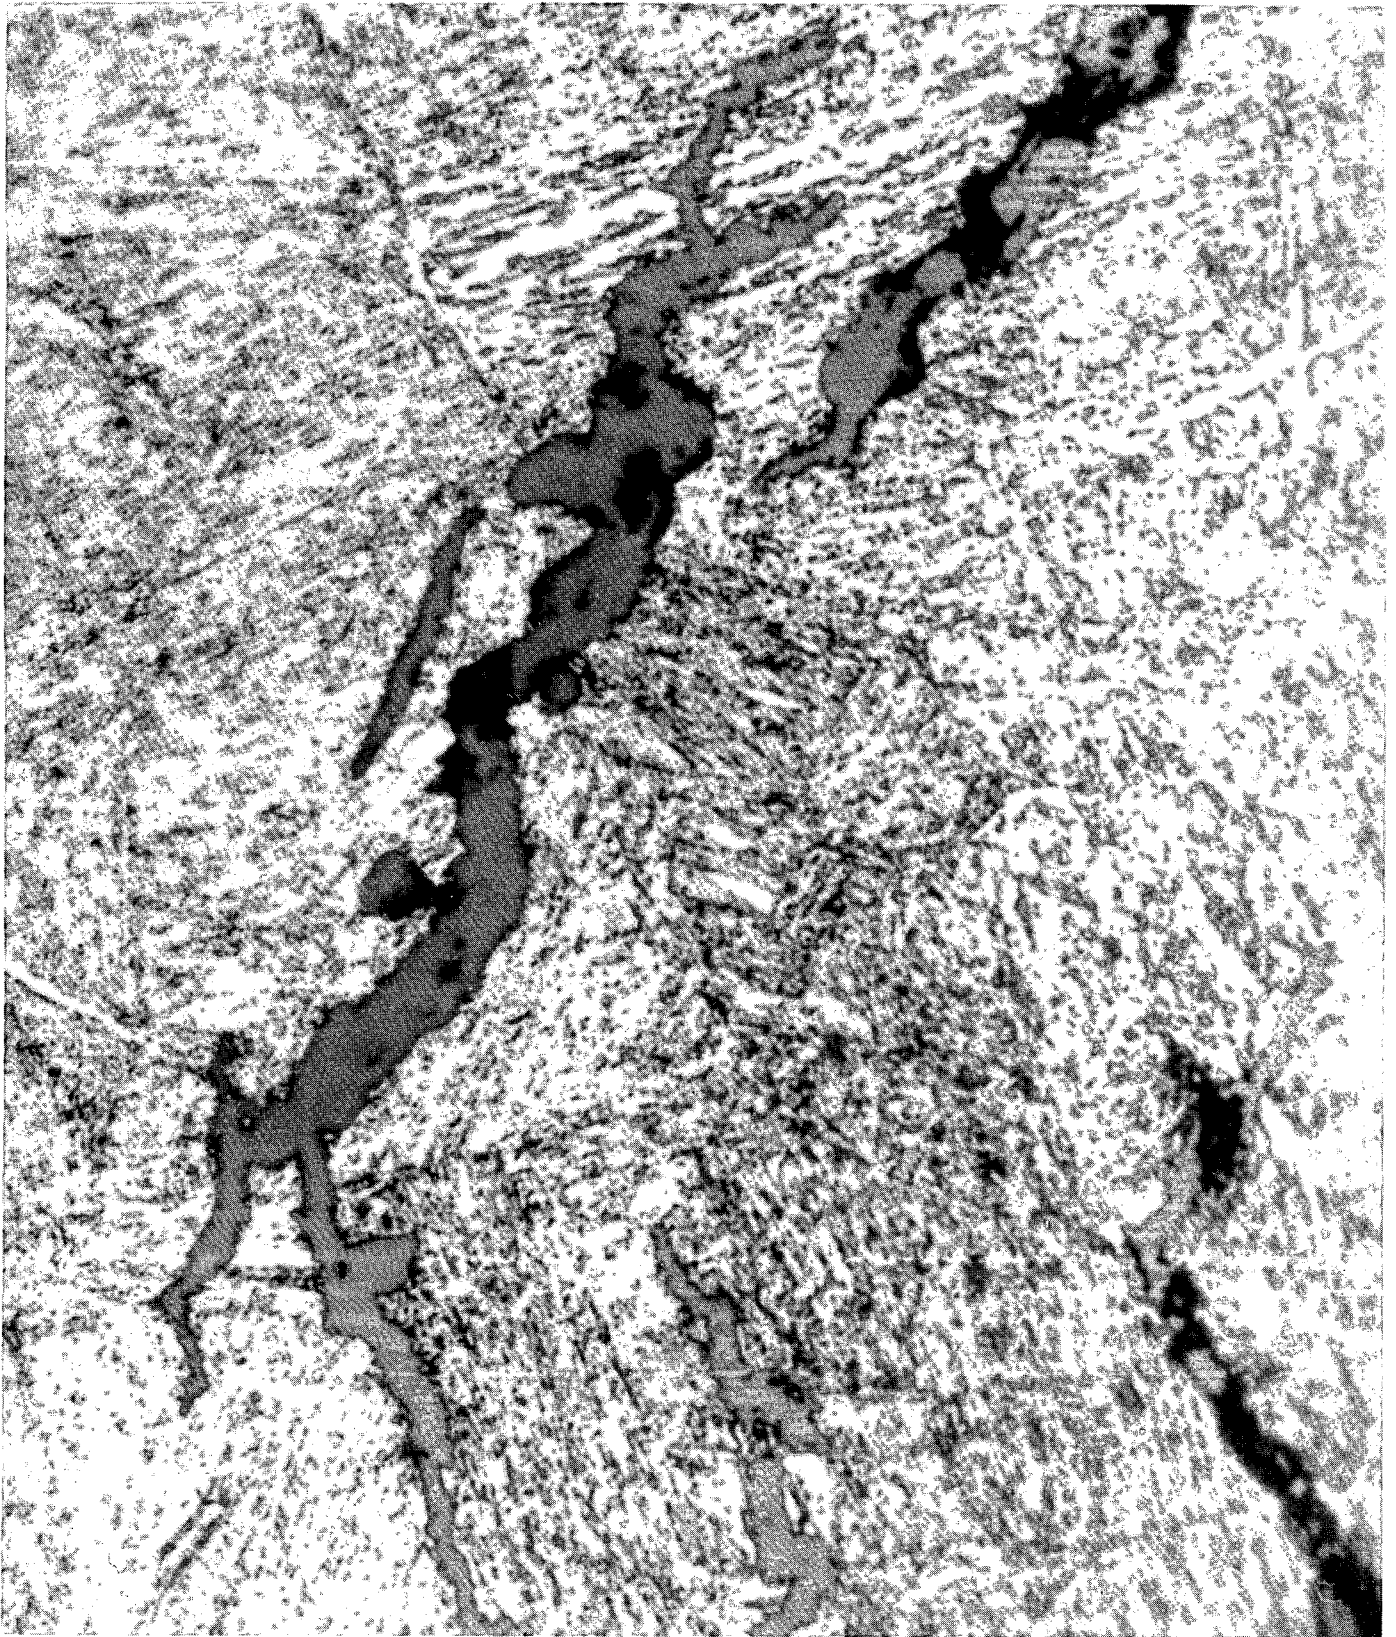
An oxide filled crack, shown in Figure 9, was analyzed by the electron microprobe and the analyst's report is as follows: "The materials found in the cracks are iron oxides with varying small amounts of Mn and Si, and an organic material, probably the epoxy mounting material. No corrodants were detected by the X-ray energy spectrometer. Specifically sought using mechanical spectrometers, and not detected, were Na, Cl, and S."

FIGURE 9. Secondary Crack filled with oxide in Sample 6A. Microprobe chemical analysis was done on this oxide. Etchant 2% Nital.
