TECHNICAL REPORT NO. 7164

METALLURGICAL EXAMINATION OF SHELL
GIRTH WELD COUPON FROM
STEAM GENERATOR 32
INDIAN POINT 3
NUCLEAR POWER PLANT

POWER AUTHORITY OF THE STATE OF NEW YORK
10 COLUMBUS CIRCLE
NEW YORK, NEW YORK

OCTOBER 19, 1982

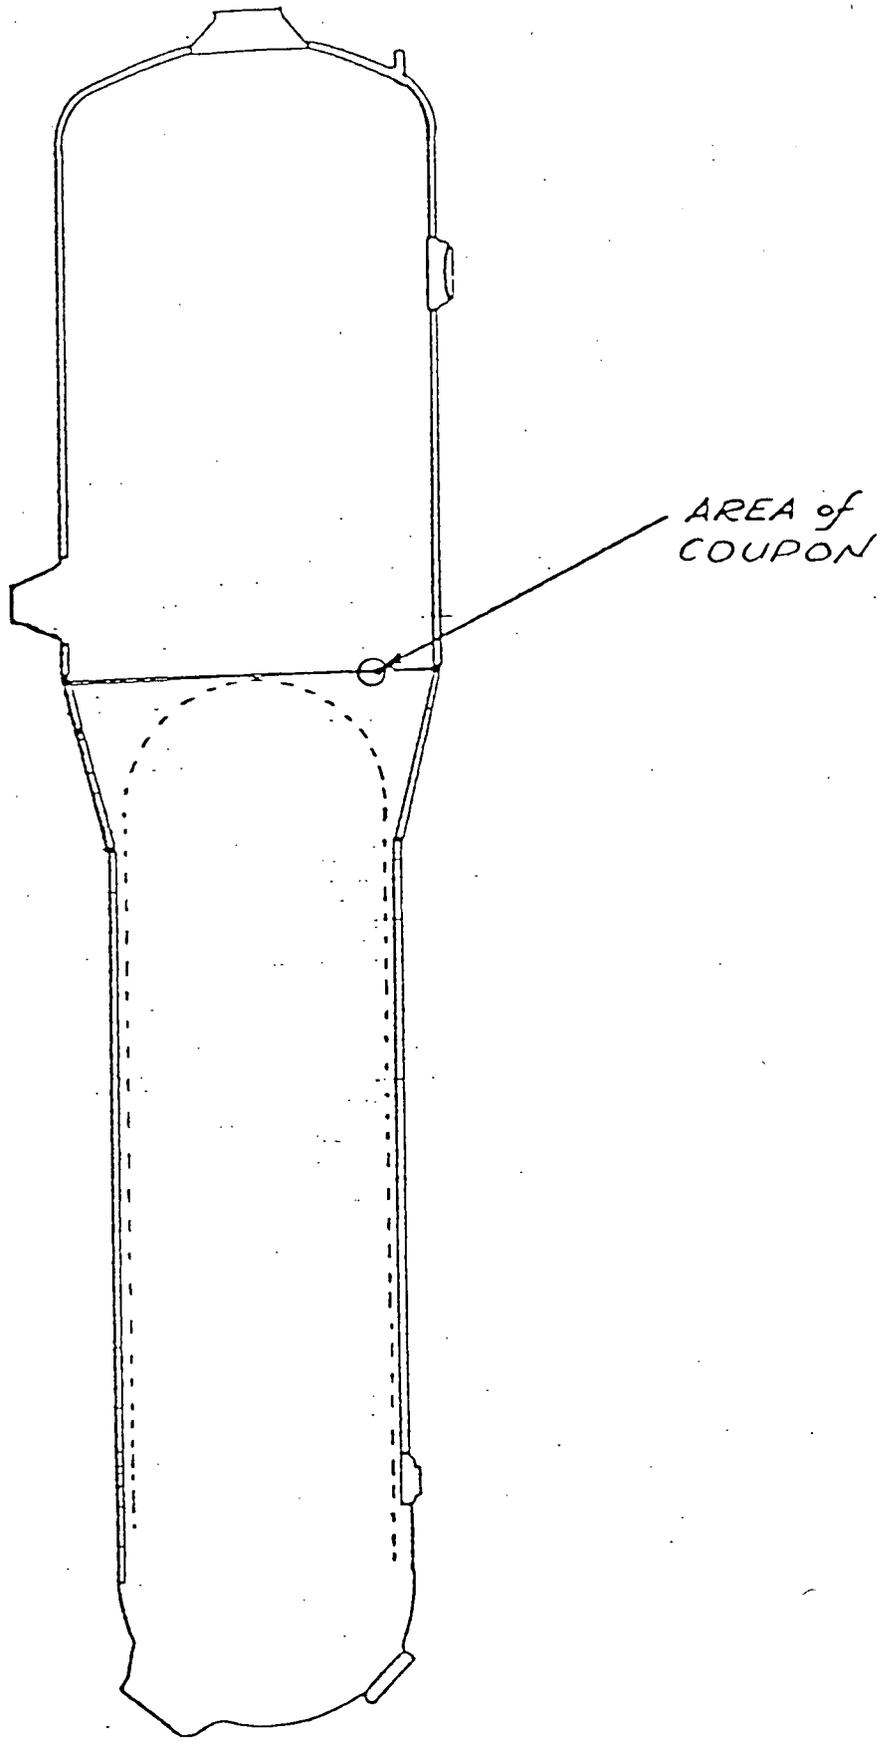
Fig. 1 LOCATION OF 6-INCH DIAMETER GIRTH WELD COUPON STEAM GENERATOR 32

The through-wall thickness leak had manifested itself on the outer surface in the form of an elongated hole measuring approximately 3/16 inch wide by 5/8 inch long. It was from the area containing the discontinuity and associated inner surface cracks that the 6-in. diameter coupon was removed. The coupon was removed by drilling a series of overlapping holes around a 6-in. diameter circumference with the discontinuity at the center. The location of the steam generator shell girth weld from which the coupon was taken is shown in Fig. 1.

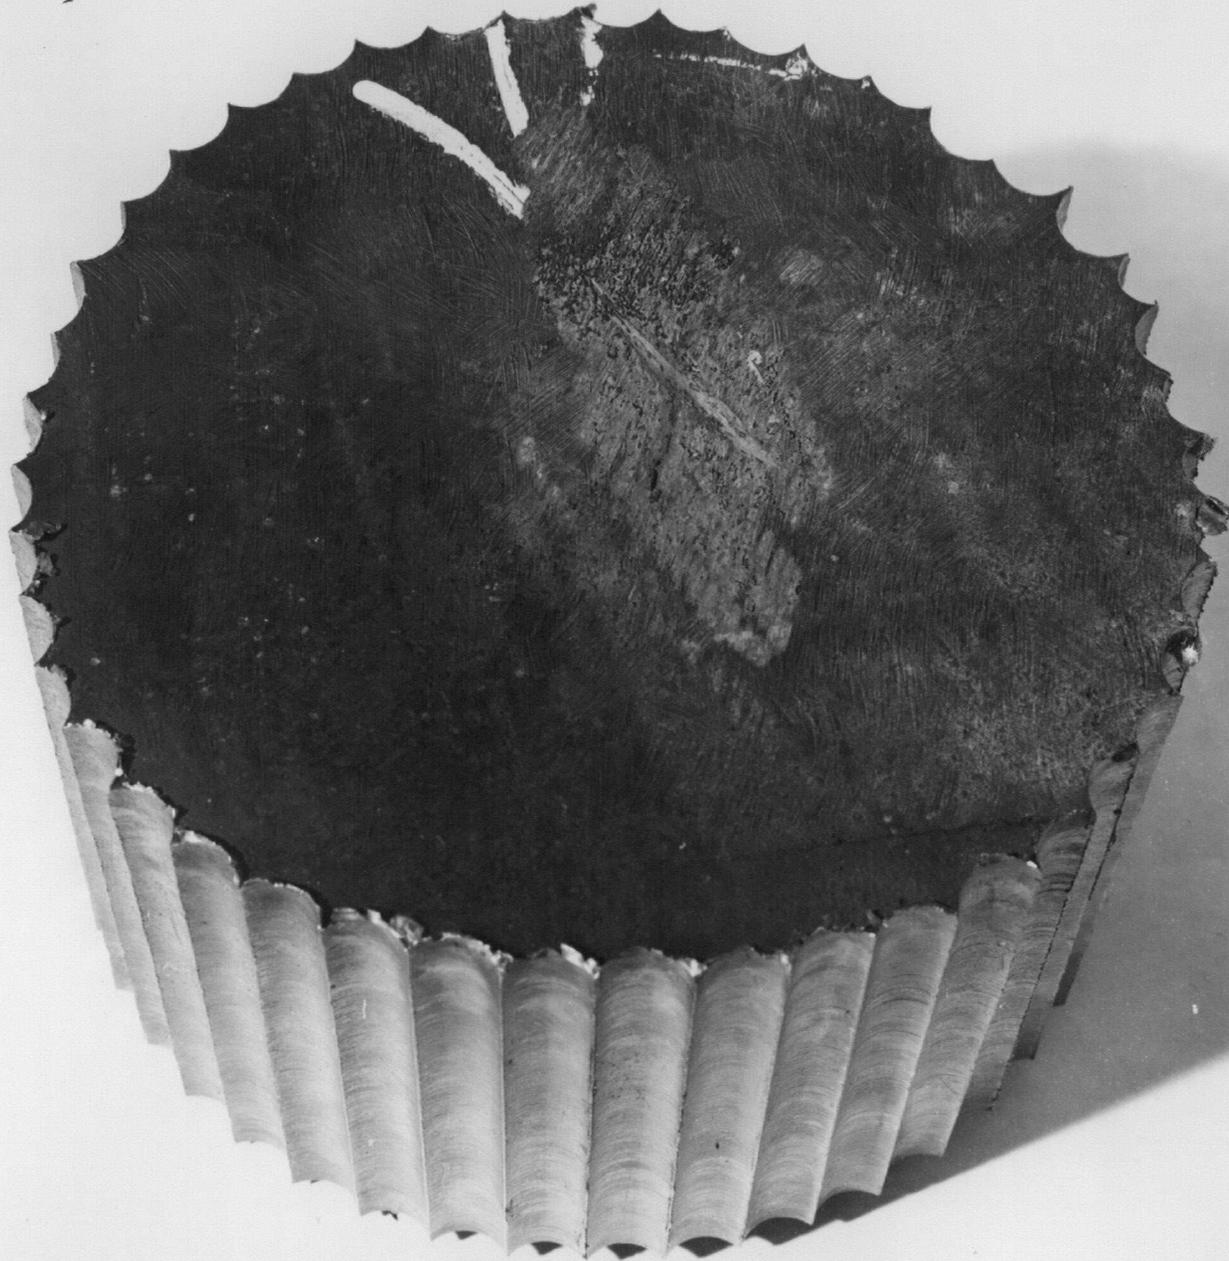
Fig. 2 GIRTH WELD COUPON FROM STEAM GENERATOR 32,
AS-RECEIVED CONDITION

The 6-in. diameter shell girth weld coupon, Figs. 2 to 4, forwarded to Lucius Pitkin, Inc. presented a relatively clean appearance free of any significant corrosion product on the inner or outer surface. The inner surface exhibited numerous fine, oxide-filled corrosion pits and several cracks generally oriented circumferentially, as shown in Figs. 5 and 6. The through-thickness elongated hole had its long axis parallel to the vertical axis of the steam generator. The periphery of the hole, as seen in Fig. 7, was smooth as would occur from erosion by escaping steam. A fine, 1/2-in. long vertical crack extended from the lower end of the elongated hole. No other cracks were present on the outer surface.

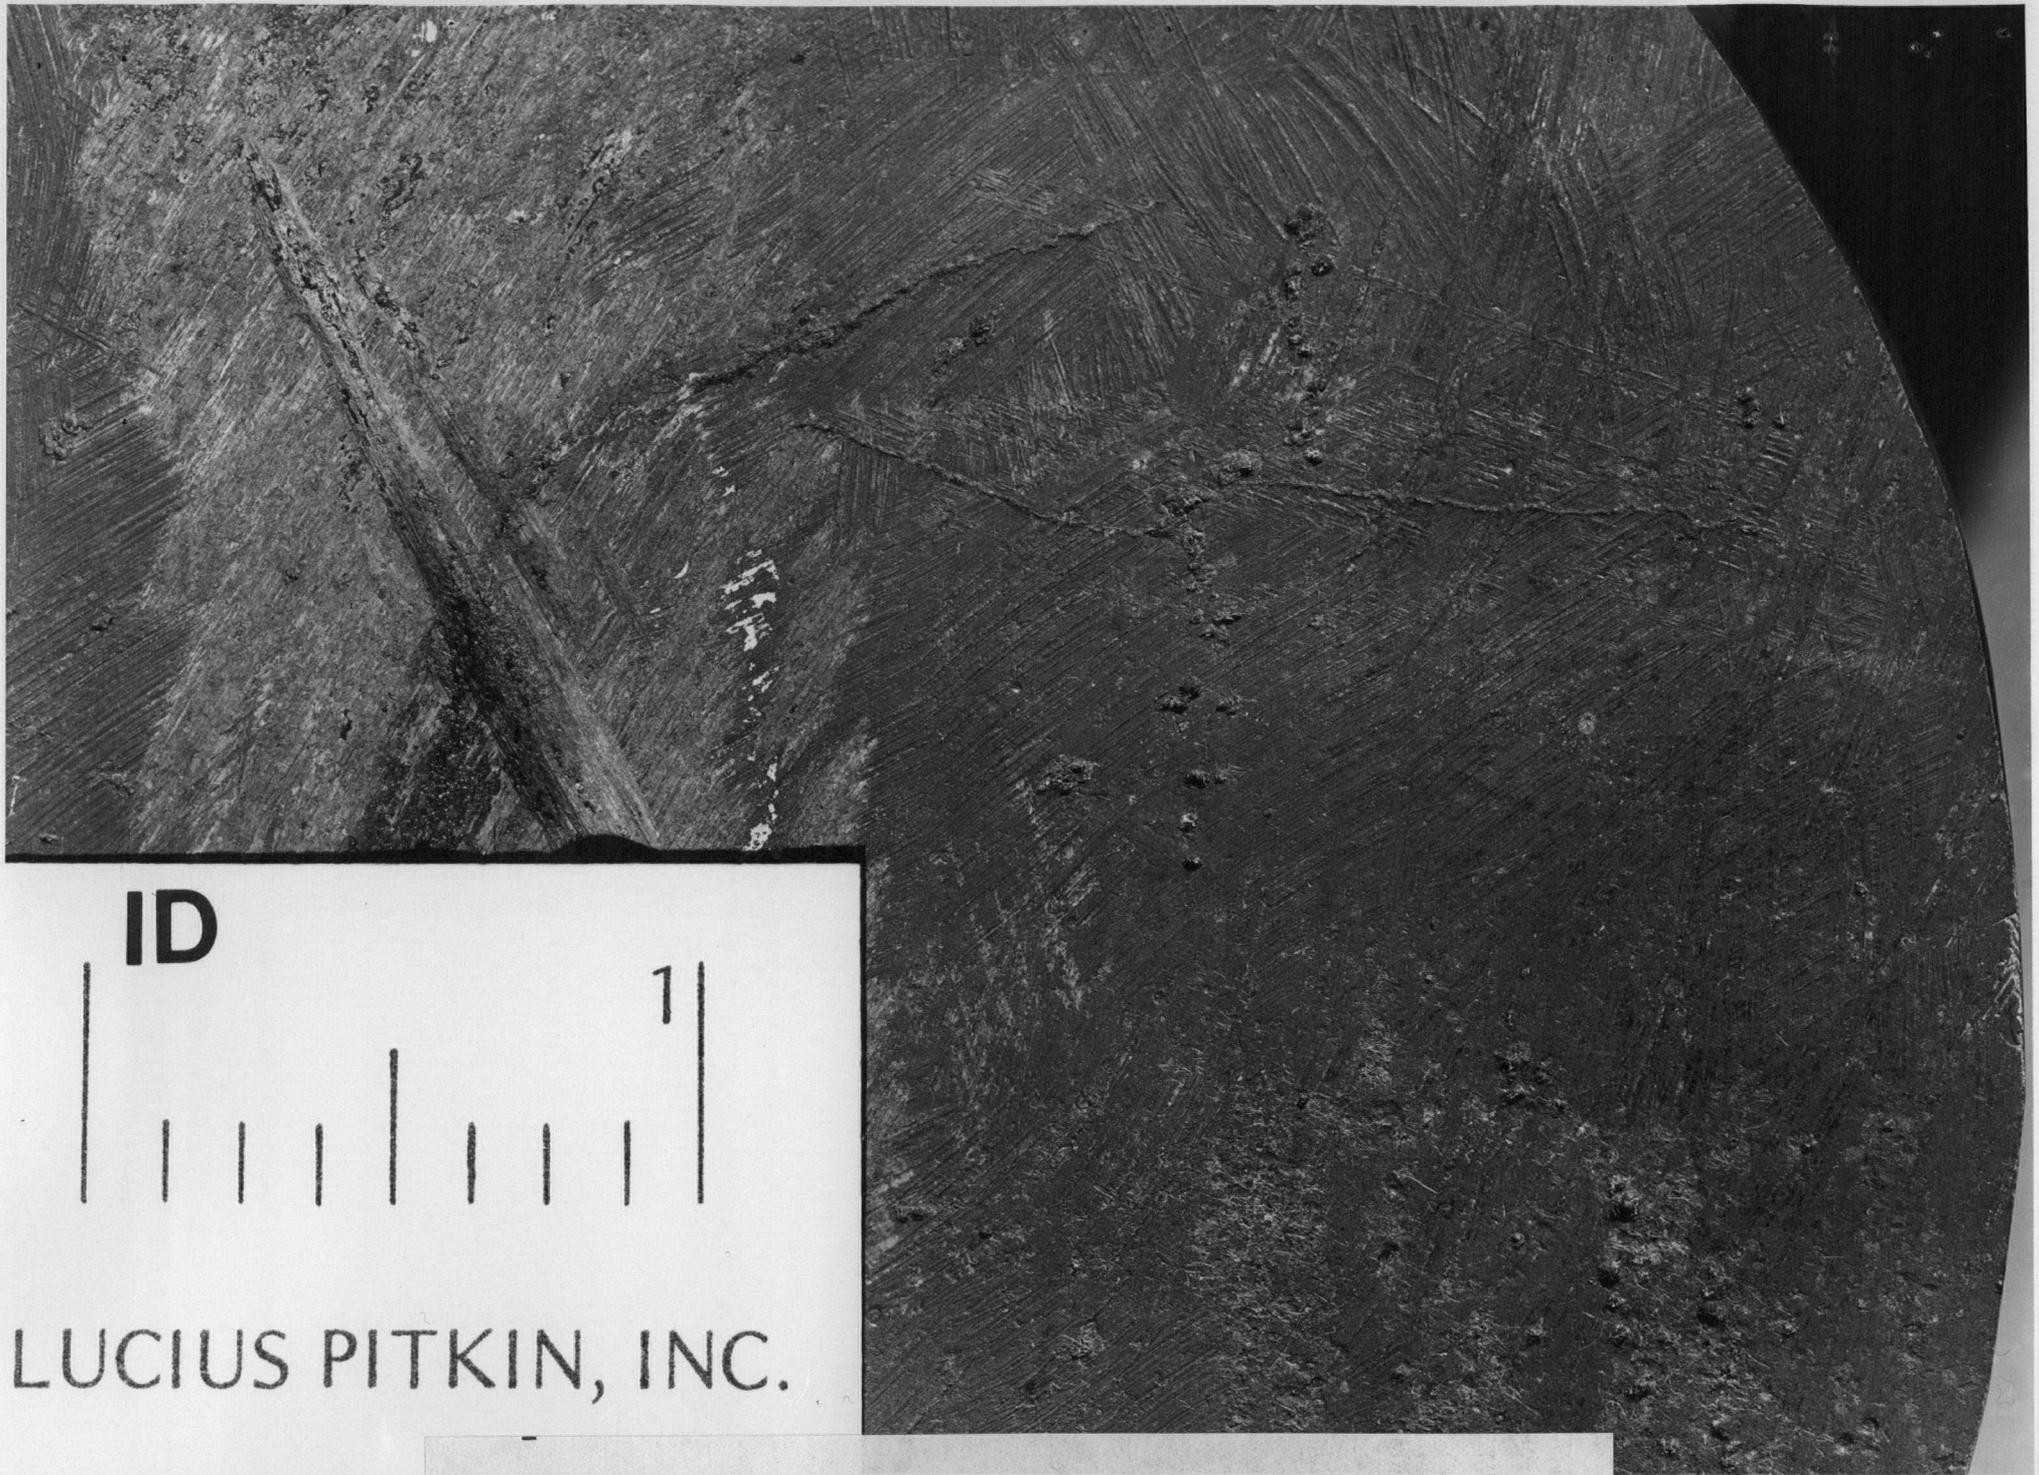
Fig. 5 INNER SURFACE CRACKS AND PITS

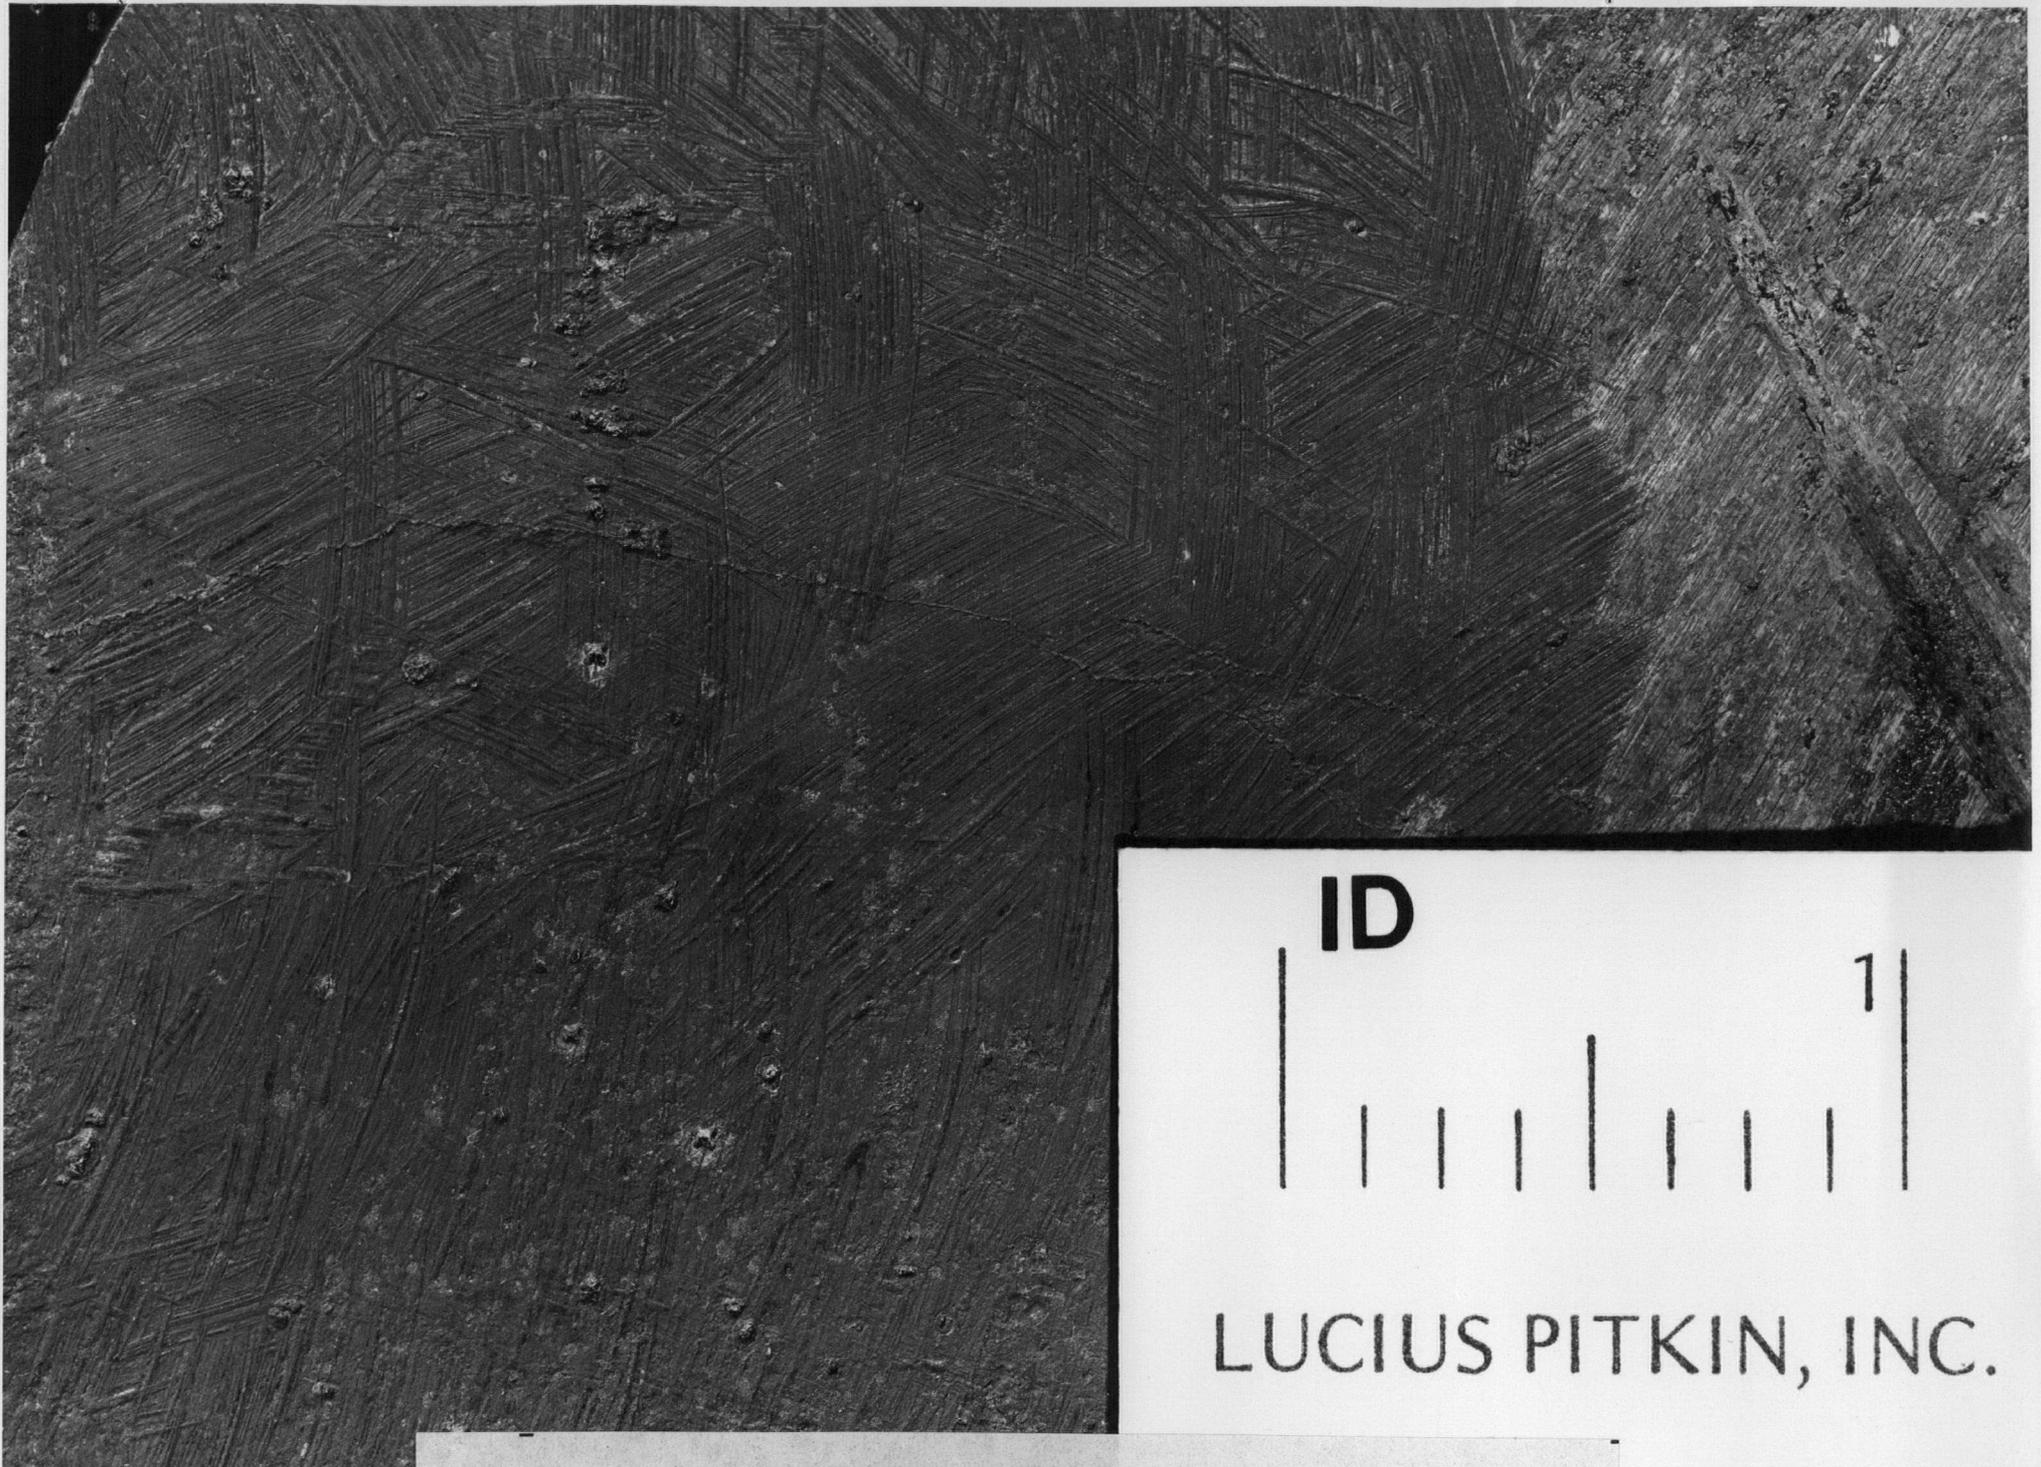
Fig. 6 INNER SURFACE CRACKS AND PITS

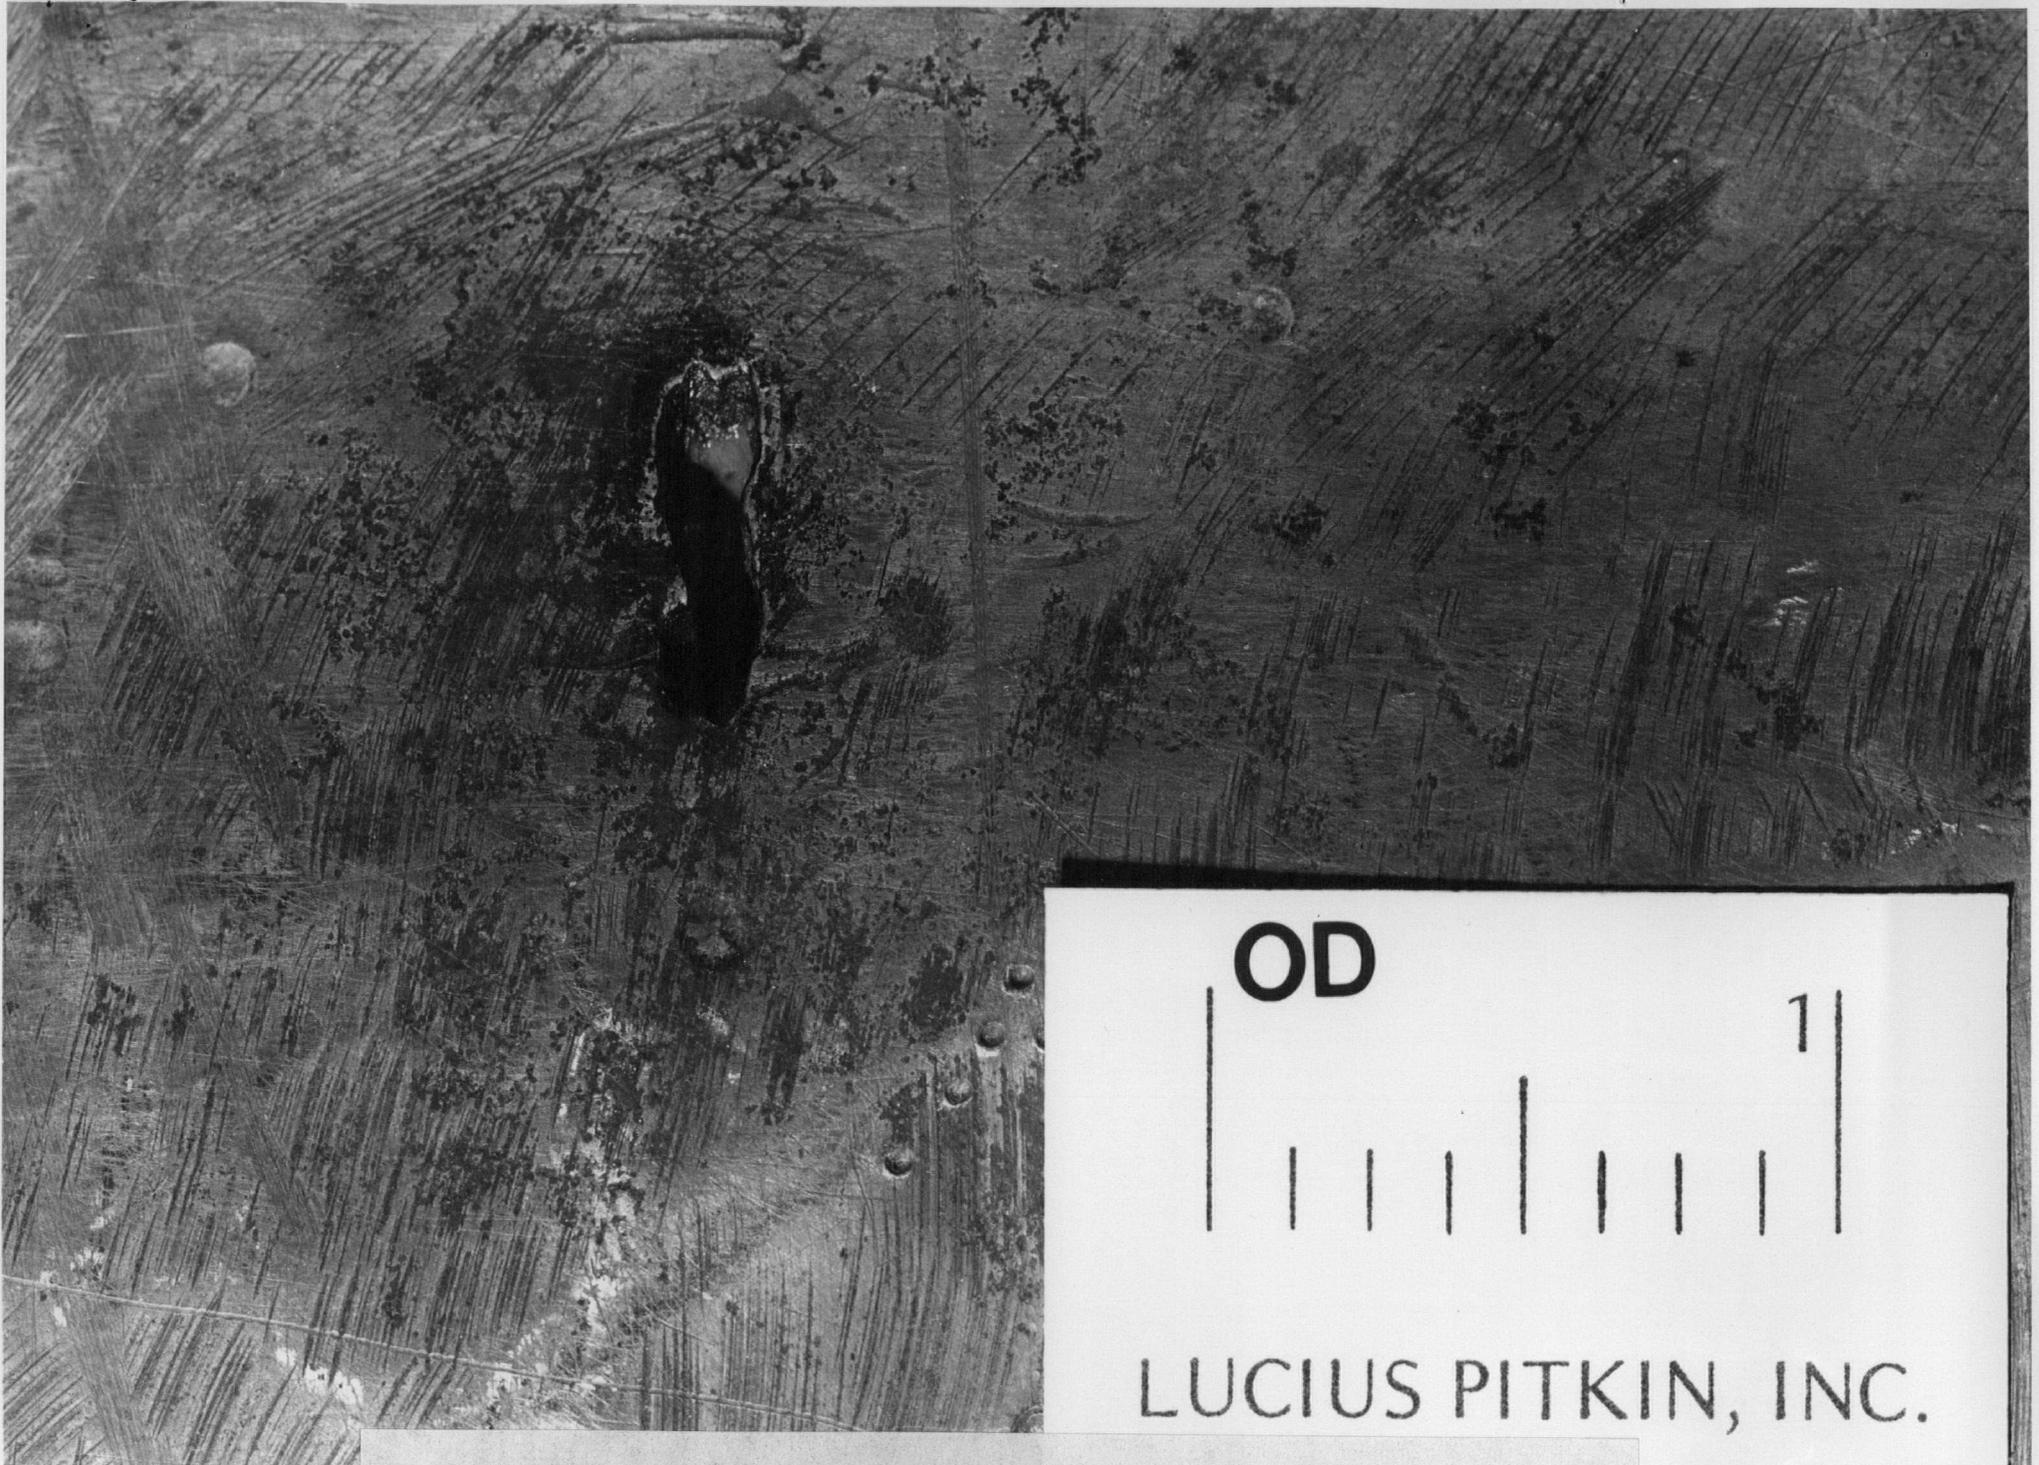
Fig. 7 THROUGH-THICKNESS DISCONTINUITY AT OUTER SURFACE

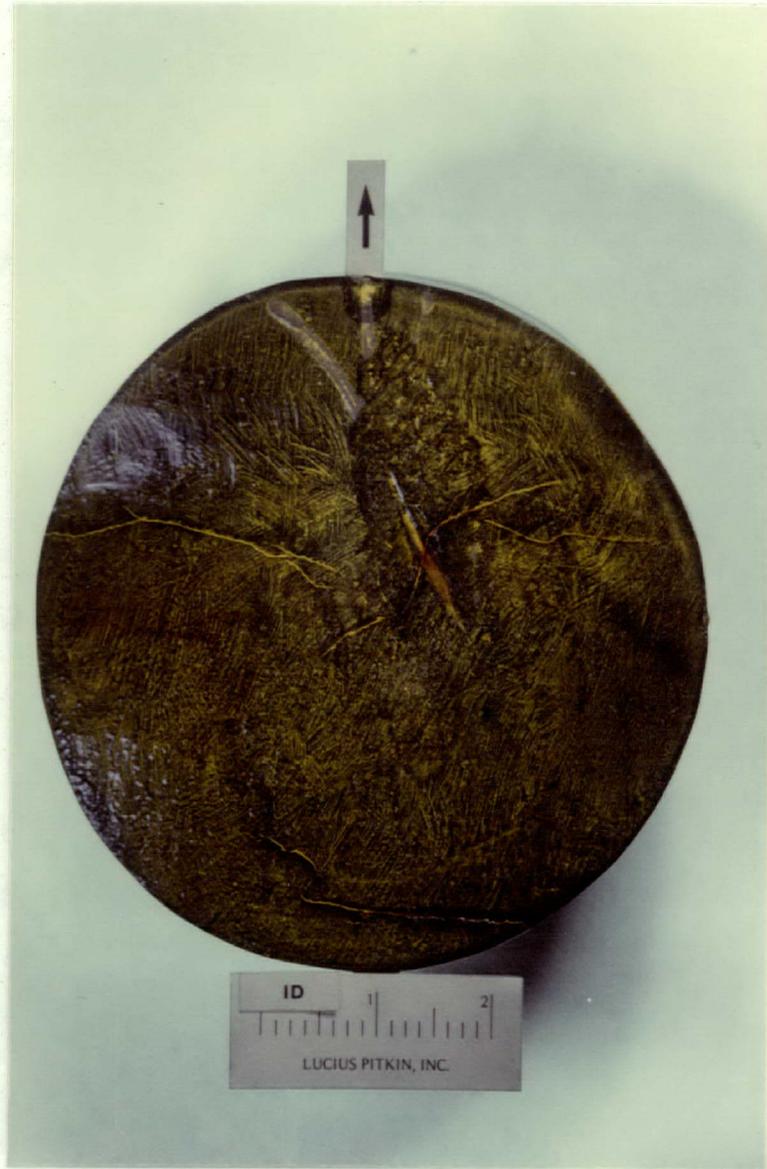
Fig. 8

The drill hole ridges present on the periphery of the coupon were uniformly ground to provide a smooth surface for nondestructive examination. The ground coupon was subjected to fluorescent magnetic-particle inspection. Numerous crack indications were found on the inner surface, three of which intersected the periphery of the coupon. Figs. 8 and 8A show the indications observed under ultraviolet

INNER SURFACE CRACKS OBSERVED WITH FLUORESCENT
MAGNETIC-PARTICLE UNDER ULTRAVIOLET LIGHT

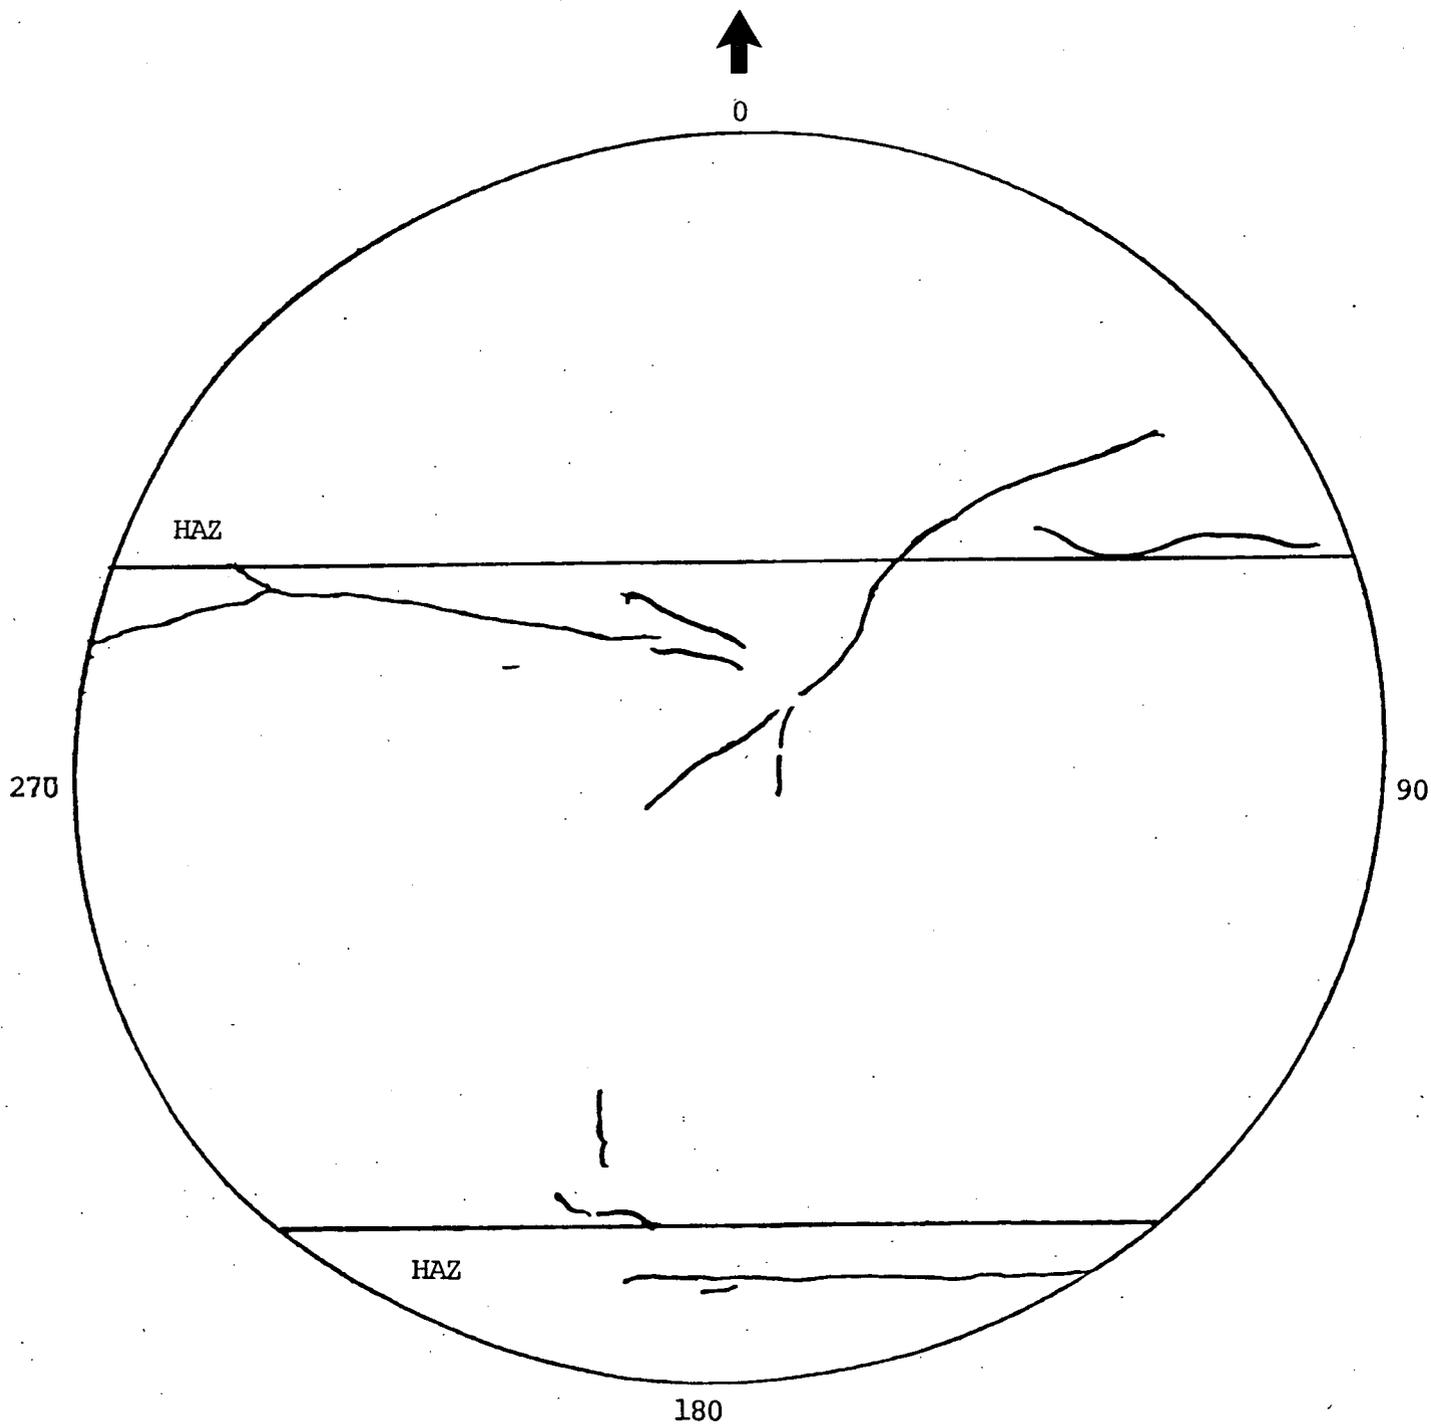
Fig. 8A INNER SURFACE CRACKS AS REVEALED BY FLUORESCENT MAGNETIC PARTICLE EXAMINATION

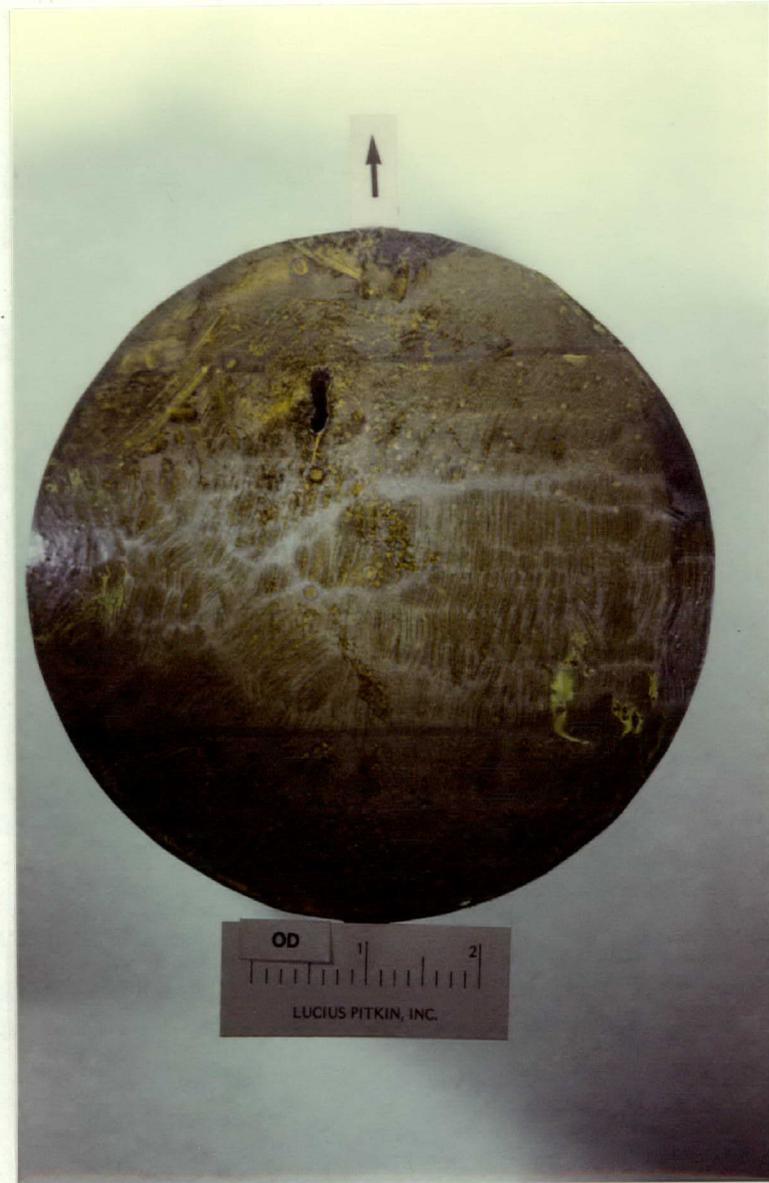
light. Fluorescent magnetic-particle examination of the outer surface revealed a fine, vertically oriented crack emanating from the lower end of the through-thickness discontinuity. No other indications were observed on the outer surface. Fig. 9 and 9A show the crack indication observed under ultraviolet light on the outer surface of the girth weld coupon.

OUTER SURFACE CRACK OBSERVED WITH FLUORESCENT
MAGNETIC-PARTICLE UNDER ULTRAVIOLET LIGHT

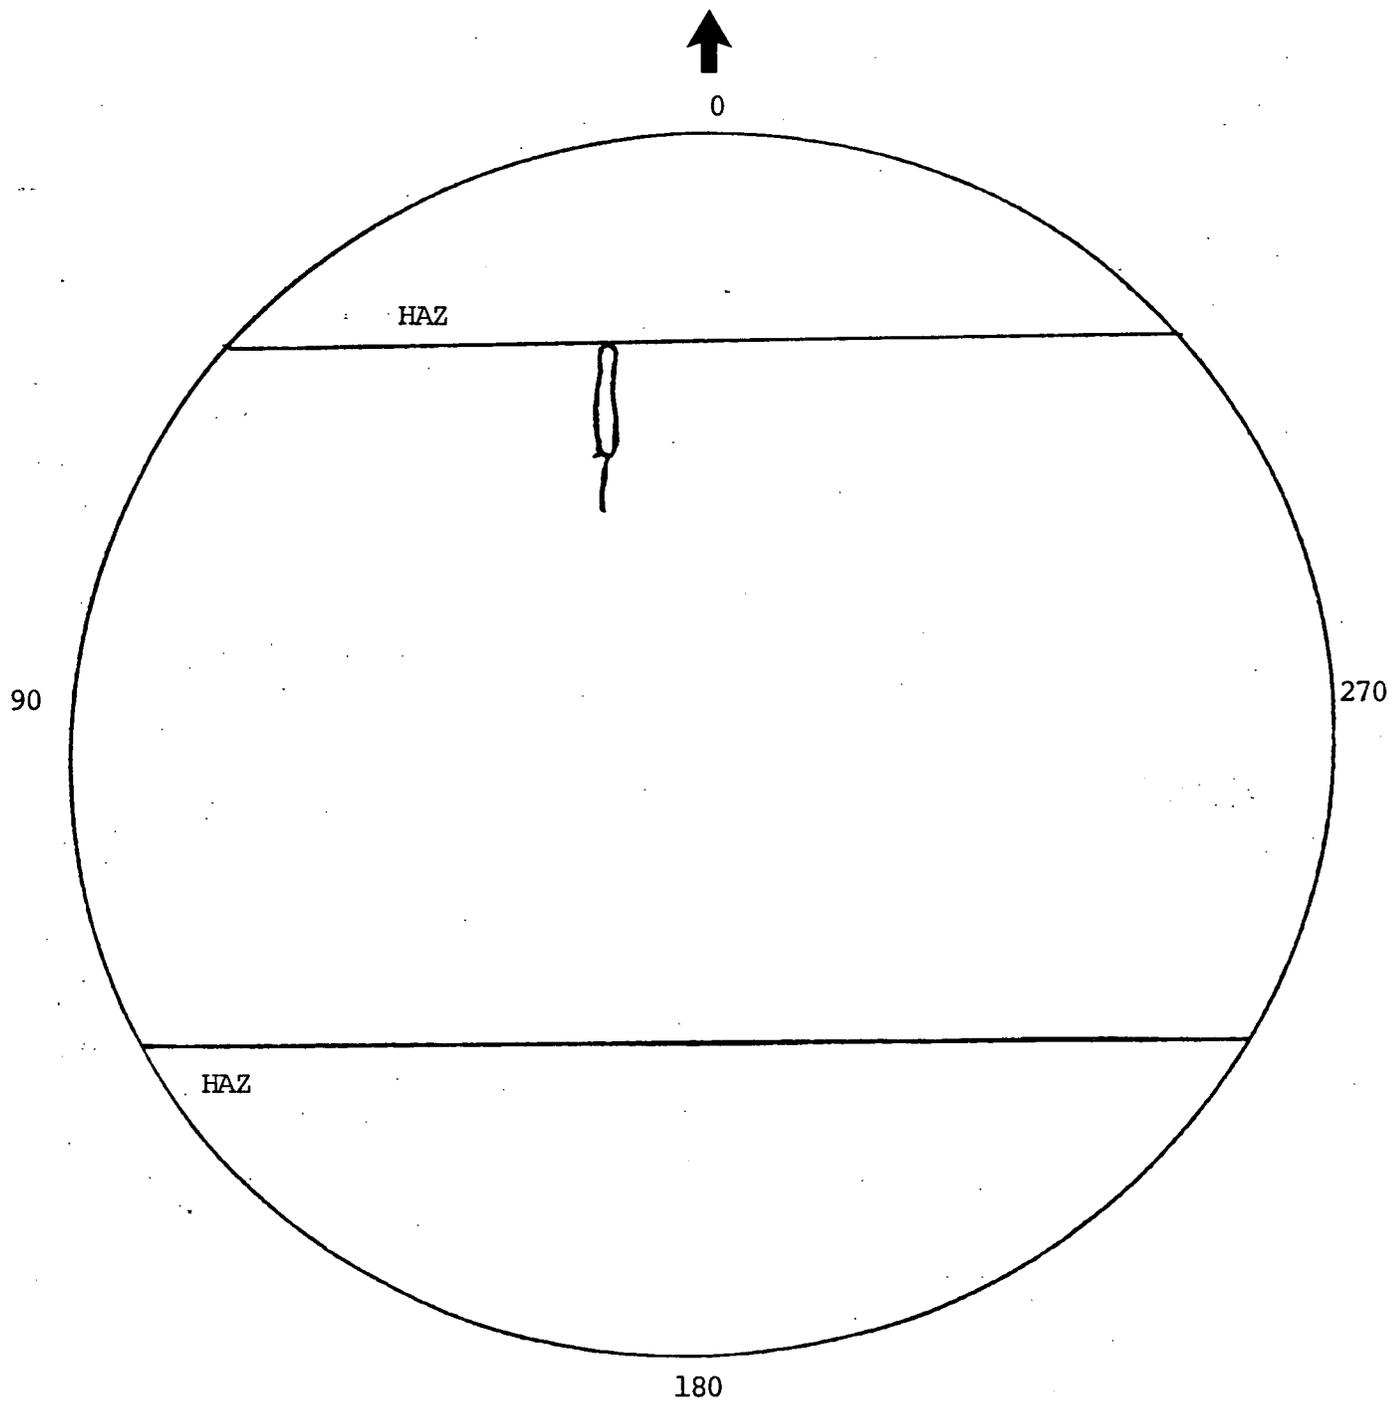
Fig. 9A OUTER SURFACE CRACKS AS REVEALED BY FLUORESCENT MAGNETIC PARTICLE EXAMINATION

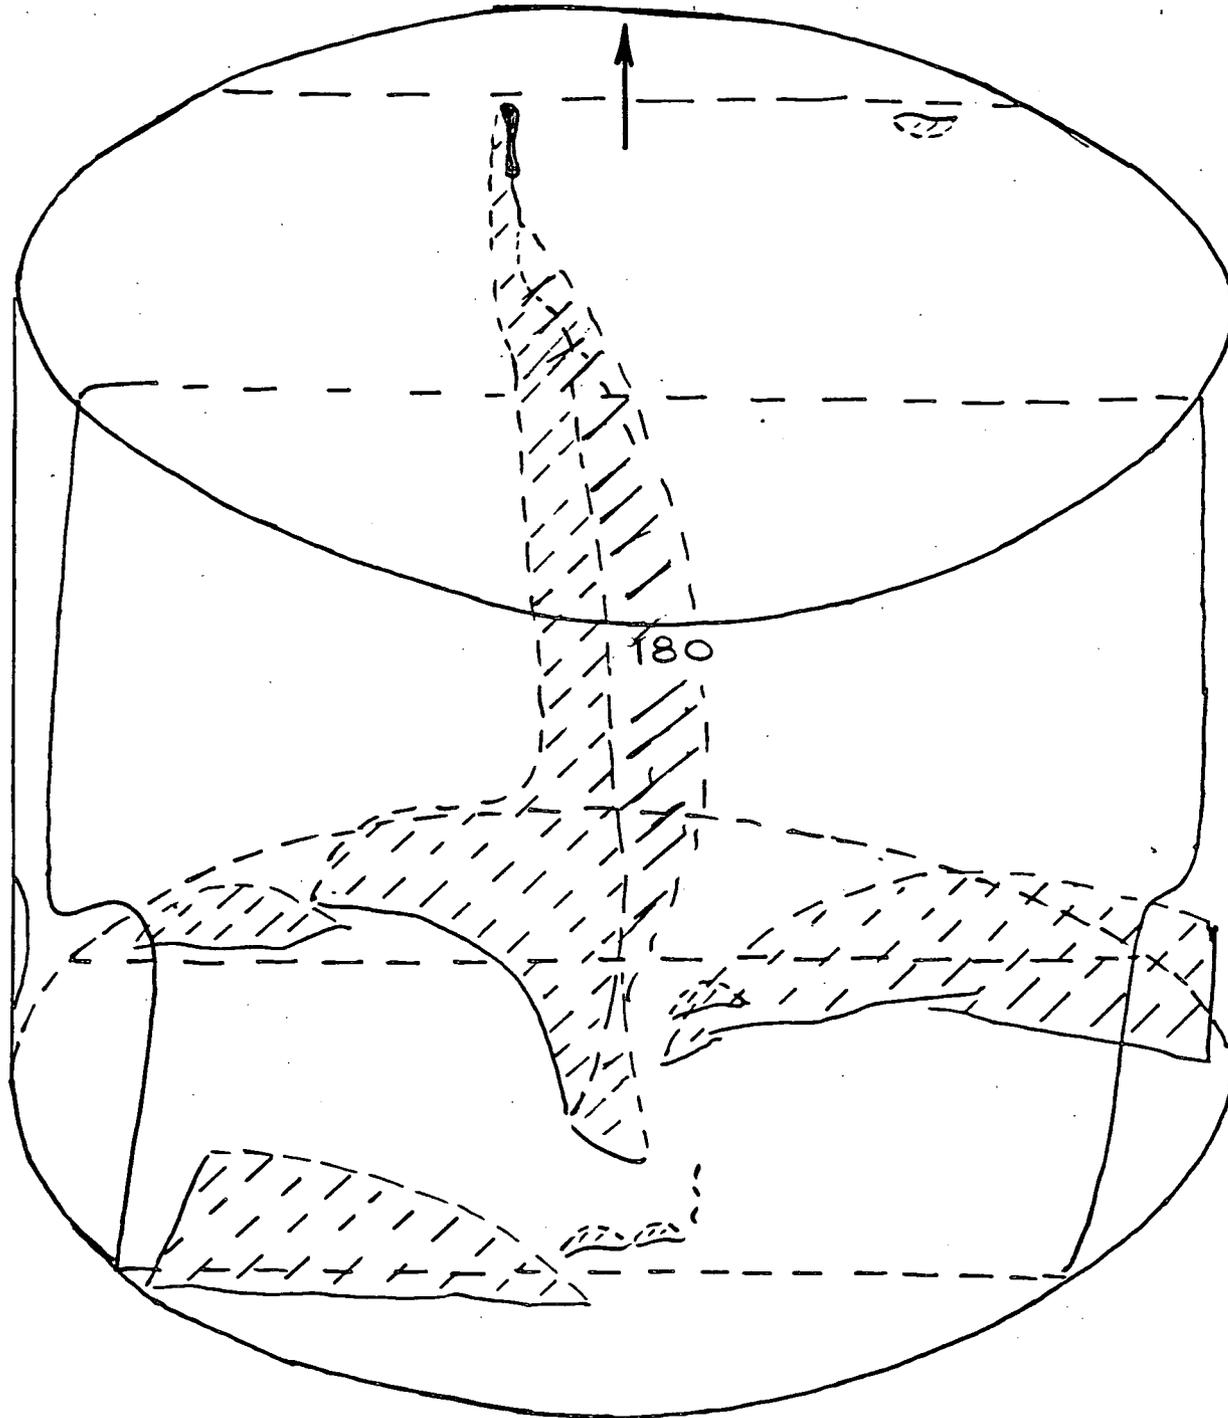
Radiographic examinations of the coupon using a Cobalt 60 source, at a source to film distance of 15 in., revealed the inner surface cracks to have propagated to varying depths. Further, it appeared that one and possibly two of the inner surface cracks had intersected the through-wall discontinuity.

The coupon was ultrasonically examined using 1 MHz and 2-1/4 MHz normal and shear wave transducers over all surfaces. Results of the ultrasonic examination confirmed that several of the inner surface cracks had attained a significant depth and that at least two of the cracks near the inner surface were associated with the through-thickness discontinuity.

Fig. 10 NONDESTRUCTIVE EXAMINATION RESULTS OF 6-INCH DIAMETER
COUPON FROM UPPER SHELL TO CONE GIRTH WELD - SG32

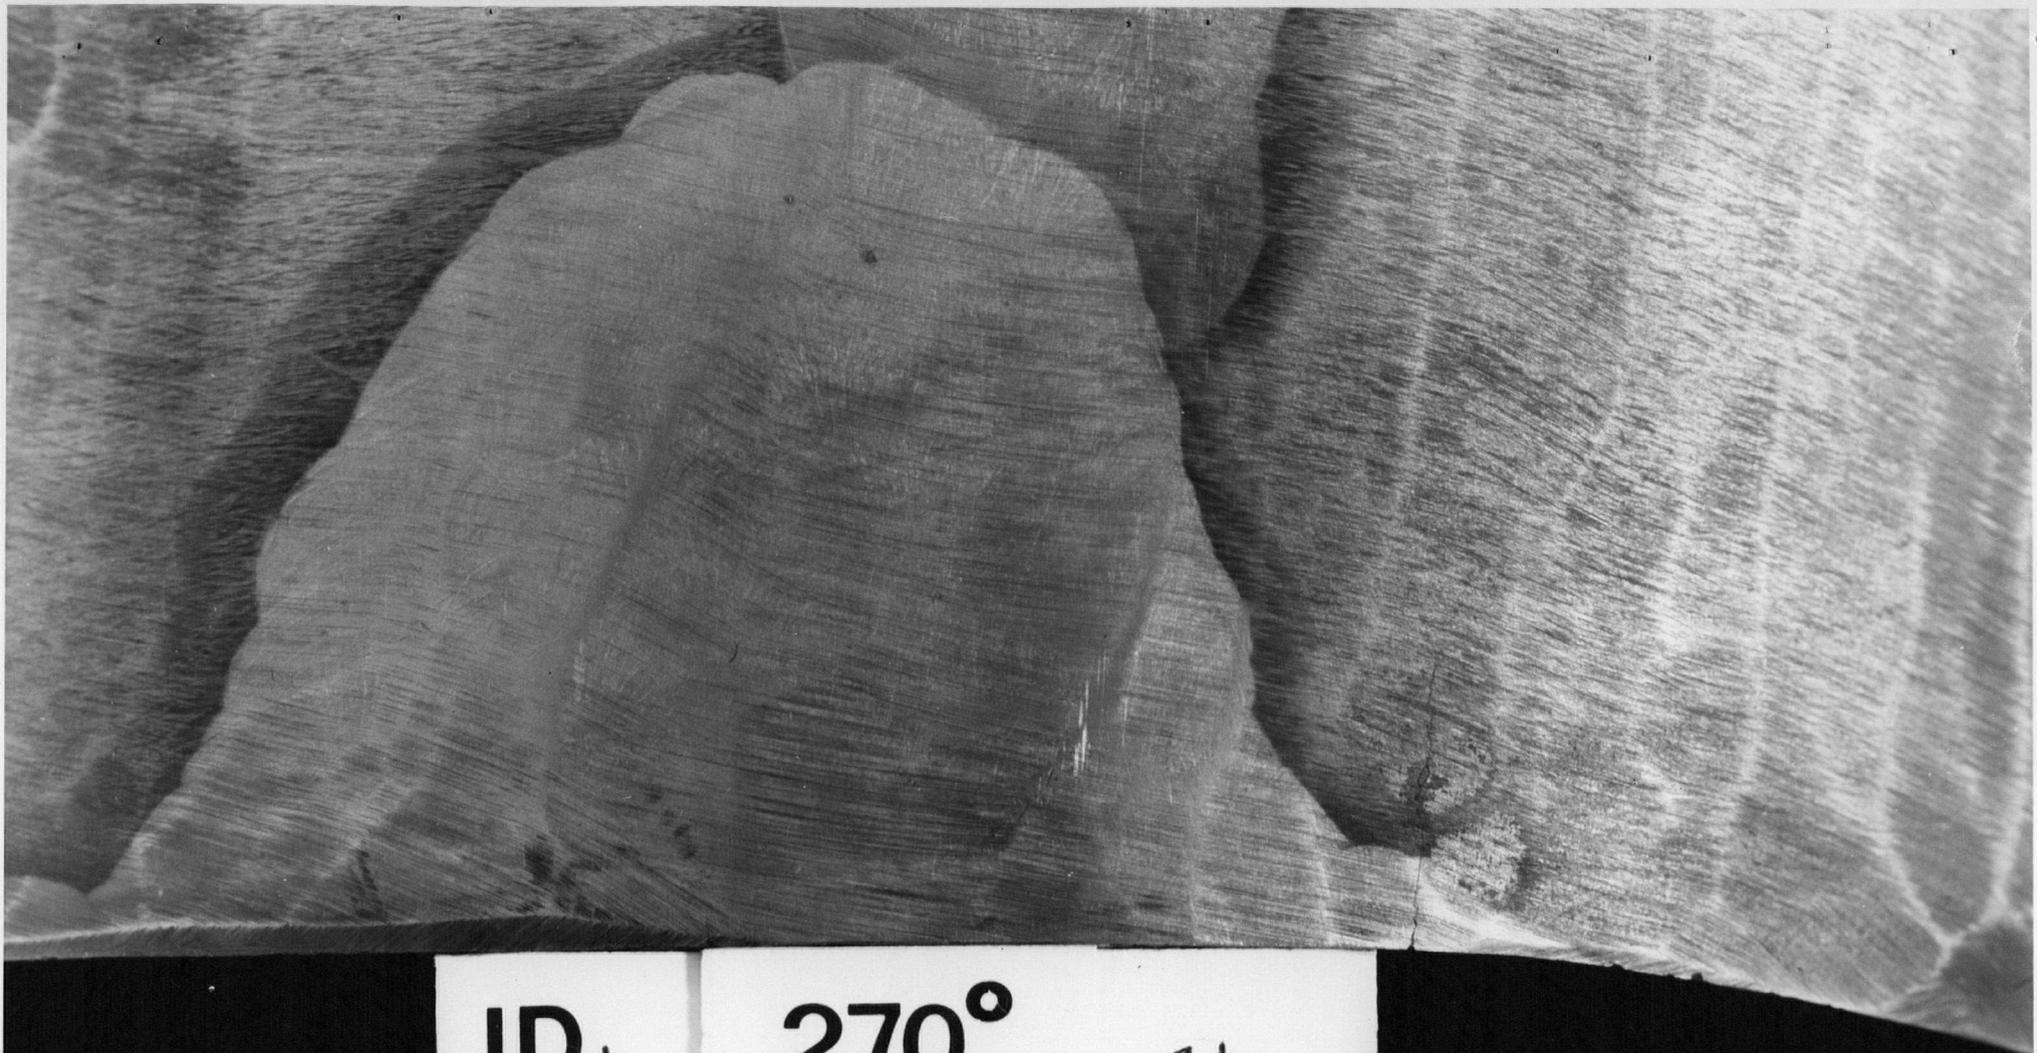
Light etching of the periphery of the coupon revealed the presence of a major weld repair at the root or inner surface of the circumferential weld. The weld repair, which was about 1-1/2 in. deep by 2 in. wide, was confined to the transition cone and extended across the diameter of the coupon. Figs. 11 through 14 are photomicrographs showing the periphery of the lightly etched coupon at 90-degree intervals. One of the the inner surface cracks which had extended into the periphery of the coupon is shown in Fig. 15.

FIG. 15 PHOTOMACROGRAPH SHOWING ONE OF THE INNER SURFACE
CRACKS WHICH HAD EXTENDED INTO THE PERIPHERY OF THE COUPON
