TECHNICAL REPORT NO. 7164

METALLURGICAL EXAMINATION OF SHELL
GIRTH WELD COUPON FROM
STEAM GENERATOR 32
INDIAN POINT 3
NUCLEAR POWER PLANT

POWER AUTHORITY OF THE STATE OF NEW YORK
10 COLUMBUS CIRCLE
NEW YORK, NEW YORK

OCTOBER 19, 1982

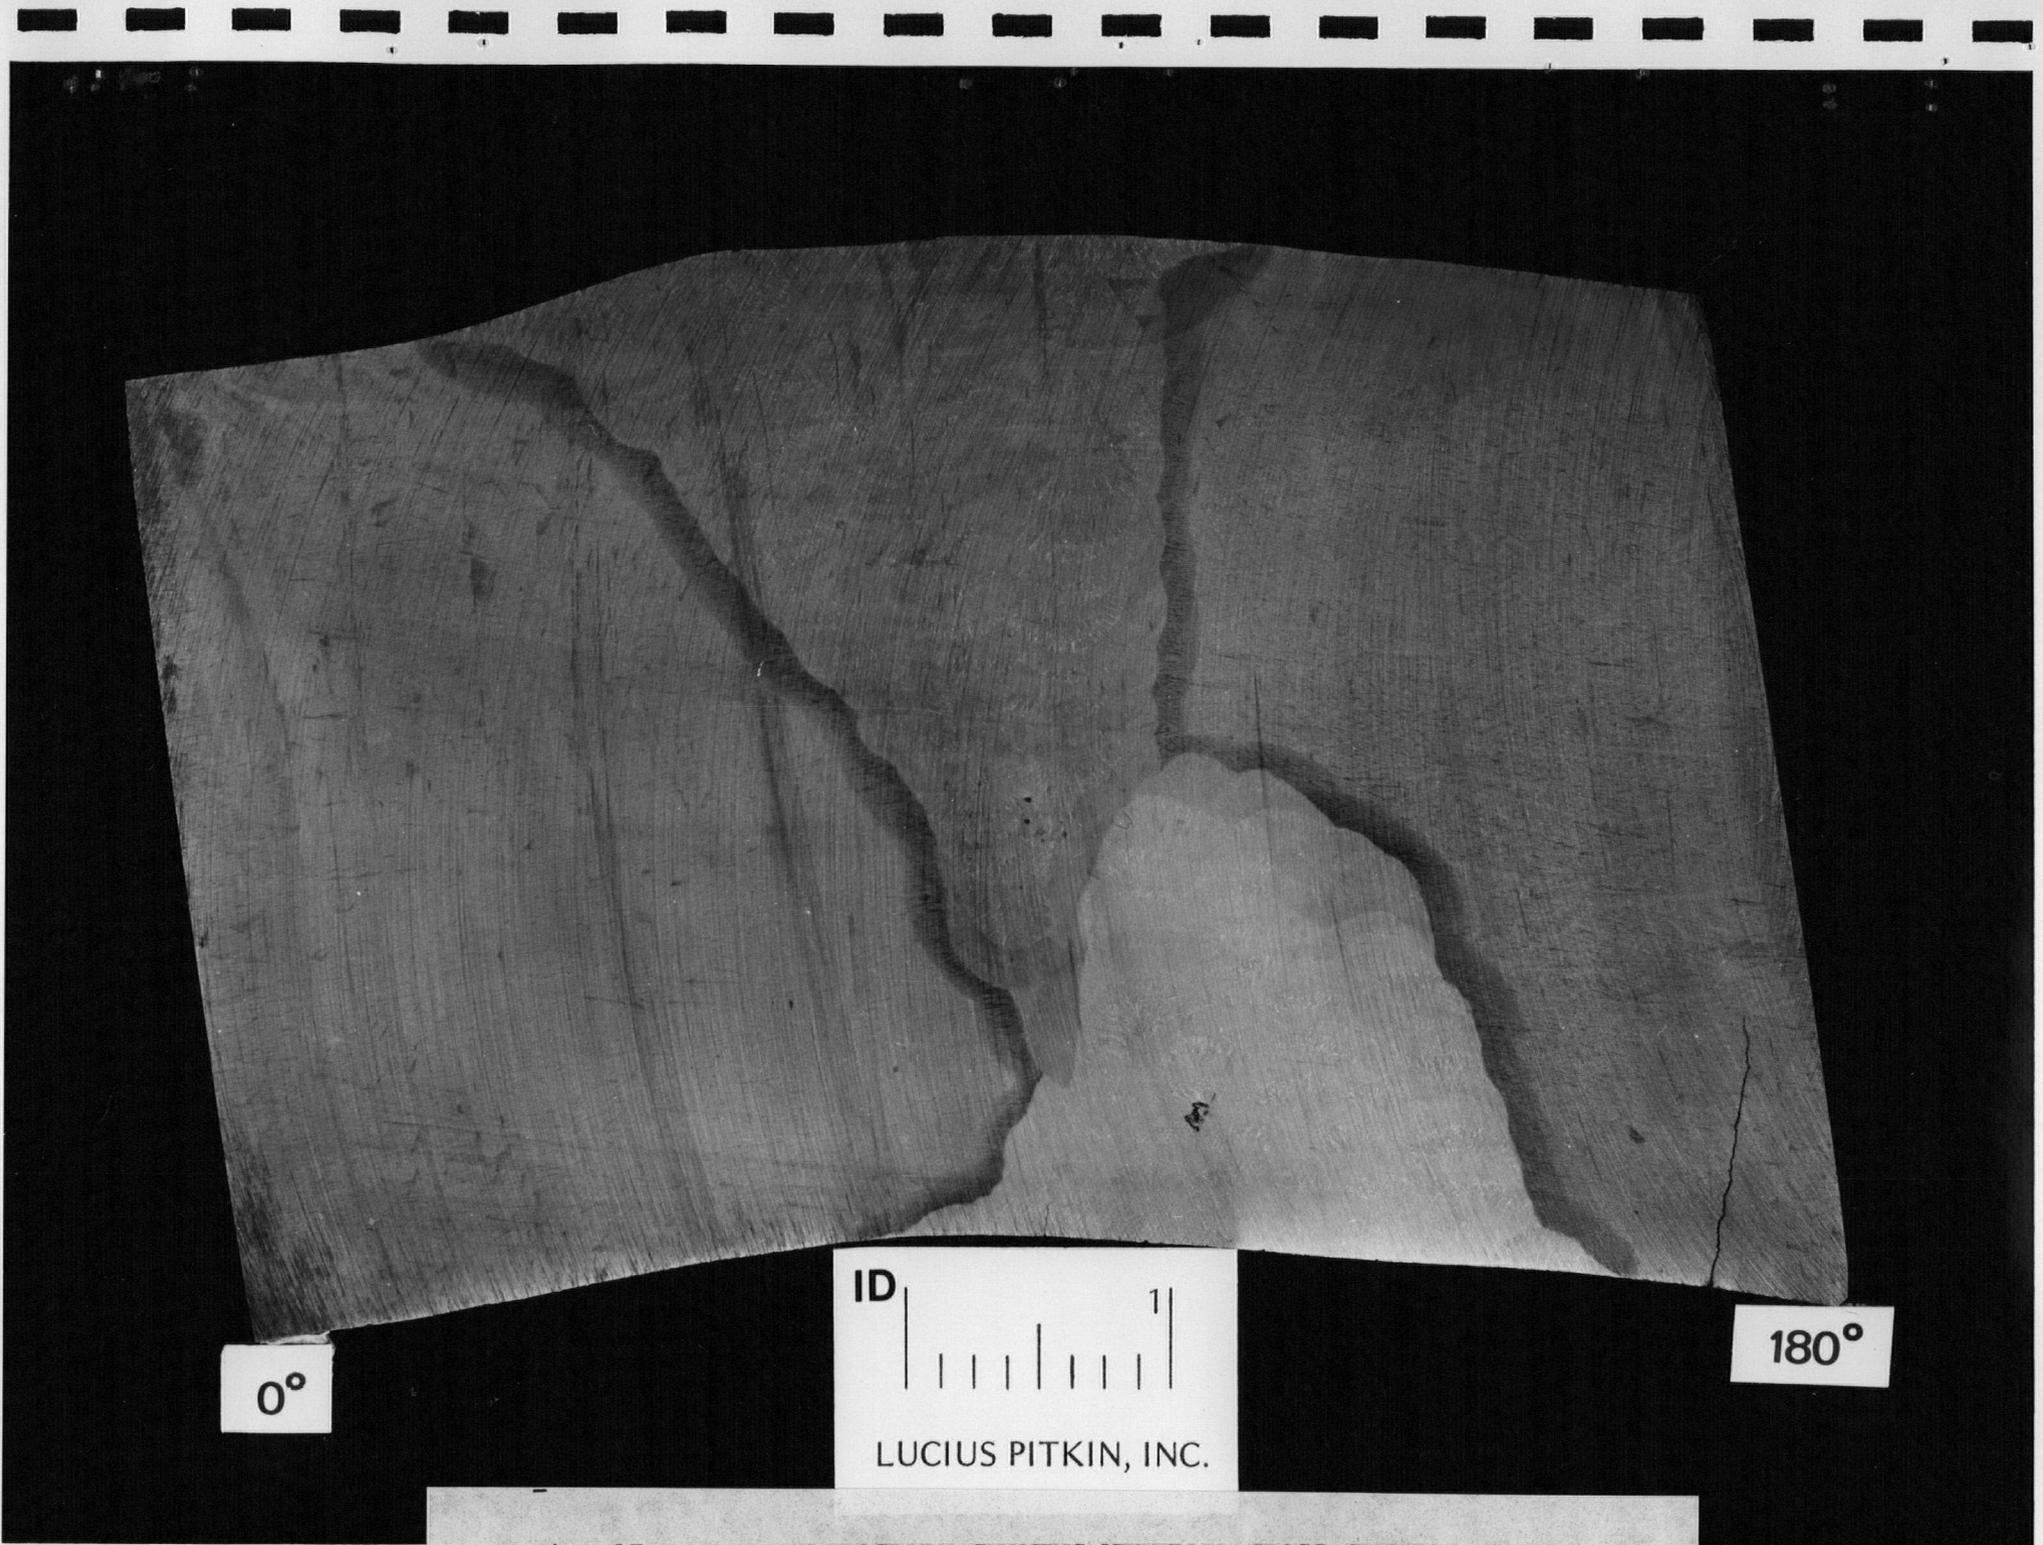
Fig. 17 PHOTOMACROGRAPH SHOWING VERTICAL CROSS-SECTION MATING TO THAT SHOWN IN FIG. 16

occurred in the repair weld in the transition cone and in the upper shell base material. The mating etched diametrical cross-section surfaces are shown in Figs. 16 and 17, respectively.

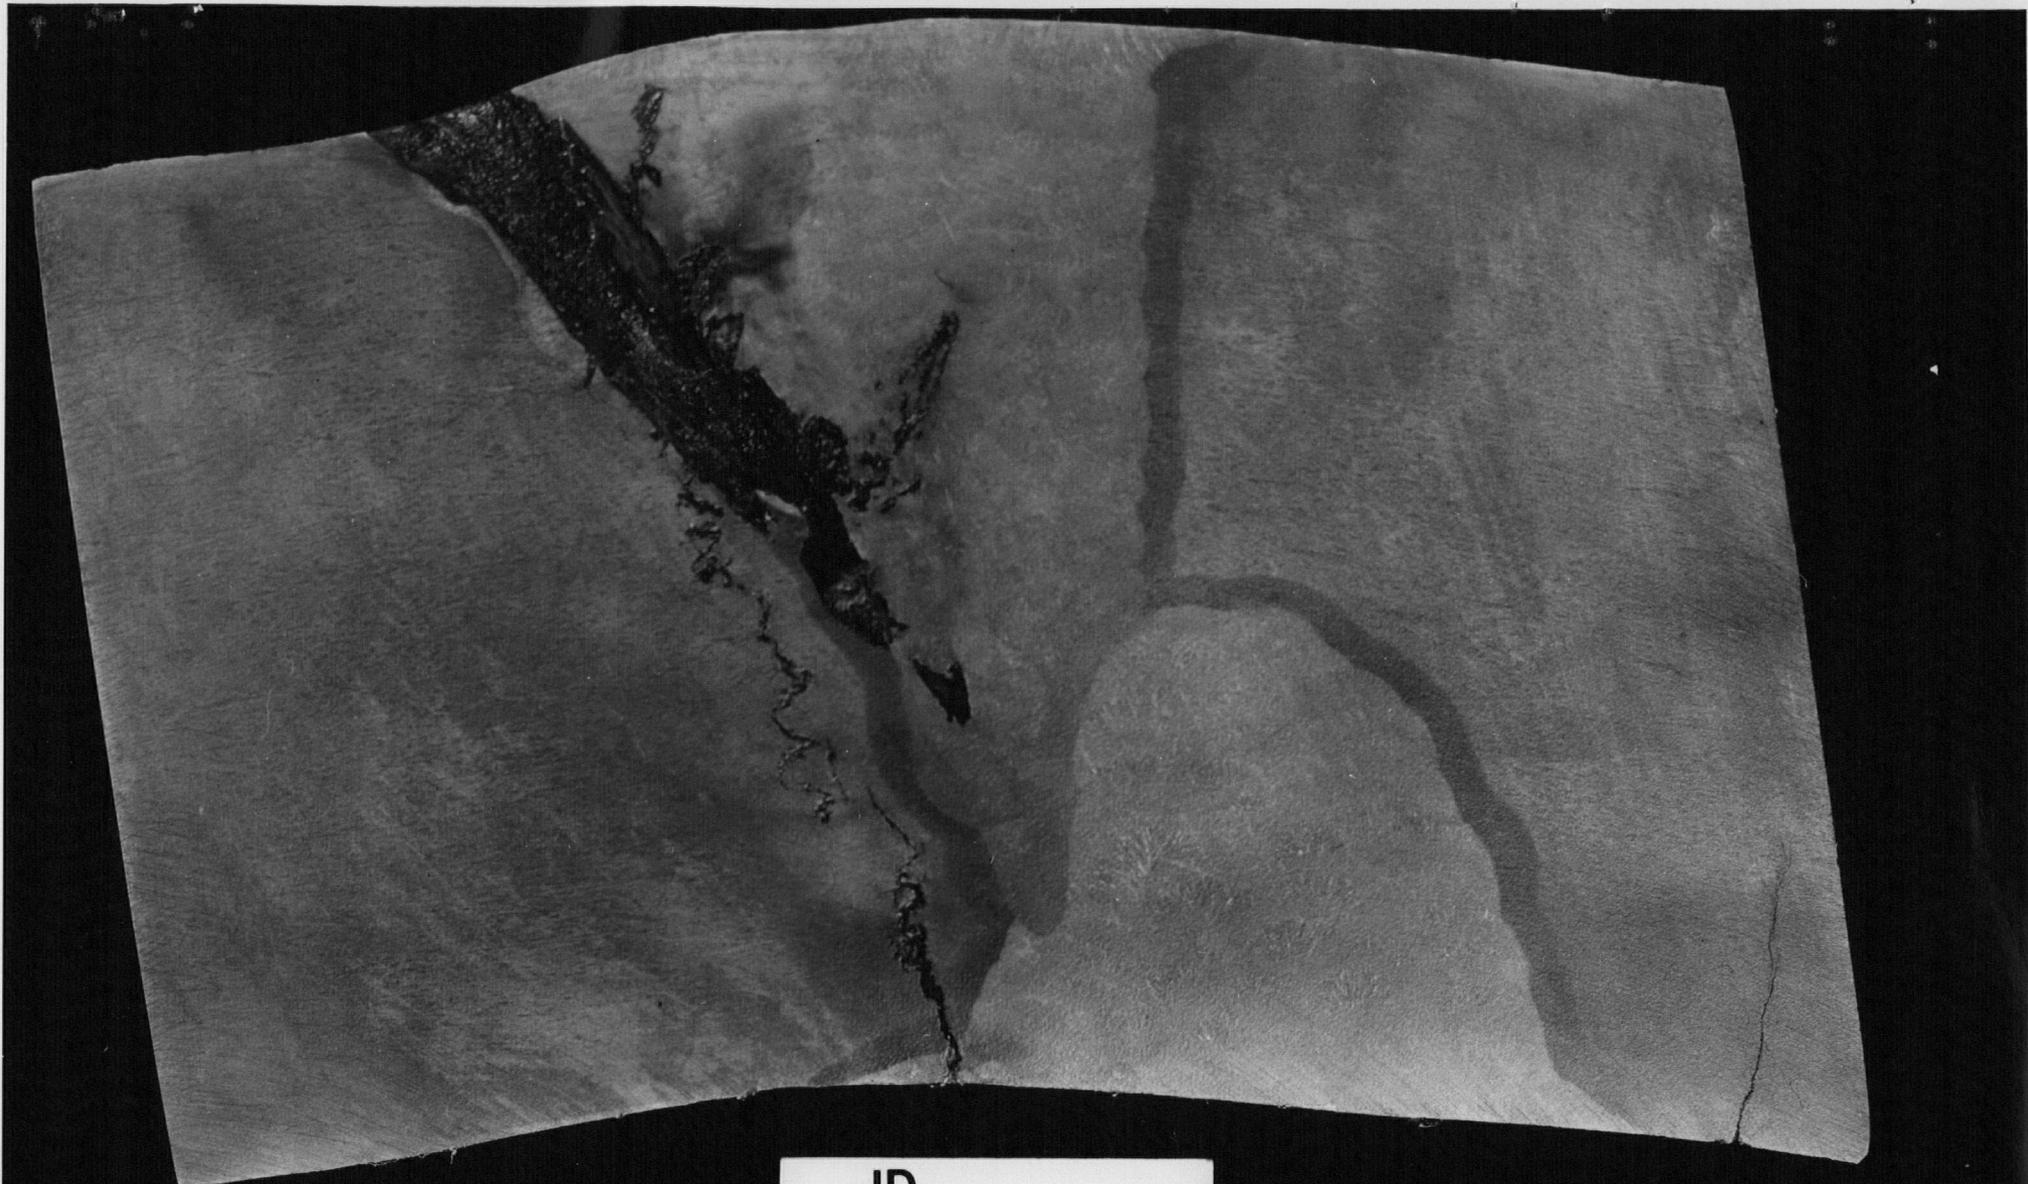
Examination of the etched cross-section revealed the presence of a somewhat irregular crack that extended from the toe of the inner surface repair weld into the crown weld at approximately mid-wall where it then joined an eroded area approximately 3/8 in. wide along the line of fusion between weld deposit and upper shell. This is shown in Fig. 18.

Fig. 18 PHOTOMACROGRAPH OF VERTICAL CROSS-SECTION ADJACENT AND SLIGHTLY THROUGH THROUGH-WALL DISCONTINUITY

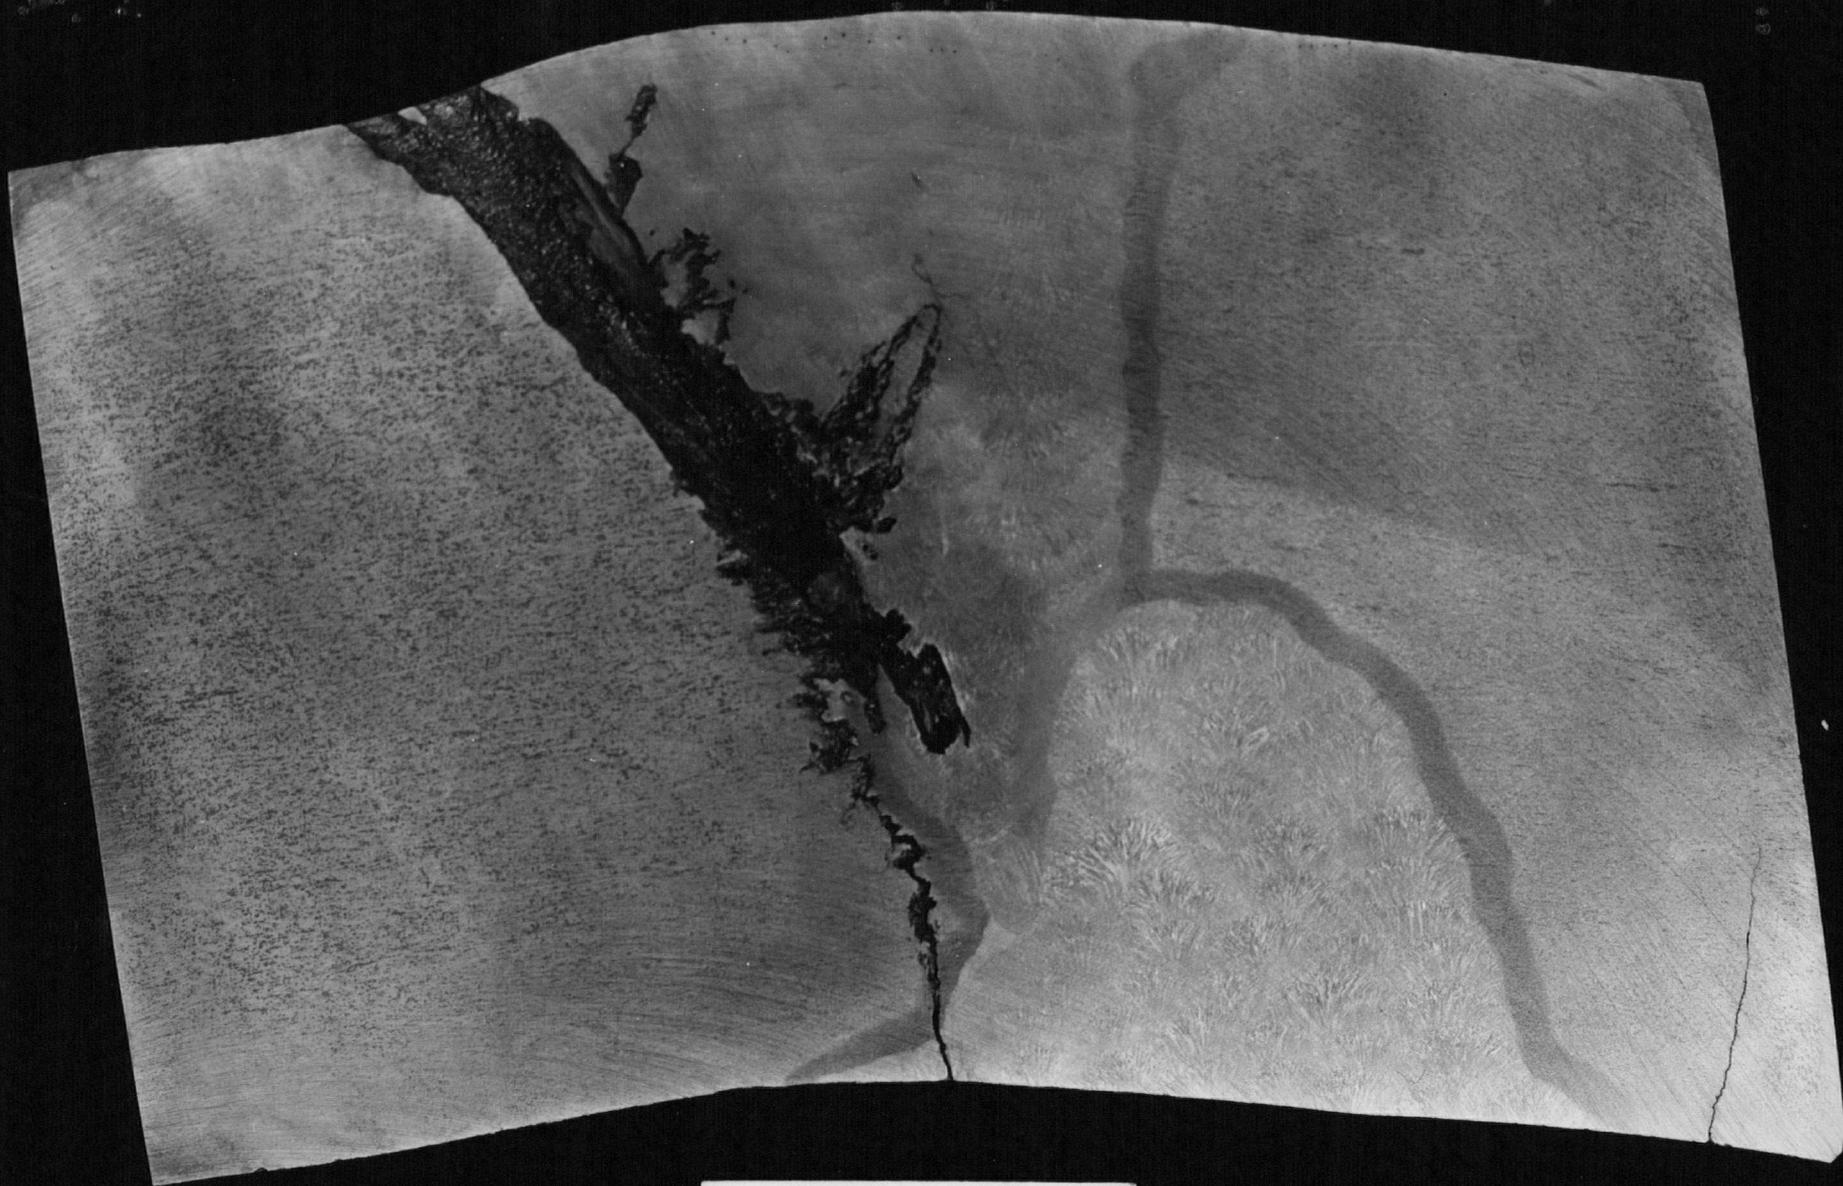
The etched cross-section, shown in Fig. 18, was re-ground an additional 0.060 in. so as to further assess the extent of cracking and nature of the through-wall discontinuity. It was observed that the crack emanating from the inner surface and the through-wall thickness discontinuity contained deposits of what appeared to be oxide, metallic copper and a fibrous, wood-like material. We were advised that the

PHOTOMACROGRAPH SIMILAR TO THAT SHOWN IN FIG. 18 EXCEPT
AFTER ADDITIONAL GRINDING OF APPROXIMATELY 1/16 INCH

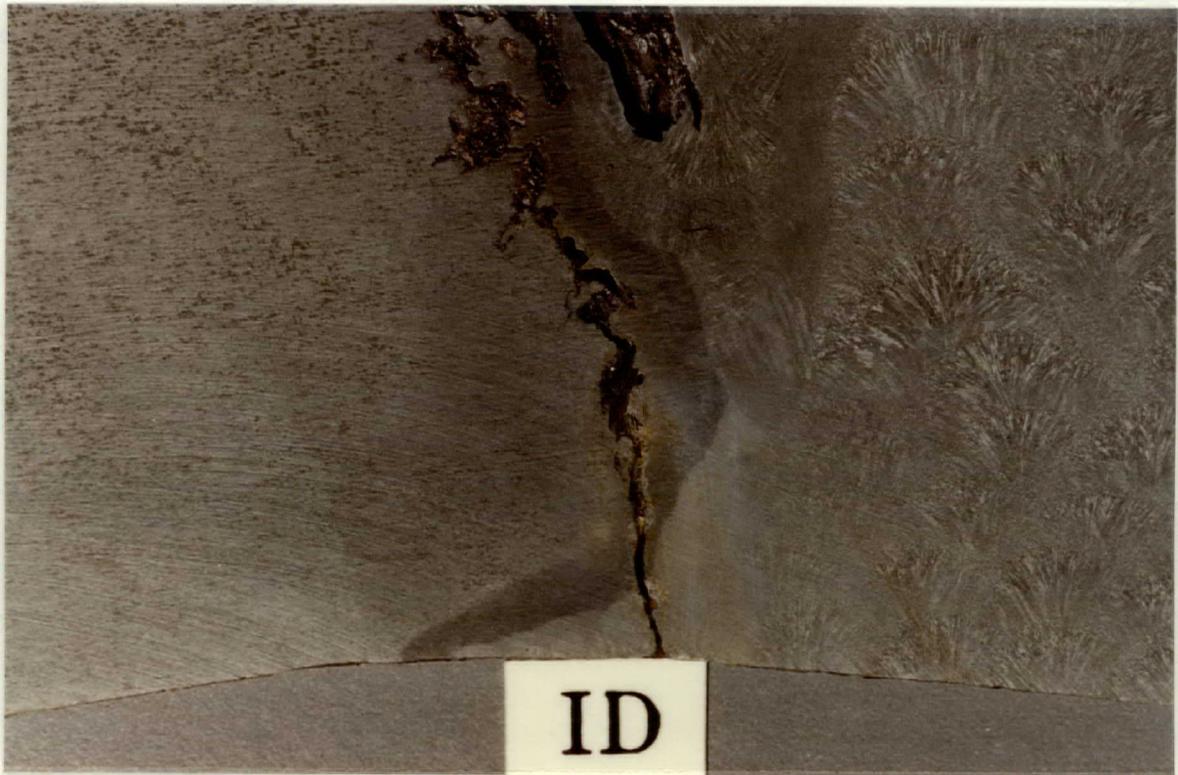
Fig. 21 PHOTOMACROGRAPH SHOWING WOOD FIBERS AND COPPER WITHIN THROUGH-THICKNESS DISCONTINUITY AT INNER SURFACE. WOOD FIBERS ARE THE RESULT OF THE INSERTION OF A WOODEN PLUG AFTER SHUTDOWN OF THE STEAM GENERATOR

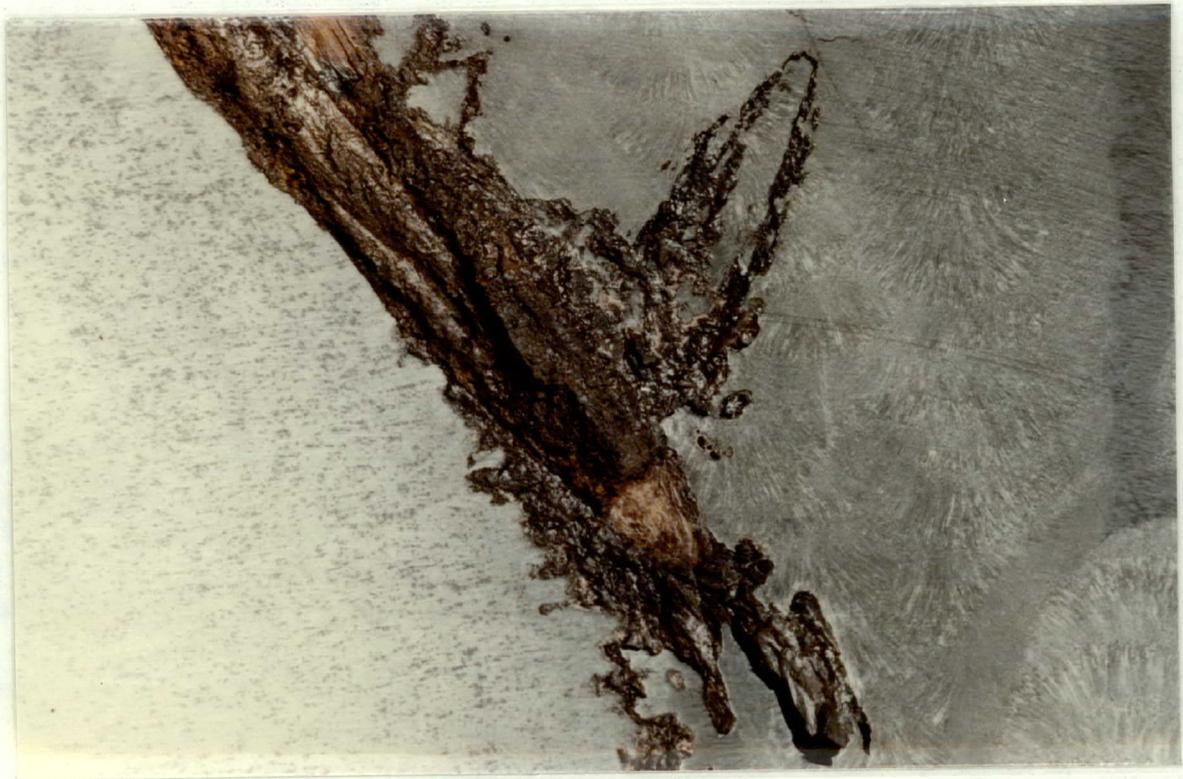
Fig. 22 PHOTOMACROGRAPH SHOWING WOOD FIBERS AND COPPER WITHIN
THROUGH-THICKNESS DISCONTINUITY AT ABOUT MID-WALL

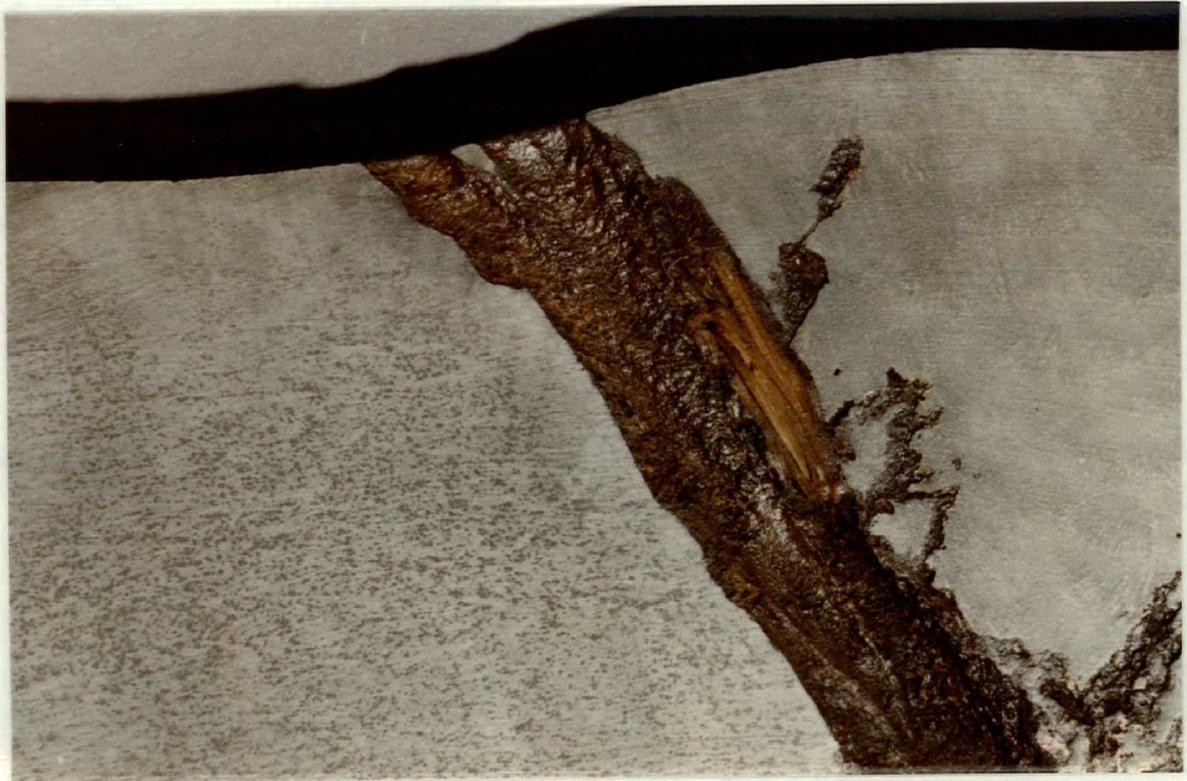
Fig. 23 PHOTOMACROGRAPH SHOWING WOOD FIBERS AND COPPER WITHIN
THROUGH THICKNESS DISCONTINUITY NEAR OUTER SURFACE

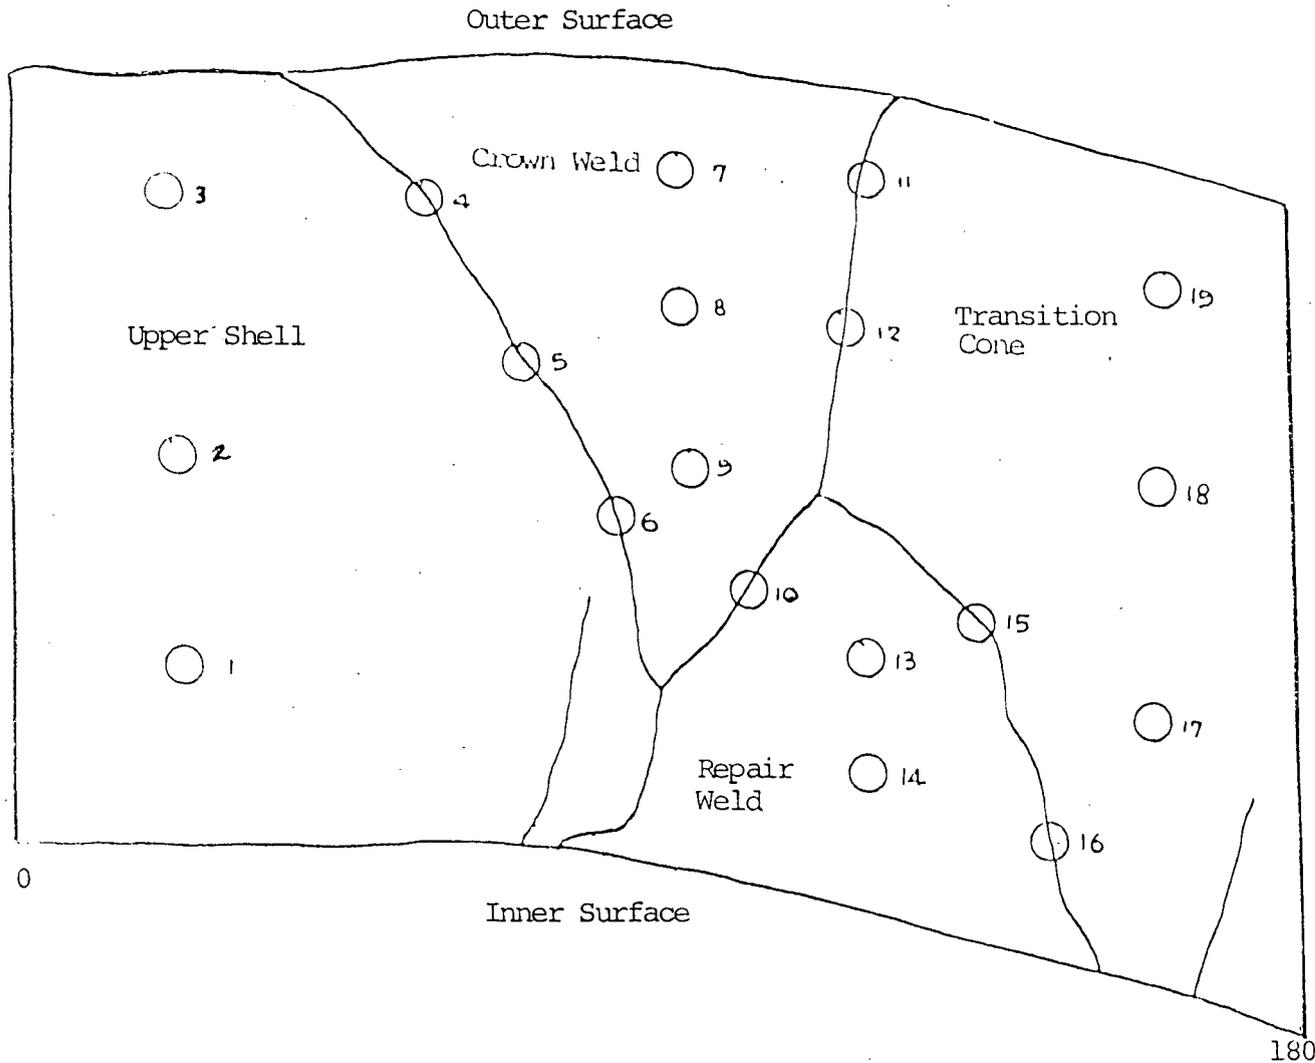
Fig. 24 BRINELL HARDNESS SURVEY (3000 KG) VERTICAL CROSS-SECTION THROUGH GIRTH WELD, S.G. 32

Brinell hardness surveys were performed on a ground longitudinal cross-section of the steam generator coupon. The surveys showed the upper shell and transition cone base materials to exhibit a uniform hardness of Brinell 190 to 200. The crown weld exhibited a uniform Brinell hardness of 210 to 230. The repair weld exhibited a uniform hardness of Brinell 190 to 200. A survey of the heat-affected zone between the upper shell/crown weld, transition cone/crown weld and the transition cone/repair weld showed the heat-affected zones to be significantly harder at Brinell 240 to 255.

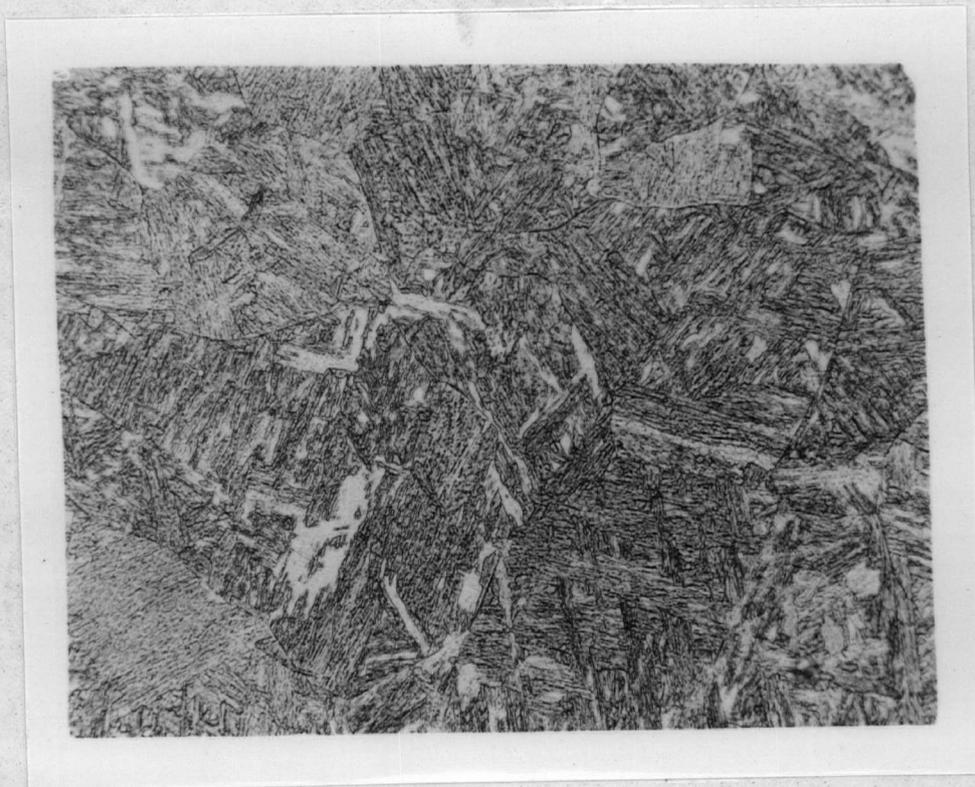
Fig. 25A

The girth weld heat-affected zone hardness was considered inordinately high at Rockwell C 39 to 41 and, in our opinion, was indicative of less-than-satisfactory stress relief heat treatment.

Photomicrograph showing the general microstructure exhibited by the heat-affected zone between crown weld/upper shell. The heat-affected zone microstructure consists of lightly tempered martensite. The hardness of the heat-affected zone shown here was Rockwell C 41-42.

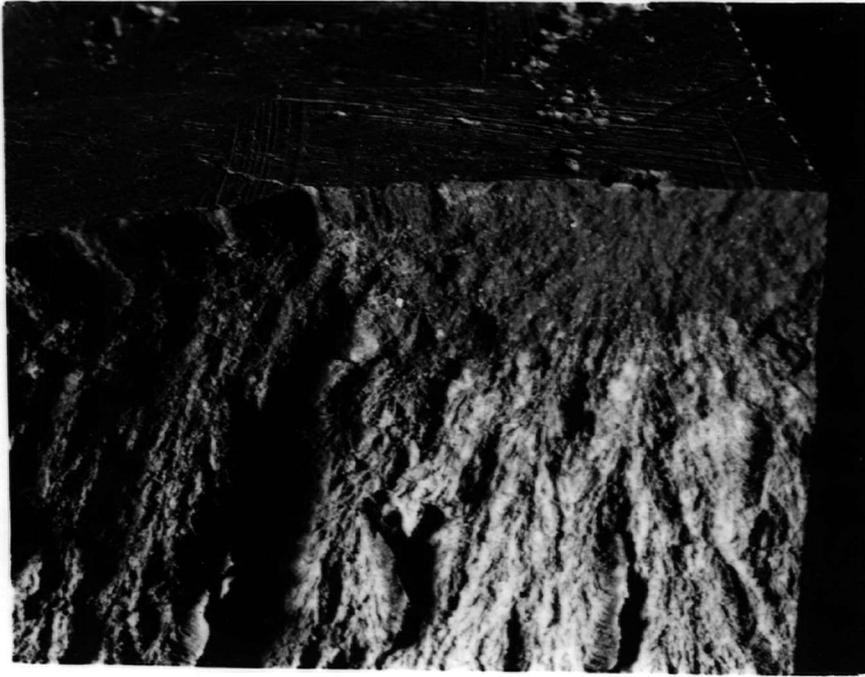
The test coupon was cut so as to intercept the weld and base metal cracks. Forced separation of a crack revealed the fracture surface to be generally smooth in appearance and to contain a thumbnail-size zone with radially oriented ridges and faint beach-like markings originating from a pit at the inner surface as is characteristic of progressive cracking. Fig. 26 is a close-up photograph showing the crack surface at the origin site at the inner surface of the coupon.

FRACTURE SURFACE OF OPENED-UP CRACK AT
INNER SURFACE OF COUPON

Close-up photograph showing the fracture surface of opened-up crack which initiated at the inner surface of the steam generator coupon. It can be seen that the fracture is associated with fine pits on the inner surface.

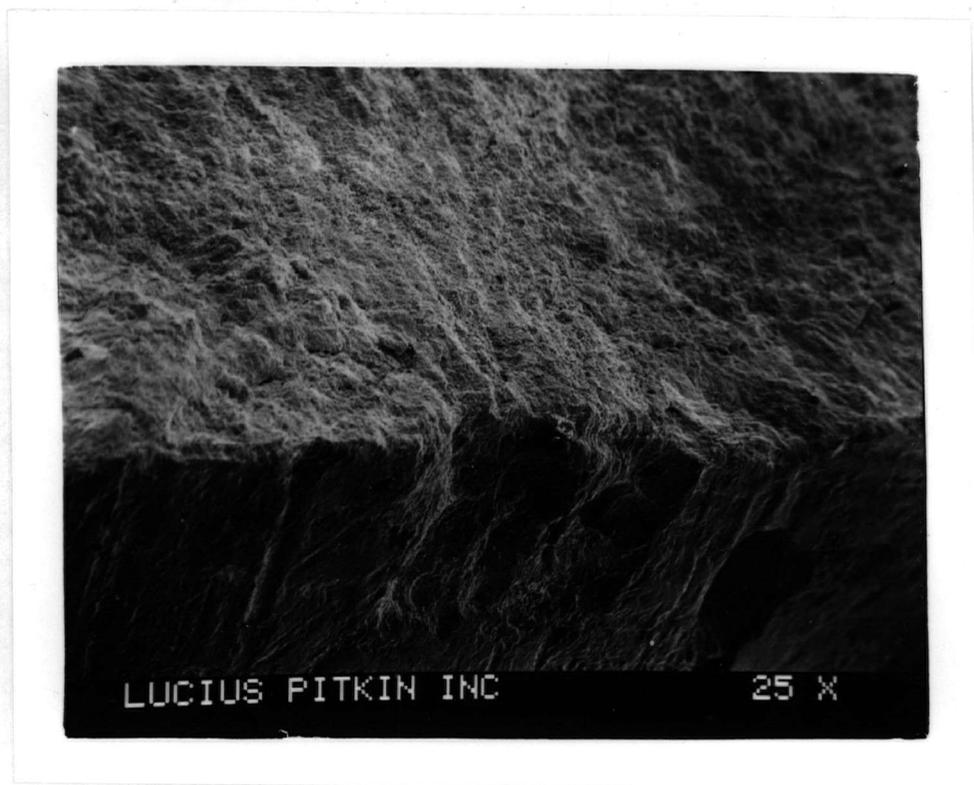
Scanning electron microscopy at the origin site of the crack surface shown in Fig. 26 revealed the presence of a corrosion product and confirmed the pitting corrosion attack at the origin site. Fig. 27 is a scanning electron micrograph of the origin site. The presence of corrosion products on the crack surface precluded the observance of striation lines. At higher magnification, the presence of discrete crystals of iron oxide was observed. These crystals are shown in Fig. 28.

Scanning electron micrograph showing the corroded fracture surface of crack which initiated at the inner surface of the steam generator coupon.

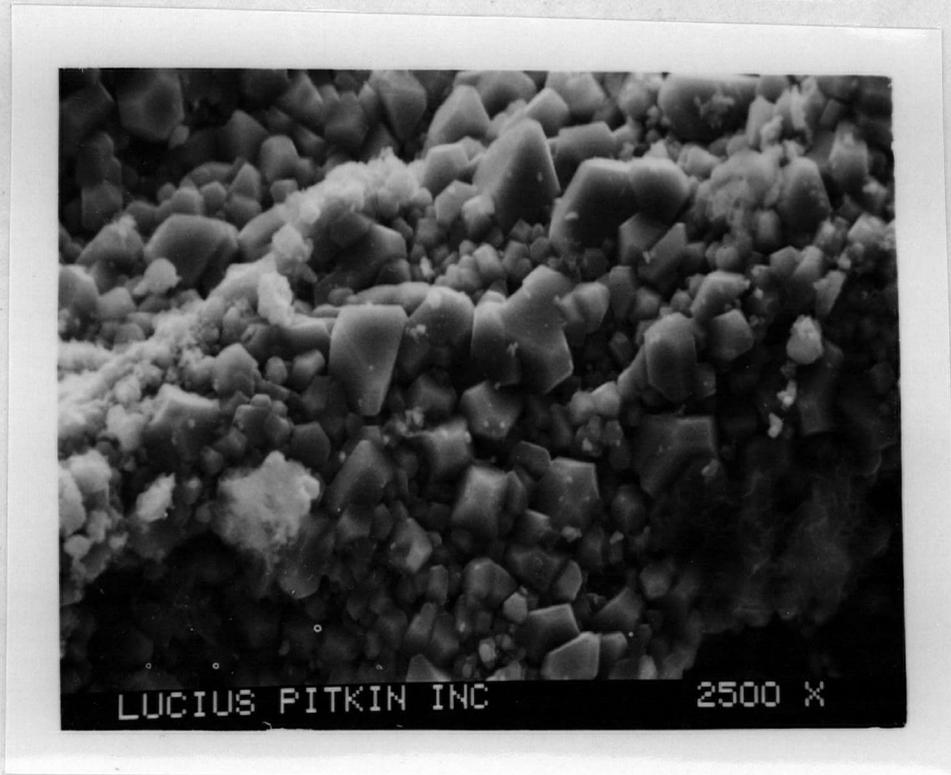
Fig. 28

Scanning electron micrograph showing discrete crystals of iron oxide present on the crack fracture surface. The presence of these iron oxide crystals is indicative of the presence of oxygen in the secondary water system.

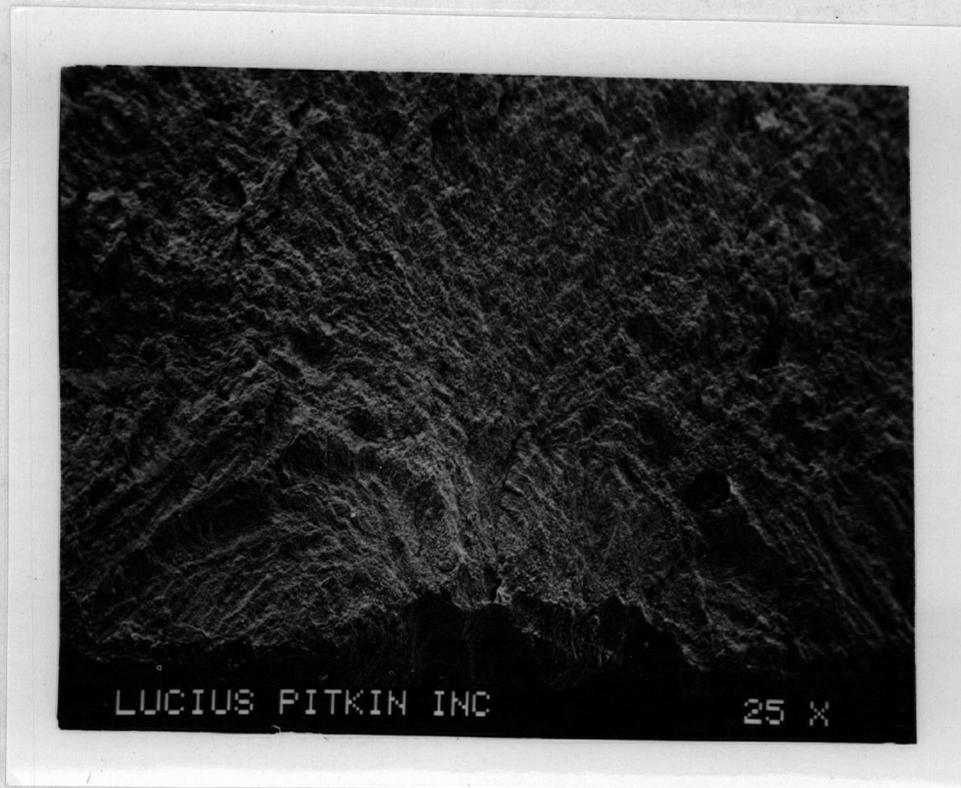
Fig. 29

SEM similar to that shown in Fig. 27, except after extensive cleaning to remove surface oxide. It can be seen that the fracture surface is generally smooth as is characteristic of progressive or fatigue cracking, but no striations could be found.

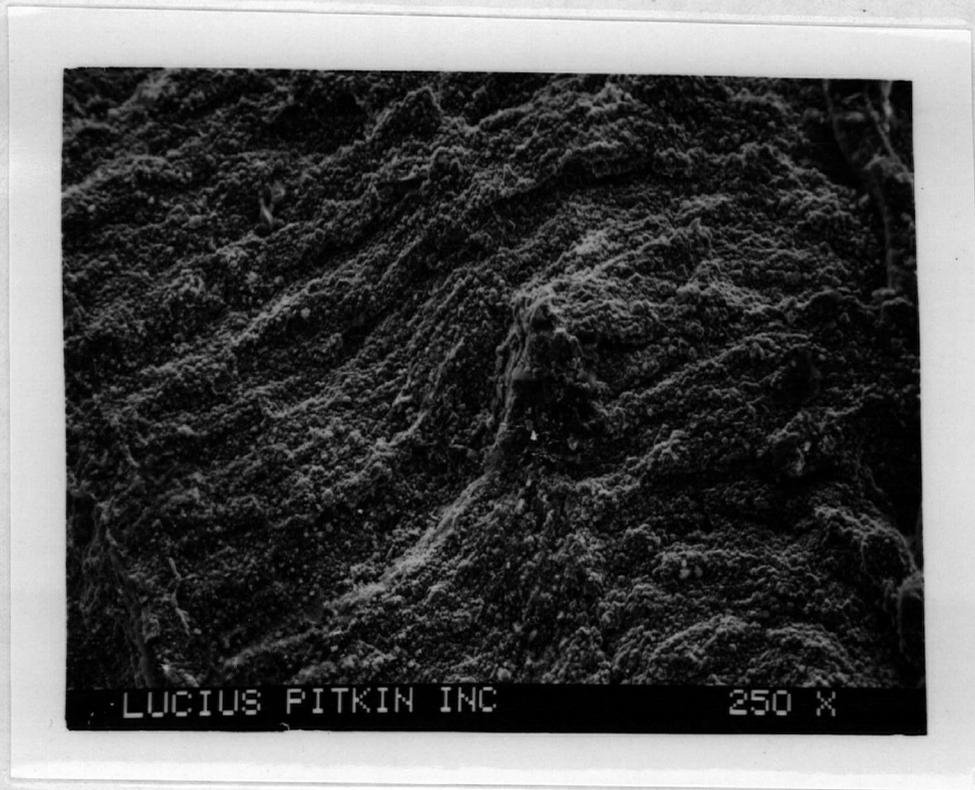
Fig. 30 CRACK FRACTURE SURFACE BELOW INNER SURFACE 250 X

Scanning electron micrograph showing the oxide covered crack fracture surface approximately 1/2 in. from the inner surface of the coupon. The somewhat radially ridged appearance of the fracture surface indicates the fracture to be the result of progressive or fatigue cracking.

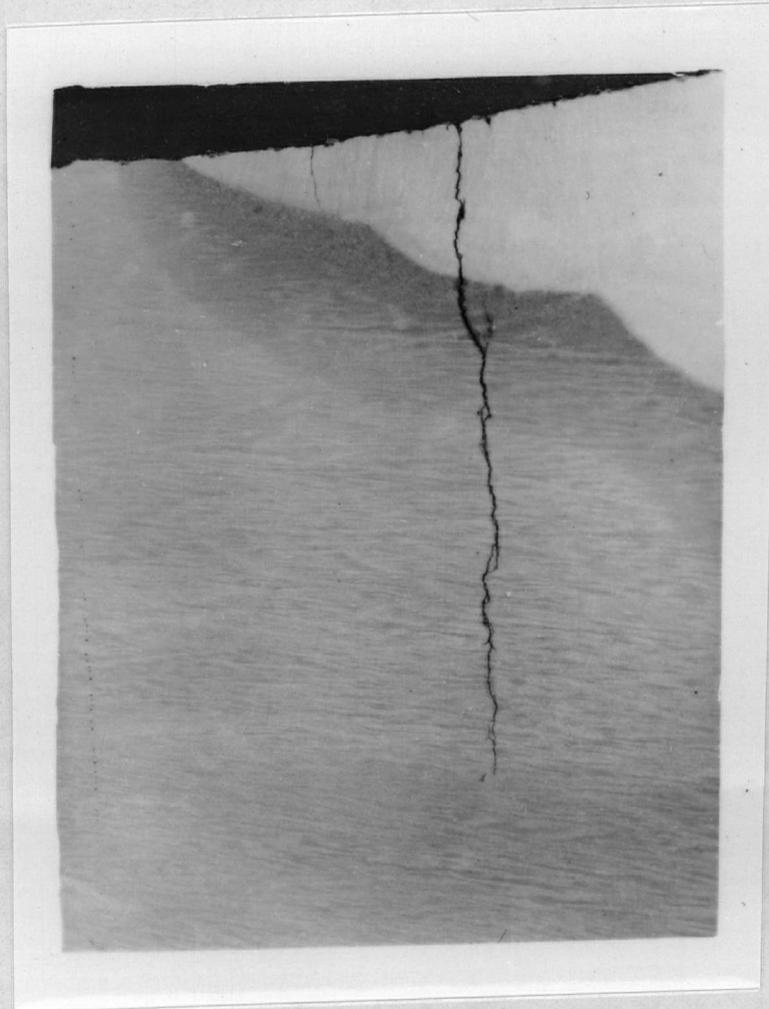
Fig. 32

CRACKS IN REPAIR WELD - INNER SURFACE

Photomicrograph showing one of the typical progressive or fatigue cracks, initiated near the toe of the repair weld, which propagated into the transition cone base material. It can also be seen that very fine, secondary cracks are present which emanate from fine pits in the surface of the repair weld metal.

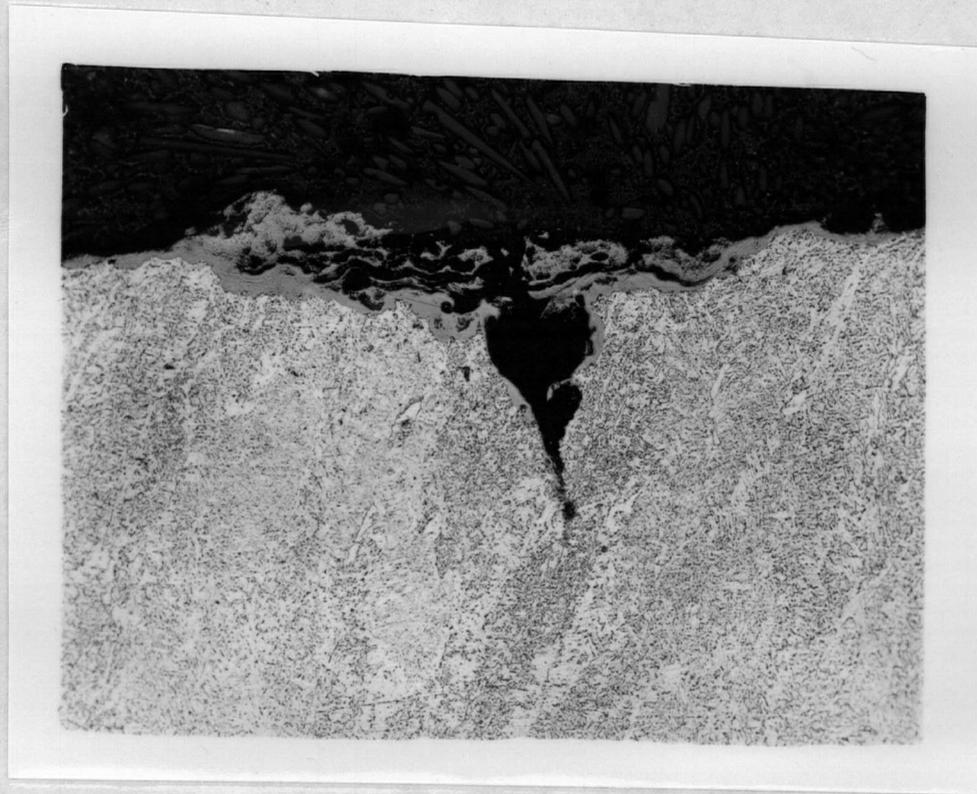
Fig. 33

CORROSION-FILLED CRACK IN REPAIR WELD

Photomicrograph showing corrosion-filled crack initiated from inner surface of repair weld.

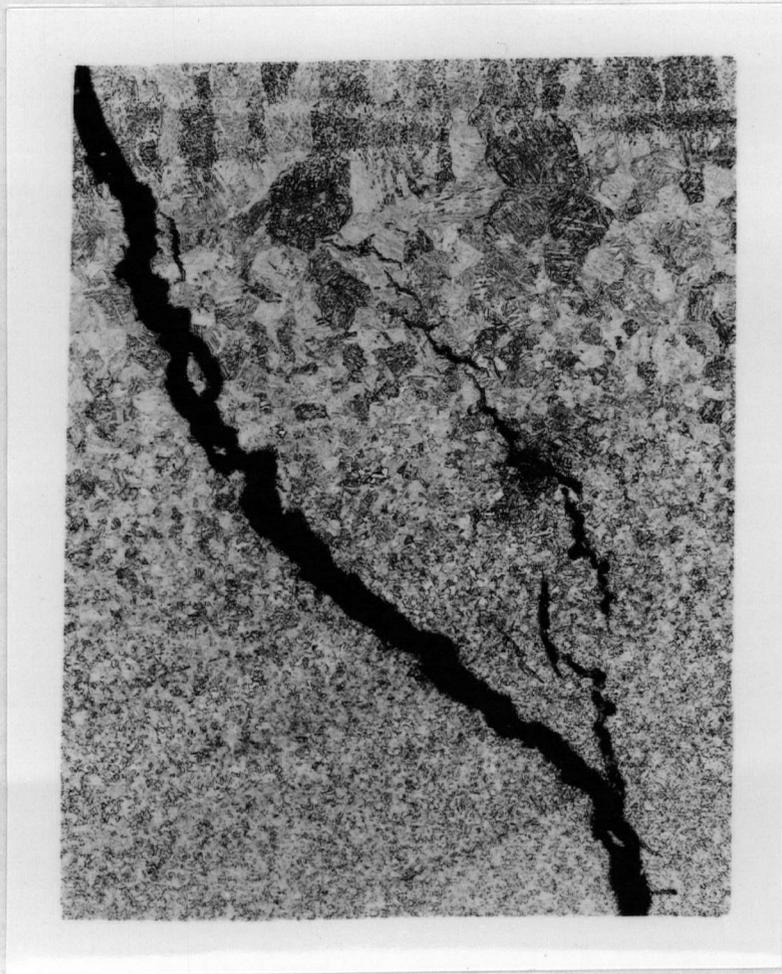
Fig. 34

PROGRESSIVE OR FATIGUE CRACKS IN REPAIR WELD

Photomicrograph showing typical progressive or fatigue cracks which had initiated from the inner surface of the repair weld and had propagated through the heat-affected zone into the transition cone base metal. It can be seen that the cracks are slightly branching and transgranular.

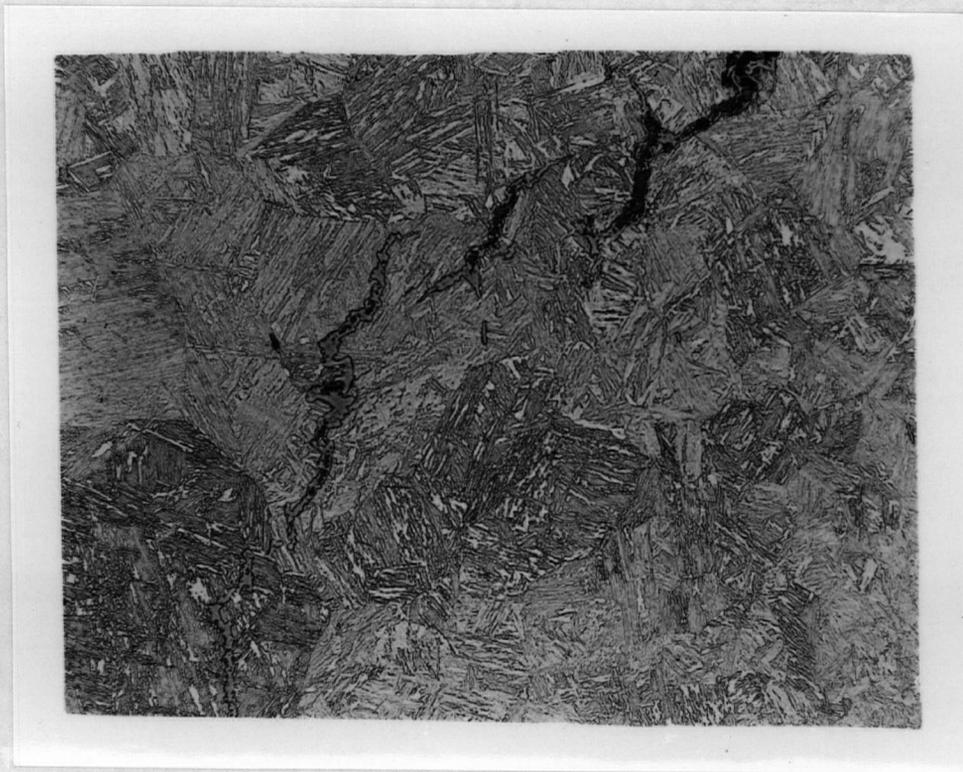
Fig. 35

HEAT-AFFECTED ZONE CRACKS

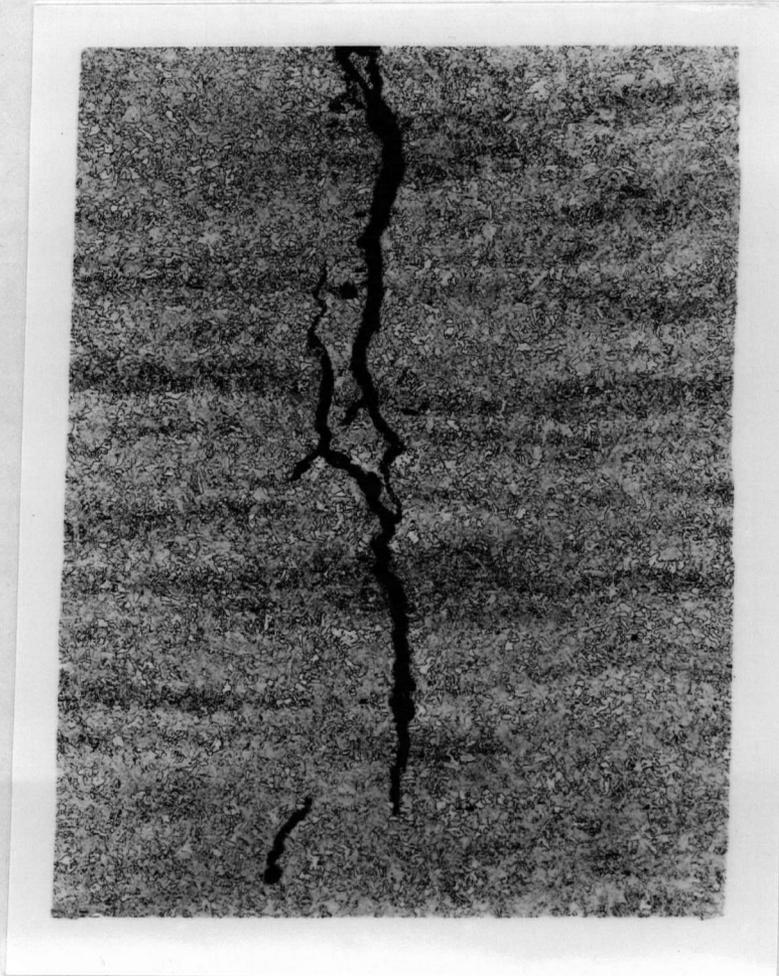
Fig. 36

TRANSITION CONE BASE METAL CRACKS

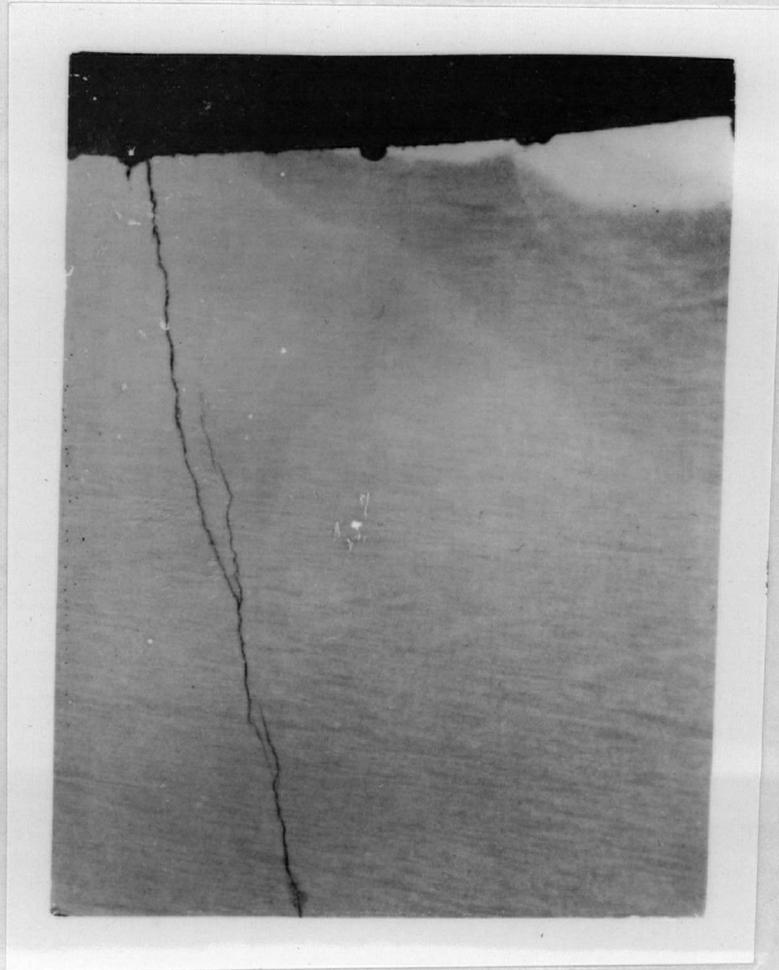
Fig. 37

INNER SURFACE CRACKS IN TRANSITION CONE

Photomicrograph showing progressive or fatigue crack emanating from corrosion pit at the inner surface of transition cone base material.
