TECHNICAL REPORT NO. 7164

METALLURGICAL EXAMINATION OF SHELL
GIRTH WELD COUPON FROM
STEAM GENERATOR 32
INDIAN POINT 3
NUCLEAR POWER PLANT

POWER AUTHORITY OF THE STATE OF NEW YORK
10 COLUMBUS CIRCLE
NEW YORK, NEW YORK

OCTOBER 19, 1982

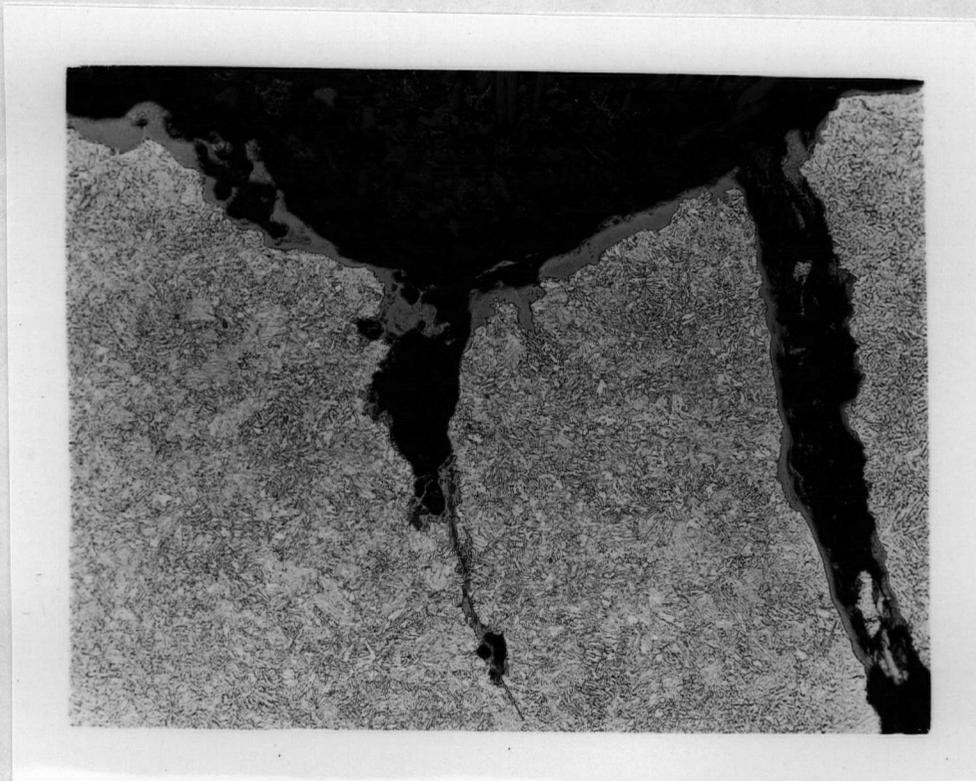
Fig. 38 INNER SURFACE CRACKS IN TRANSITION CONE 100 X

Photomicrograph similar to that shown in Fig. 37 except at higher magnification more clearly showing the corrosion-filled transgranular fatigue cracks which initiated from an inner surface pit.

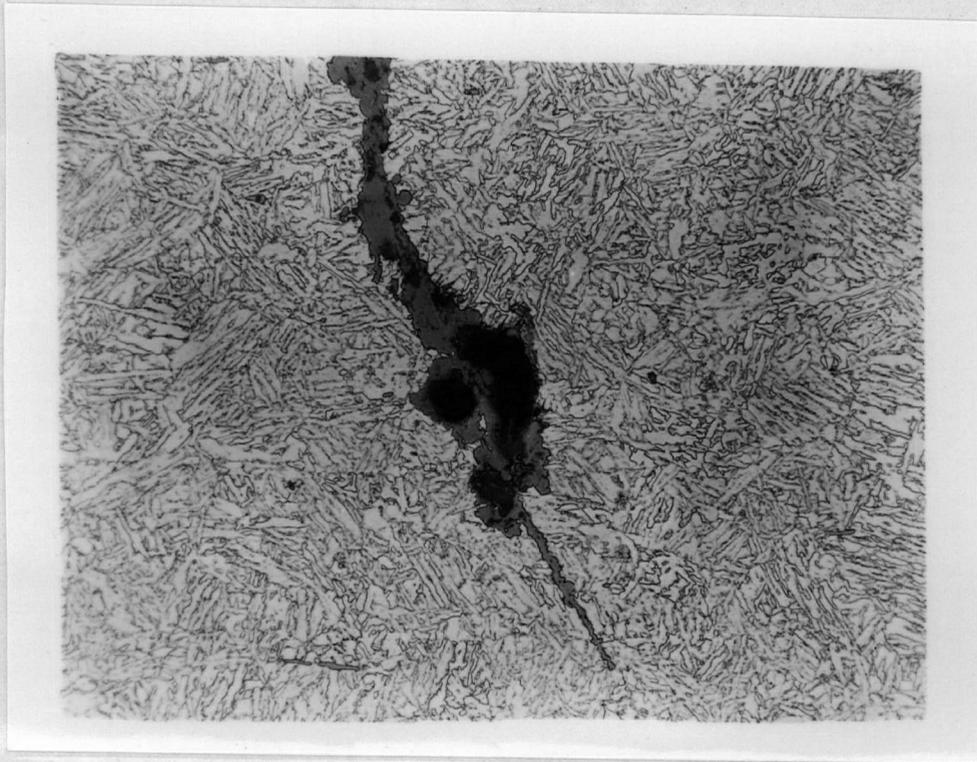
Fig. 39

CORROSION-FILLED CRACK - TRANSITION CONE

Photomicrograph showing the tip of the progressive or fatigue crack shown in Figs. 37 and 38. It can be seen that the crack is corrosion filled and transgranular as is typical of progressive or fatigue cracking.

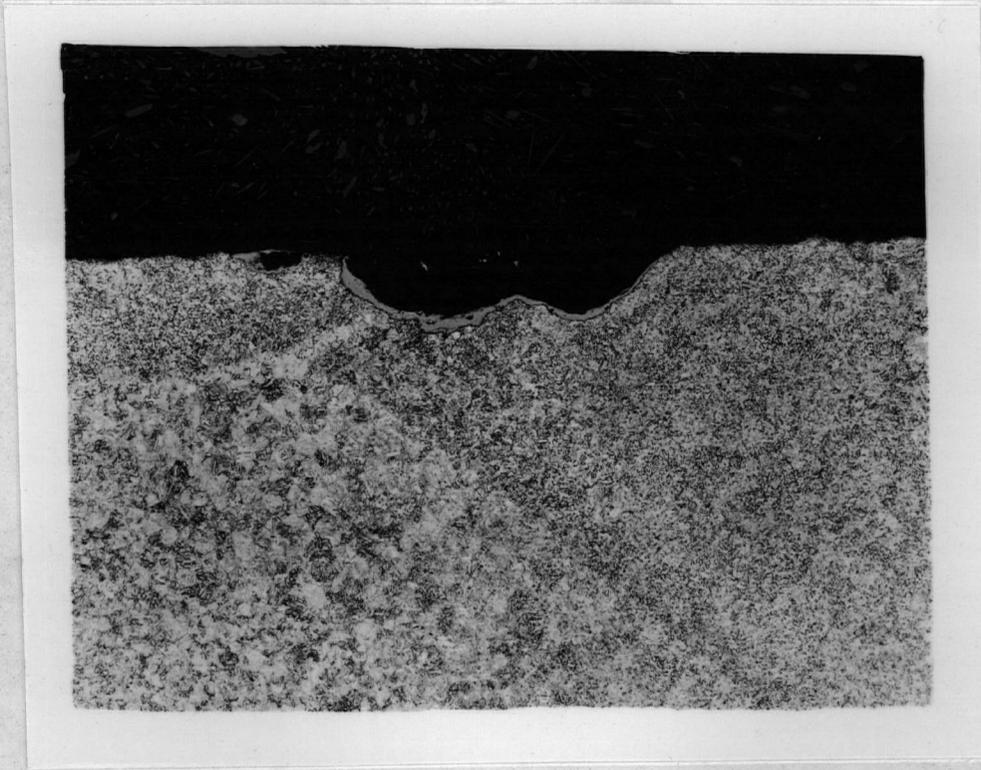
Fig. 39A

Photomicrograph showing the presence of fine pits on the inner surface of the coupon near the heat-affected zone.

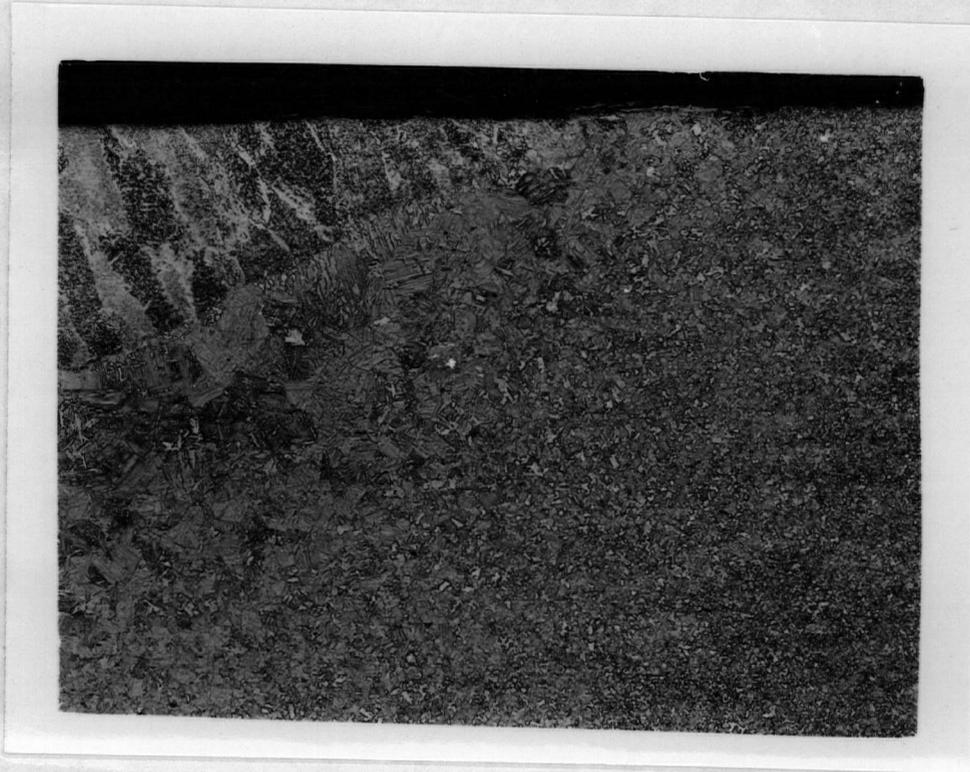
Fig. 40

Photomicrograph showing the general microstructure in the heat-affected zone between the repair weld and transition cone base material. The microstructure shown here consists of lightly tempered martensite.

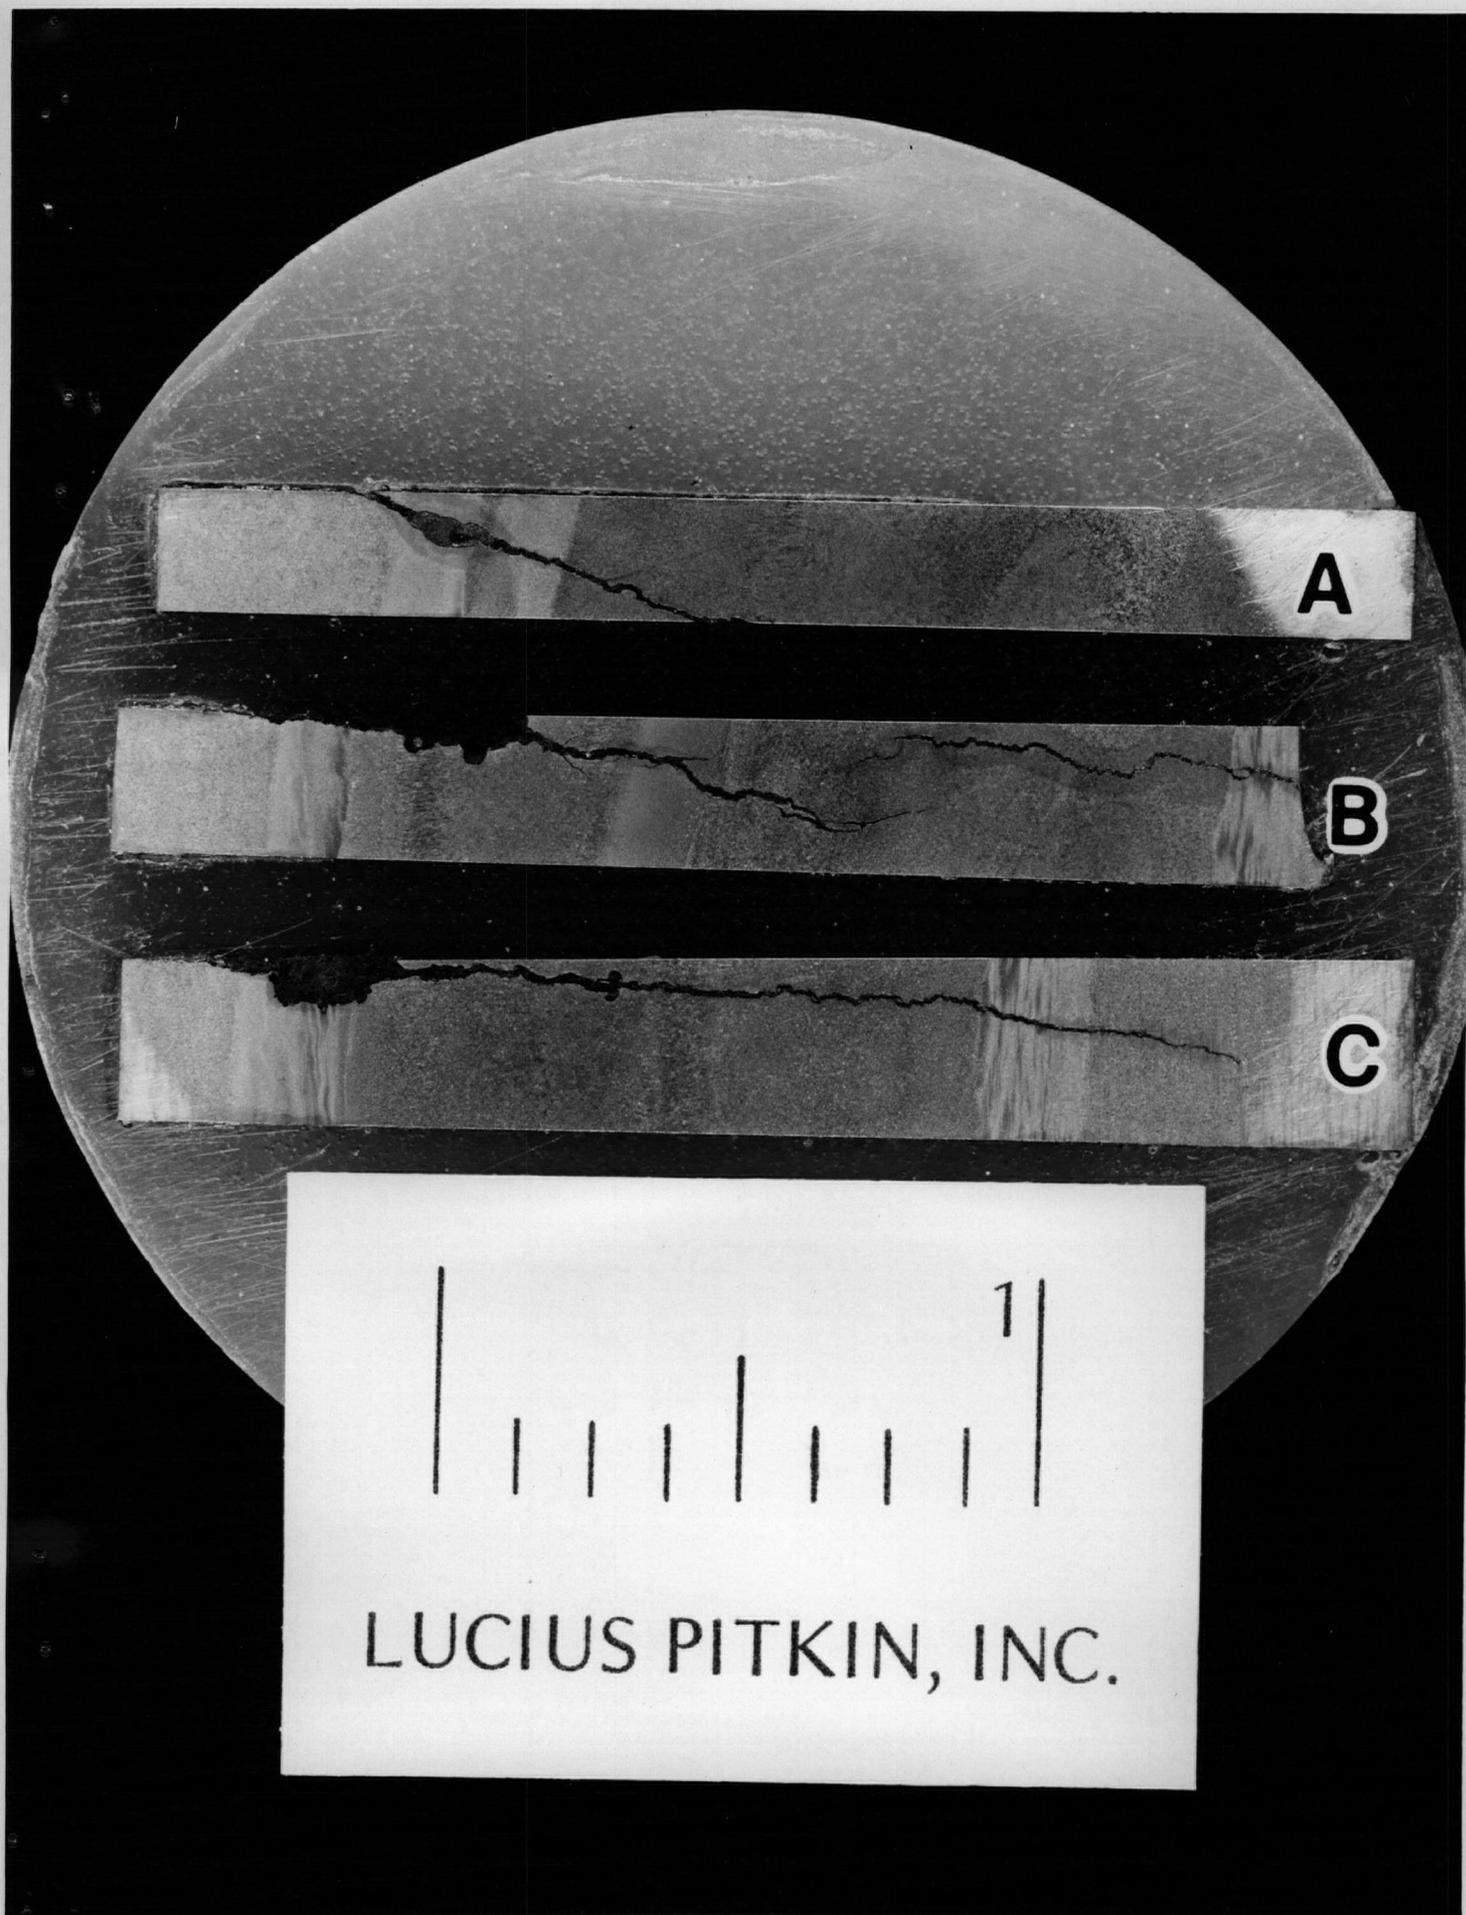
Fig. 43 PHOTOMACROGRAPH SHOWING VERTICALLY ORIENTED CRACK IN MICROSPECIMENS A THROUGH C

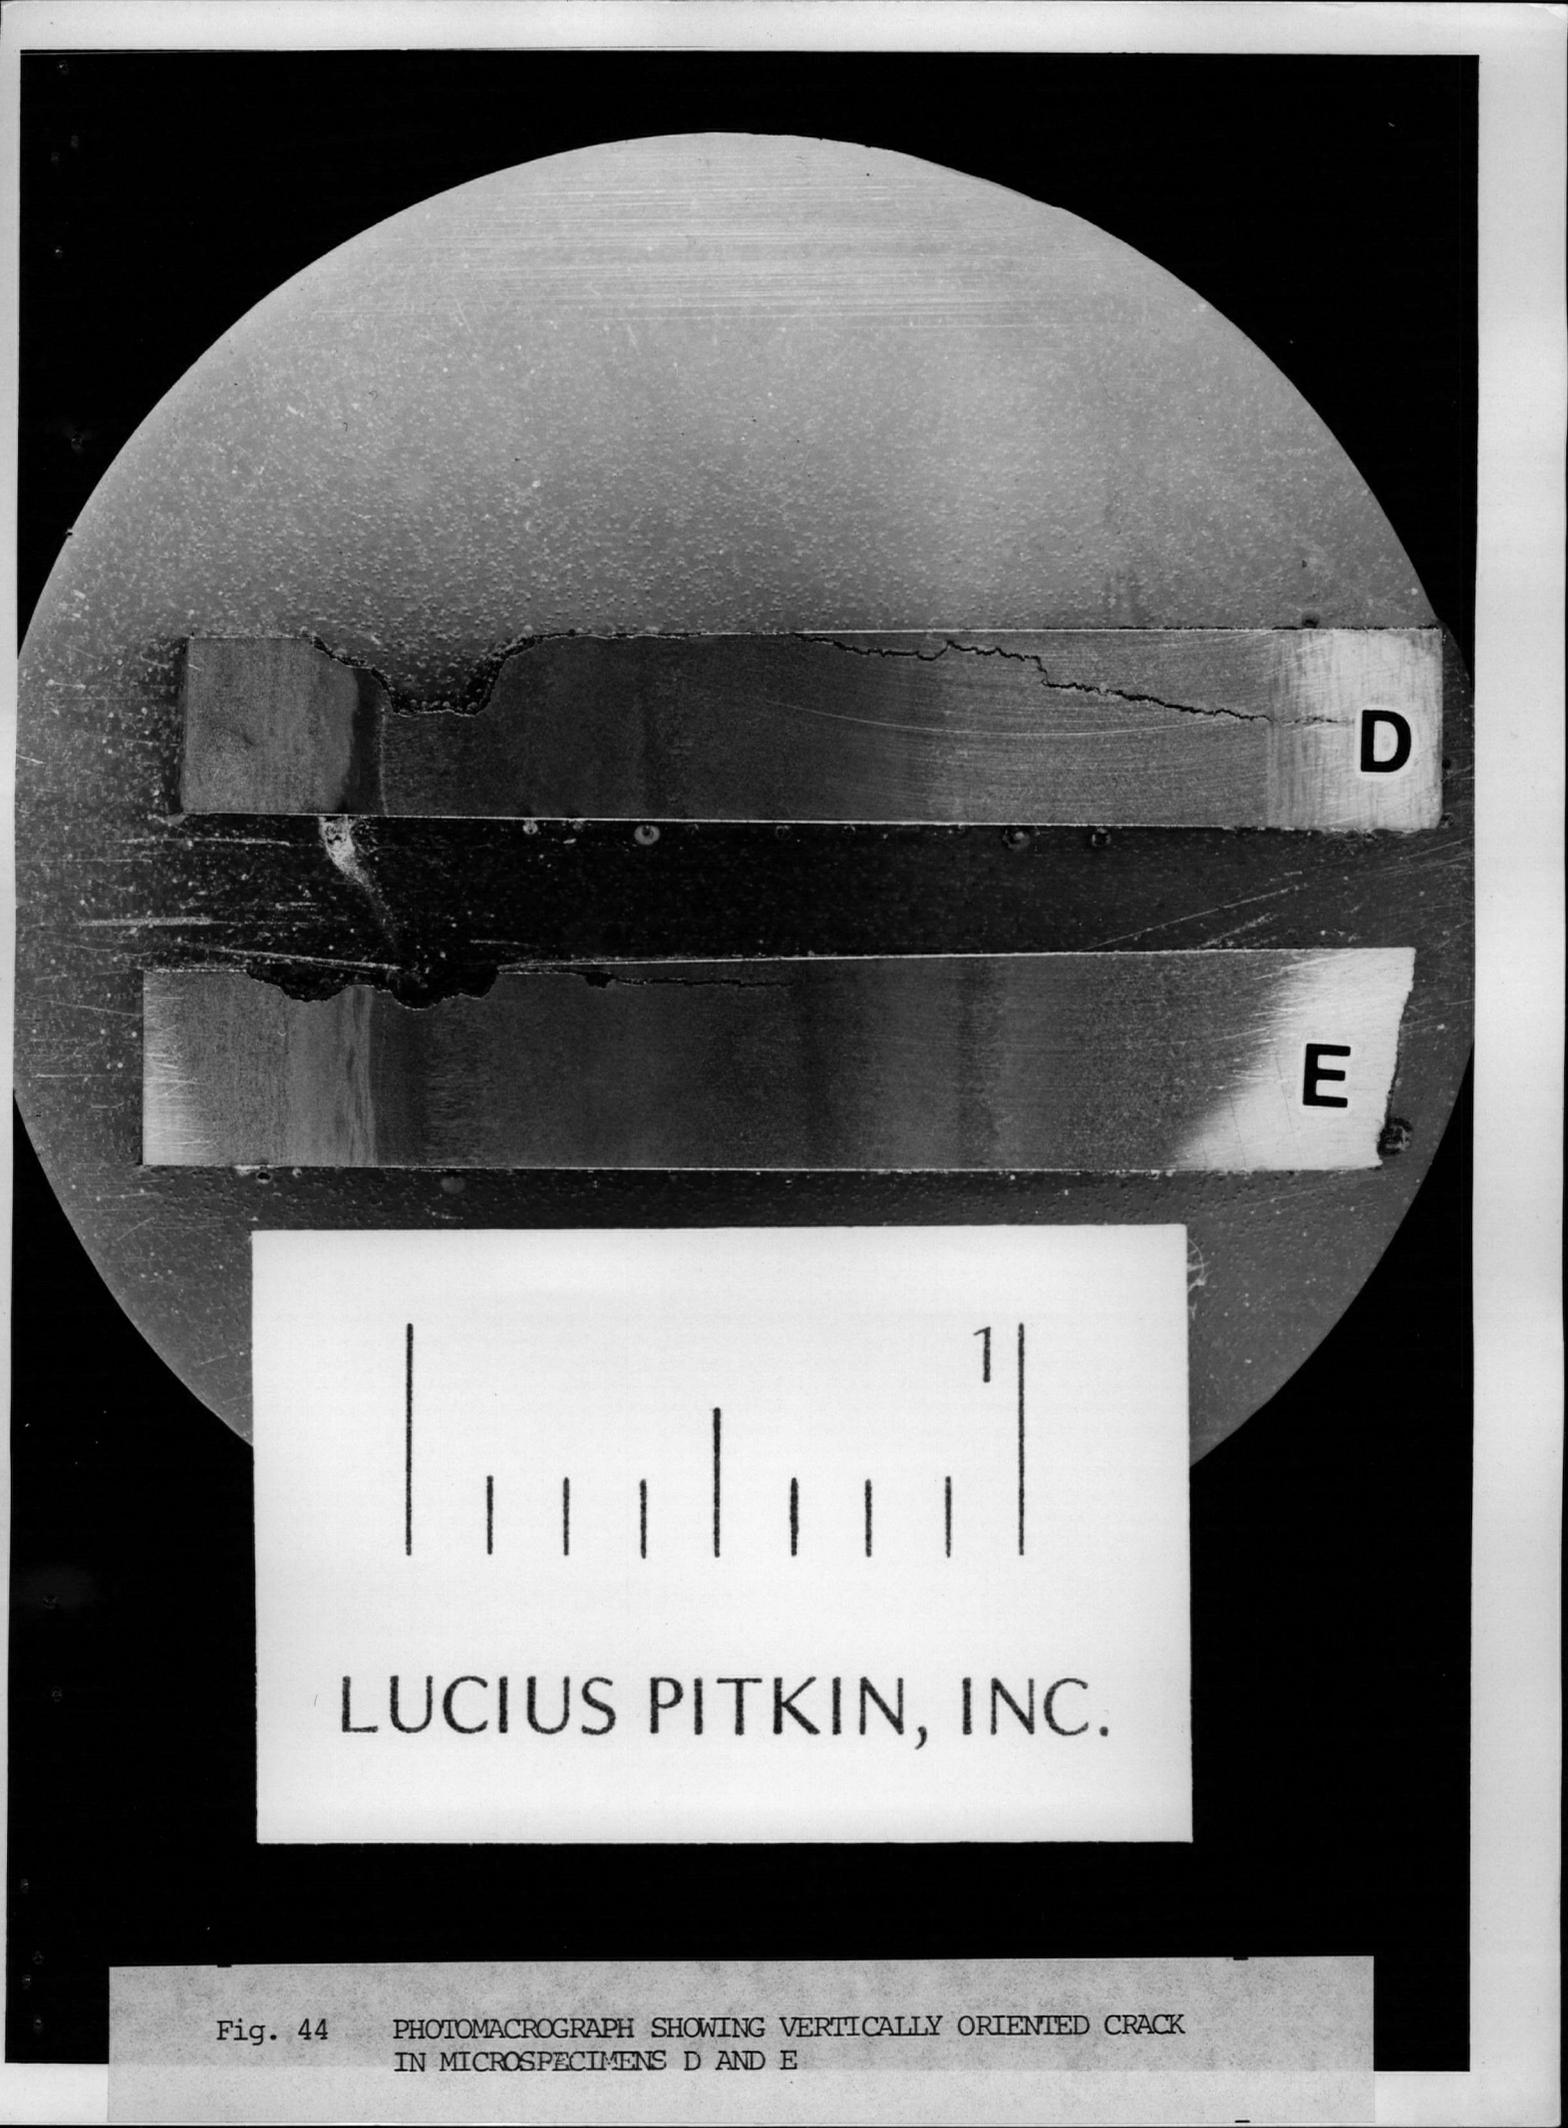
Fig. 44 PHOTOMACROGRAPH SHOWING VERTICALLY ORIENTED CRACK IN MICROSPECIMENS D AND E

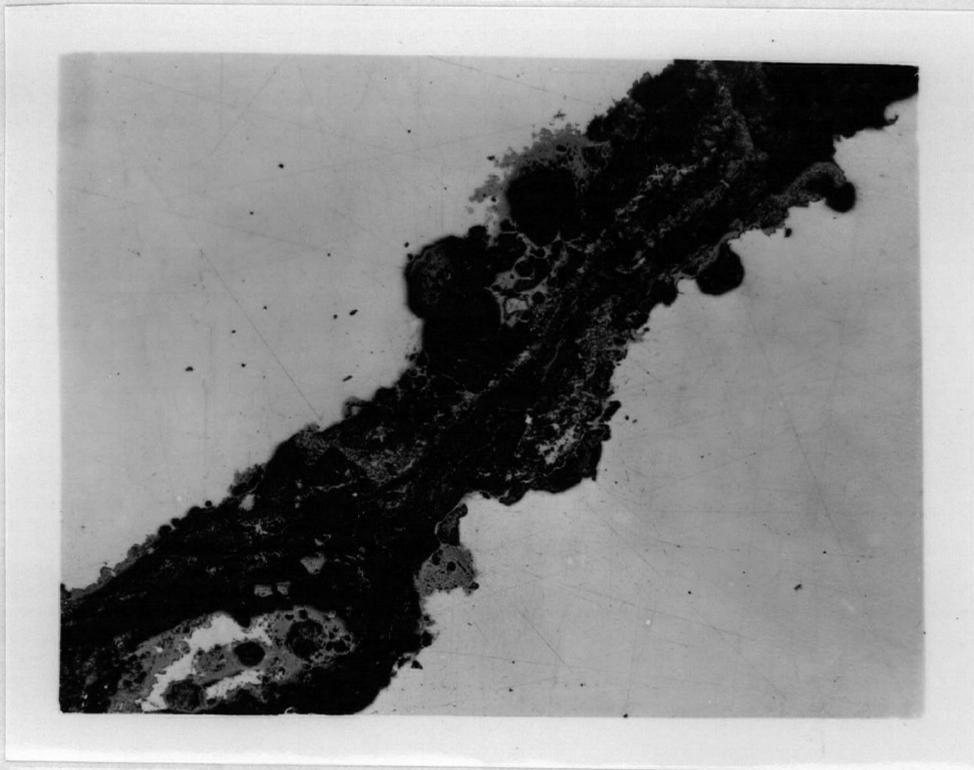
Fig. 45

Photomicrograph showing the oxide-filled vertically oriented through-wall crack. No evidence of weld defects such as slag or gross porosity is associated with the crack. The area shown here is from specimen B (Fig. 43).

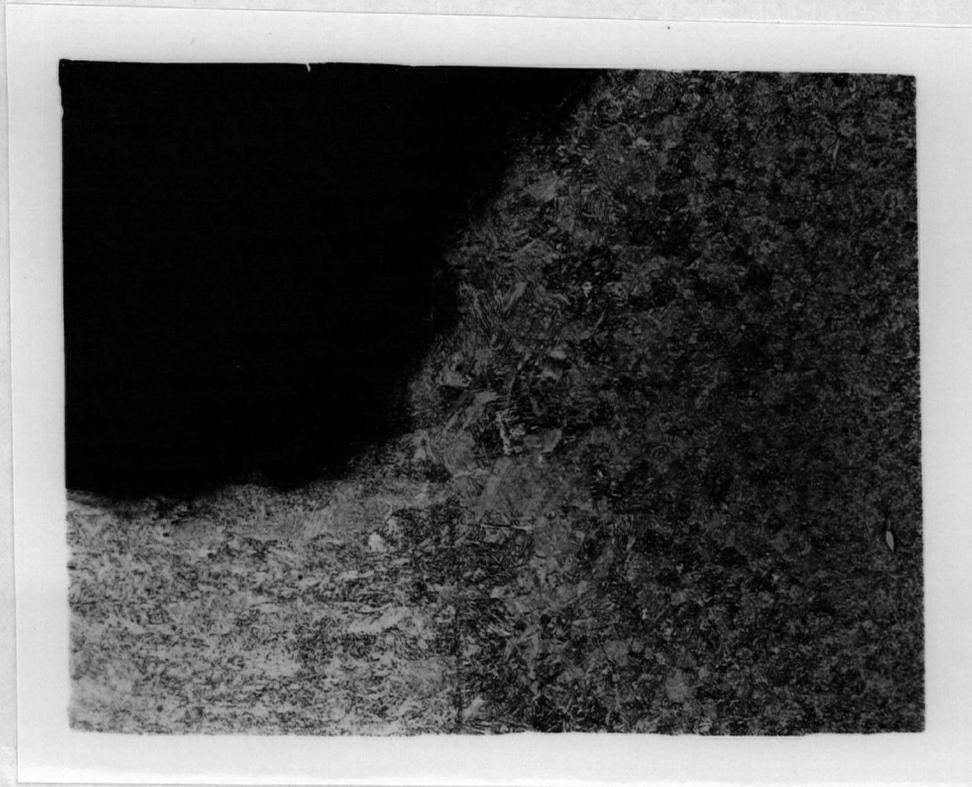
Fig. 46

Photomicrograph showing the vertically oriented through-wall crack in the area of upper shell/crown weld heat-affected zone. It can be seen that the crack profile is smooth and slightly eroded as would occur from steam/water escaping from the generator.
