9.0 Lakeview, Oregon, Disposal Site

The Lakeview, Oregon, Uranium Mill Tailings Radiation Control Act (UMTRCA) Title I Disposal Site, inspected on July 14 and 15, 2009, was in good condition. No cause for a follow-up or contingency inspection was identified.

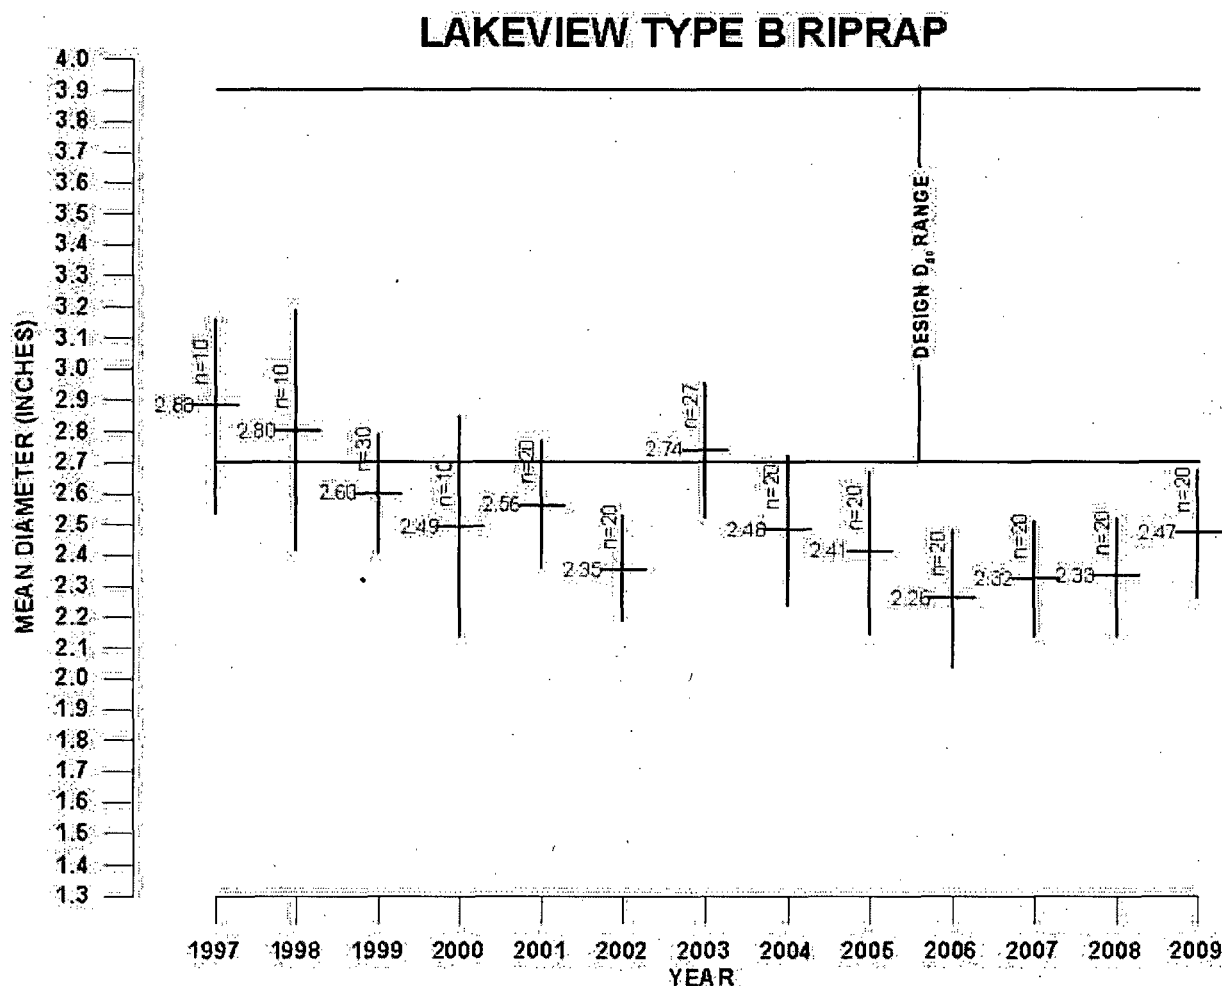
Figure 9-2. Side Slope Riprap Size Monitoring Results for the Lakeview Disposal Site

DOE initiated annual riprap gradation monitoring of the west side slope in 1997. Addendums to the Lakeview LTSP require that DOE annually determine the D_{50} value of the west side slope riprap to ensure that it is large enough to protect the disposal cell from a major precipitation event. Gradation monitoring was performed for the 13th consecutive year. An additional sieve size (less than 1 inch) was added to the procedure during this monitoring. Sampling locations are randomly selected prior to each monitoring event. Particle size distribution by count data was collected at 20 locations where 25 rocks are sampled. An evaluation of the rock size measurement data indicates that the side slope riprap D_{50} is 2.47 inches with a 95 percent confidence interval between 2.27 and 2.67 inches (Figure 9–2). The results of the 2009 gradation monitoring are provided as Appendix A. The 2009 D_{50} value is 0.14 inch greater than the value of 2.33 inches measured during monitoring in 2008. The 2008 result basically replicated the 2007 result of 2.32 inches, which was greater than the 2006 result of 2.26 inches. These D_{50} values show an upward trend since 2006, which may indicate that the degradation rate of the riprap has slowed in recent years. Prior results, from 1997 through 2006, indicated a gradual overall decrease in the cover rock D_{50} size by about 20 percent. Ongoing inspections of the north side slope riprap continue to support the determination that although rock degradation is occurring in this area, it is not nearly as prevalent as that which is occurring on the west side slope.

As specified in the Lakeview LTSP, the original cell design required a D_{50} design range envelope of 2.7 to 3.9 inches for Type B side slope riprap gradation to ensure that the cell is protected from erosion. Because the D_{50} value is below this size, DOE is currently considering D_{50} recalculations using more current site information and other options to ensure that the side slope riprap is of adequate size and durability to provide long-term erosion protection for the cell.

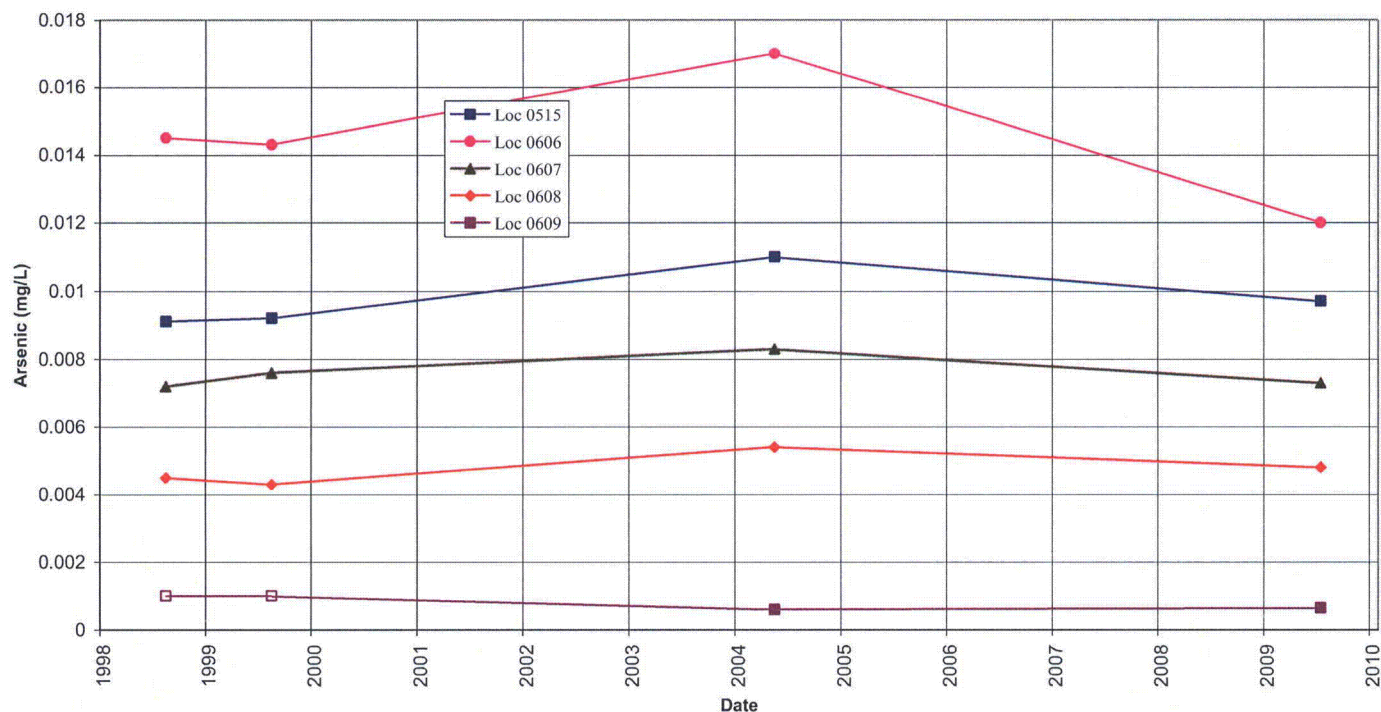
Figure 9-3. Time-Concentration Plot of Arsenic in Groundwater at the Lakeview Disposal Site

range, and either decreased or remained stable, as shown on the time-concentration plot in Figure 9-3. Cadmium concentrations decreased slightly in MW-0515 and remained undetected at the method detection limit in the other wells (Figure 9-4). Uranium concentrations increased slightly in all five wells but remained within the historical range (Figure 9-5). Based on the monitoring results to date, there is no indication of any degradation of groundwater near the site. The next cell performance monitoring is scheduled for 2014.

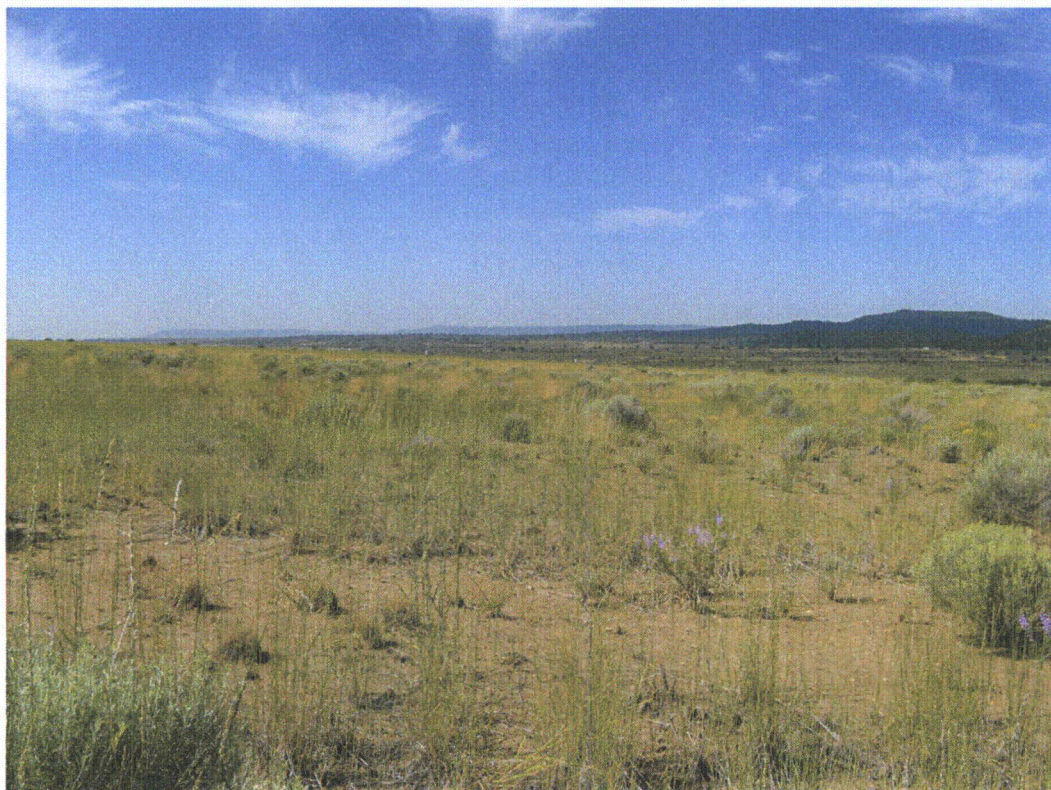
Top of the Disposal Cell—At the time of cell construction, the entire cell top slope was covered in 12 inches of Type A riprap followed by 4 inches of soil placed over the riprap. The soil was included to allow for a grass cover to be established, which would help minimize the visual impacts of the cell. Grasses and forbs growing on the top of the disposal cell have gradually increased over the years, and patches of deeper-rooted wheatgrasses have spread. The design for the top of the disposal cell has created conditions that favor the growth of deep-rooted plants. The growth of shrubs is favored by the movement of precipitation through the riprap, bedding, and compacted soil (radon barrier) layers. Many mature rabbitbrush, sagebrush, and bitterbrush plants continue to spread on top of the disposal cell. Some sparsely vegetated to bare areas still exist on top of the disposal cell, but to a lesser extent than was observed during last year's inspection. PL-1 shows the vegetative cover. Some small animal tracks were observed on the top cover.

LKV 7/2009. PL-1. View south across the disposal cell top, showing vegetative cover.

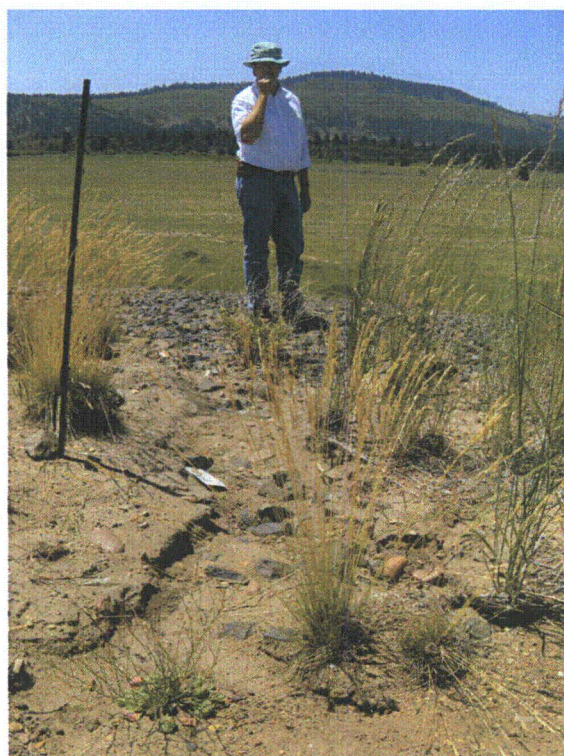
The contact boundary between the cell top and side slopes was inspected. No evidence of erosion was observed along the north contact; however, approximately 25 areas with minor erosion rills were observed in the top slope soil cover along the west contact. The largest of the minor rills (PL-2) was measured and had maximum dimensions of 11 inches long, 20 inches wide, and 4 inches deep. Dispersed soil was deposited as delta formations in the rock riprap adjacent to where the rill channels entered the side slope, showing how the water contacted the rock and became dispersed and expanded. The largest delta was approximately 52 inches long. These delta formations indicate that flow channelization does not occur when runoff water enters the side slope. The riprap rock cover is present beneath the top slope soil cover and under the slope crest, and continues as the side slope. No structural or cell performance concerns are associated with the rills, but they will continue to be evaluated during annual inspections.

LKV 7/2009. PL-2. Minor erosion rills at contact between the top cover and west side slope.

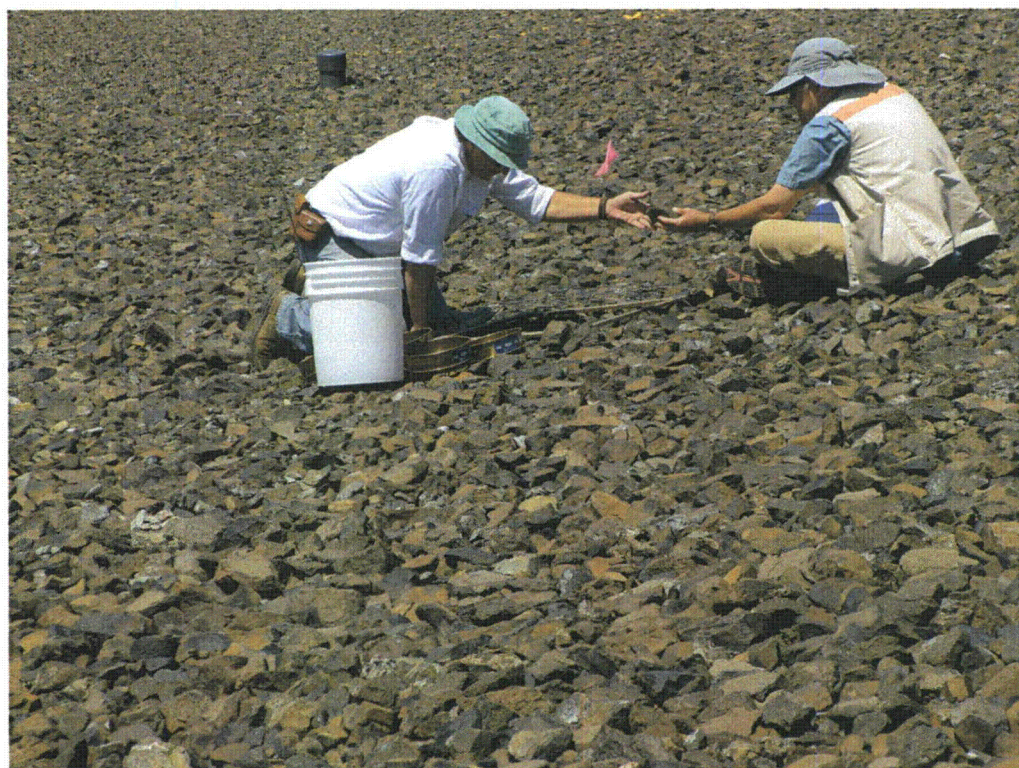
DOE initiated annual rock durability monitoring during the 2009 inspection using a draft procedure that NRC reviewed. The durability monitoring was conducted in conjunction with the gradation monitoring, using the same rocks. After a rock's size was determined, the rock was handed to the geologist/mineralogist for rock type identification (PL-4). The associated durability class code was then recorded under the appropriate rock size column for that sample location. It should be noted that these general durability classes were assigned by a geologist/mineralogist's examination of the rocks and are not based on laboratory durability testing standards.

LKV 7/2009. PL-4. Inspectors conducting rock gradation and durability monitoring.

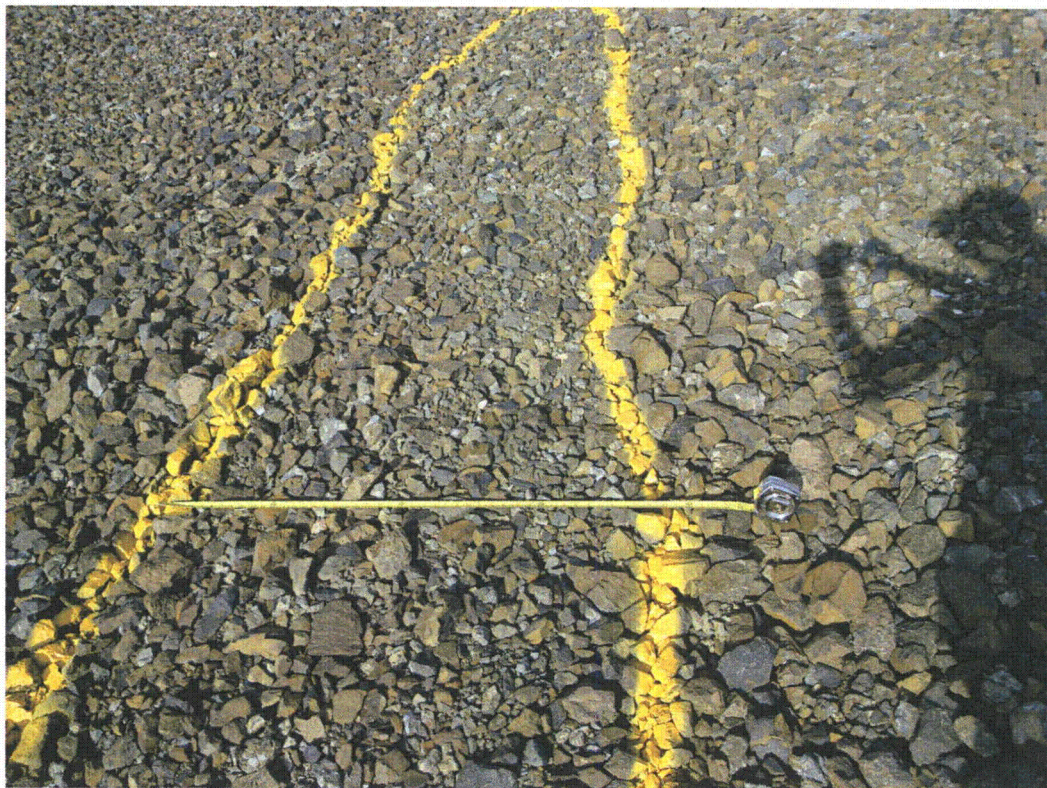
LKV 7/2009. PL-6. "Streak" area with smaller-sized rocks on west side slope.

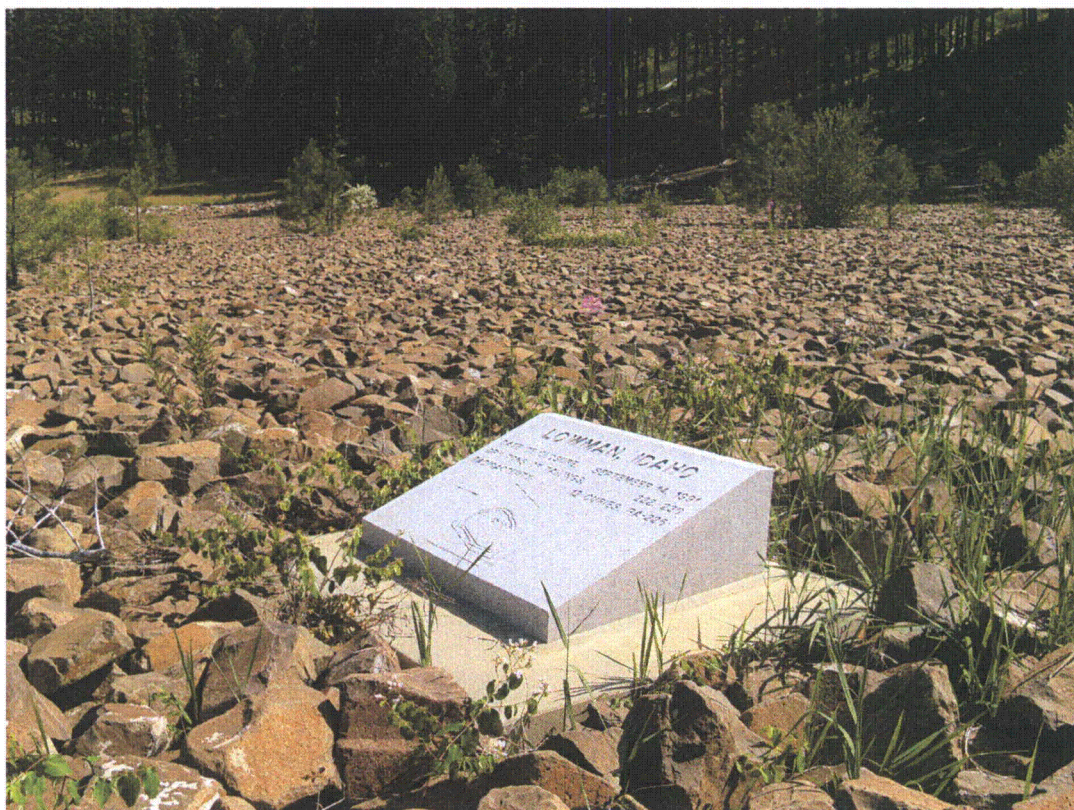
Site Markers and Monuments—There are two site markers (PL-1), four boundary monuments, and three combination survey/boundary monuments. All were in excellent condition.

LOW 7/2009. PL-1. Site marker SMK-2 on the disposal cell cover.

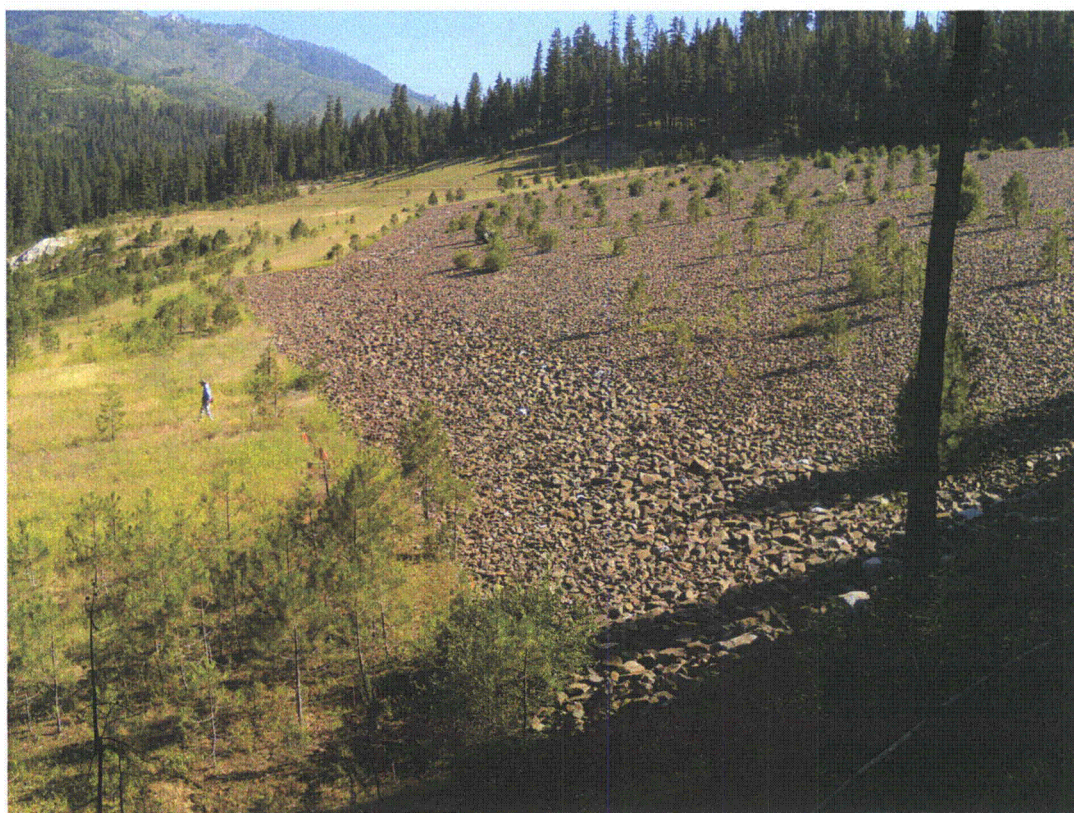
Top and Side Slope of the Disposal Cell—The 8-acre disposal cell was completed in 1991. Basalt riprap armors the top and west-facing side slope of the disposal cell. An apron of larger riprap surrounds the disposal cell on all sides. The riprap was in excellent condition, and no evidence of instability, such as subsidence, slumping, or cracking, was observed on any of the cell surfaces (PL-2).

LOW 7/2009. PL-2. West slope and apron of the disposal cell.

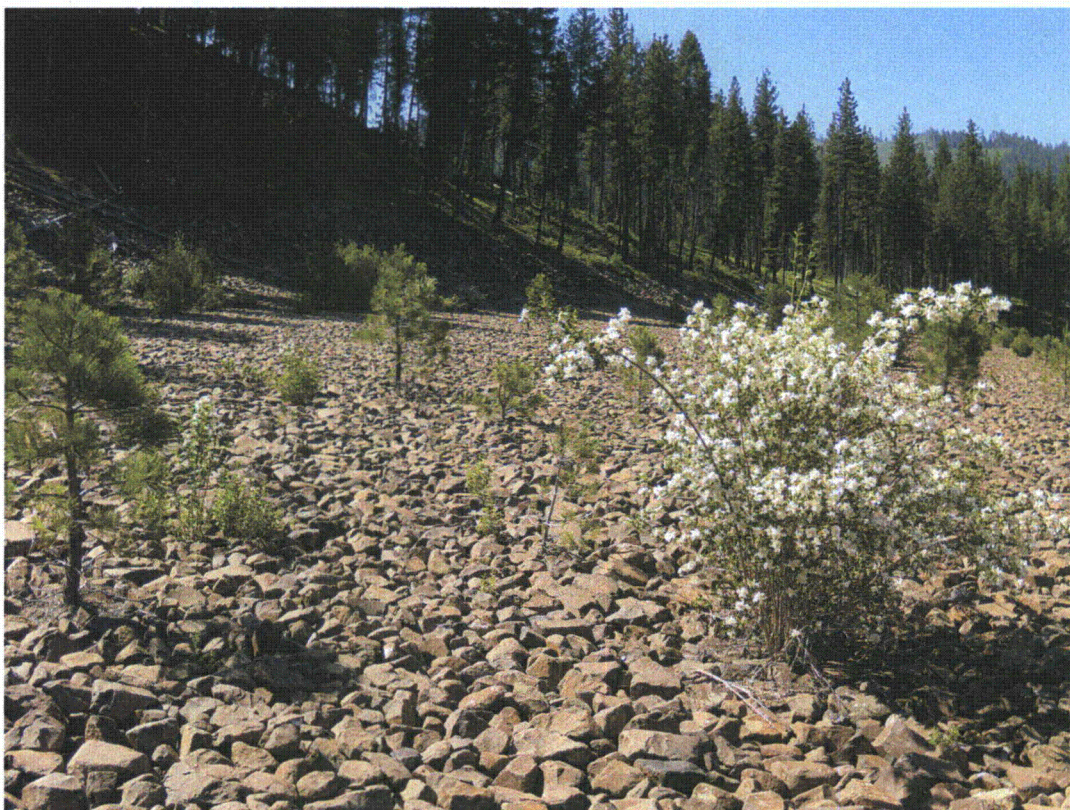
Vegetation encroachment by tree, shrub, and wildflower species continues on the top and side slopes of the disposal cell (PL-3). Encroachment is a natural process operating at this location and will be allowed to continue in accordance with the LTSP. Although DOE is not required to remove ponderosa pine trees as they mature, the LTSP states that DOE will repair any damage that occurs to the riprap cover and underlying cover layers caused by blowdown or other processes to maintain protection from erosion and possible consequent dispersion of cell contents. The largest ponderosa pine trees on the cover are now approximately 10 feet tall.

LOW 7/2009. PL-3. Vegetation on the disposal cell cover.

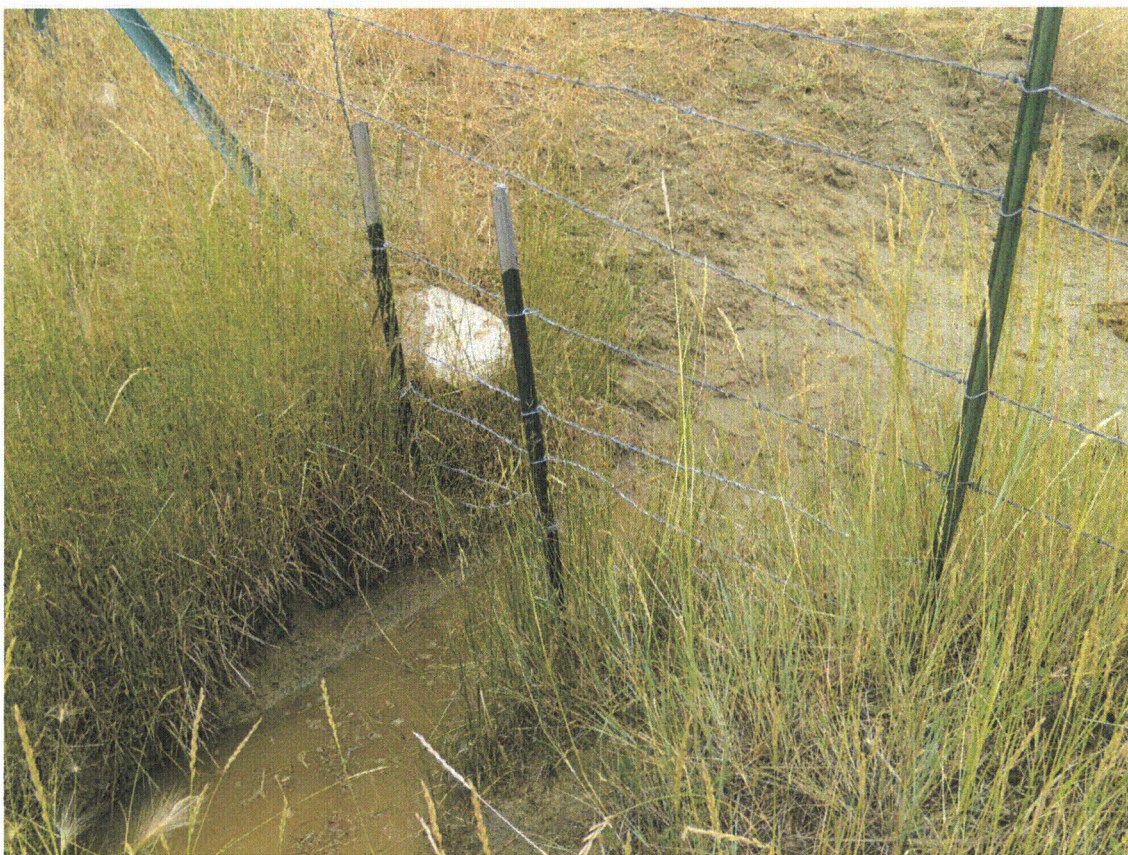
MAY 8/2009. PL-1. Fence repairs to close the gap at the outlet of Gully No. 1.

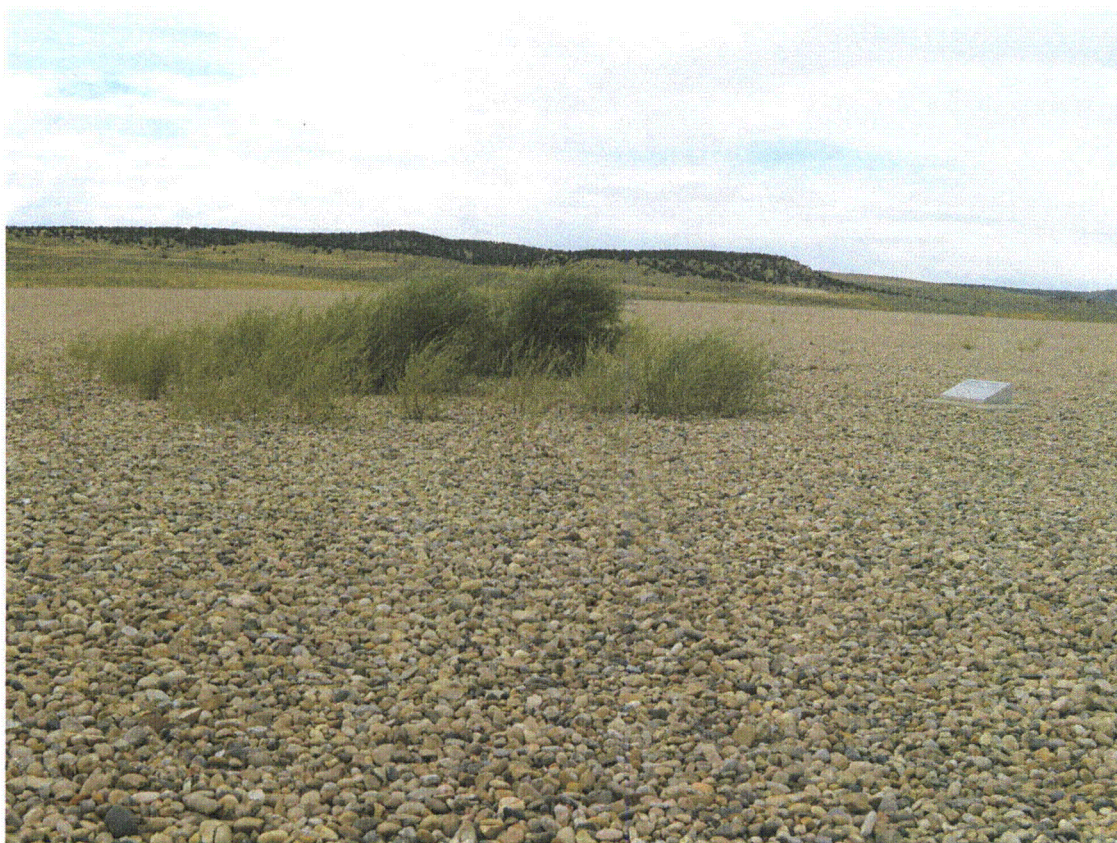
MAY 8/2009. PL-4. Willows on the disposal cell top adjacent to site marker SMK-2.

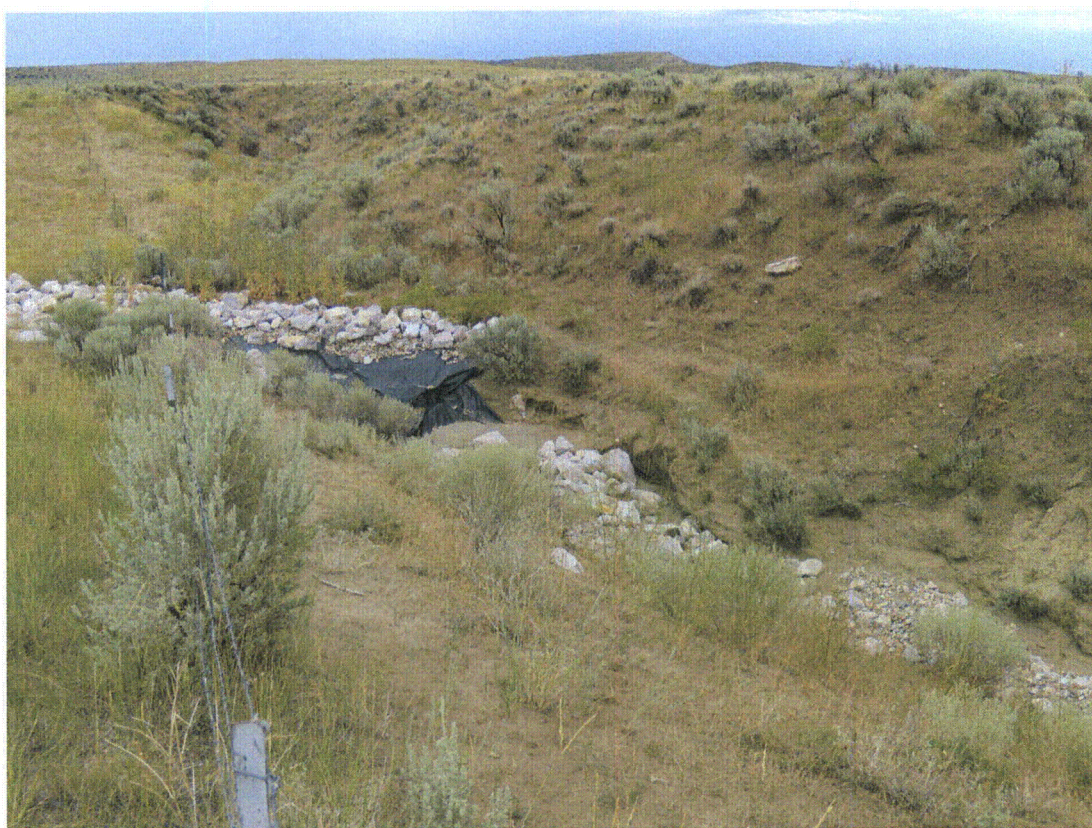
MAY 8/2009. PL-6. Washout riprap at the outlet of Swale No. 1.

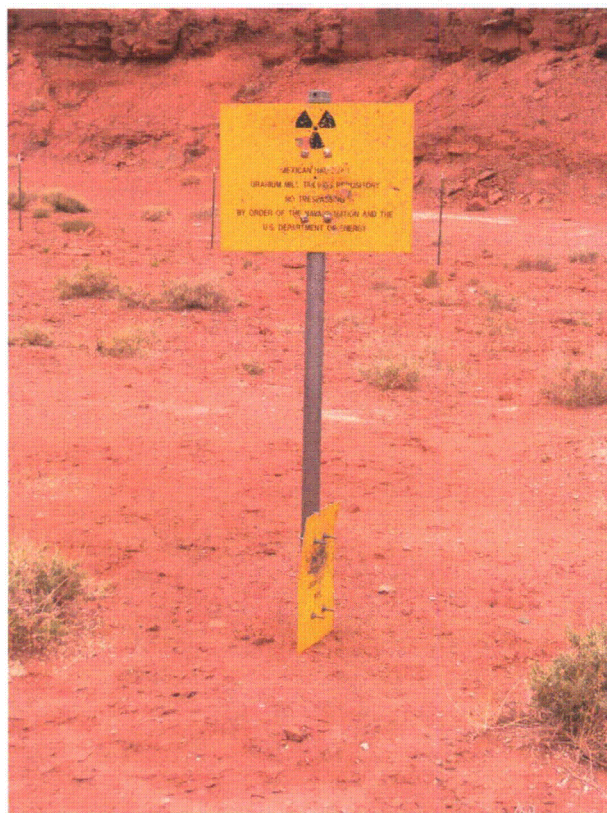
HAT 4/2009. PL-1. Damaged perimeter sign P23.

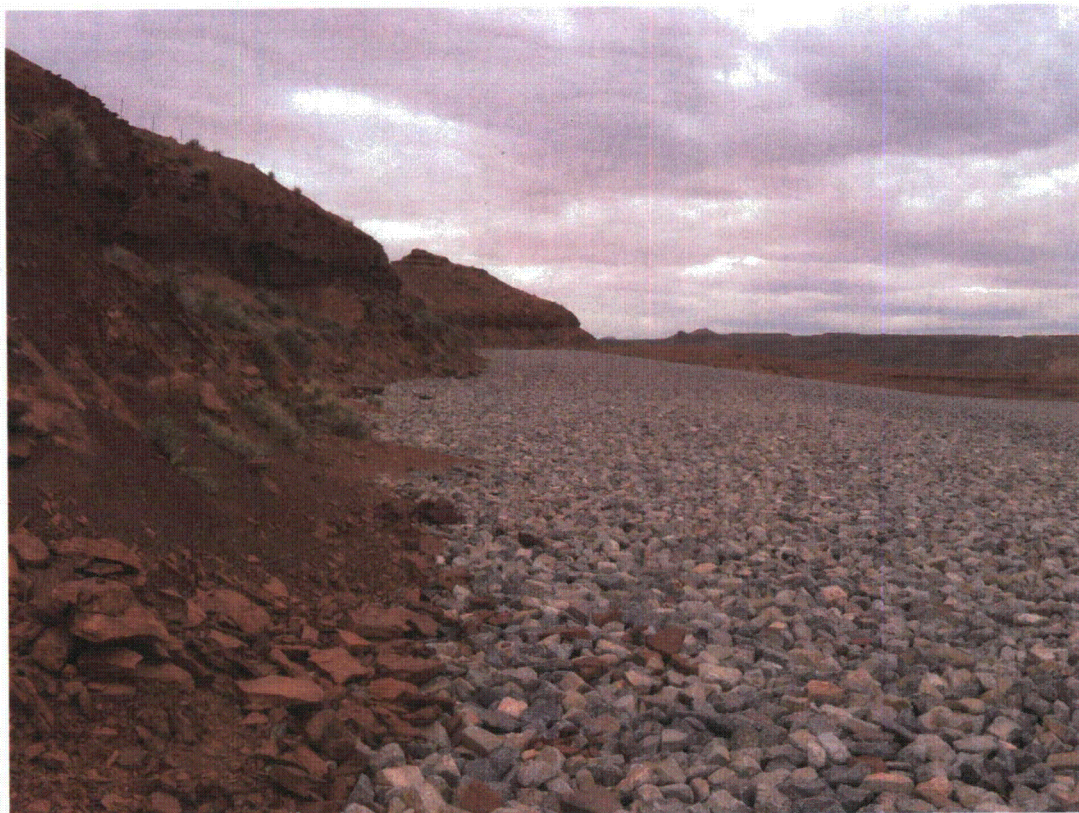
HAT 4/2009. PL-4. Erosion of rock and soil onto the riprap apron all along this section.

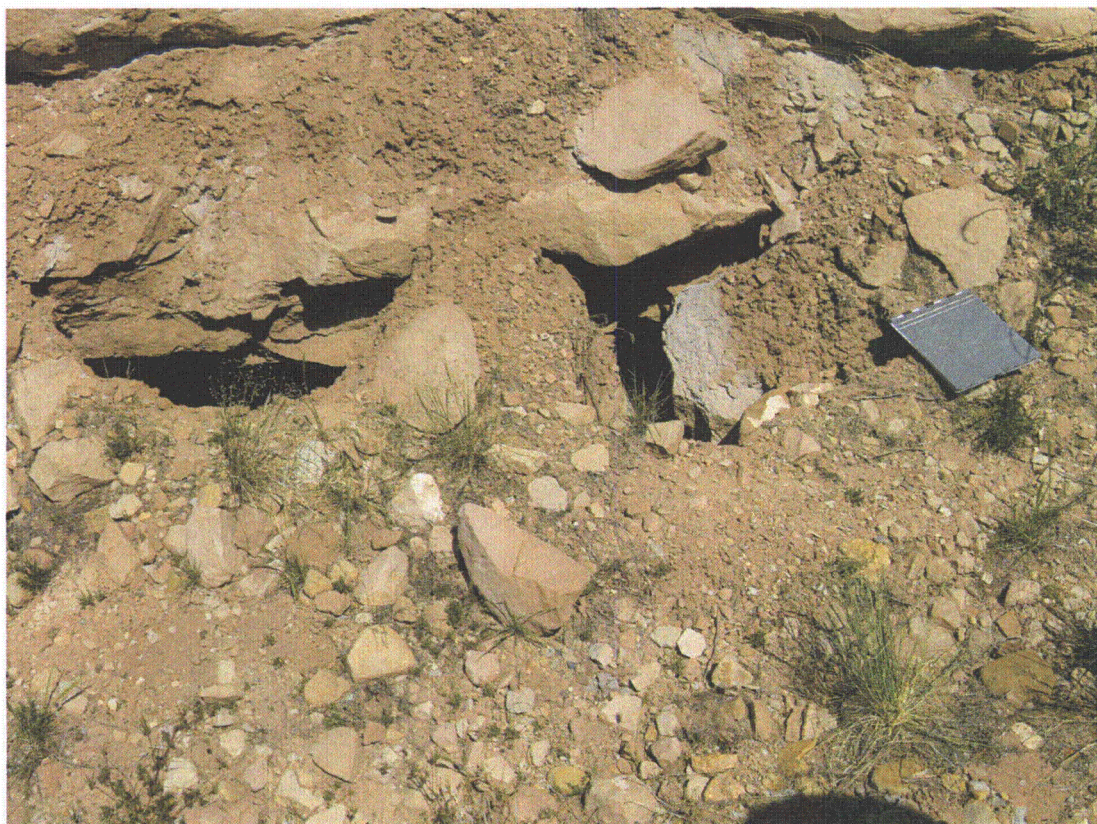
NAD 5/2009. PL-1. Erosion along west side of lower access road (repaired in August 2009).

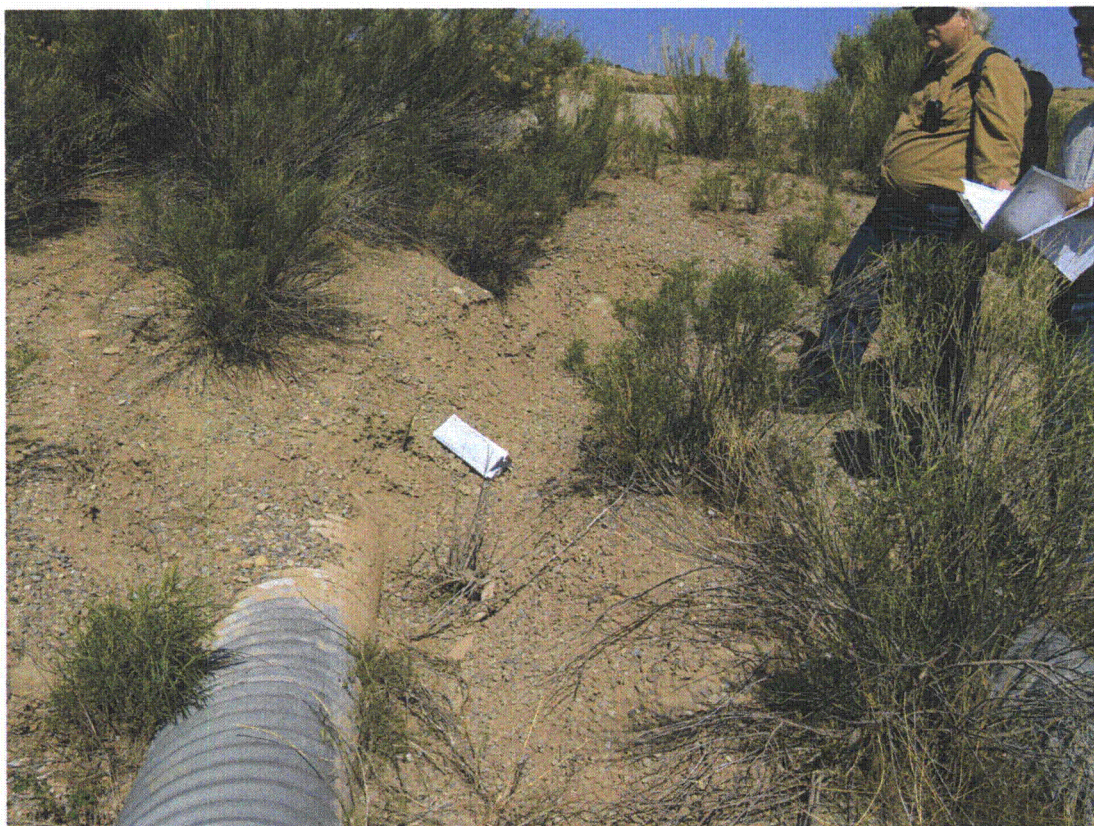
NAD 5/2009. PL-3. View of gullies developing along culverts under the county road.

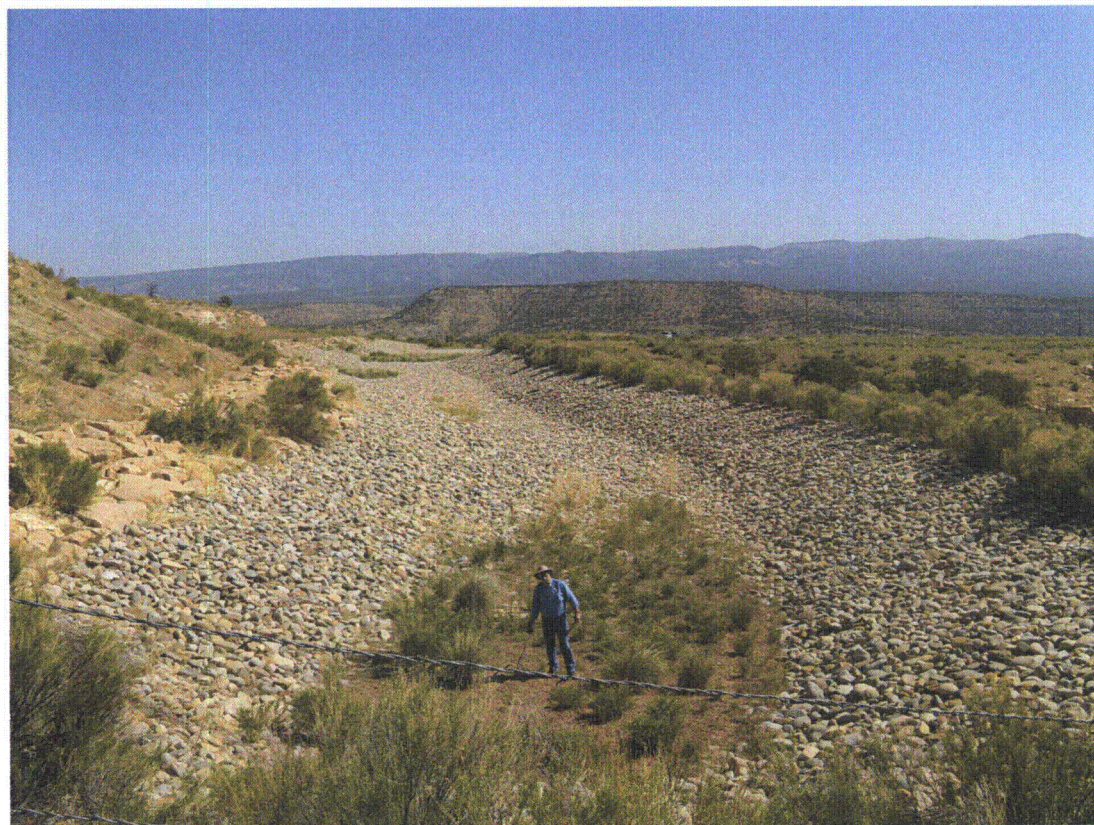
NAD 5/2009. PL-4. Sediment deposition in interceptor channel; small tamarisk/knapweed in center.

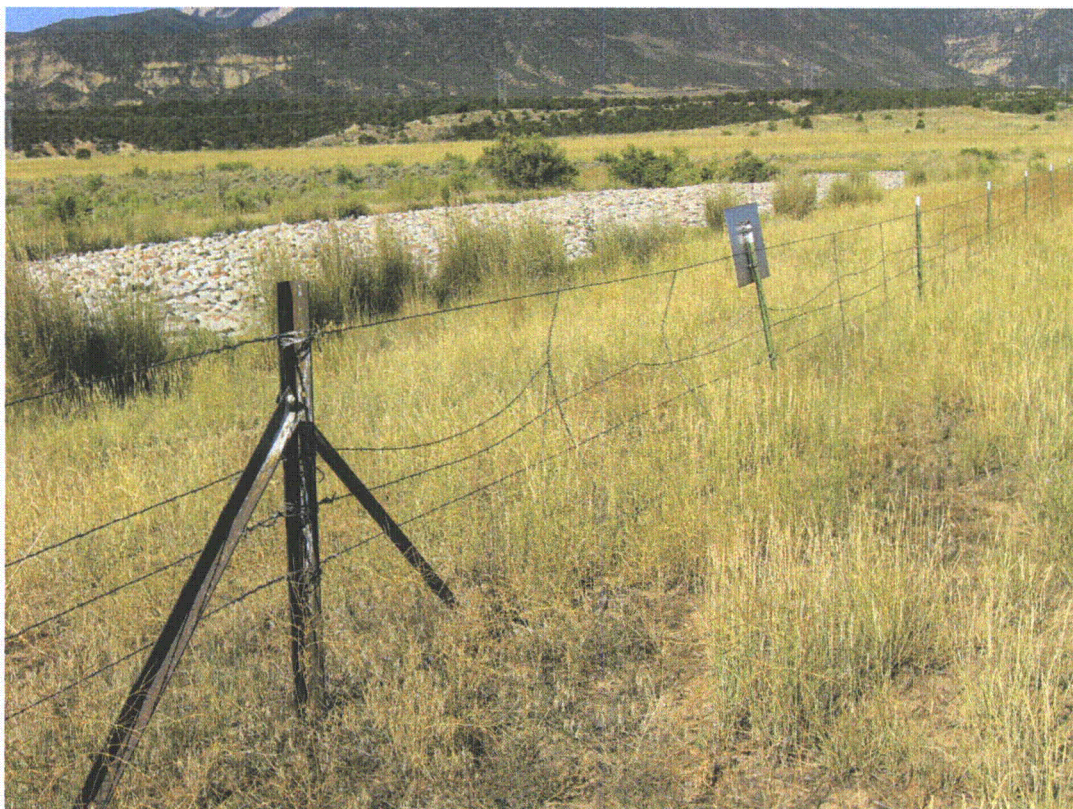
RFL 8/2009. PL-1. Broken wire strand in the south fence.

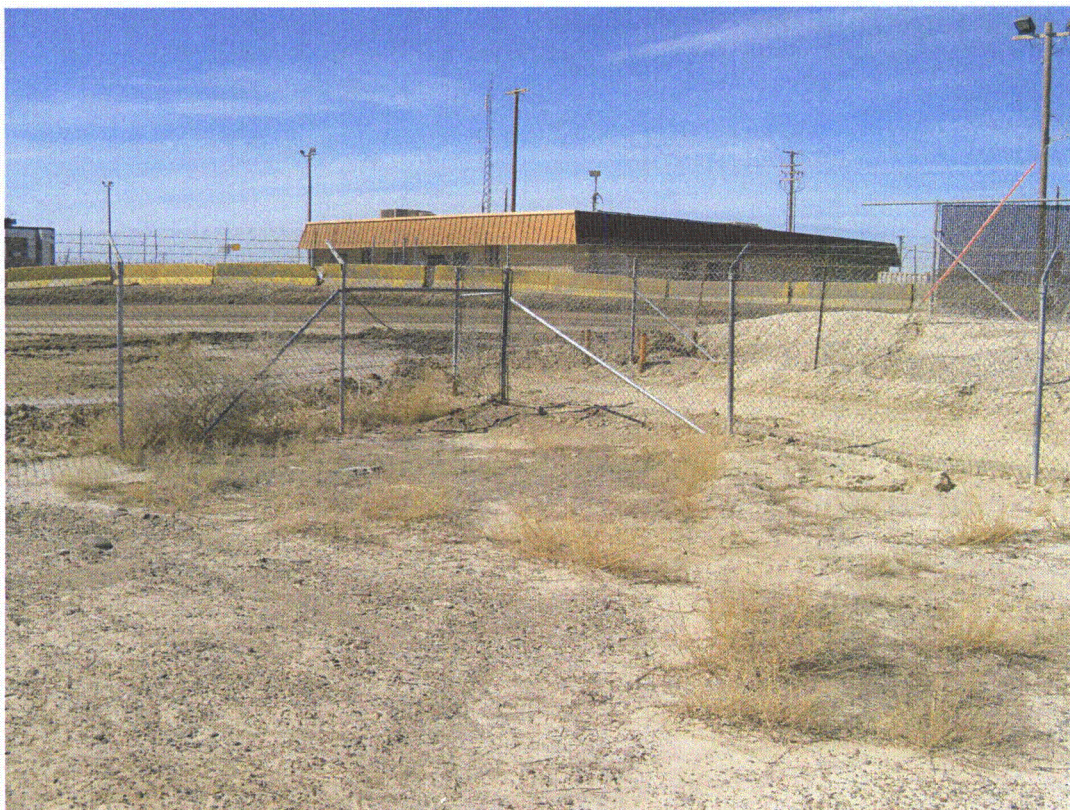
SLC 4/2009. PL-1. Repaired fence in the northwest corner of the site.

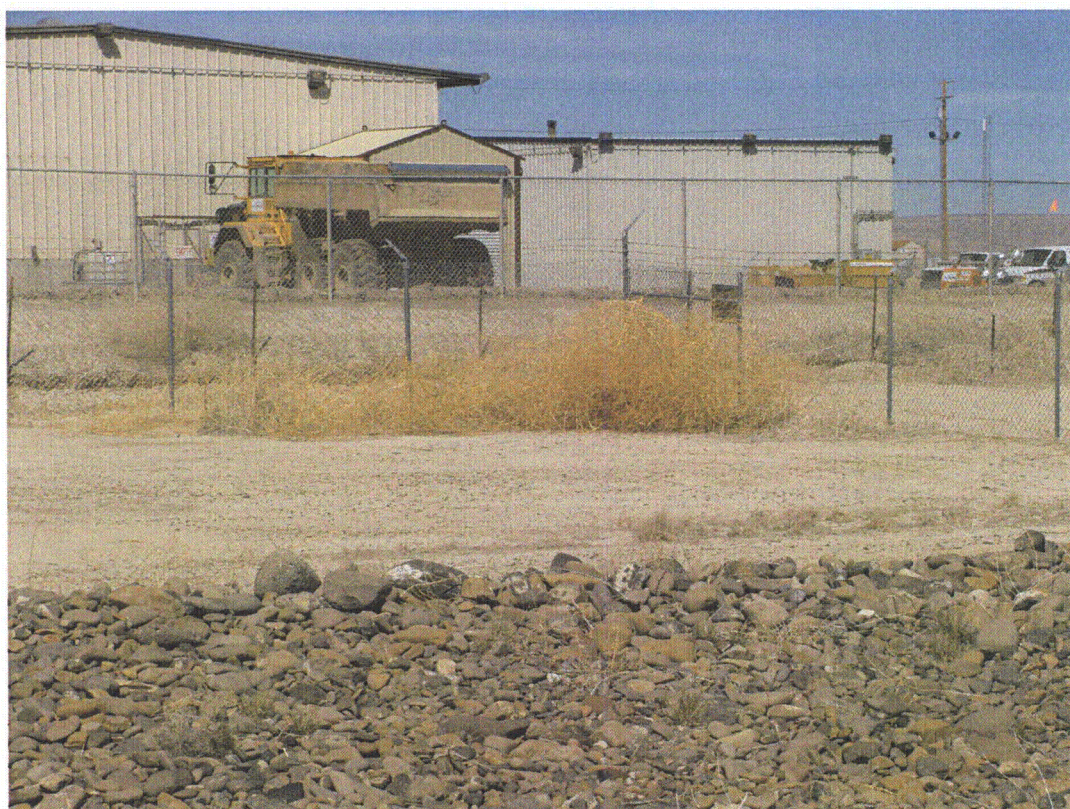
- 15A Tumbleweeds were found to have accumulated against the fence in the northeast corner (PL-2); as per follow up correspondence with EnergySolutions the tumbleweeds had been removed.

SLC 4/2009. PL-2 Tumbleweed accumulation within the inner northeast fence corner.

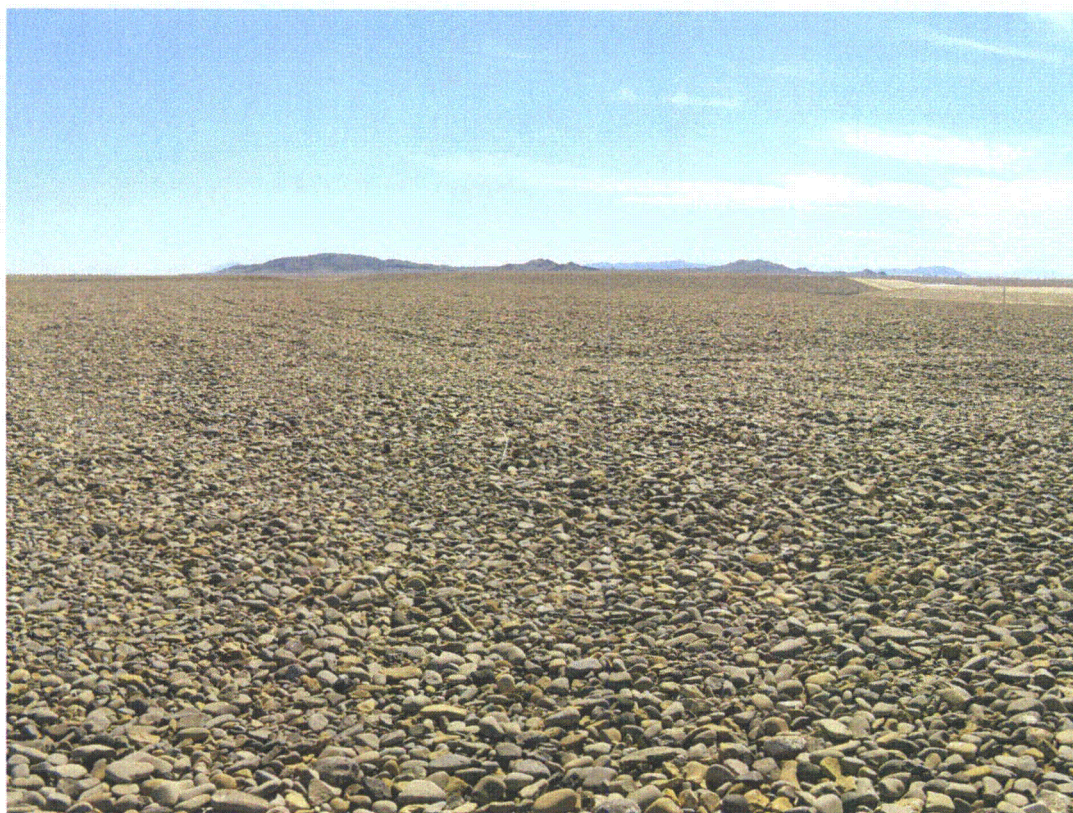
SLC 4/2009. PL-4. Slight depressions southwest of site marker SMK-2 on the disposal cell top.

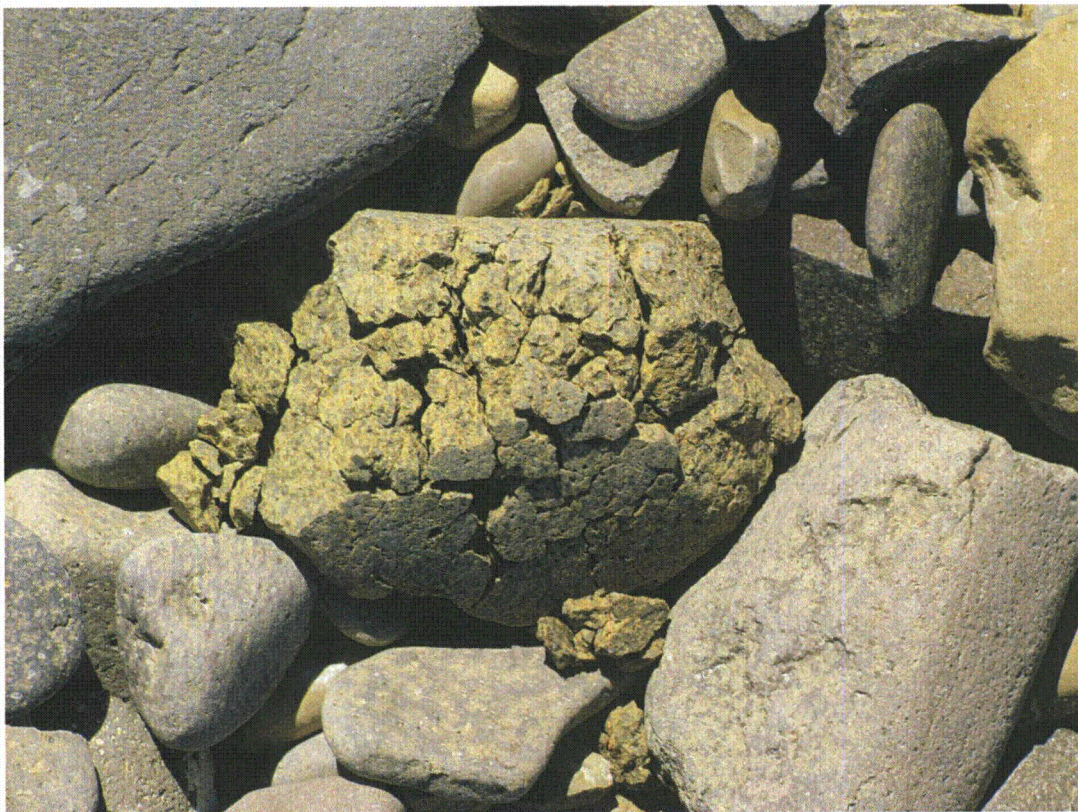
SLC 4/2009. PL-5. Weathering riprap on the disposal cell.

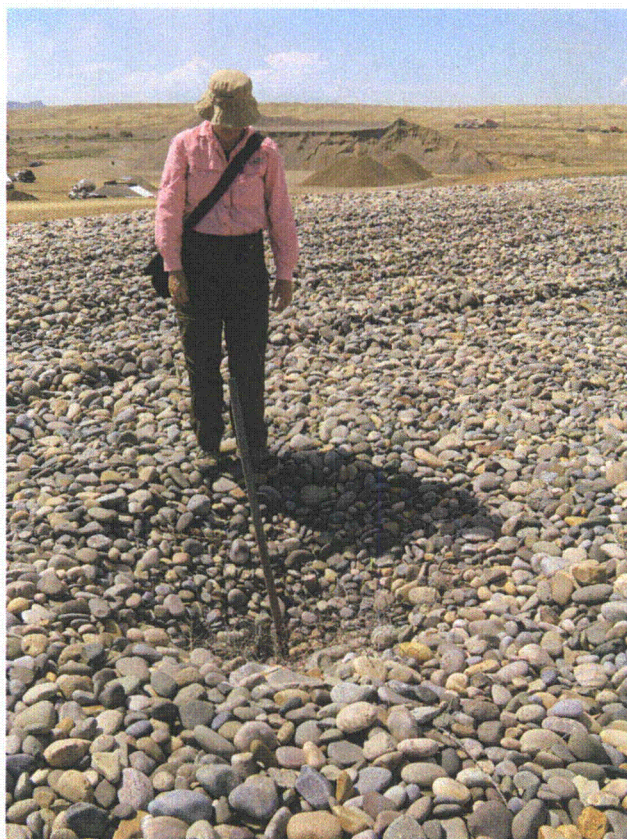
SHP 5/09. PL-1. Conical depression found on top of the disposal cell.

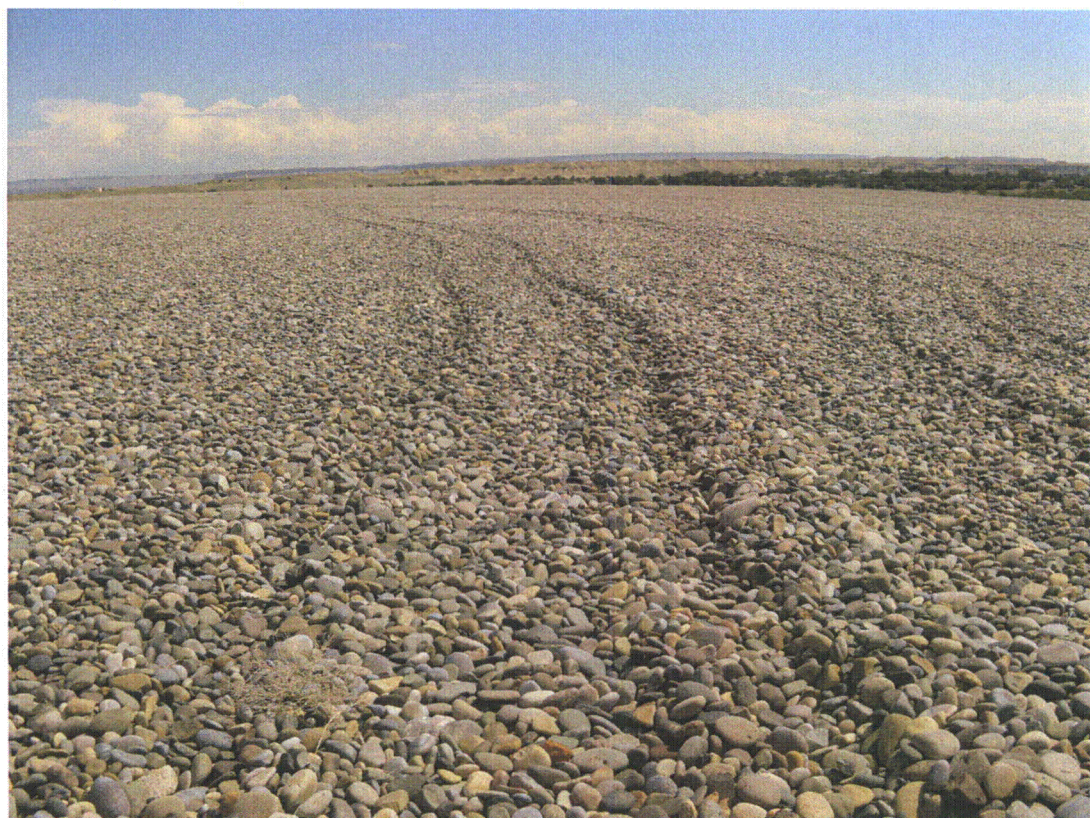
SHP 5/09. PL-2. Vehicle ruts on the surface of the disposal cell.
