9.0 Lakeview, Oregon, Disposal Site

The Lakeview, Oregon, Uranium Mill Tailings Radiation Control Act (UMTRCA) Title I Disposal Site, inspected on July 14 and 15, 2009, was in good condition. No cause for a follow-up or contingency inspection was identified.

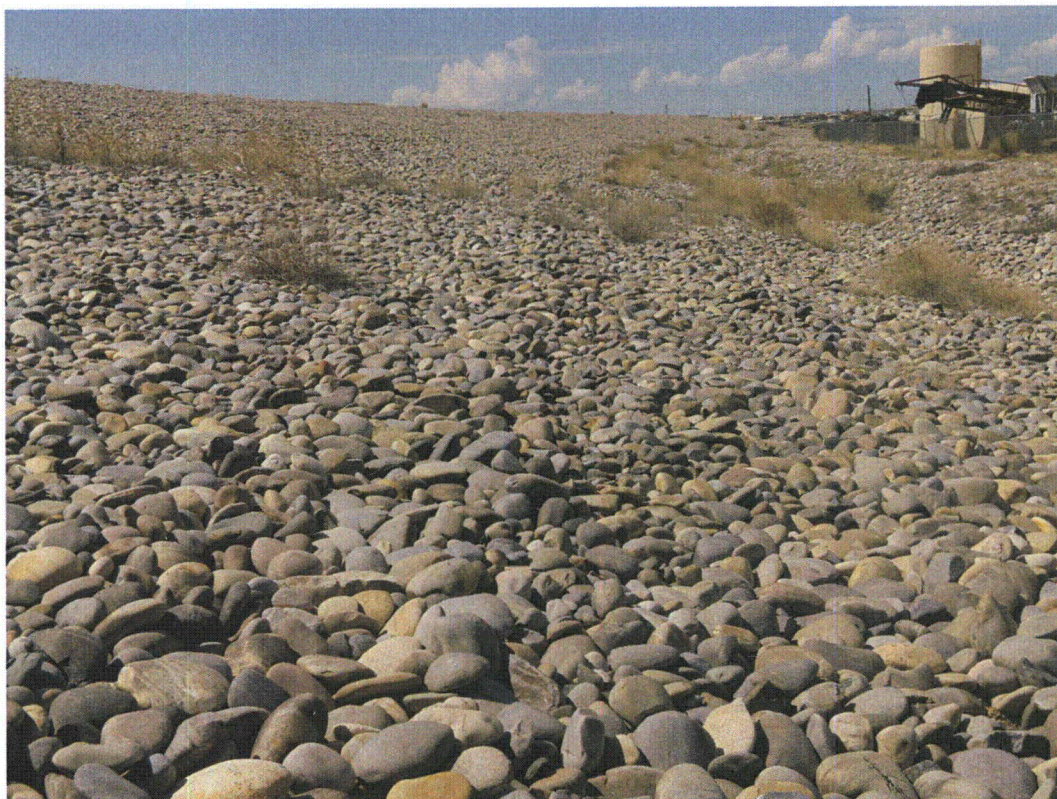
SHP 5/09. PL-3. Dead vegetation on the disposal cell slopes and drainage channel.

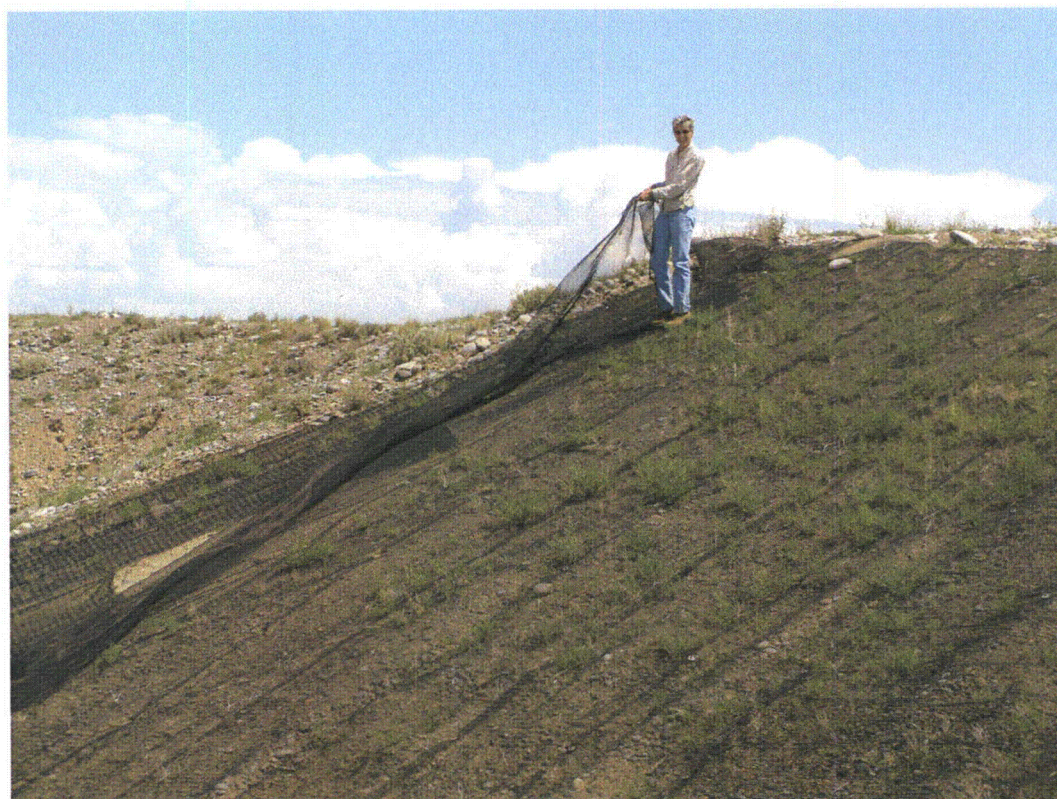
SHP 5/09. PL-4. Loose erosion fabric on the slope of the hill above the outflow channel.

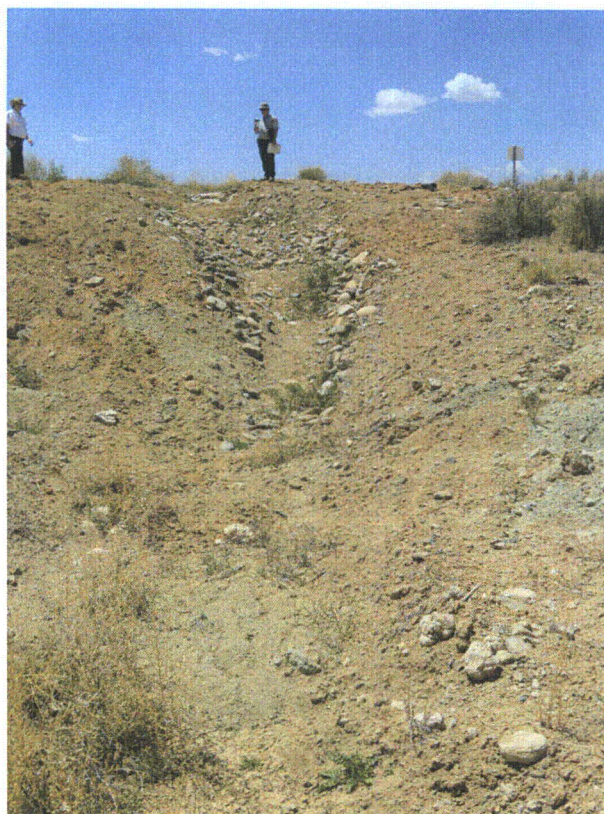
SRD 5/2009. PL-4. Erosion in west corner of retention pond.

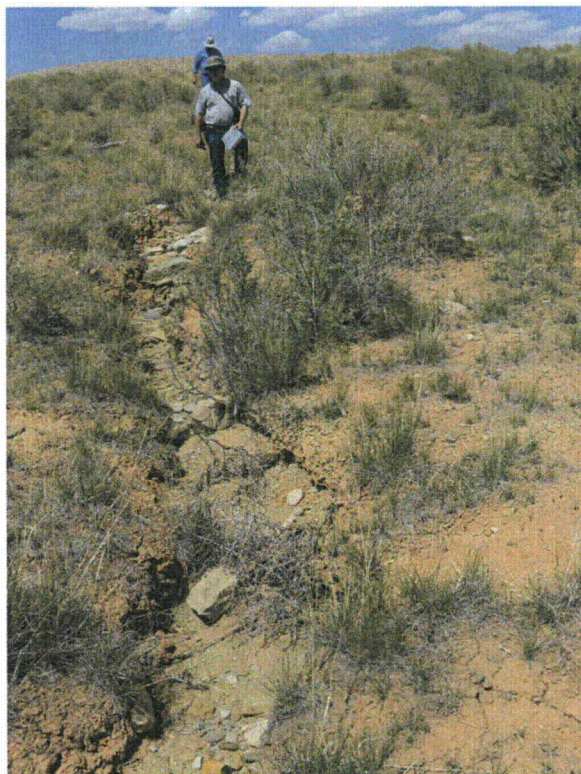
SRD 5/2009. PL-5. View to north-northwest of erosion southeast of apron.

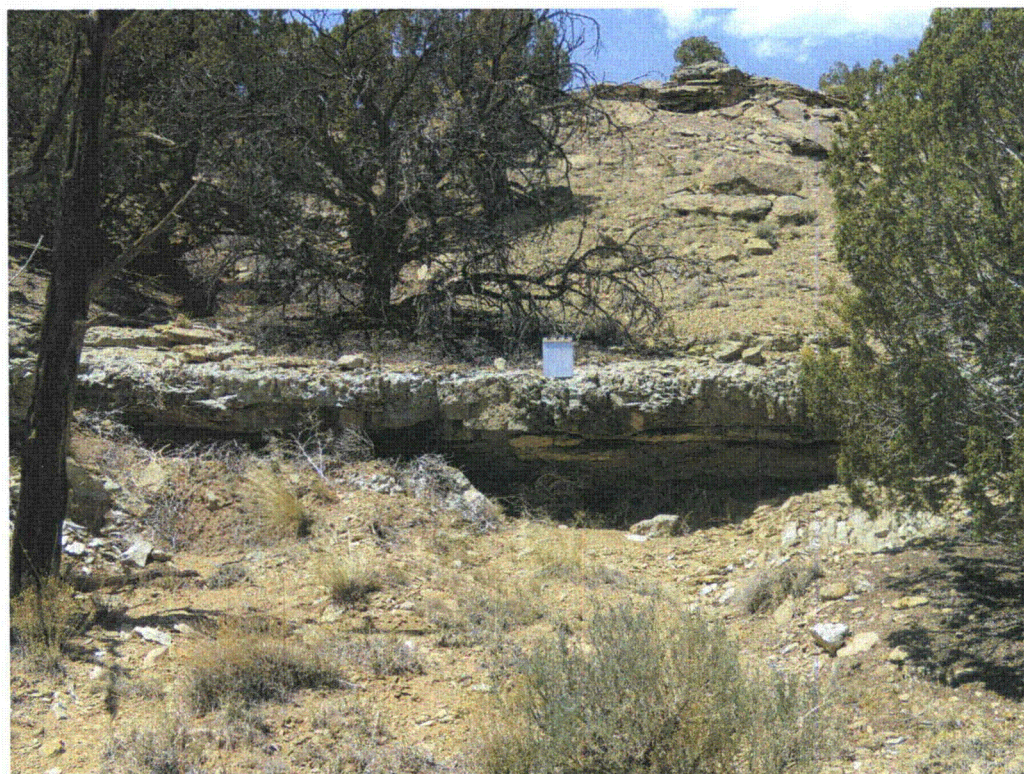
SRD 5/2009. PL-6. Dakota contact showing lack of moisture.

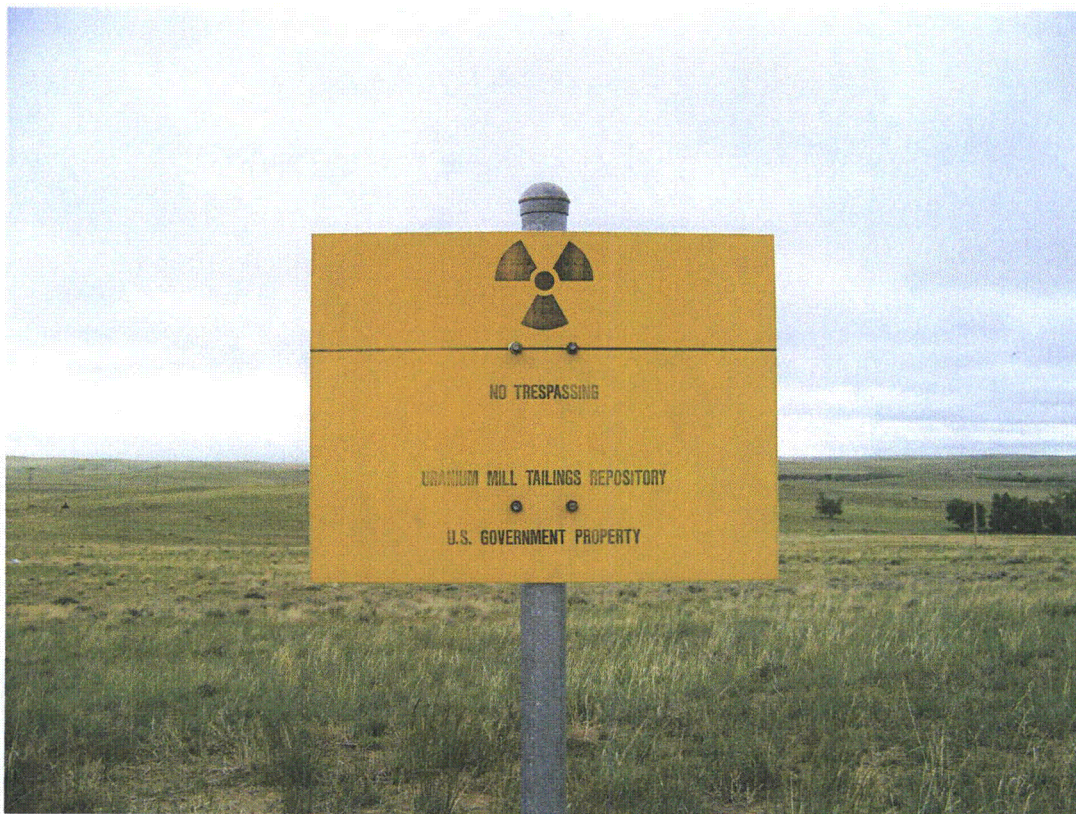
SPK 6/2009. PL-1. Faded perimeter sign P10.

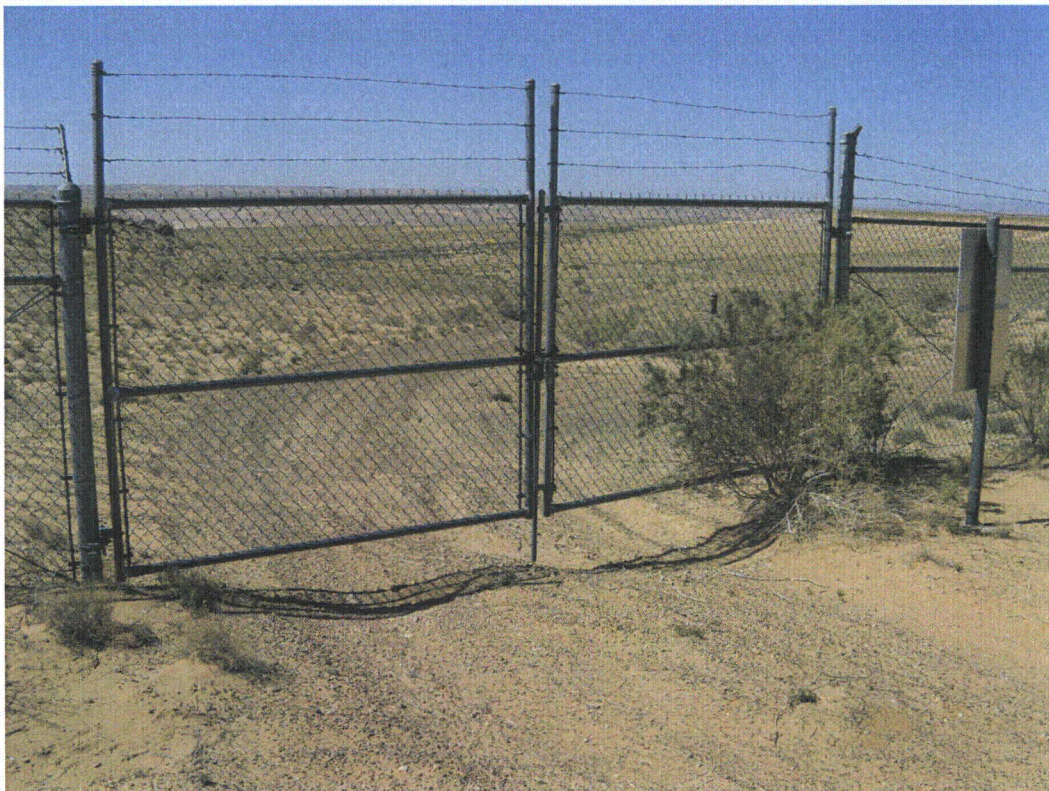
TUB 4/2009. PL-1. Gap under the vehicle gate at the southeast corner of the site.

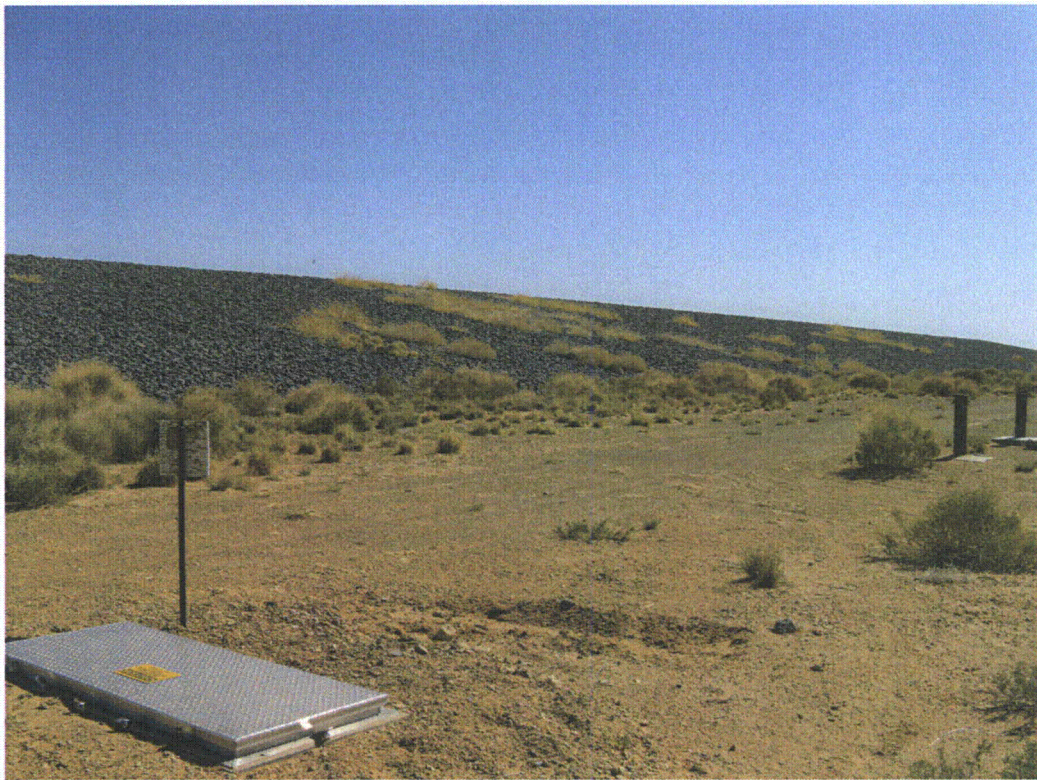
TUB 4/2009. PL-3. Vegetation encroachment on the south side slope of the disposal cell. Photograph taken from extraction well 1107.

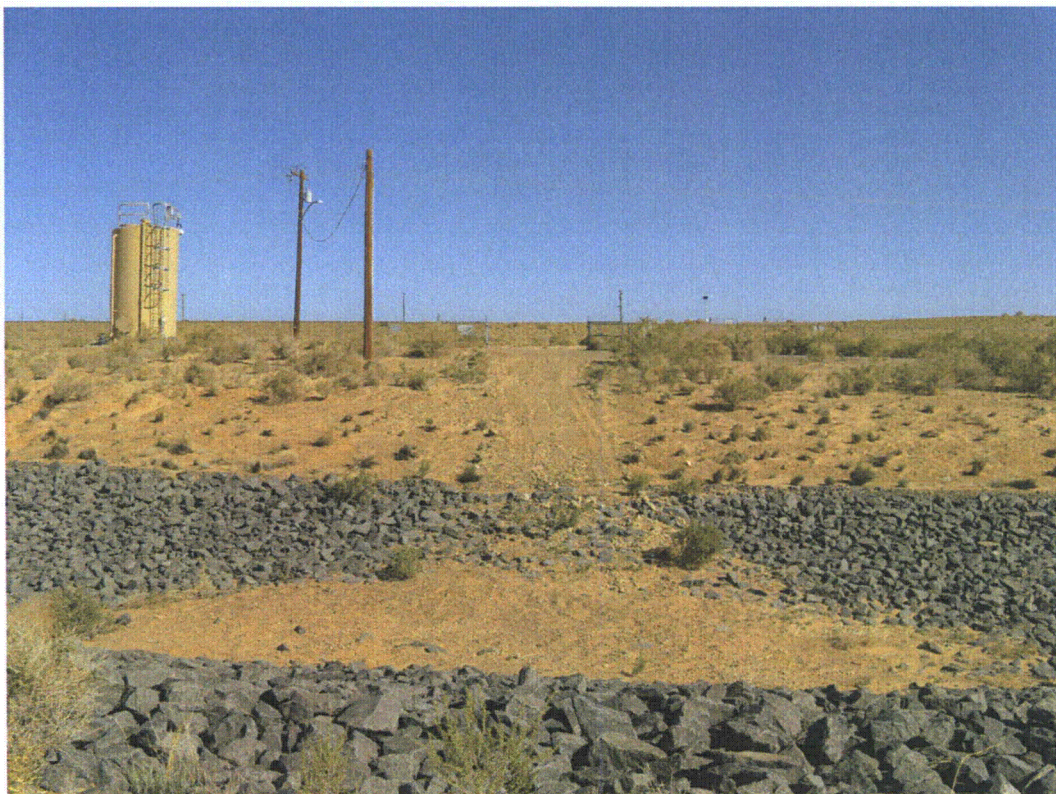
TUB 4/2009. PL-4. Erosion deposition into the north diversion channel below the distillate tank.
