Consolidated Edison Company of New York, Inc.  
4 Irving Place, New York, NY 10003  
Telephone (212) 460-2533

November 2, 1984

Re: Indian Point Unit No. 2  
Docket No. 50-247

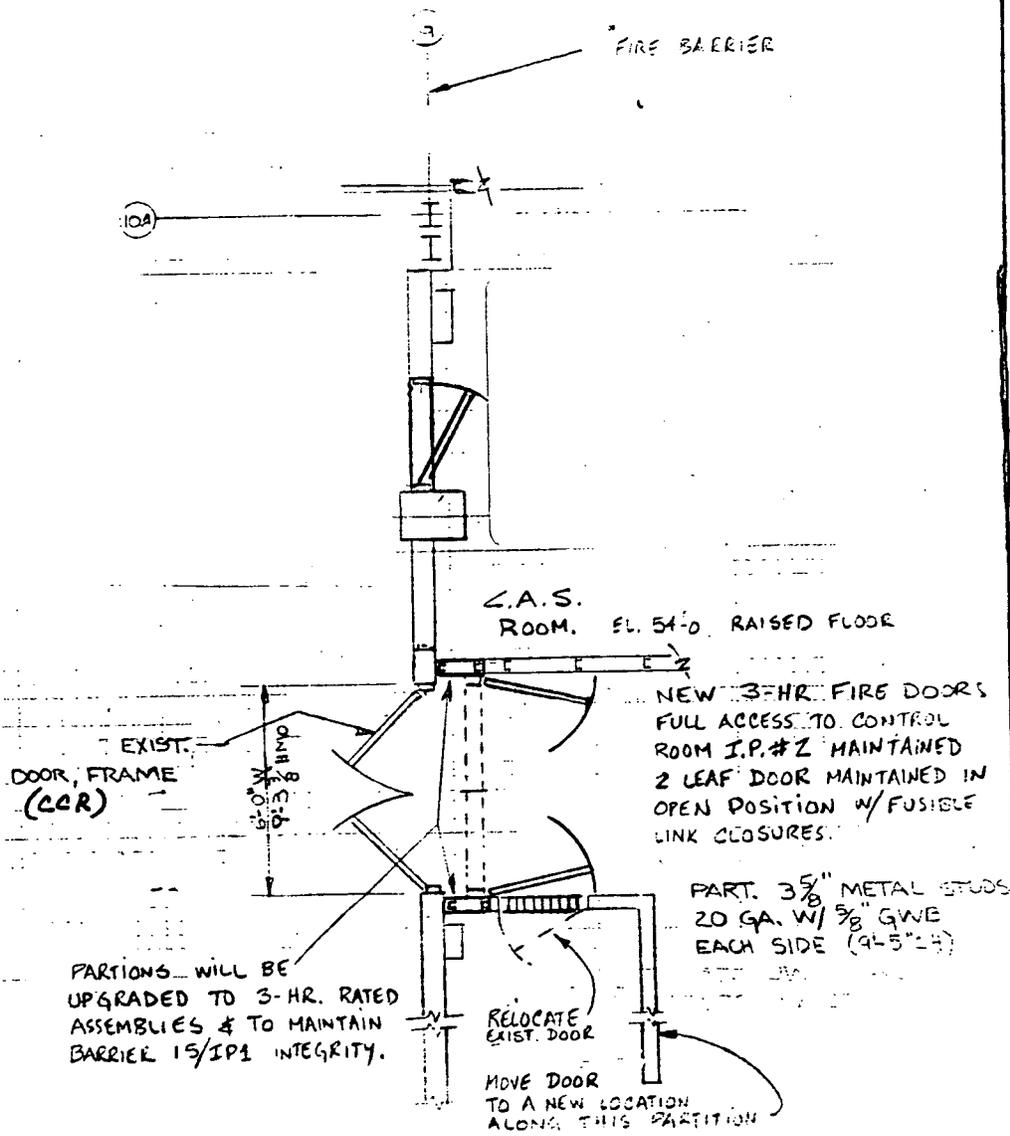
SKETCH 1

The west control room wall is a Type I fire barrier (3-hour), as described in Enclosure 4 to our September 9, 1983 submittal. There are two doors in the west wall requiring a 3-hour fire rating. The single-leaf door to the Central Alarm Station (see Figure 2-1 of our September 9, 1983 submittal), although not carrying a UL label, is a 3-hour rated fire door modified for security purposes according to the manufacturer's documentation. However, according to UL, the door cannot be labeled due to the security modifications. We have determined that this door is adequate with respect to Branch Technical Position 9.5-1 and our September 9, 1983 submittal. The double-leaf door to the Central Control Room is a security door of a bullet-proof construction with other modifications made to it for security purposes. Although of substantial construction, according to UL, it is sufficiently different that it cannot be considered a 3-hour rated door nor can it carry a UL label. As such, Con Edison is installing a properly rated and labeled double-leaf fire door in series with the bullet-proof door, shown on the attached drawing. We expect to complete this work by March 31, 1985. Because the control room security door is of substantial construction, and the Senior Watch Supervisor's office and Central Alarm Station are adjacent to it and since the control room is continuously manned, we do not consider additional compensatory measures to be warranted in the interim period that it takes to procure and install the fire door.
