Sandia National Laboratories

October 29, 1987

Subject: Indian Point Unit 2 Vessel Indication Inspection 1987

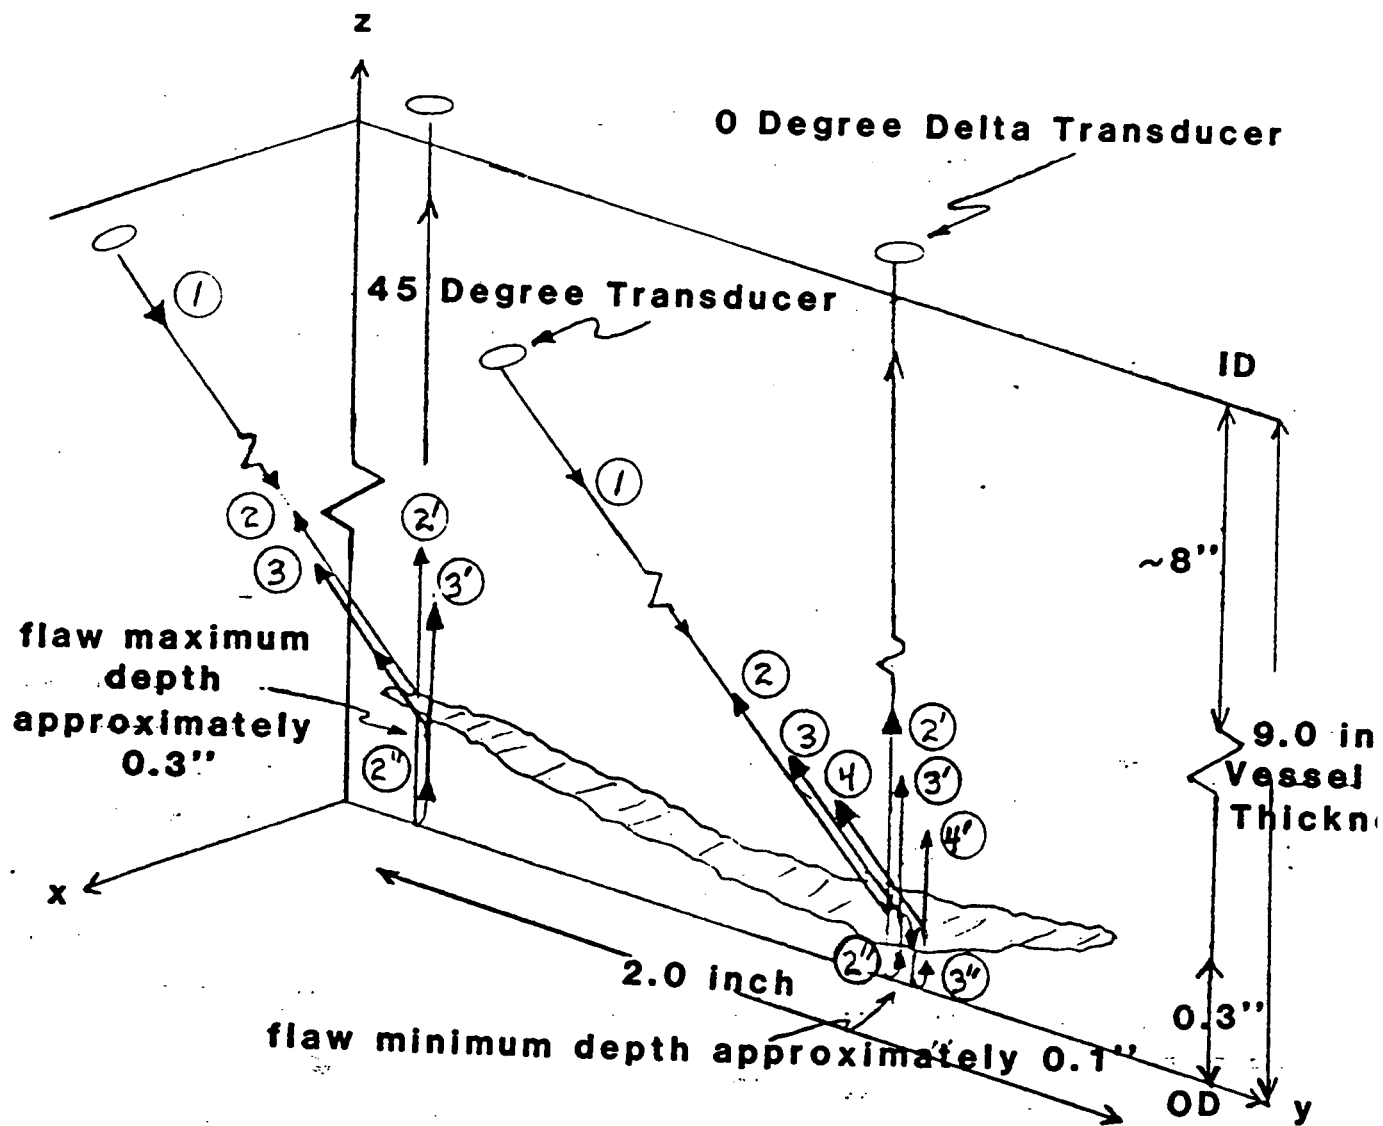
The features of the A-scan echoes can be explained by assuming that the sound energy is incident on a single flaw where portions of the energy are being scattered in many different directions. The main pulse as observed in the pulse echo mode is due to that portion of the energy being scattered directly from the flaw back toward the transducer. The main pulse as observed by the delta 0 degree transducer is due to that portion of the energy being scattered directly toward the ID wall of the vessel. The trailing pulses are due to that portion of the energy being scattered toward the OD wall of the vessel where it is reflected back toward the flaw and subsequently scattered toward the pulse echo transducer and toward the OD surface again to form the 2nd trailing pulse. A portion of the energy reflected from the OD surface of the vessel passes the flaw and arrives at the 0 degree transducer in the delta mode to form the trailing pulses observed

Figures 1 and 2 show a cross sectional view of a model of the flaw geometry where possible ray paths of the scattered energy are displayed. A characteristic A-scan trace is also shown in Figure 2. The distances and depth of the flaw were determined from the preliminary pulse echo and delta data reviewed at the Indian Point Unit 2 site.

FIGURE 1. Schematic of possible ray paths of scattered energy from an incident 45° angle beam at two locations of the flaw.

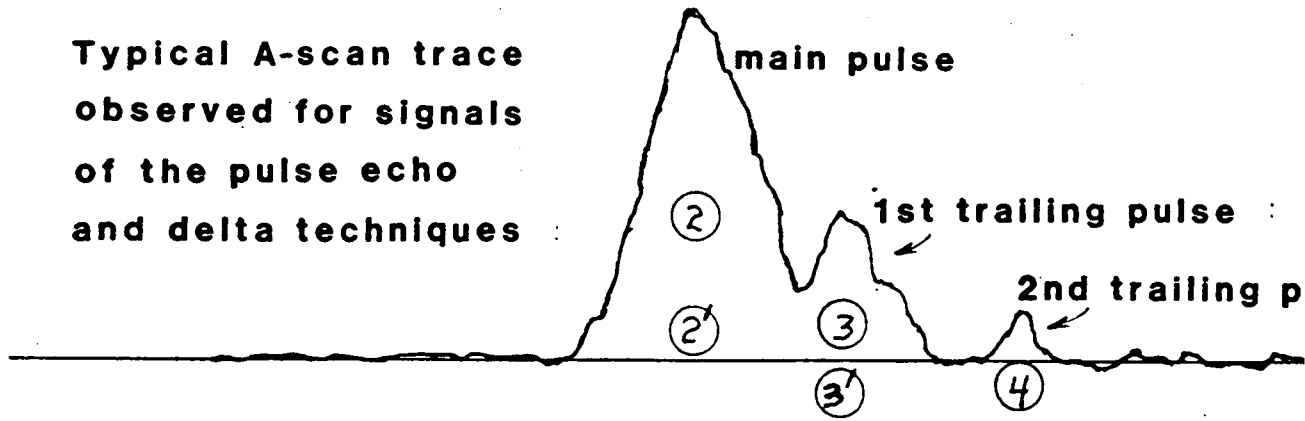
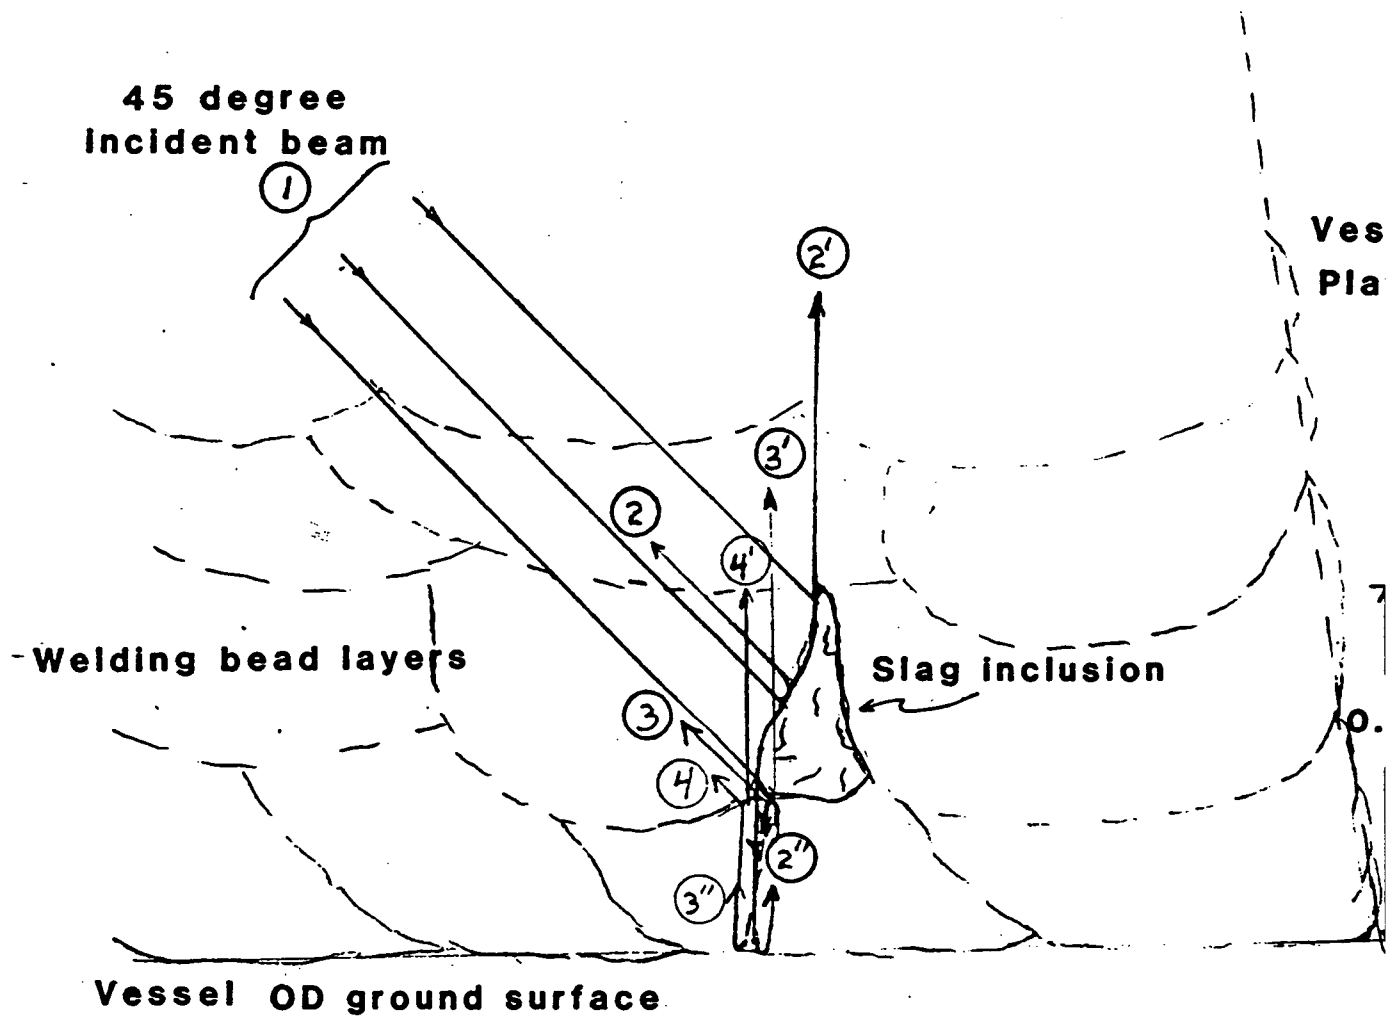
The A-scan characteristics of the pulse echo and delta signals were very similar. They both showed one large amplitude pulse from the flaw with one or two equidistant trailing pulses which were successively reduced in amplitude. The amplitudes of the trailing pulses increased in unison with the large pulse as the transducer approached the flaw. The trailing pulses reached a maximum with the maximum of the large pulse, and they decreased in unison with the large pulse as the transducer passed over the flaw. The second feature of the A-scan traces was that the time separation of the trailing pulses was a maximum at the extremities of the flaw length and it was a minimum when the large pulse was at maximum amplitude near the middle of the flaw.

by it. A second explanation of the trailing pulses is that a portion of the energy of the main pulse is trapped within the flaw volume which may be a slag inclusion, and multiple reflections of the pulse within the inclusion produce the trailing pulses. Since the time separation of the trailing pulses increases near the extremities of the flaw length, it appears that the scattering model may be more plausible because the distance between the flaw surface and the OD wall of the vessel can increase at the extremities of the flaw length, whereas the flaw volume is not expected to enlarge near its extremities.

It is therefore concluded that the flaw in Indian Point Unit 2 reactor vessel is not a crack which is connected to the OD surface of the vessel. The flaw is most likely a thin slag inclusion which is very close to the OD vessel surface with a

Typical A-scan trace
observed for signals
of the pulse echo
and delta techniques

FIGURE 2. Characteristic A-scan for a Pulse Echo and Delta Transducer Configuration corresponding to the possible ray paths from a slag inclusion within the weld.
