Re: Indian Point Unit No. 2
Docket No. 50-247

Response to NRC Bulletin No. 87-01
"Thinning of Pipe Walls in Nuclear Power Plants"

Consolidated Edison Company of New York, Inc.
Indian Point Unit No. 2
Docket No. 50-247
September 11, 1987

Metallurgical Analysis Summary Report

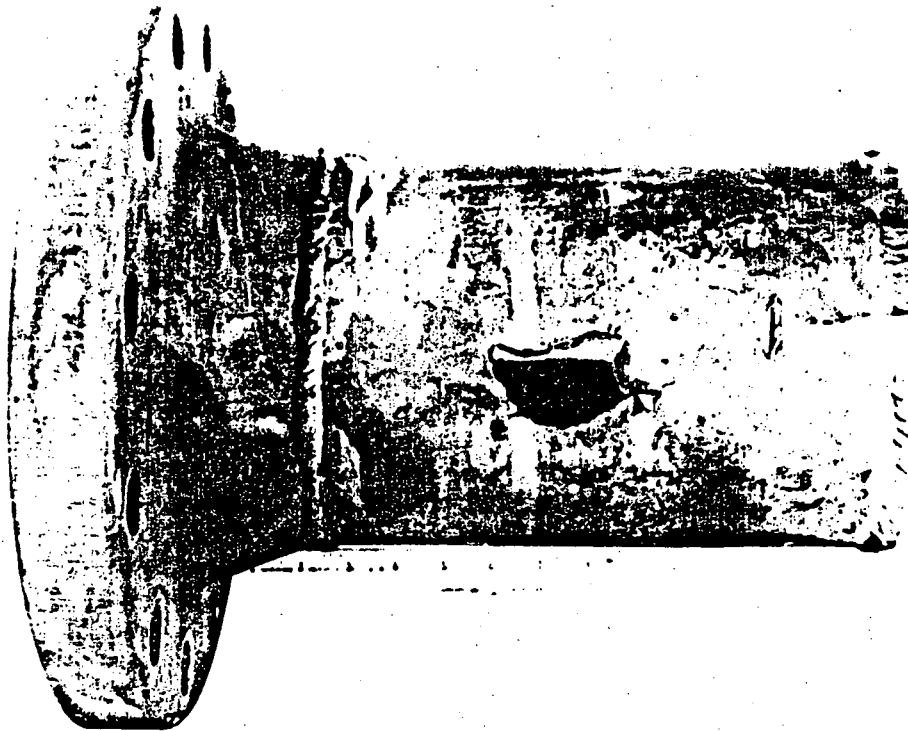
FIGURE 1

The as-received spool piece is shown in Figure 1. The failure consisted of a circular thin-lipped rupture approximately midway between the the pipe-to-flange welds. The spool piece was 12 inches long. In the Laboratory, a transverse section was cut through the pipe approximately 1 inch from the failure. The extensive wall thinning which occurred on the failed side of the pipe is shown in Figure 2. Ultrasonic thickness measurements over the surface of the pipe is provided in Figure 3. The measurements ranged from 0.075 inch near the failure to a maximum of 0.200 inch. The specified wall thickness was 0.280 inch (schedule 40).

As-received 6 inch schedule 40 spool piece

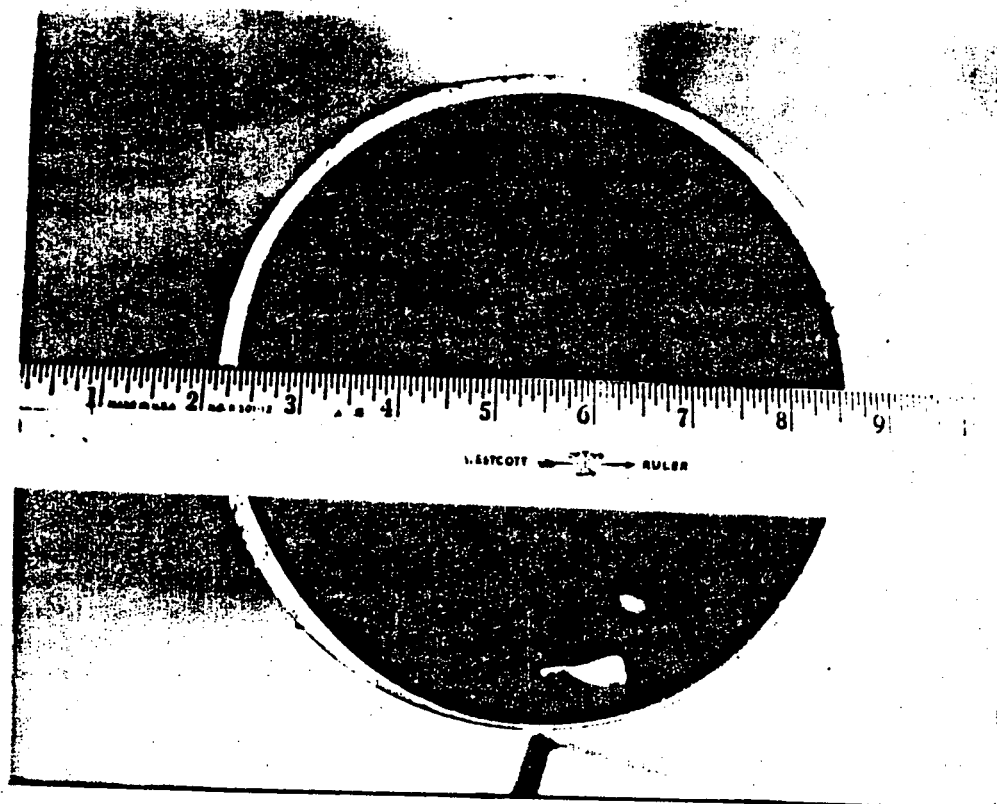
FIGURE 2

Extensive, nonuniform wall thinning is seen.
The failure is on the bottom.

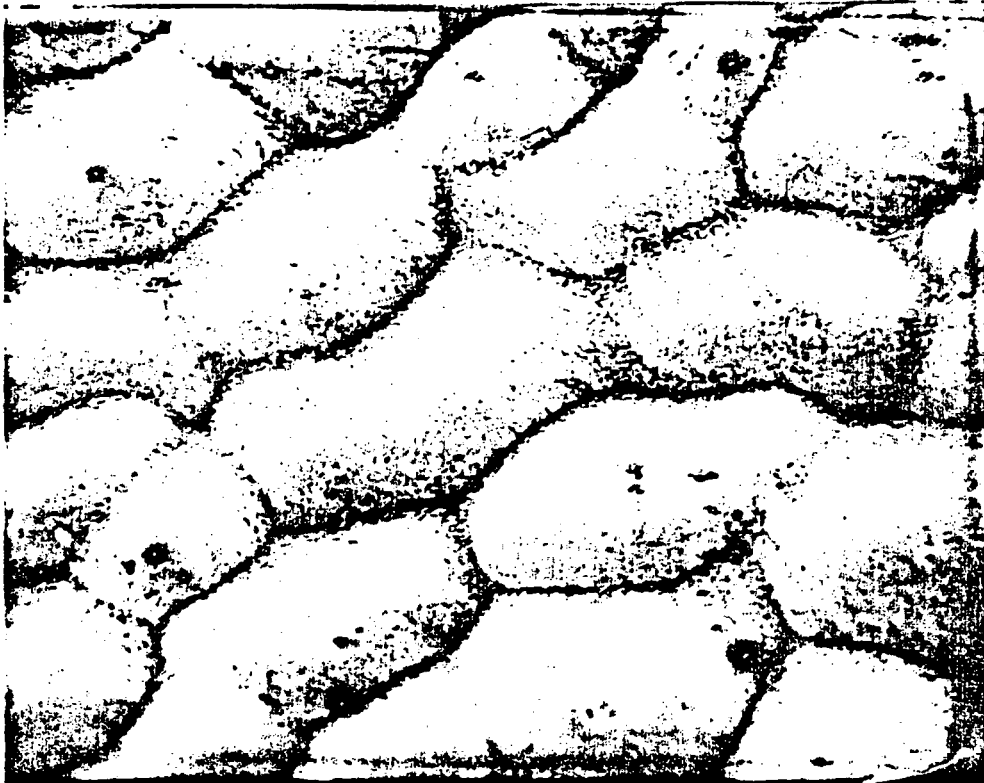
FIGURE 5

A scanning electron micrograph was obtained and is provided in Figure 5. This structure was typical of the internal surface of the pipe. This topographic scalloped surface was also reported in the elbow failure at Navajo Generating Station Unit 3 in November 1982.

Cause of Failure: Based upon the evidence presented above, the cause of failure was single phase erosion-corrosion, also referred to as flow-assisted-corrosion. The failure can be attributed to the installation of an incorrect material for the specified operating conditions.

Scanning electron micrograph of the internal surface of the pipe.
The scalloped surface is typical of erosion-corrosion failures.
Magnification: 40x.

Recommendations: All feedwater piping should be inspected by ultrasonic thickness testing to determine the extent of the problem. An inspection program is currently being formulated at Indian Point by Quality Assurance.

All in-service and replacement spool pieces should be evaluated to determine conformance to UE&C piping specifications. Engineering should evaluate the piping configuration to determine the extent that the piping geometry contributed to the failure.

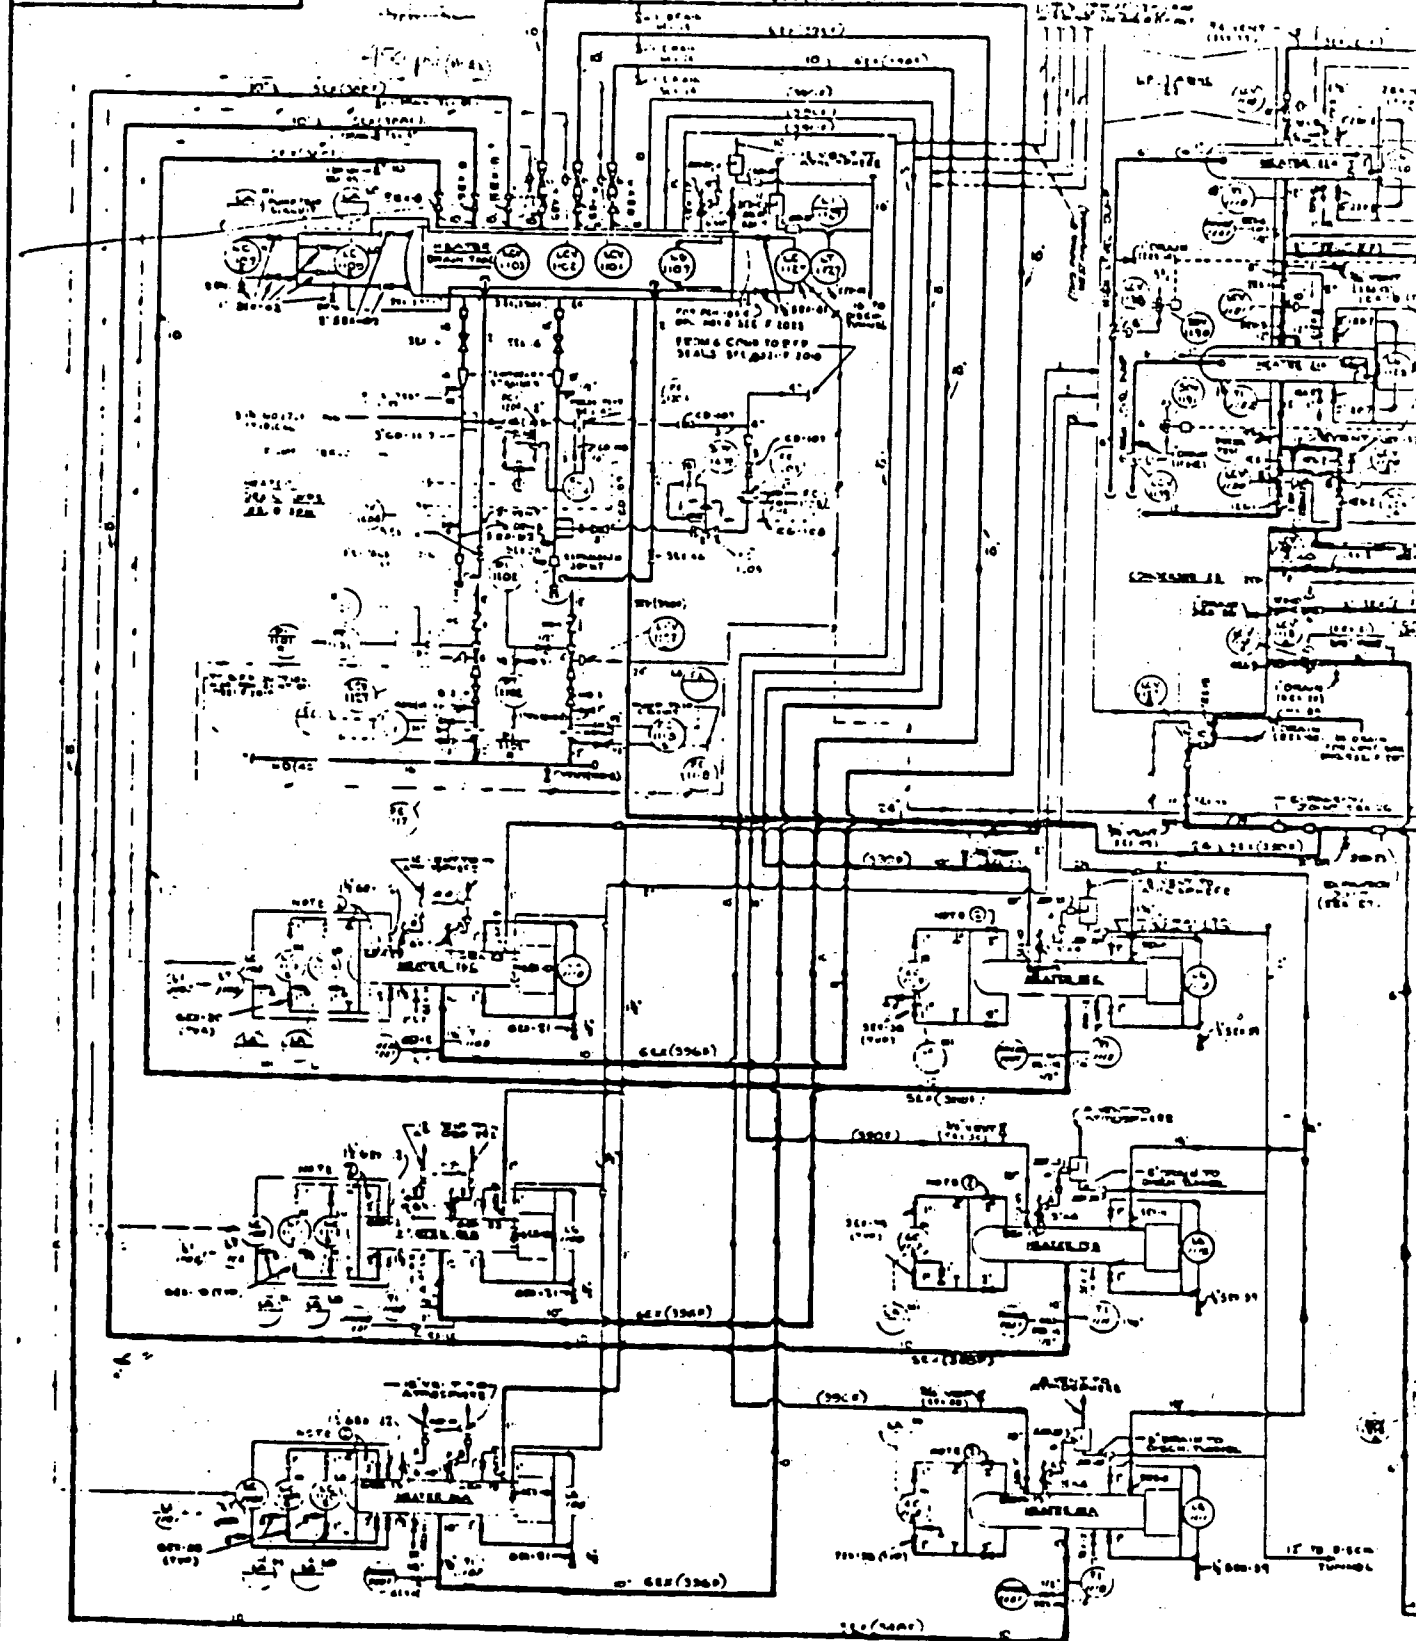
The United Engineers & Constructors (UE&C) Specification 9321-01-248-18 Class D2 for 10 inch and smaller schedule 40 pipe from the level control valve to the heater drain tank for Heater No. 6 requires ASTM A335 Grade P5 alloy steel for piping and ASTM A182 Grade F5 alloy steel for flanges, see the attached page 18A of the piping specification. Grades P5 and F5 alloy steel consists of 0.15% carbon max., 4.0 - 6.0% chromium and 0.45 - 0.65% molybdenum.

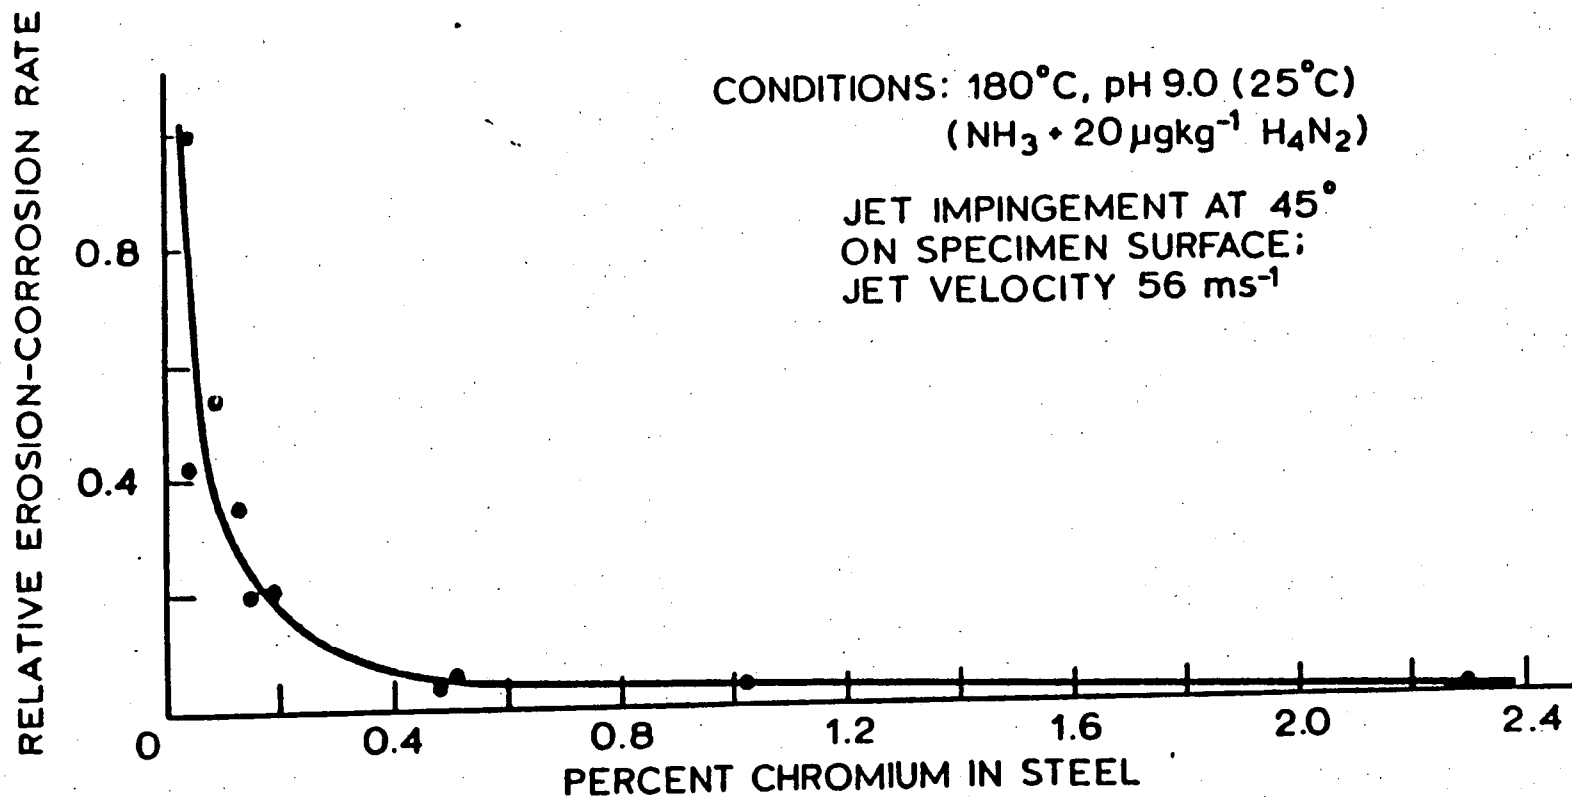
FIG.4 EFFECT OF CHROMIUM CONTENT ON EROSION-CORROSION
RATE OF MILD AND LOW CHROMIUM ALLOY STEELS (DUCREUX, 1982)

The effect of the erosion-corrosion rate as a function of chromium content in steel is shown in the attachment from the EPRI Workshop on Erosion-Corrosion of Carbon Steel Piping - Nuclear and Fossil Plants, April 1987.
