**OPERATIONAL DATA SUMMARY
INDIAN POINT 2**

**W. A. Christenson
C. M. Landgraver
C. J. Lovell**

May 1988

**Operational Data Analysis and Evaluation Unit
NRC Technical Assistance Group
EG&G Idaho, Inc.
Idaho National Engineering Laboratory
Idaho Falls, ID 83415**

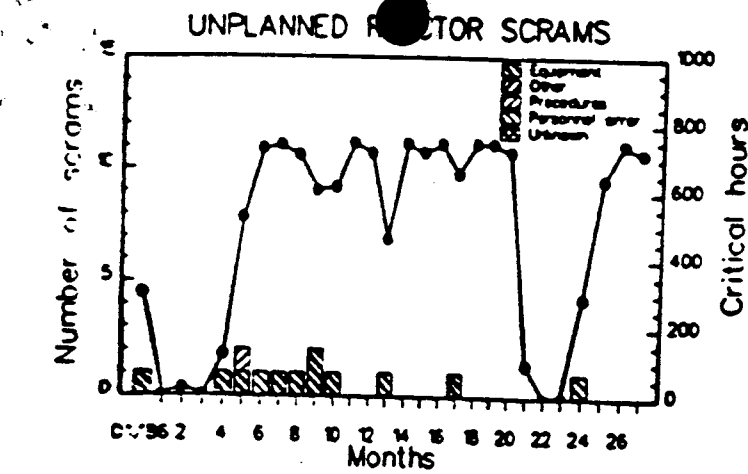
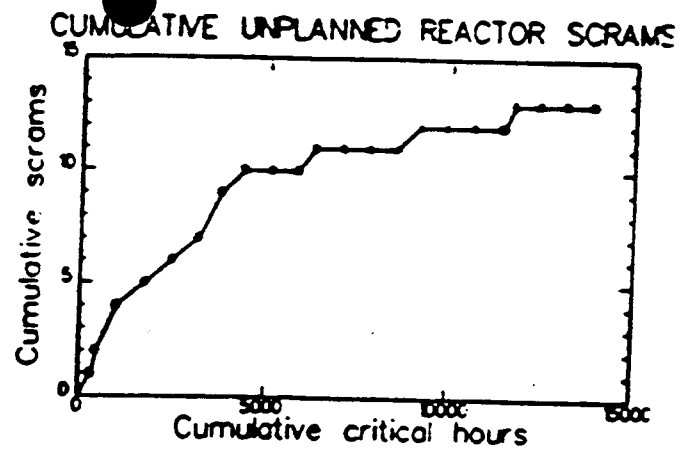
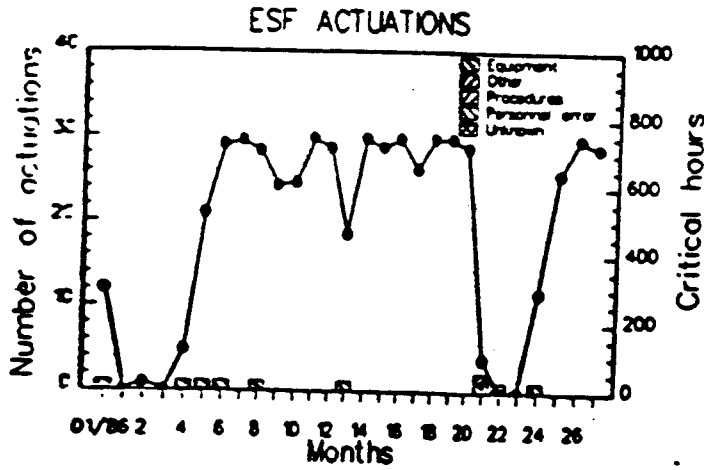
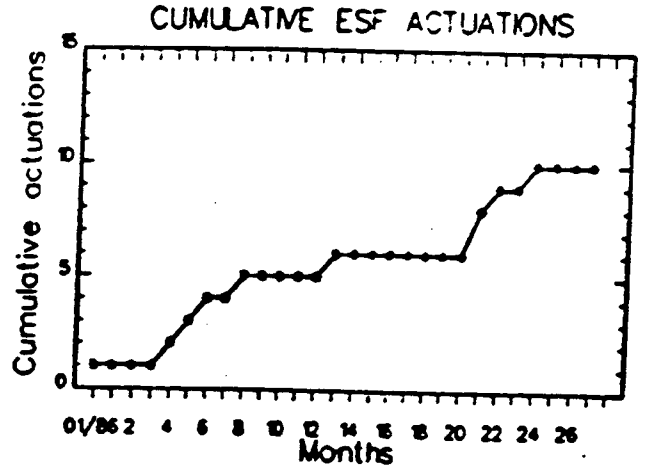
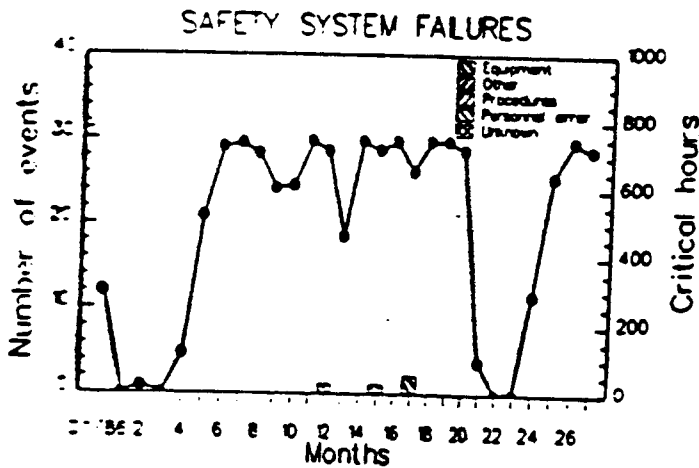
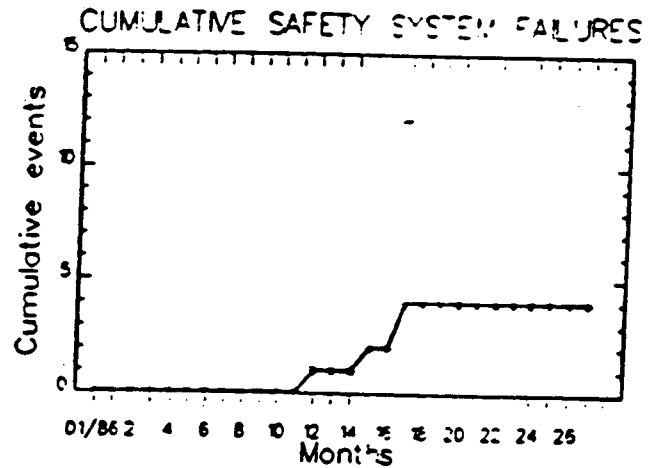
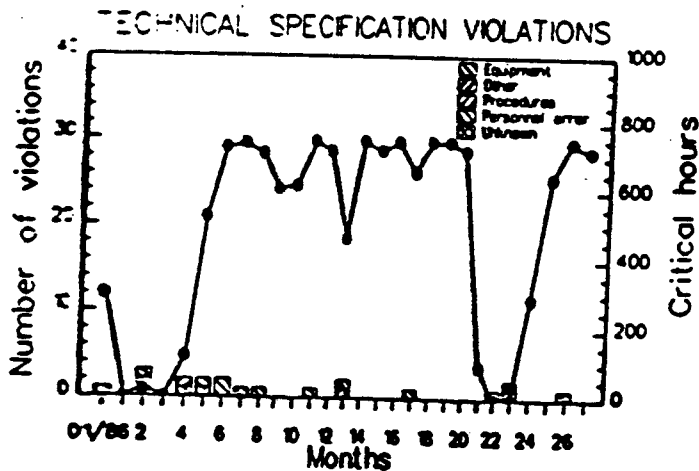
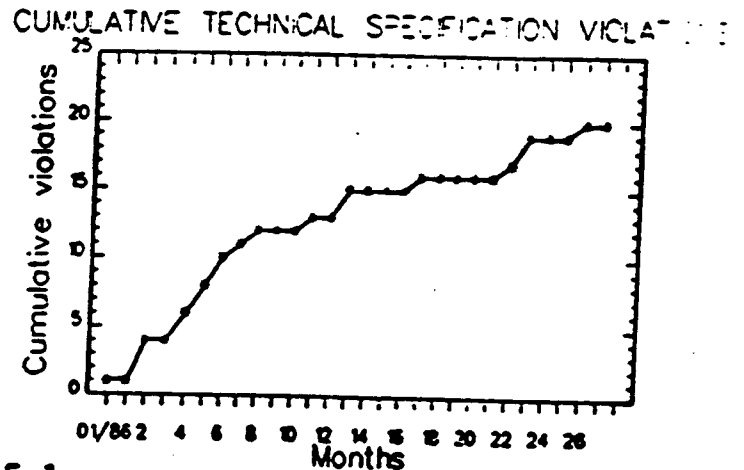
FIGURE 1

The performance of Indian Point 2 has improved over the period of evaluation in all study areas. Figure 1 is a graphical presentation of the data in the four study areas. The most significant improvement occurred in the area of Technical Specification Violations and Shutdowns with over a 50% decrease in the number of reported events from 1986 to 1987. The overall improvement and a reduction in the unplanned scram rate is reflected in the most current Systematic Assessment of Licensee Performance (SALP) Report.
