Re: Indian Point Unit No. 2
Docket No. 50-247

SUBJECT: Request for Relief to Allow Continued Plant Operation with an "As Found" Through-Wall Leak in the Service Water Piping in Accordance with 10 CFR 50.55a (g)(6)(i) and NRC Generic Letter (GL) 90-05

Evaluation of 3" line 409-2 (22 Zurn Strainer blowdown line) with a pinhole.

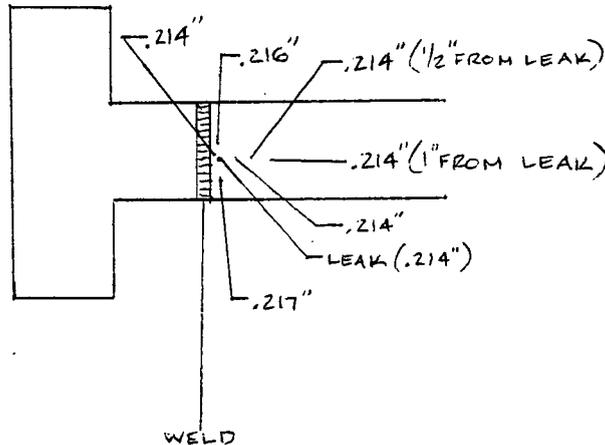
ULTRASONIC THICKNESS MEASUREMENT RECORD SHEET

Ultrasonic testing (UT) has been conducted on the affected area and has neither identified the pinhole nor has there been any wall thinning in the area. Evaluation of the pinhole in accordance with the approach contained in Enclosure 1 of GL 90-05 has determined that plant operation with this condition unaddressed by a repair meets pipe design requirements for both normal and abnormal conditions, including a Seismic Safe Shutdown. The weepage "as is" poses no housekeeping problems relating to itself or surrounding safety equipment. There is no significant flow diversion threat from this leak to the system cooling function requirements.

UT readings around the pinhole are uniform and indicate full wall thickness.
