Re: Indian Point Unit No. 2  
Docket No. 50-247

**SUBJECT:** Evaluation of a Relevant Condition in Accordance With ASME  
B&PV Code, Section XI (IWB-3522) For Class 2 Piping, and Request  
for Approval of an Alternative to Code Repair in Accordance with 10  
CFR 50.55a(a)(3)(I)

LIQUID PENETRANT EXAMINATION REPORT

ULTRASONIC THICKNESS MEASUREMENT RECORD

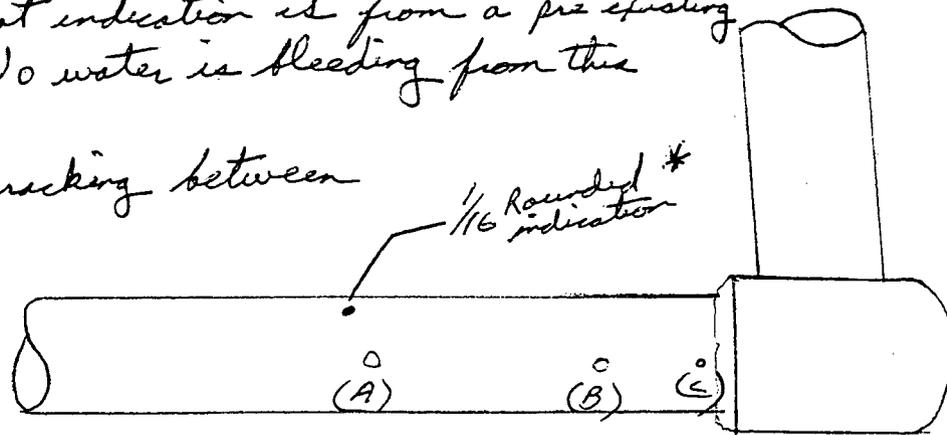
\* It appears that indication is from a pre existing  
arc strike. No water is bleeding from this  
indication  
There is no cracking between  
pin holes A & B.

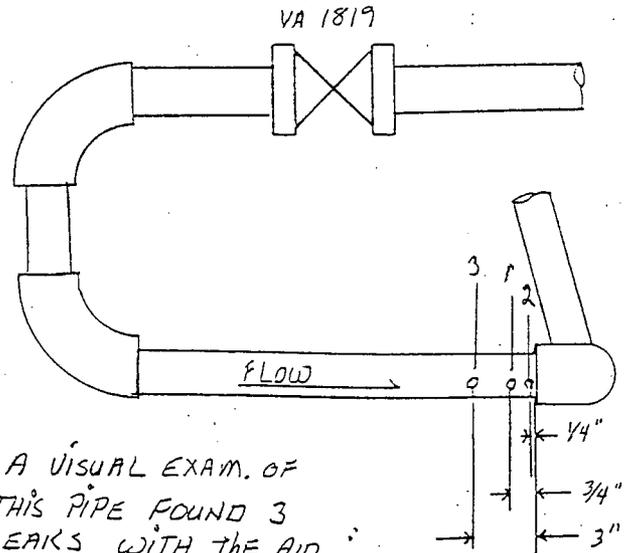
VIEW LOOKING DOWN STREAM

LEAK # 1

140	140	140	141	142	
140	140	140	141	142	
143	142	139	138	140	142
143	142	142	138	140	142
142	142	145	138	140	142
142	142	147	142	140	142

LEAK # 2

142	142	142	143
140	140	140	143
139	139	142	143
139	139	142	143
140	138	140	142
140	138	140	142

NOTE: A VISUAL EXAM. OF THIS PIPE FOUND 3 LEAKS WITH THE AID OF PENETANT DEVELOPER.

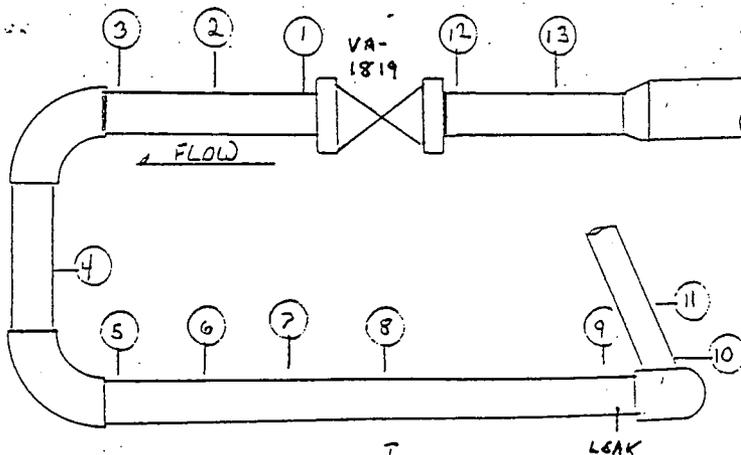
TOP	SIDE	BOT	SIDE
1	.130	.155	.171	.143
2	.129	.149	.174	.160
3	.127	.158	.175	.138
4	.124	.159	.177	.147
5	.143	.142	.140	.138
6	.139	.140	.142	.139
7	.146	.142	.144	.138
8	.141	.143	.140	.139
9	.140	.139	.140	.140
10	.288	.298	.309	.281
11	.282	.313	.285	.281
12	.176	.161	.131	.156
13	.178	.158	.132	.161

NOTE: AREA 9 - VISUAL EXAM FOUND  
 PIN: HOLE LEAK. READINGS IN AREA WERE ALL AROUND .140"  
 R<sub>HT</sub>
