SUBJECT: Response to Request for Information Concerning Confirmatory Action Letter
1-97-002 Topical Event.

CONSOLIDATED EDISON COMPANY OF NEW YORK, INC.
INDIAN POINT UNIT NO. 2
DOCKET NO. 50-247
FEBRUARY, 1997

RESPONSE TO REQUEST FOR INFORMATION

Main Feed Regulating Valve Failures

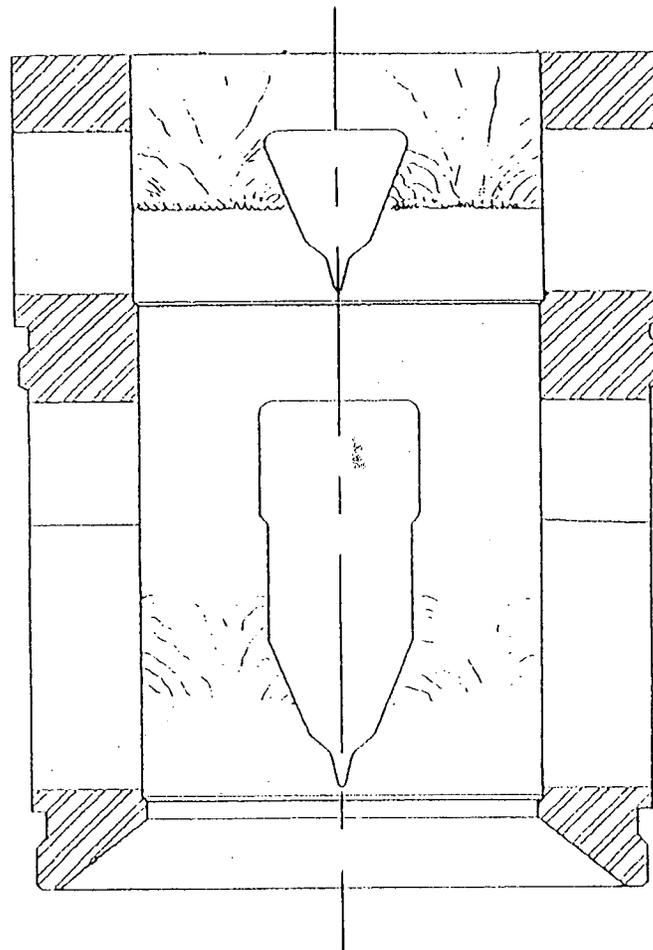
Main Feedwater Reg. Valve

- Scored Cages and Plugs
- FCV 437L
 - Plug Stuck in Cage
 - Seal Damage - Grit Suspected
 - Flow Grooving
- Grit Damage Suspected, Parallel Flow Path to Main Feedwater Reg. Valves

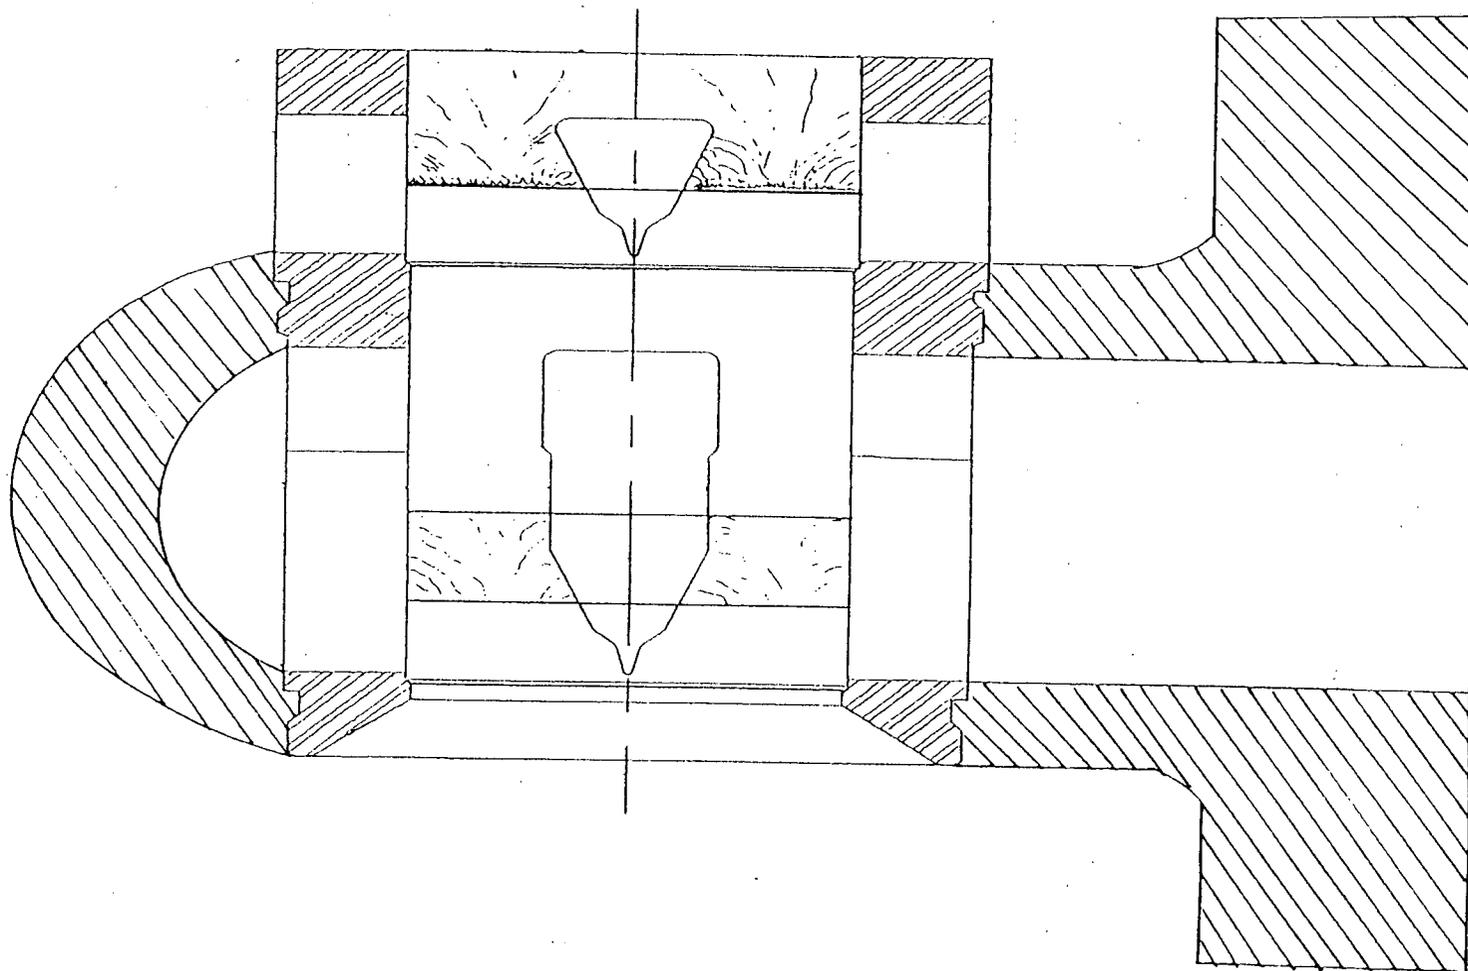
Main Feedwater Reg. Valve

- Material in HDT and Embedded Particles
MFRVs are the Same

- Damage to MFRV Caused by Amasteel Grit

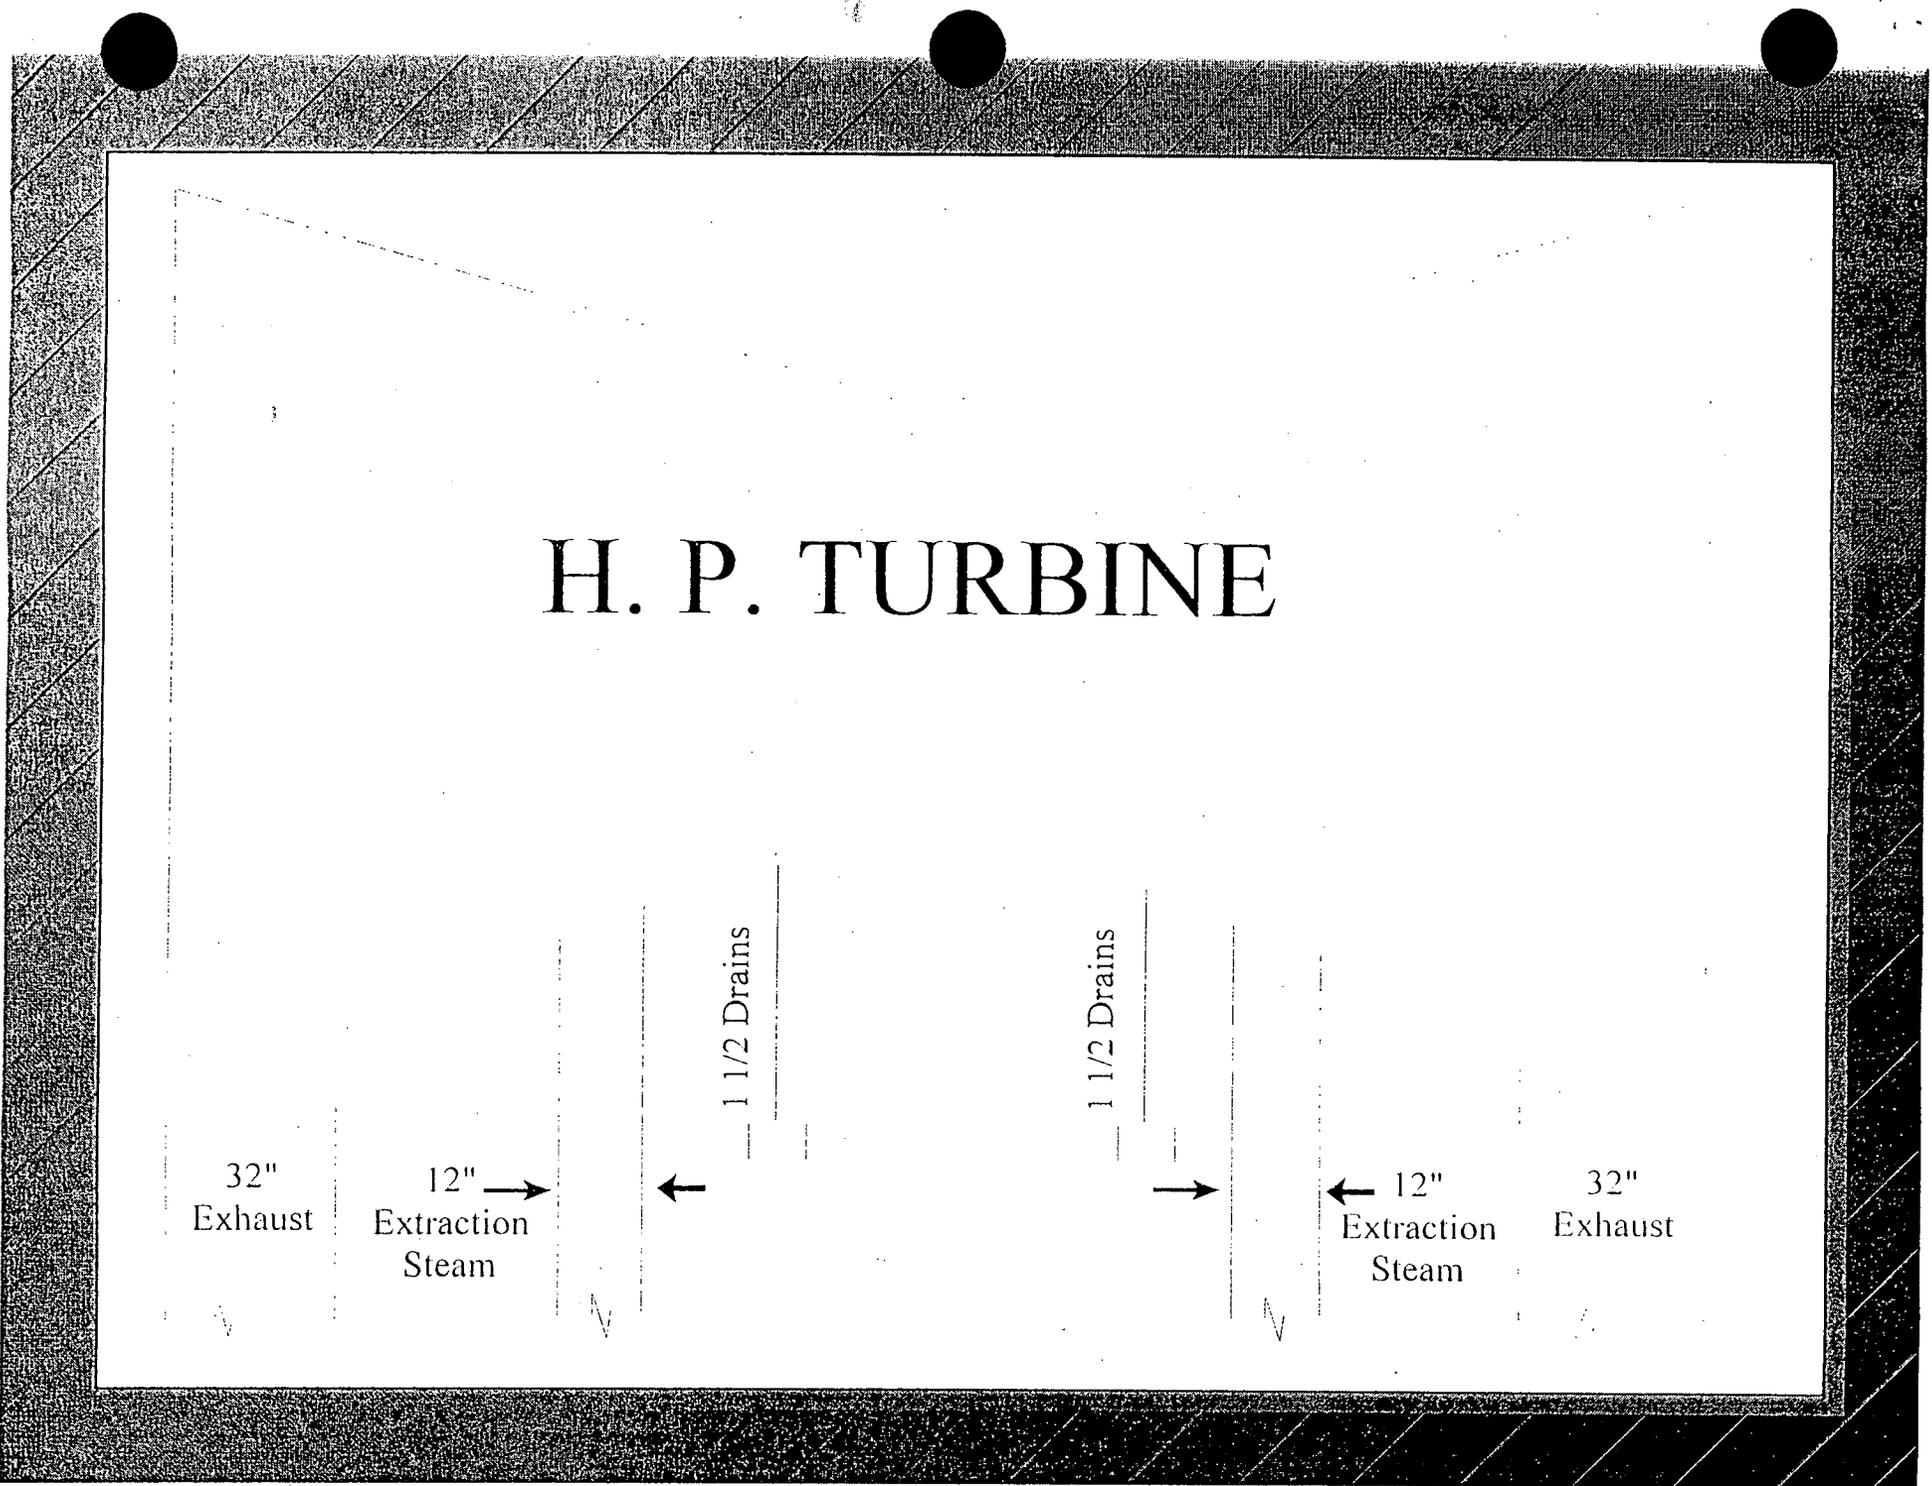
The grit appears to have entered the pre-separator devices in the High Pressure Turbine exhaust due to faulty foreign material exclusion controls and final system cleaning that was inadequate

← 12"
Extraction
Steam

32"
Exhaust
