Preliminary Examination of Cracks in Alloy 152, 52, and 52M Weld Metals

MB Toloczko
MJ Olszta

January 2010

Prepared for
U.S. Nuclear Regulatory Commission
under a Related Services Agreement
with the U.S. Department of Energy
Contract DE-AC05-76RL01830
NRC Project JCN N6547

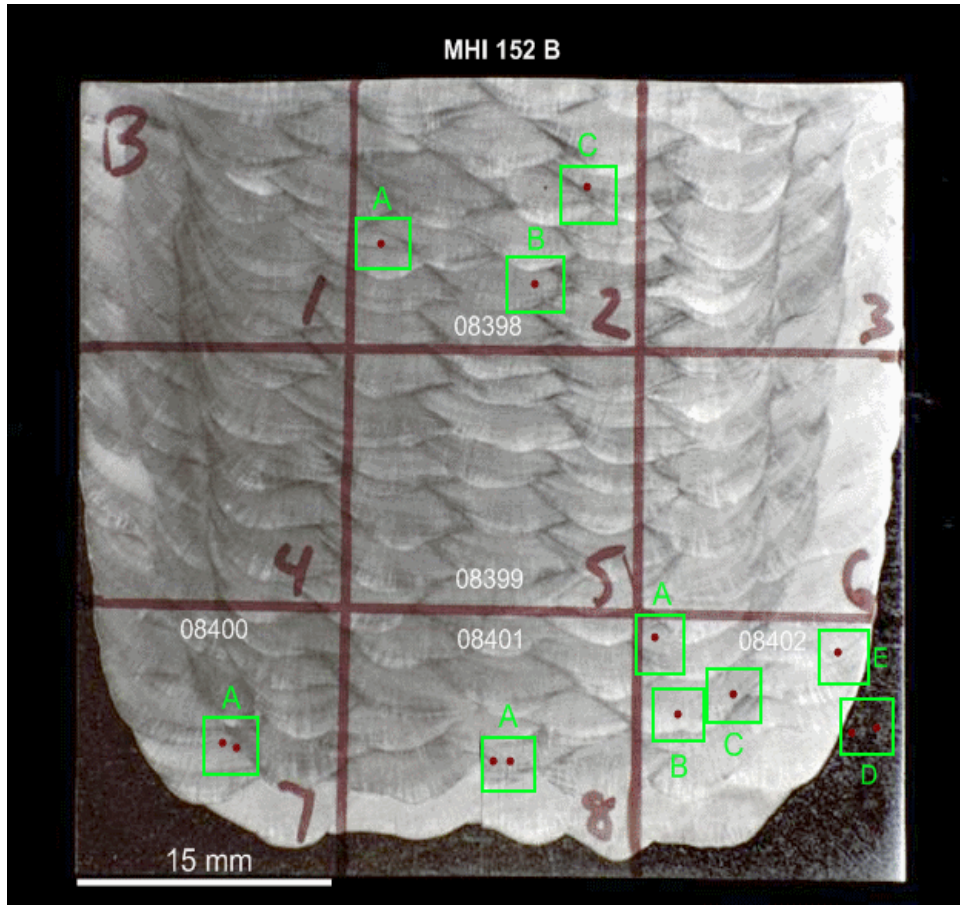
Three slices of the MHI Alloy 152 material were examined for weld defects. The first slice (B) is shown in Figure 3.1. For this slice and all the other MHI weld slices, only those pieces with ID codes in white lettering were examined as these were the expected areas of highest weld residual stress. The small green boxes indicate areas that appeared to contain weld defects in our overview examinations. However, detailed metallography determined that few of these features were cracks. Most were small pits probably resulting from inclusion or precipitate pullout during polishing as shown in Figure 3.2. Only a few cracks were found in the lower right region of the Alloy 152 weld (#08402) and typical small cracks are presented in Figure 3.3. The largest crack was found near the 304SS – Alloy 152 interface, possibly in a region of altered composition. The overview of Alloy 152 slice F in Figure 3.4 shows several locations where cracks were thought to be present in the initial examination. As with slice B, detailed metallographic examination revealed that the majority of small indications were only pits created by pullout of second-phase particles during polishing. An example of this damage and a crack are shown in Figure 3.5. Examination of slice X, shown in Figure 3.6, revealed no cracks except the crack that extended from the butt joint at the bottom of the U-groove weld.

Figure 3.1. Overview Image of the Alloy 152 Weld Slice B with areas Showing Possible Weld Defects Highlighted by the Green Boxes

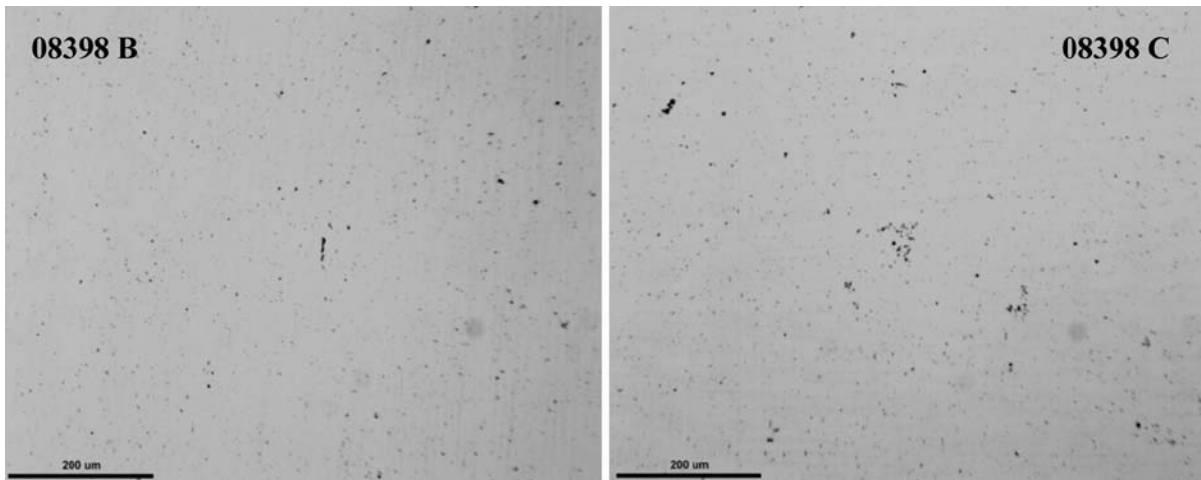
Figure 3.2. Optical Metallographs Illustrating Regions in the Alloy 152 Weld Metal Slice B. Most areas only reveal fine pits due to particle pullout. Scale markers in lower left of each micrograph represent 200 μm .

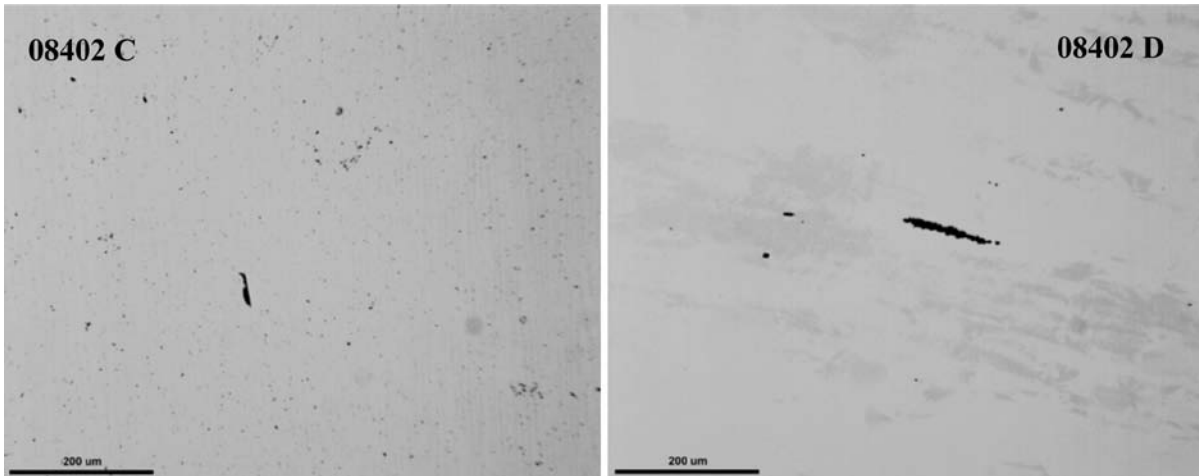
Figure 3.3. Optical Metallographs Illustrating Regions in the Alloy 152 Weld Metal Slice B. The images show small weld cracks, 08402C is in the Alloy 152 weld metal while 08402D is near the 304SS – Alloy 152 interface. Scale markers in lower left of each micrograph represent 200 μm.

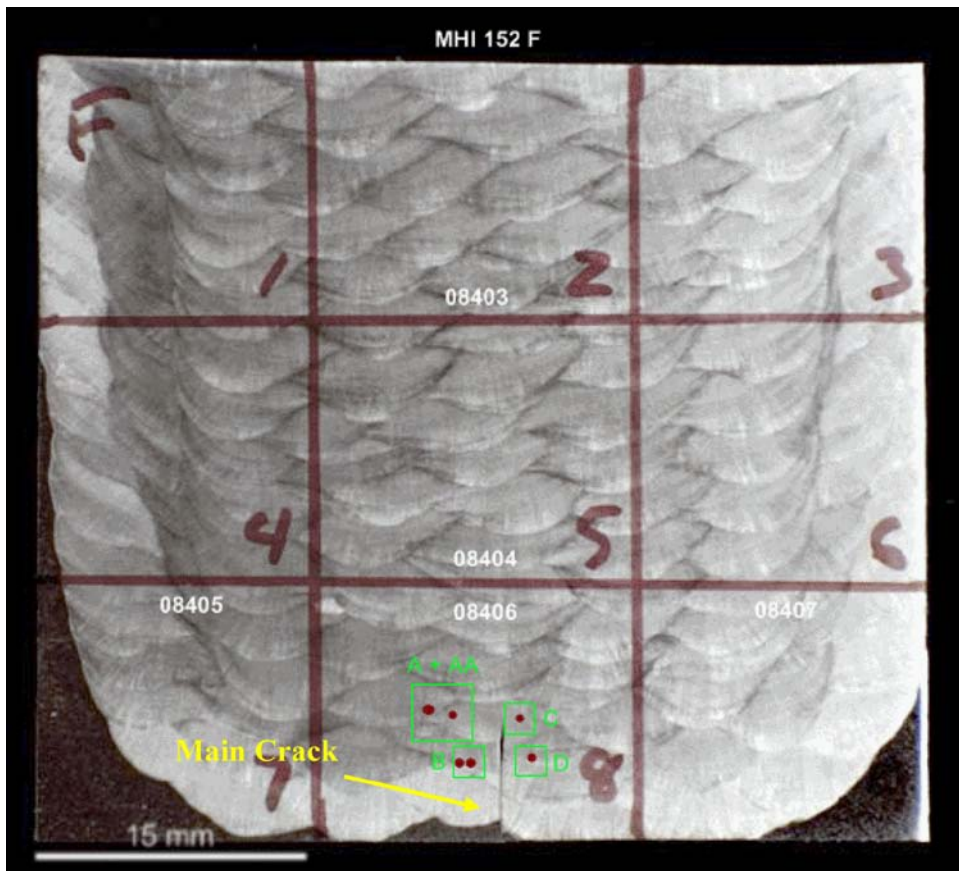
Figure 3.4. Overview Image of the Alloy 152 Weld Slice F with Areas Showing Possible Weld Defects Highlighted by the Green Boxes

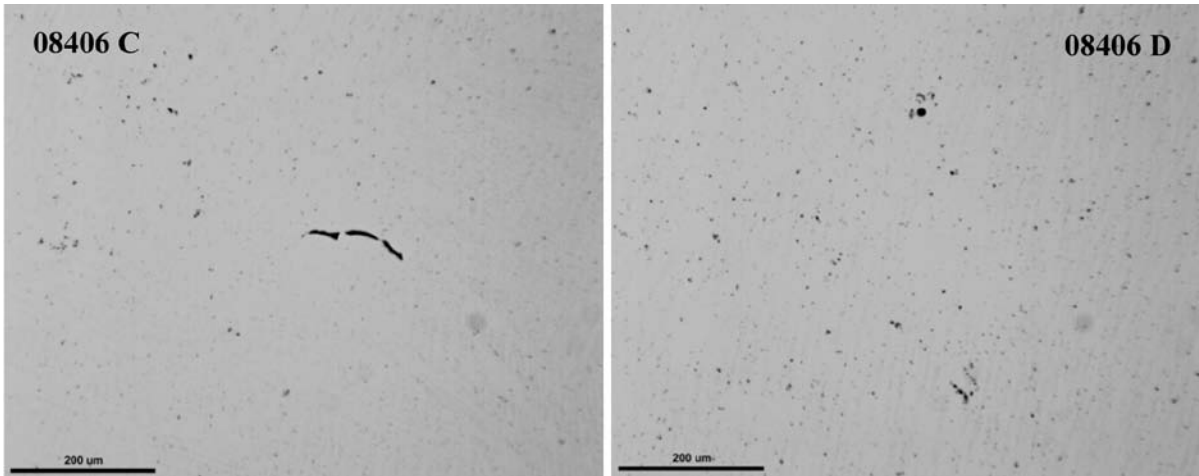
Figure 3.5. Optical Metallographs Illustrating Regions in the Alloy 152 Weld Metal Slice F. Most areas only reveal fine pits due to particle pullout. A small weld crack is seen in 08406C near the main crack. Scale markers in lower left of each micrograph represent 200 μm .

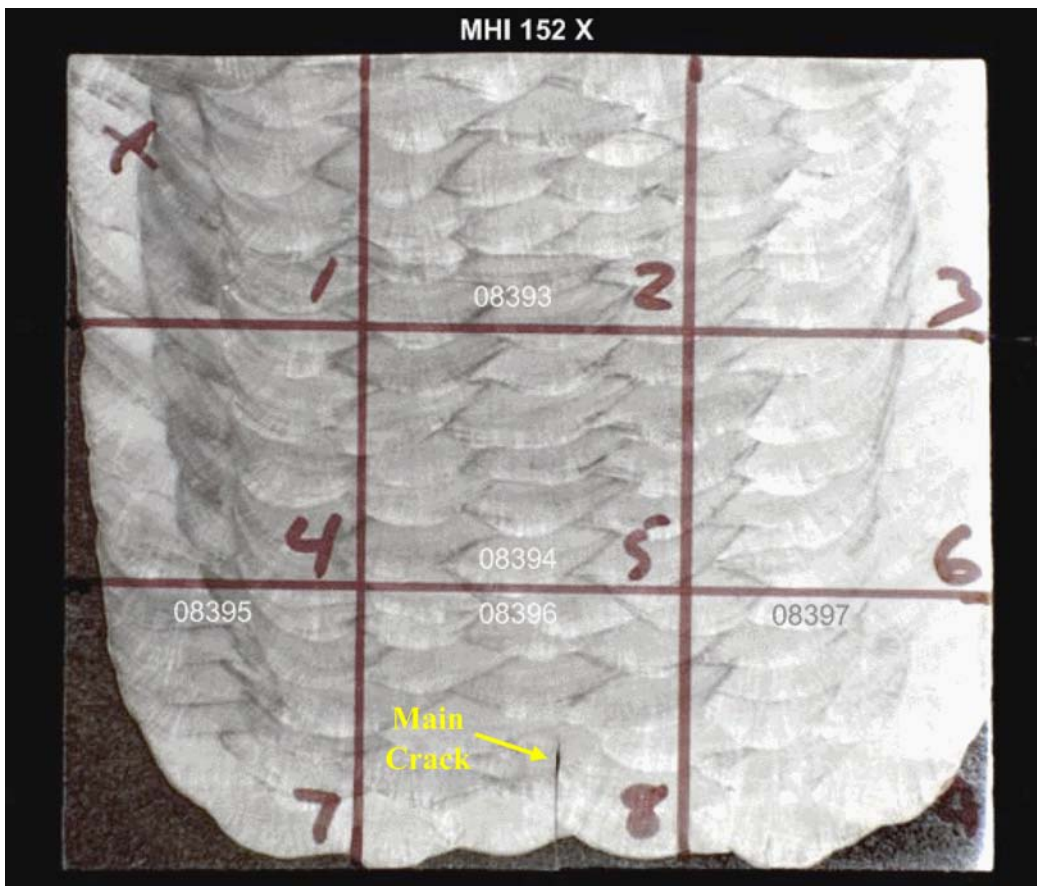
Figure 3.6. Overview Image of the Alloy 152 Weld Slice X. No areas containing weld cracks were identified except for the crack extending from the 304SS joint.

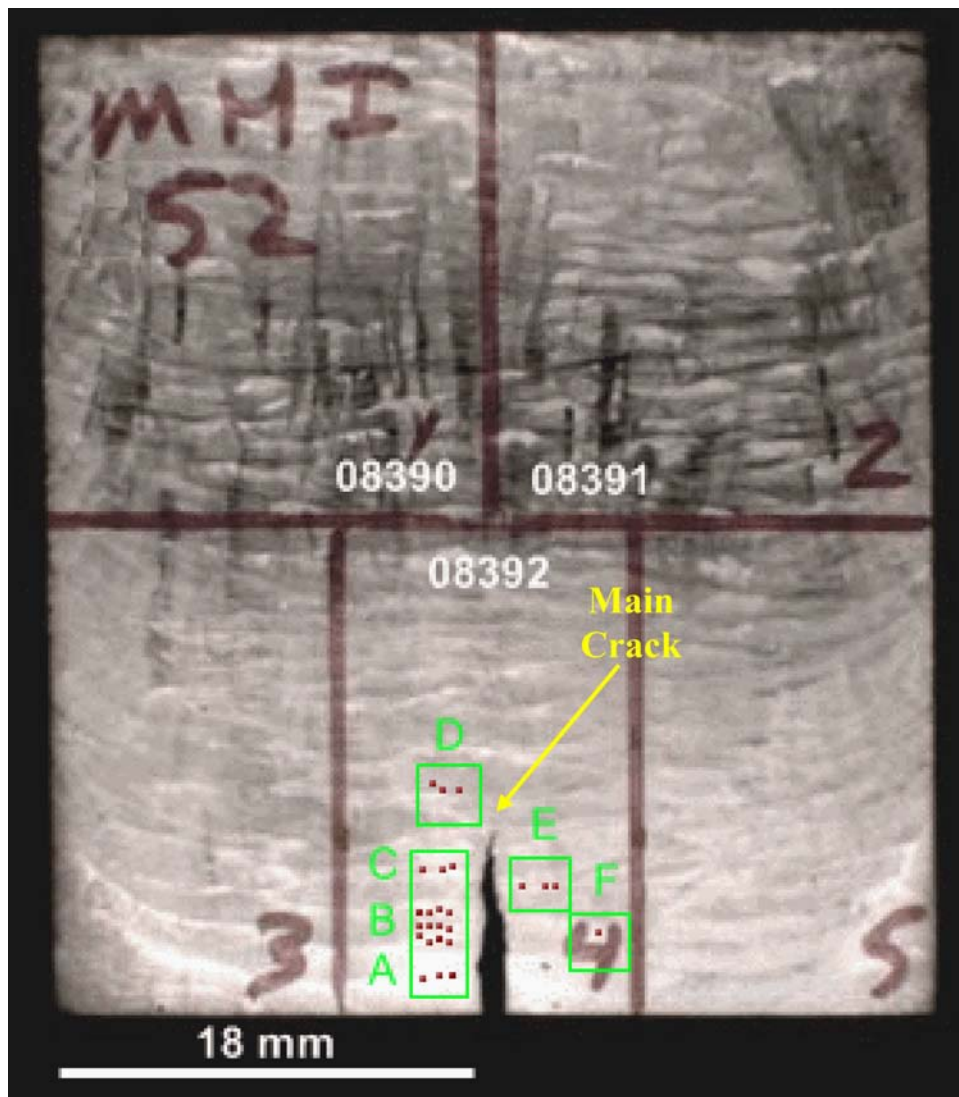
The Alloy 52 weld, which was fabricated by GTAW instead of SMAW, has a large degree of weld-induced separation at the base of the U-groove where the two plate pieces meet. A long macroscopic crack can be seen extending up through the Alloy 152 butter passes and into the Alloy 52 fill weld as shown in Figure 3.7. Many cracks were identified in the Alloy 52 weld metal around this macroscopic crack with examples shown in Figure 3.8. These cracks are roughly parallel to the large main crack in most instances and span from 300–500 μm in length. Etching of selected cracks, as shown in Figure 3.9, reveals that the cracks are located on grain boundaries as expected. No obvious features can be seen on the cracks that explain their location on these particular grain boundaries. The remainder of the slice was free of any weld defects.

Figure 3.7. Overview Image of the Alloy 52 Slice Showing Large Separation and Cracking Extending Up from the Butt Joint at the Bottom of the U-groove. Large amounts of weld cracks were found in the region around this large crack but nowhere else in the slice.

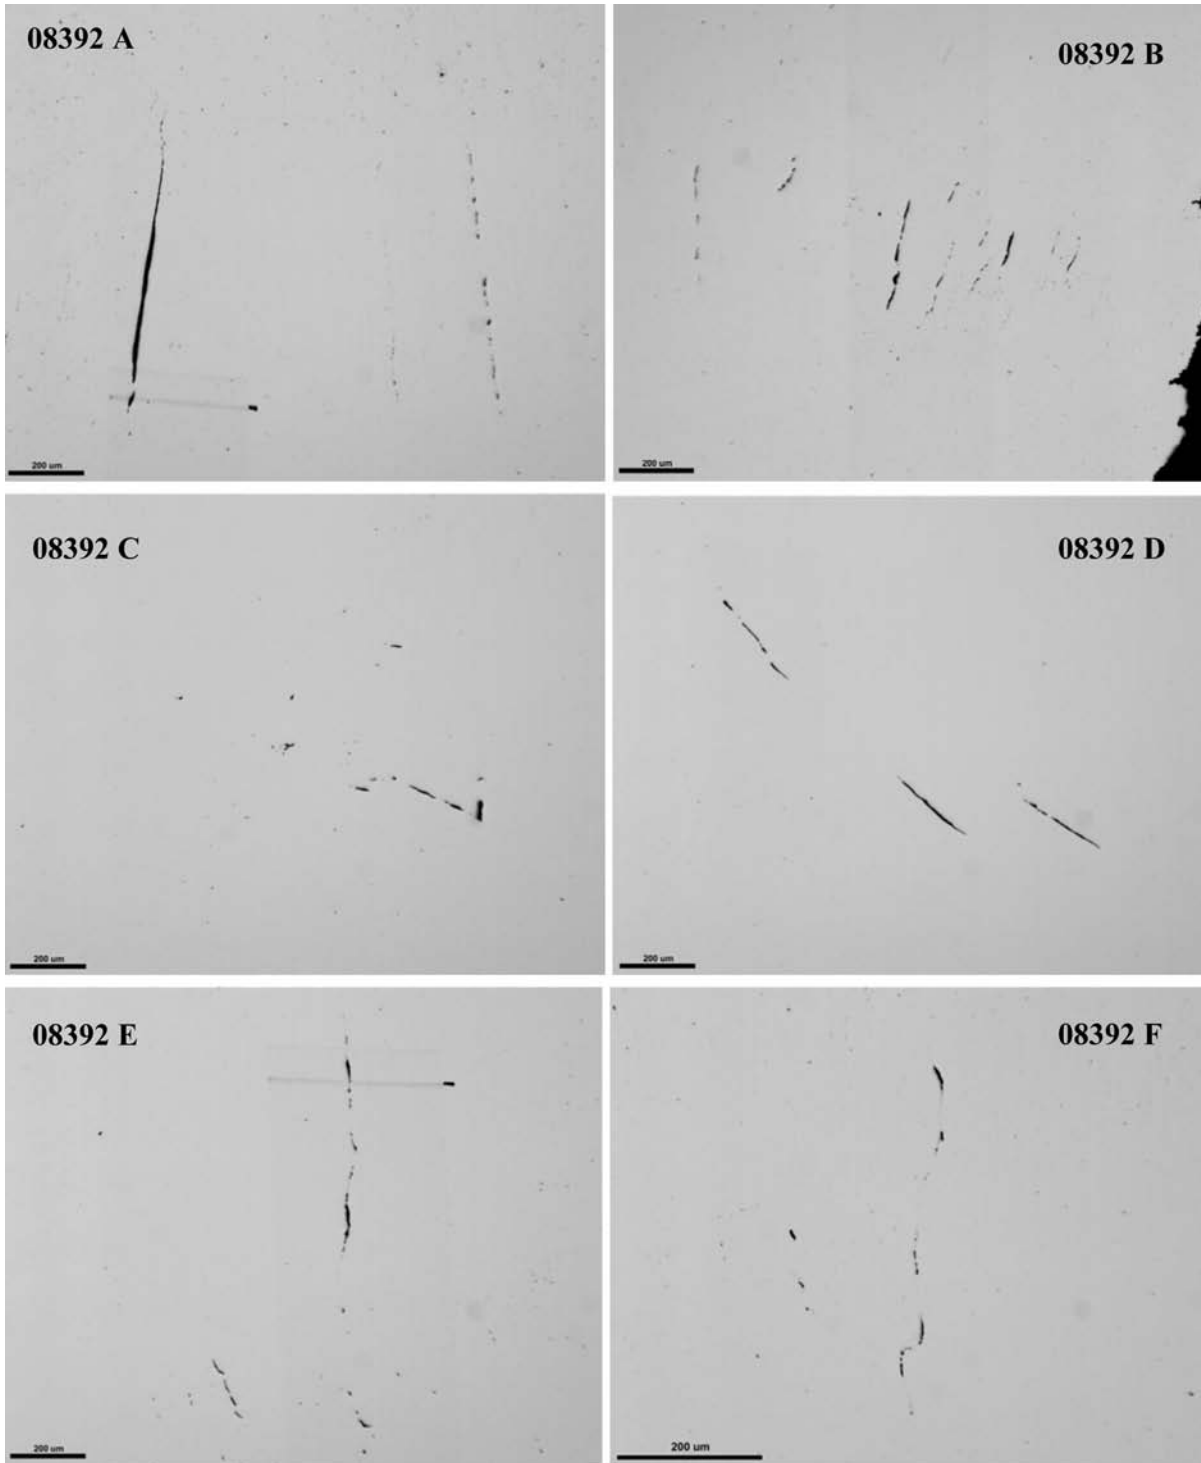
Figure 3.8. Weld Cracks in Alloy 52 Weld Metal Adjacent to Main Crack as Illustrated in Figure 3.7. Scale markers in lower left of each micrograph represent 200 μm.

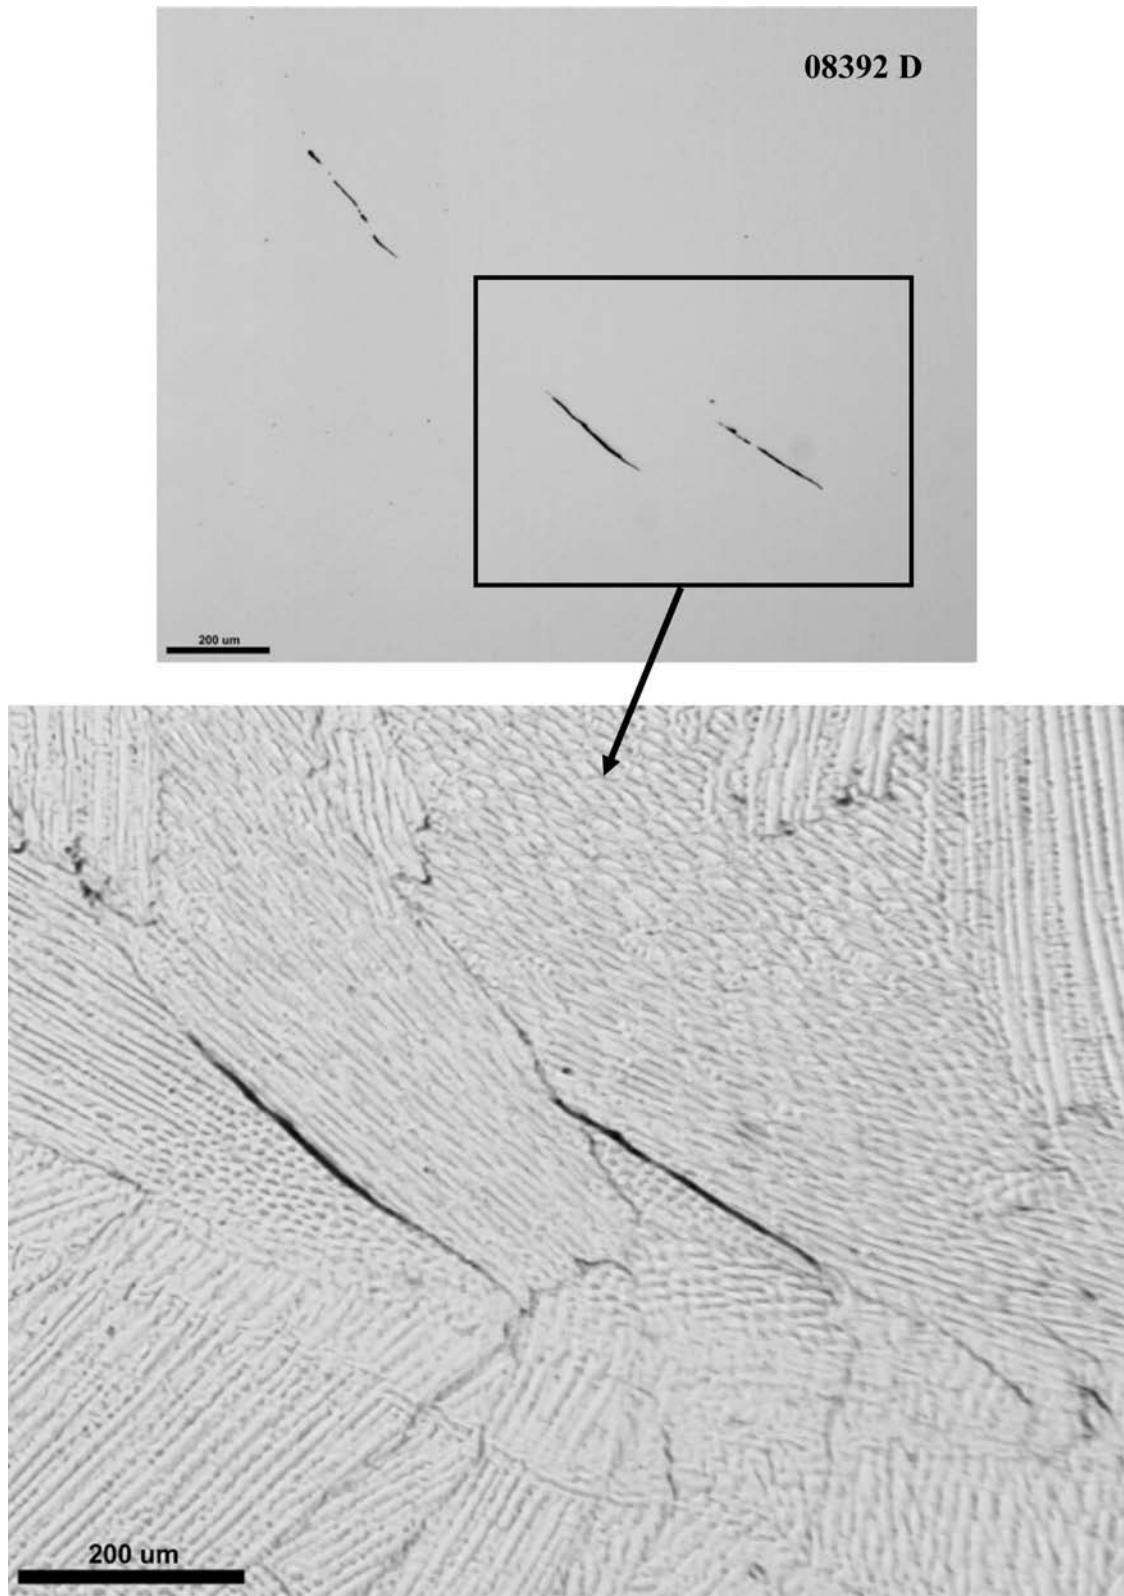
Figure 3.9. Etched Weld Microstructure is Shown to Illustrate the Typical Morphology of the Cracks in the MHI Alloy 52 Weld Metal

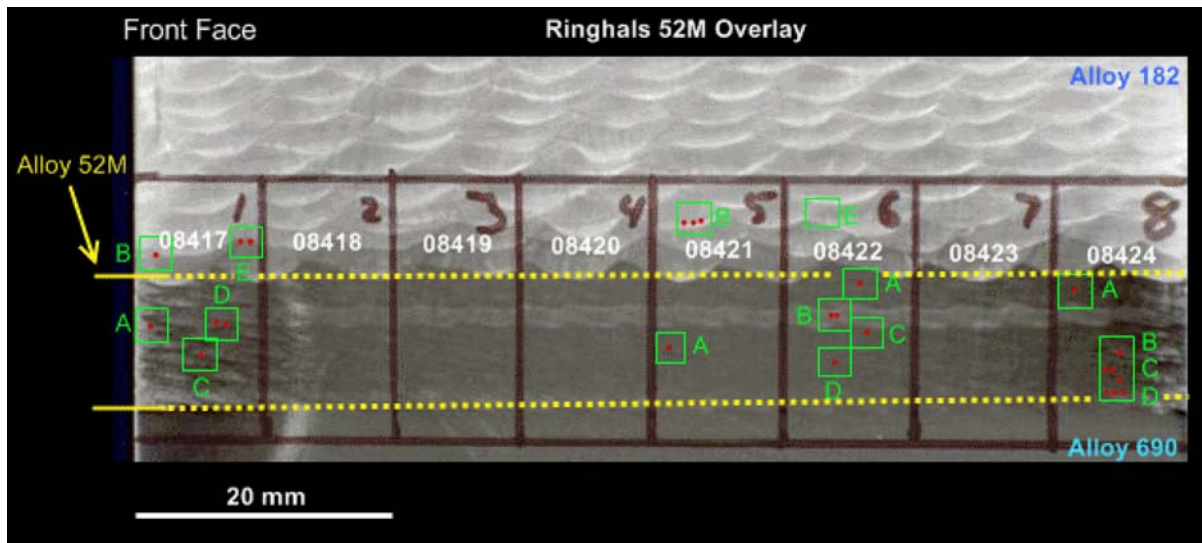
Figure 3.10. Overview Image of the Alloy 52M – Alloy 182 Overlay Slice A (front face) Showing the Alloy 690, Alloy 52M, and Alloy 182 Layers Along with Selected Regions of Analysis

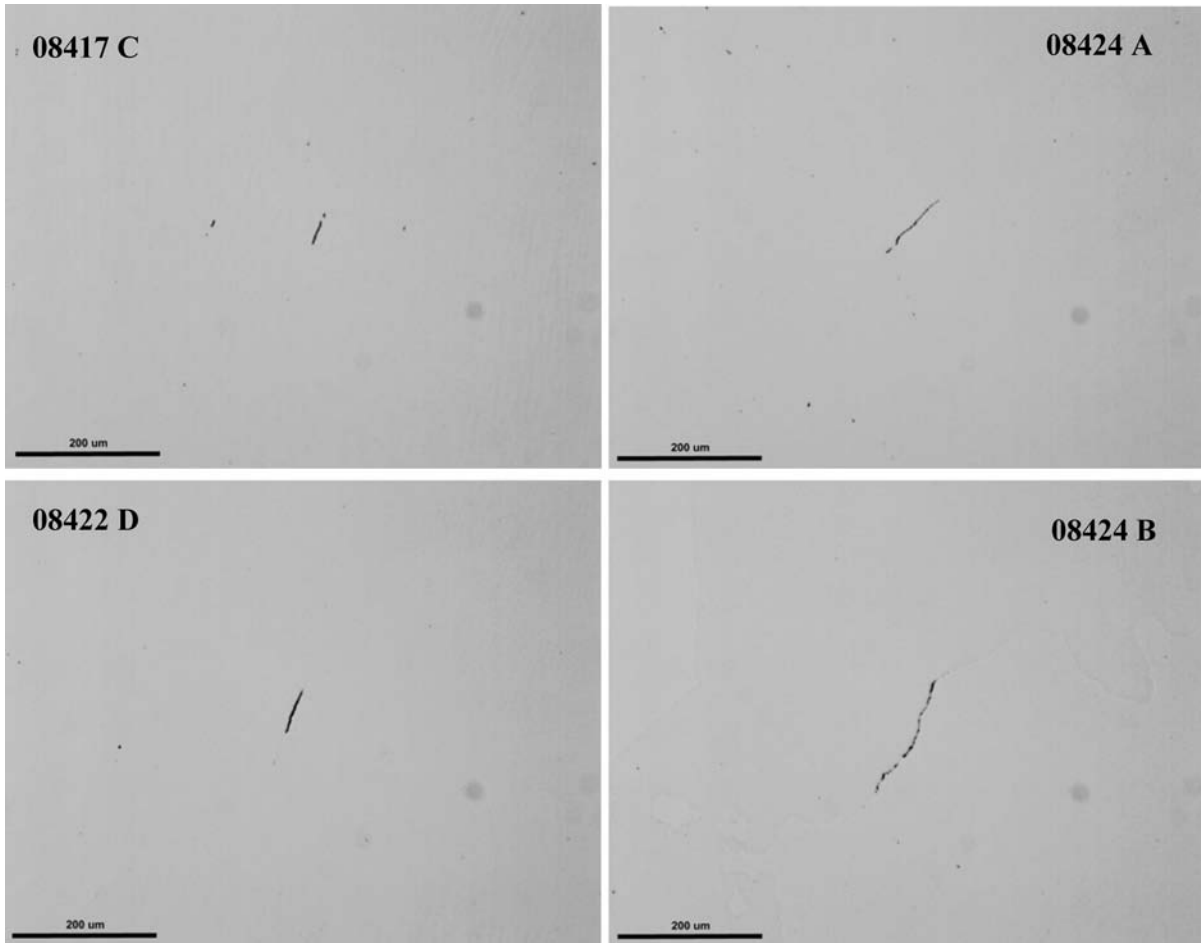
Figure 3.11. Optical Metallographs Illustrating Regions in the Alloy 52M Overlay Slice A (front face) Containing Weld Cracks. Scale markers in lower left of each micrograph represent 200 μm.

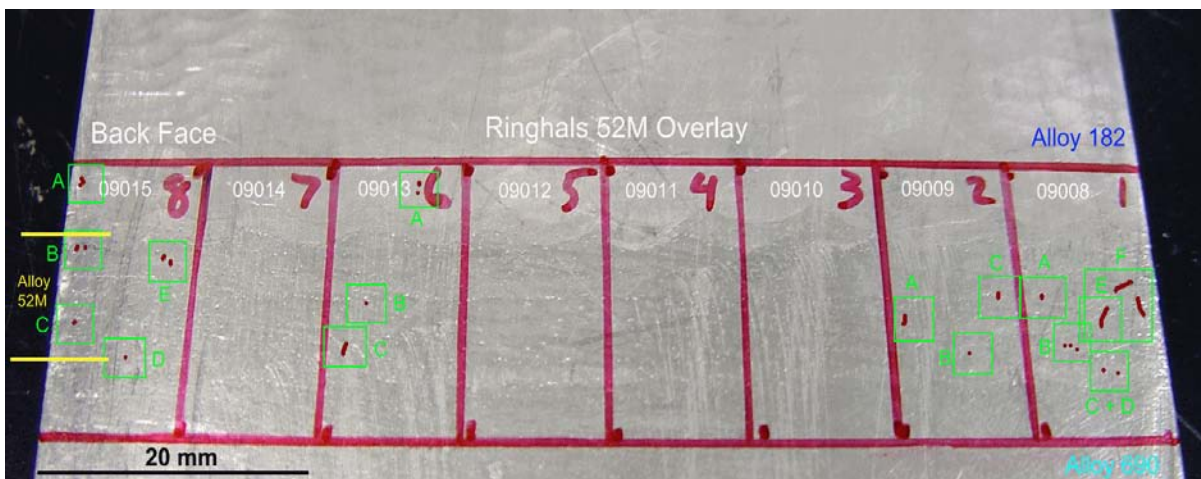
Clusters of weld cracks were also found in the back face slice of the Ringhals Alloy 52M overlay mockup as shown in Figure 3.12 with the location of the clusters matching the location found in the front face slice. The clustering of the cracks suggests some characteristic difference in the weld material or welding parameters in these regions on the overlay mockup. Examples of weld cracks found in this back face slice are shown in Figure 3.13. Several of the metallographic specimens were subsequently etched to reveal the location of the weld cracks relative to the grain structure as shown in Figure 3.14 and Figure 3.15. As with the MHI Alloy 52 U-groove mockup, the weld cracks are located on grain boundaries with no outstanding features explaining their presence on these particular interfaces.

Figure 3.12. Overview Image of the Alloy 52M – Alloy 182 Overlay Slice B (back face) Showing Selected Regions of Analysis

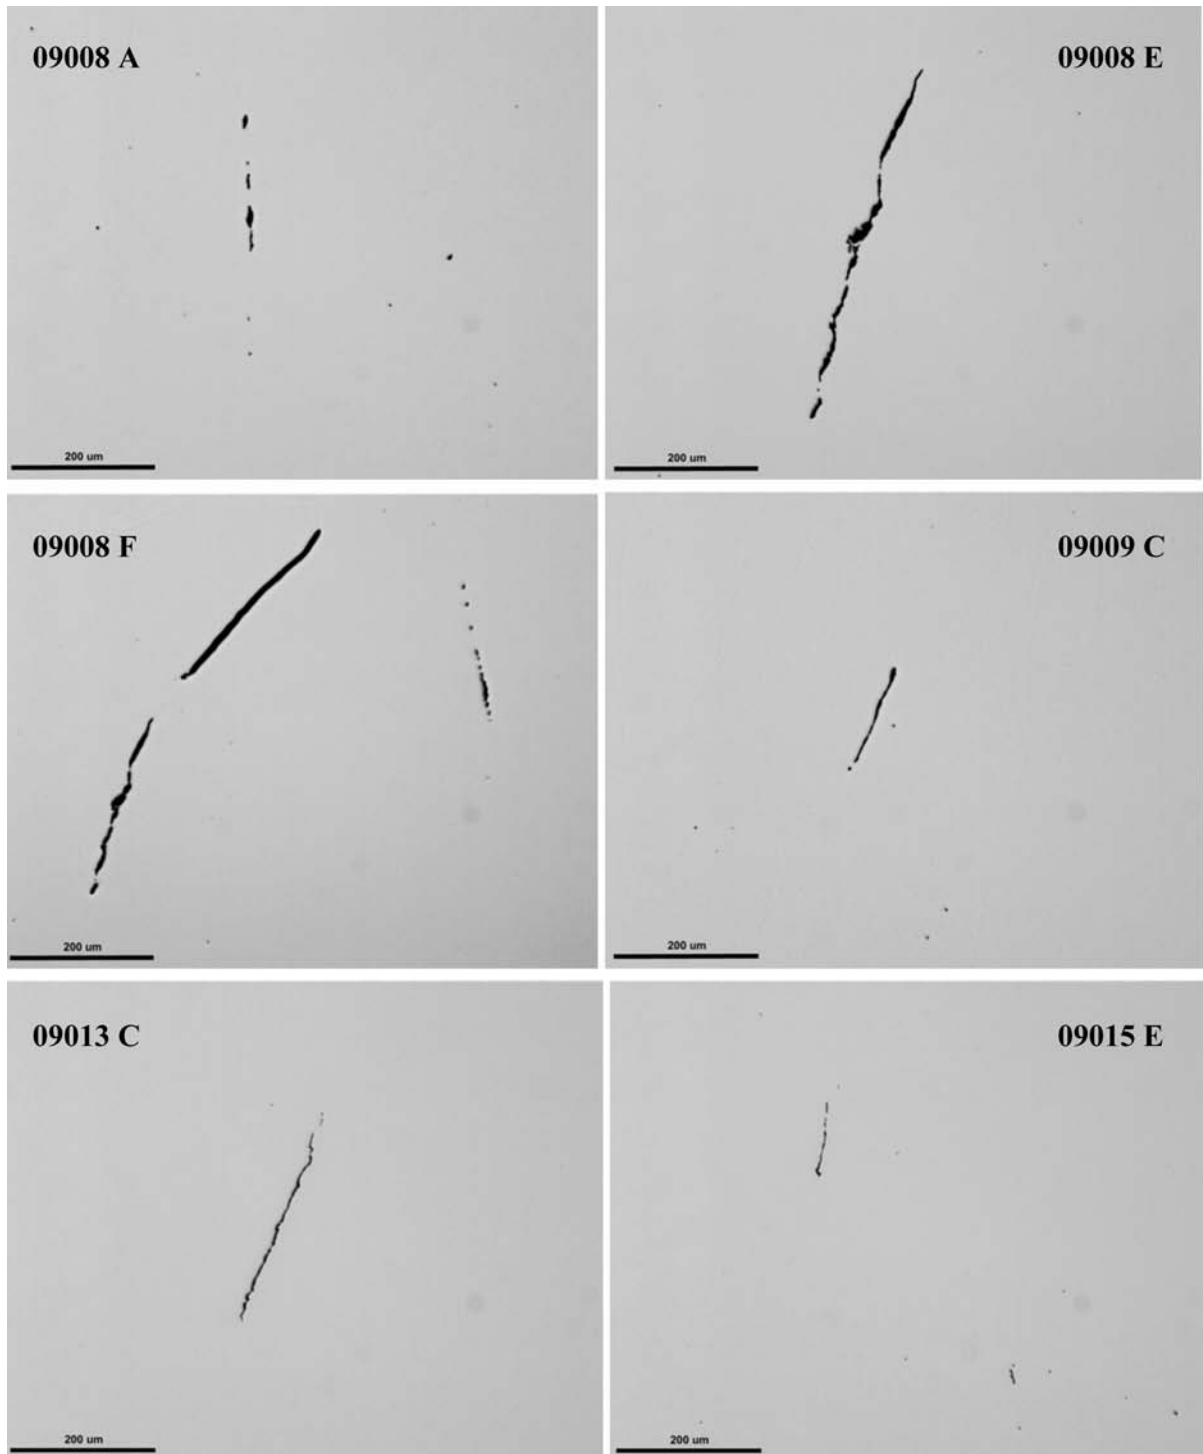
Figure 3.13. Optical Metallographs Illustrating Regions in the Alloy 52M Overlay Slice B (back face) Containing Weld Cracks. Scale markers in lower left of each micrograph represent 200 μm .

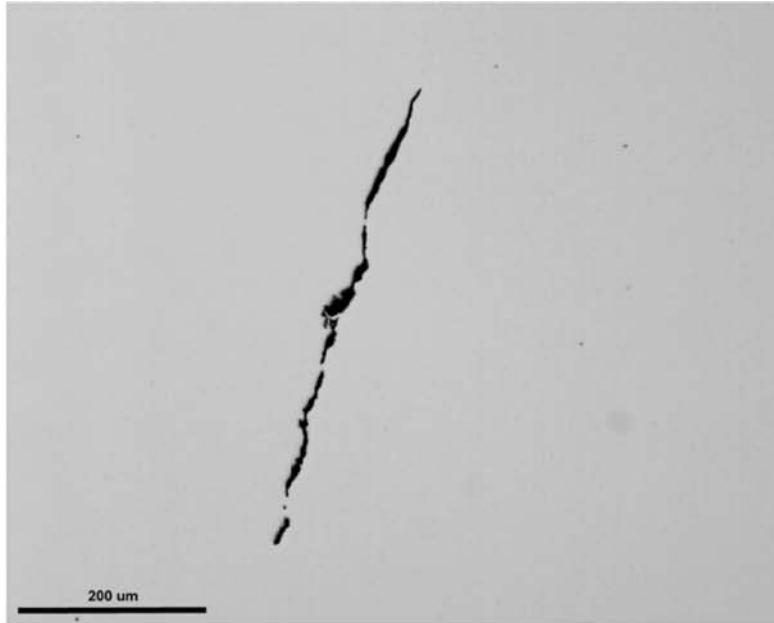
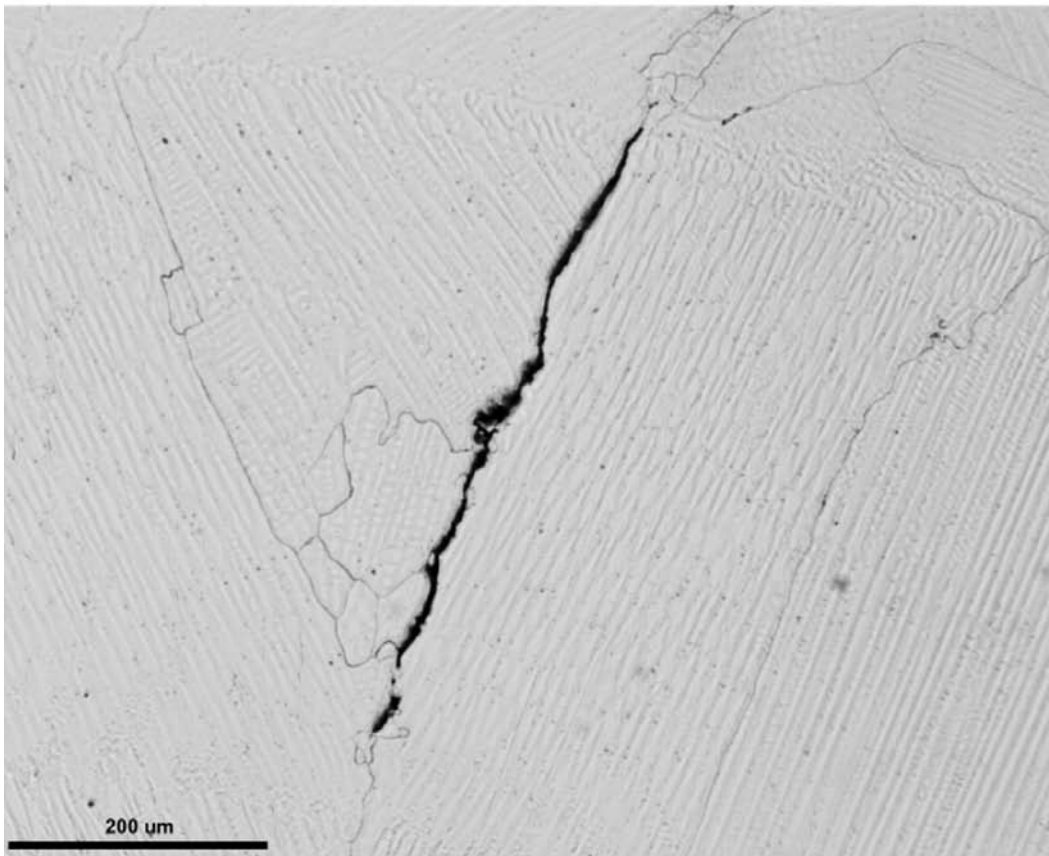
Figure 3.14. Etched Weld Microstructure is Shown to Illustrate the Typical Morphology of the Cracks in the Alloy 52M Overlay

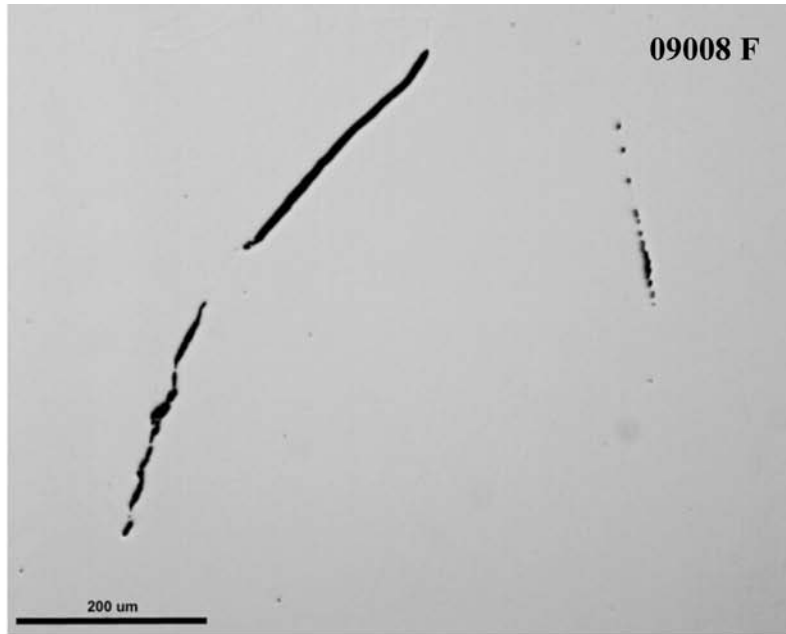
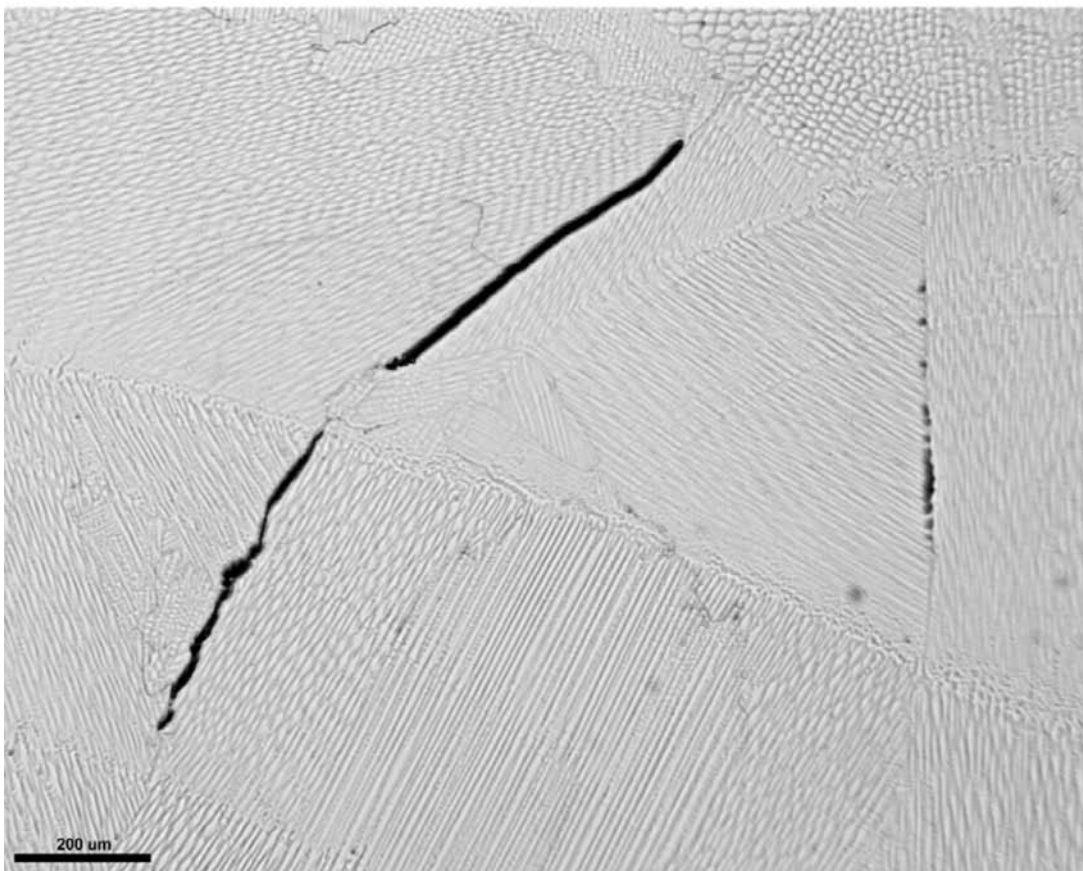
Figure 3.15. Etched Weld Microstructure is Shown to Illustrate the Typical Morphology of the Cracks in the Alloy 52M Overlay

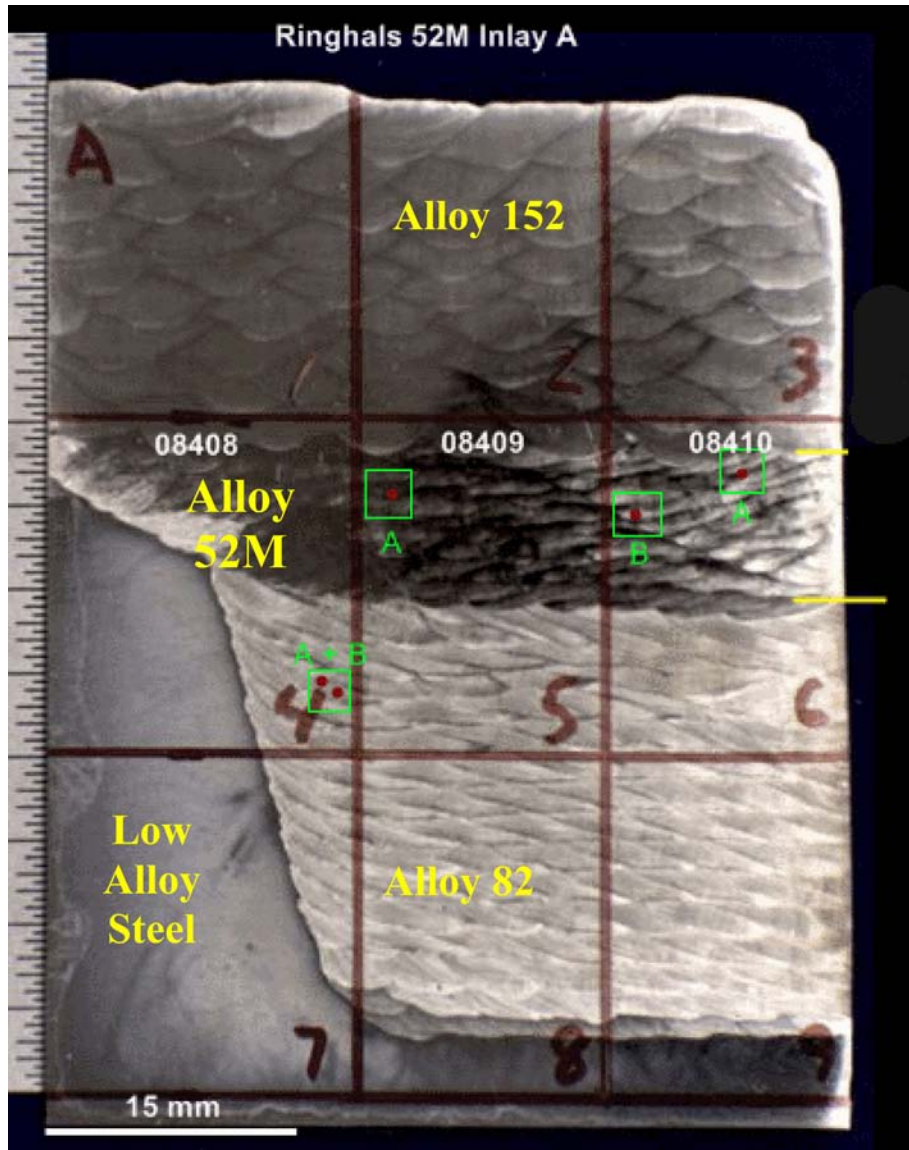
An overview of the Ringhals Alloy 52M inlay slice “A” with the cut plan is shown in Figure 3.16. The small green boxes again identify sections that were examined in detail. Several indications of cracking in the upper region of the Alloy 52M weld were observed during preliminary examination, but only one indication was determined to be a weld crack as shown in Figure 3.17. Some small cracks were also found in the Alloy 82 weld metal in one region.

Figure 3.16. Overview Image of the Alloy 52M Inlay Mockup Slice A Showing the Low-Alloy Steel, Alloy 82, Alloy 52M and Alloy 152 Layers Along with Selected Regions of Analysis

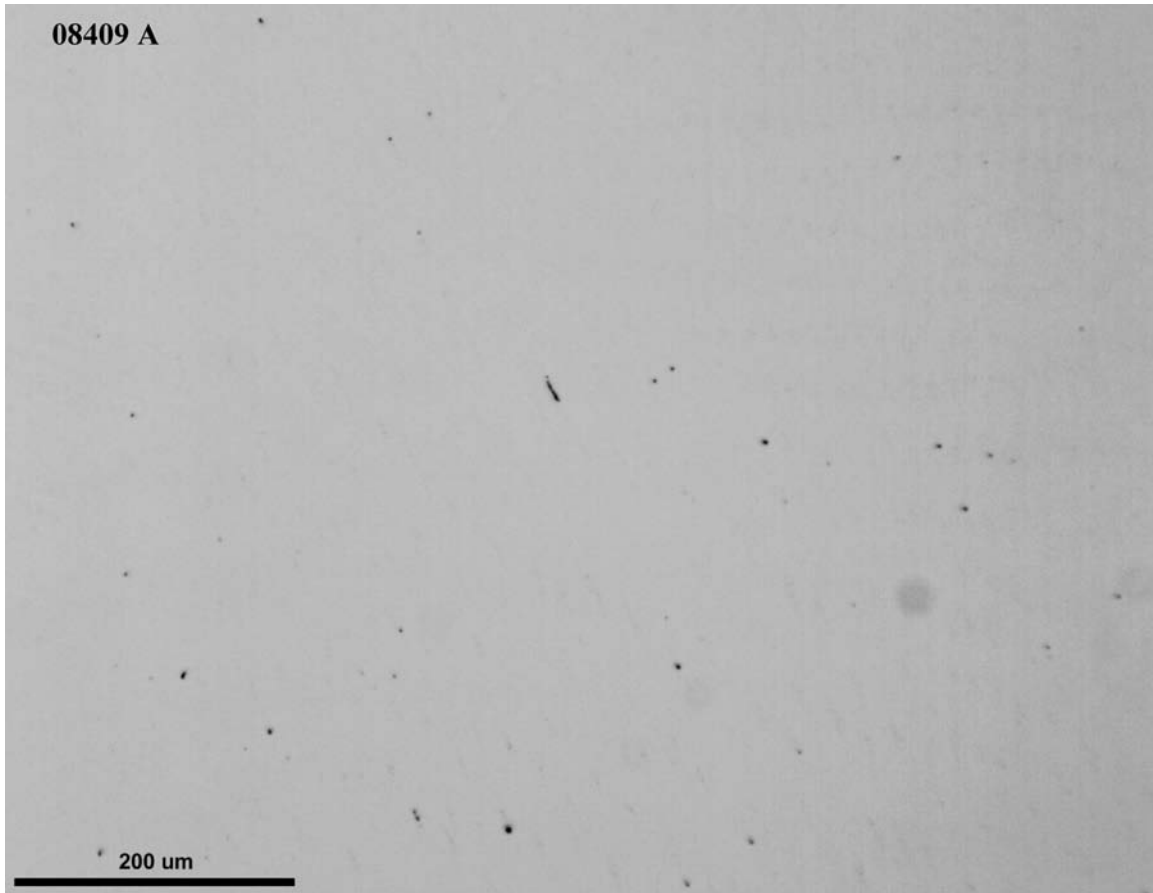
Figure 3.17. Optical Metallograph Illustrating a Region in the Alloy 52M Inlay Slice A Containing Small Pits Probably Resulting from Particle Pullout during Polishing. The only evidence for a weld crack in this slice is shown.

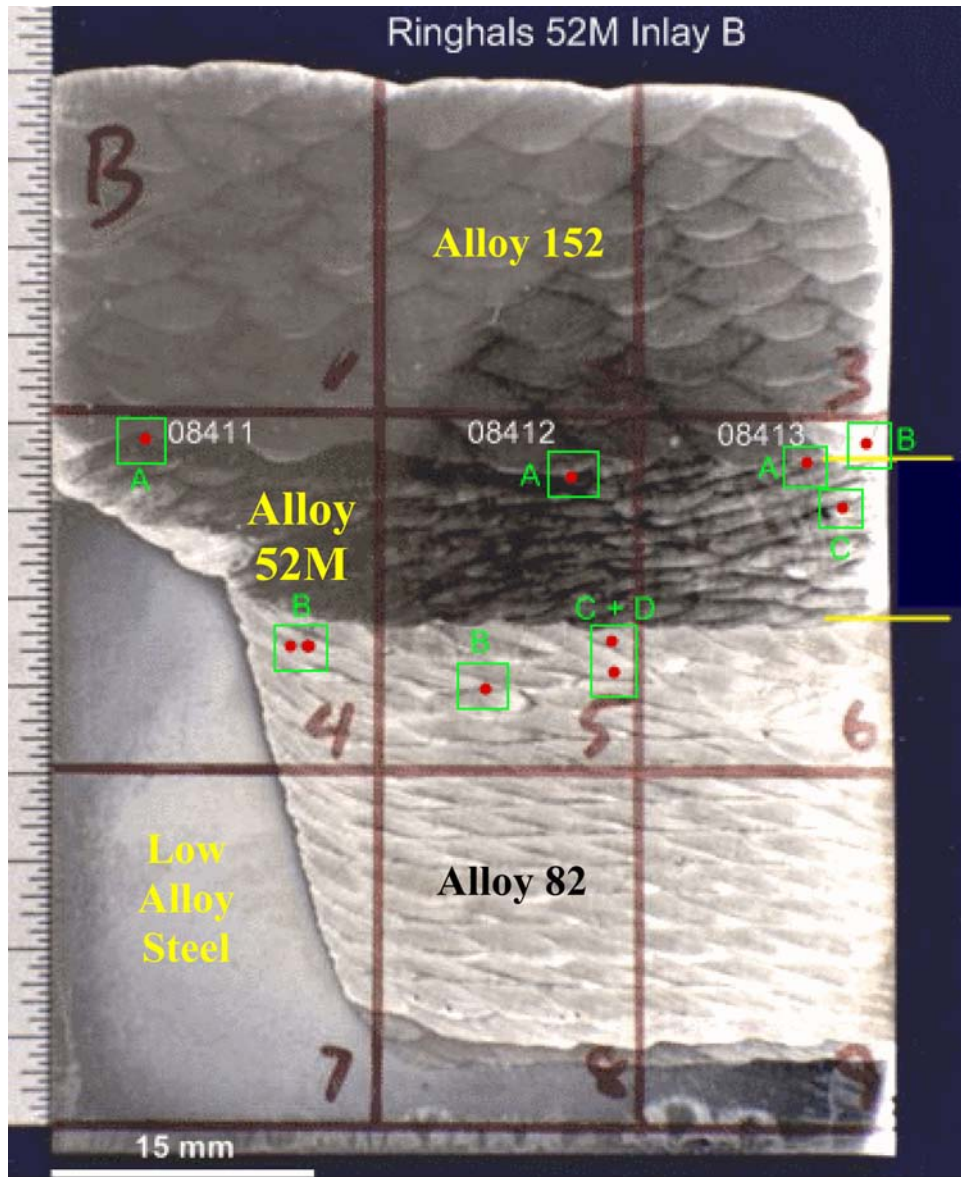
Figure 3.18. Overview Image of the Alloy 52M Inlay Mockup Slice B Showing the Low-Alloy Steel, Alloy 82, Alloy 52M and Alloy 152 Layers Along with Selected Regions of Analysis

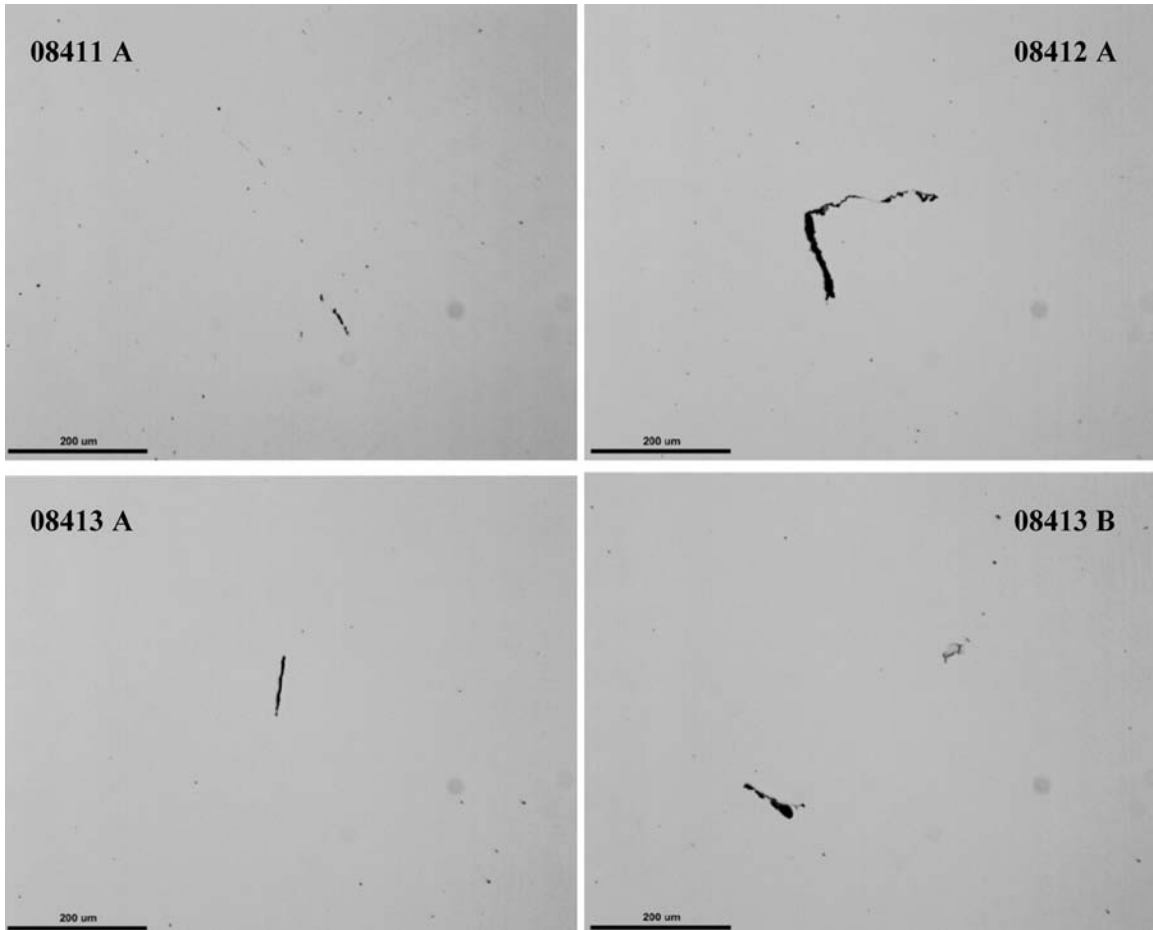
Figure 3.19. Optical Metallographs Illustrating Regions in the Ringhals Alloy 52M inlay Mockup Slice B Containing Small Weld Cracks in the Alloy 52M Weld Metal. Scale markers in lower left of each micrograph represent 200 μm .

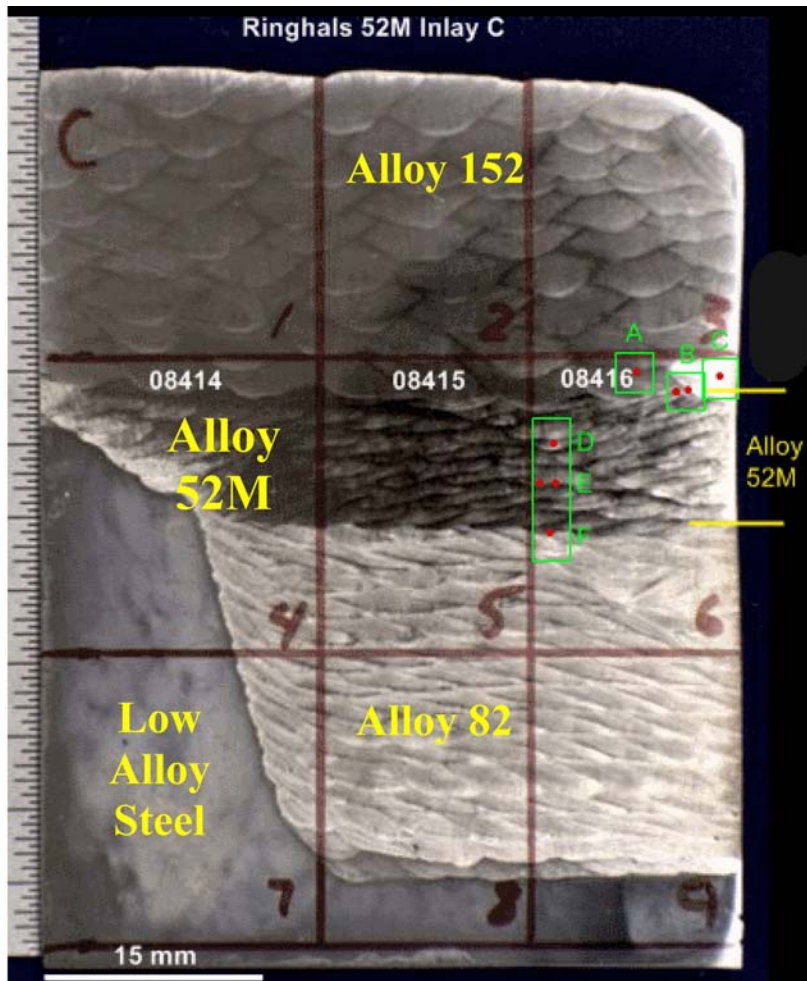
An overview image of the Ringhals Alloy 52M inlay mockup, slice C, is shown in Figure 3.20. Several short and long cracks were observed in the Alloy 52M inlay with two examples of longer weld cracks shown in Figure 3.21. The weld cracks were clustered in one region slightly to the right of center of the slice.

Figure 3.20. Overview Image of the Ringhals Inlay Mockup Slice C Showing Regions Where Indications of Weld Cracks were Observed and Analyzed
