Preliminary Examination of Cracks in Alloy 152, 52, and 52M Weld Metals

MB Toloczko
MJ Olszta

January 2010

Prepared for
U.S. Nuclear Regulatory Commission
under a Related Services Agreement
with the U.S. Department of Energy
Contract DE-AC05-76RL01830
NRC Project JCN N6547

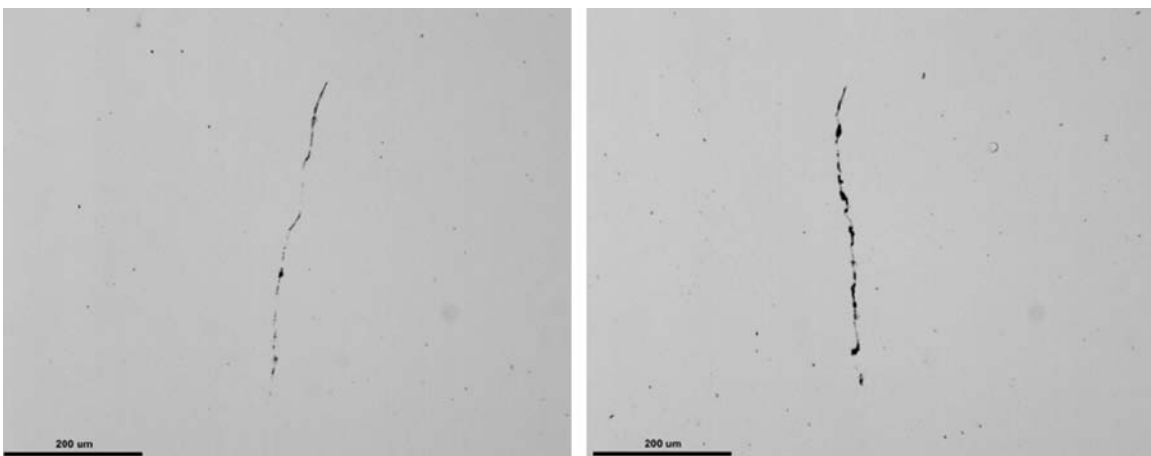
Figure 3.21. Two Examples of Weld Cracks Found in Ringhals Inlay Mockup Slice C. The scale markers on the images represent 200 µm.

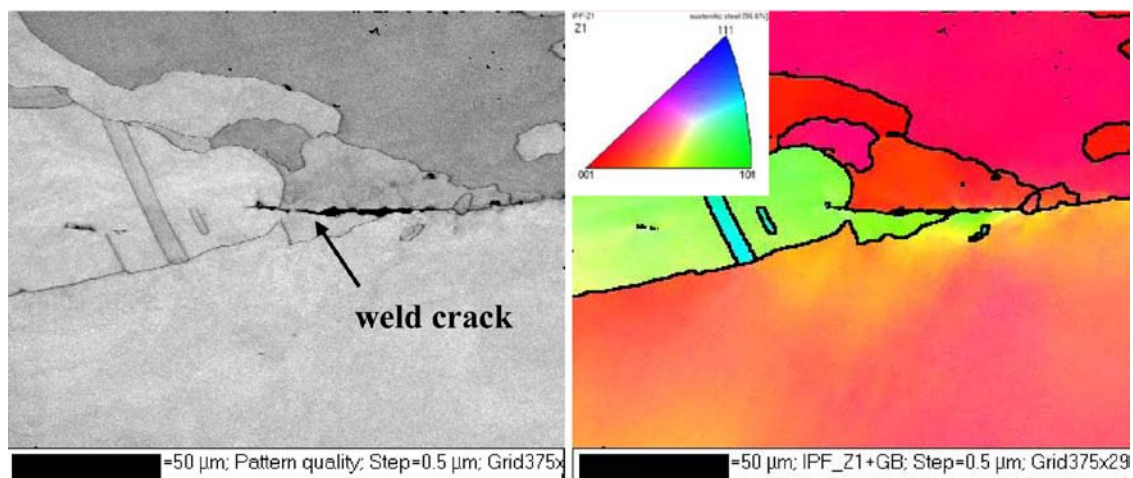
Figure 4.1. EBSD Pattern Quality and IPF-Z Images of a Weld Crack in the Ringhals Alloy 52M Inlay (C-6) Showing Weld Metal Microstructure, Crack Morphology, and Areas of Deformation

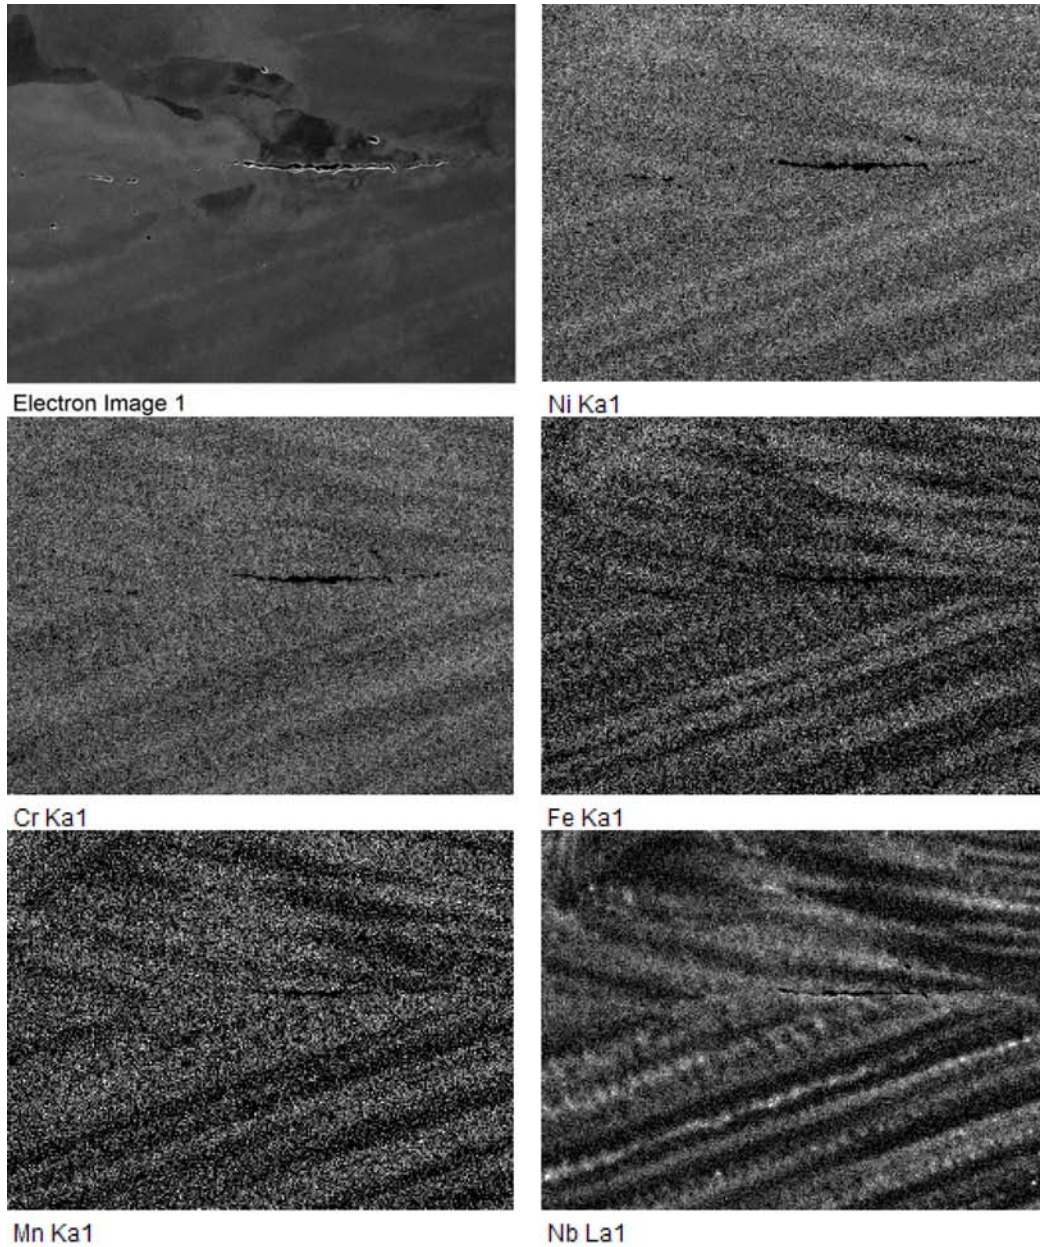
Figure 4.2. SEM-BSE Image and EDS Maps of the Ringhals Alloy 52M Inlay Weld (C-6) Revealing Significant Compositional Variations within Grains Particularly for Nb

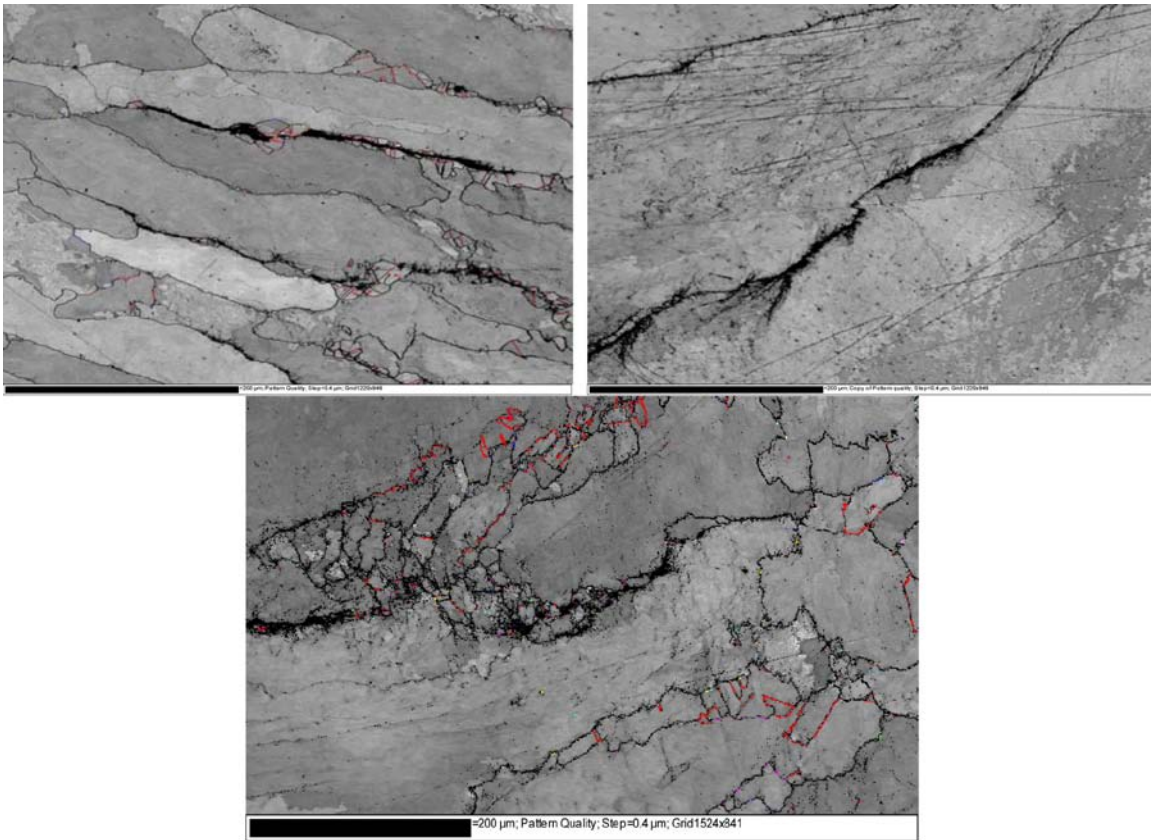
Figure 4.3. EBSD Pattern Quality Images of Three Regions of Cracks in the MHI Alloy 52 U-Groove Weld Where EBSD Characterization was Performed. Each region is near the main center crack shown in Figure 3.7 and these cracks are represented by the optical images in Figure 3.8.

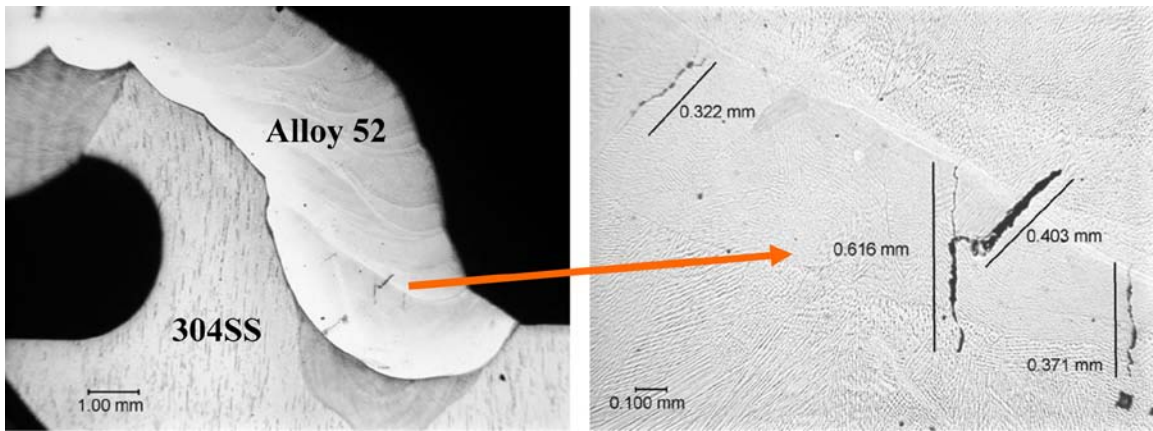
Figure 4.8. Optical Micrographs Provided by Ringhals Showing an Alloy 52 Weld Metal Overlay on a 304SS Housing. An example of a large crack is shown.

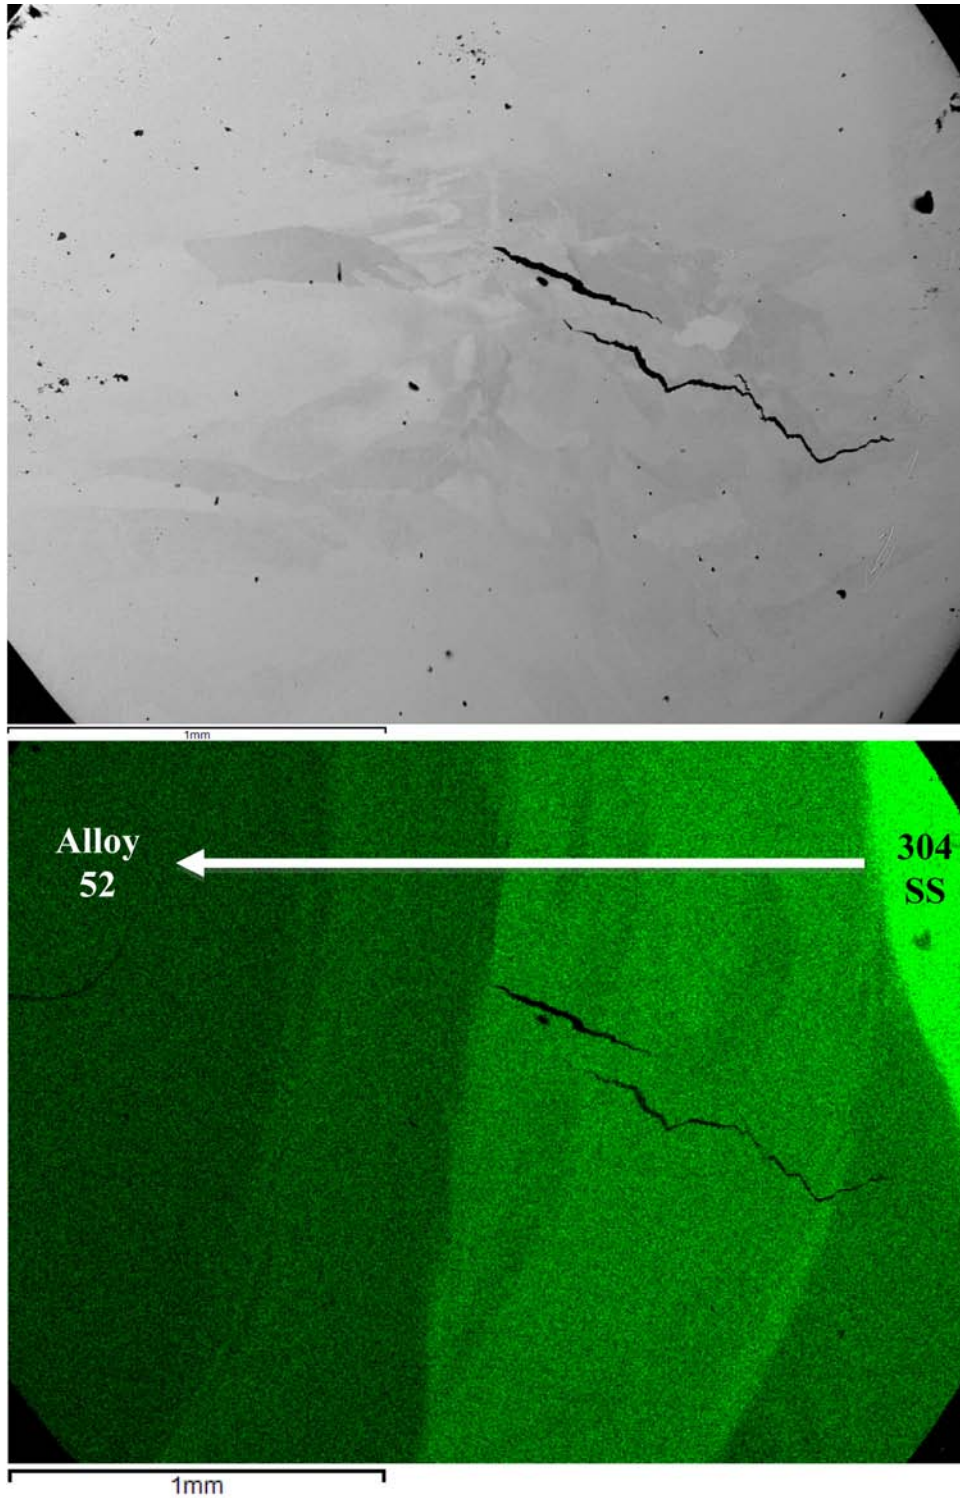
Figure 4.11. SEM and EDS Compositional Map for Fe Illustrating Location of Hot Cracks in the Dilution Layer Between Alloy 52 and 304SS for Overlay Sample VY3

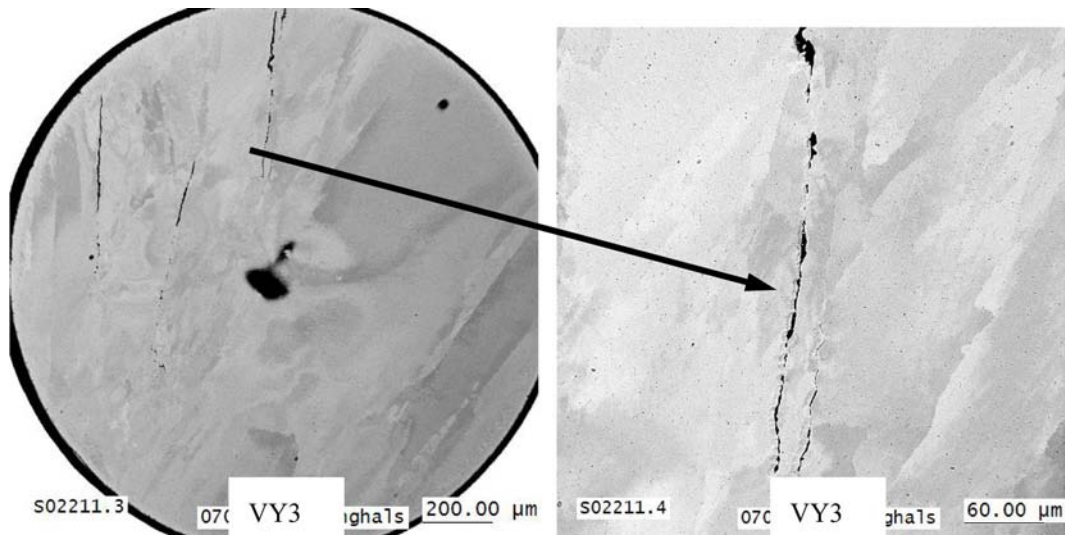
Figure 4.15. Backscatter SEM Images Showing Weld Cracks in Alloy 52 Overlay Sample VY3 and Identifying Region for ATEM Examinations

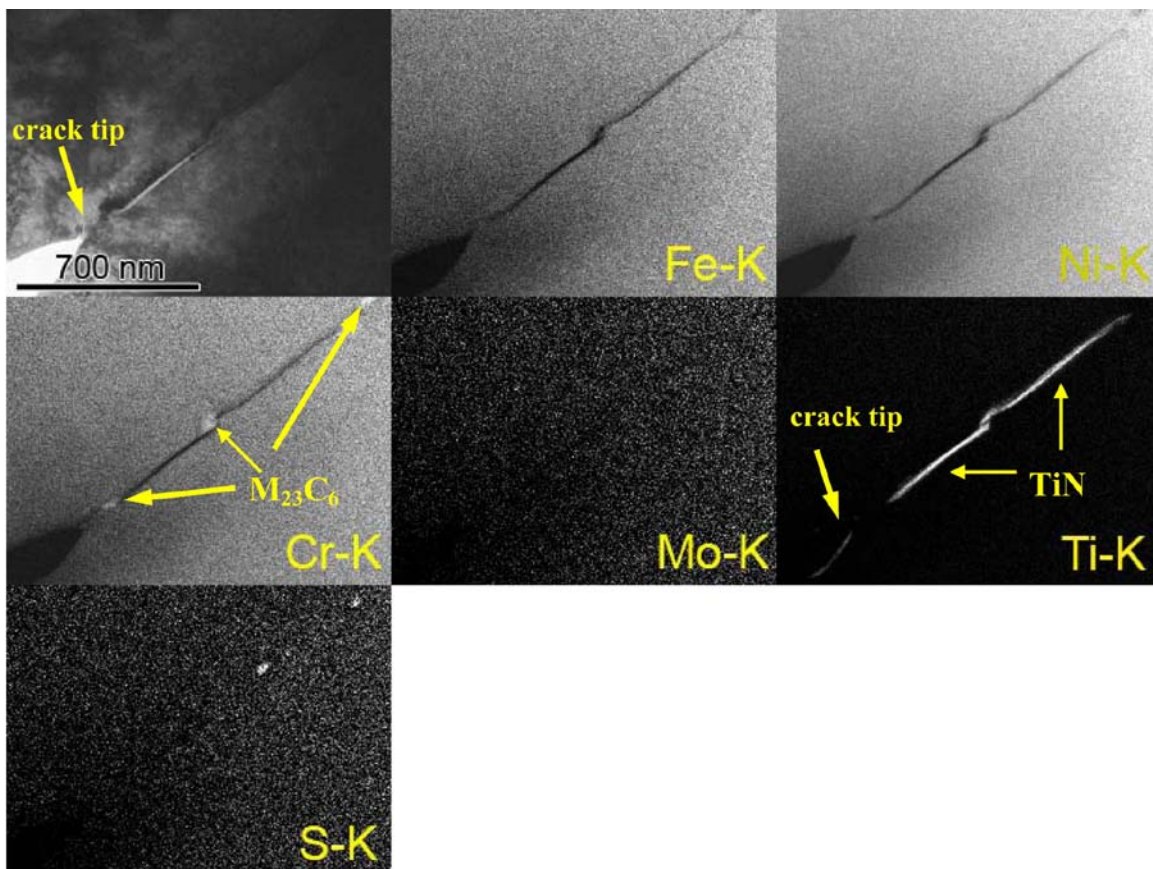
Figure 4.16. TEM Micrograph and Elemental Maps of an IG Crack in Sample VY3. A continuous TiN phase is observed along the grain boundary in front of the crack.

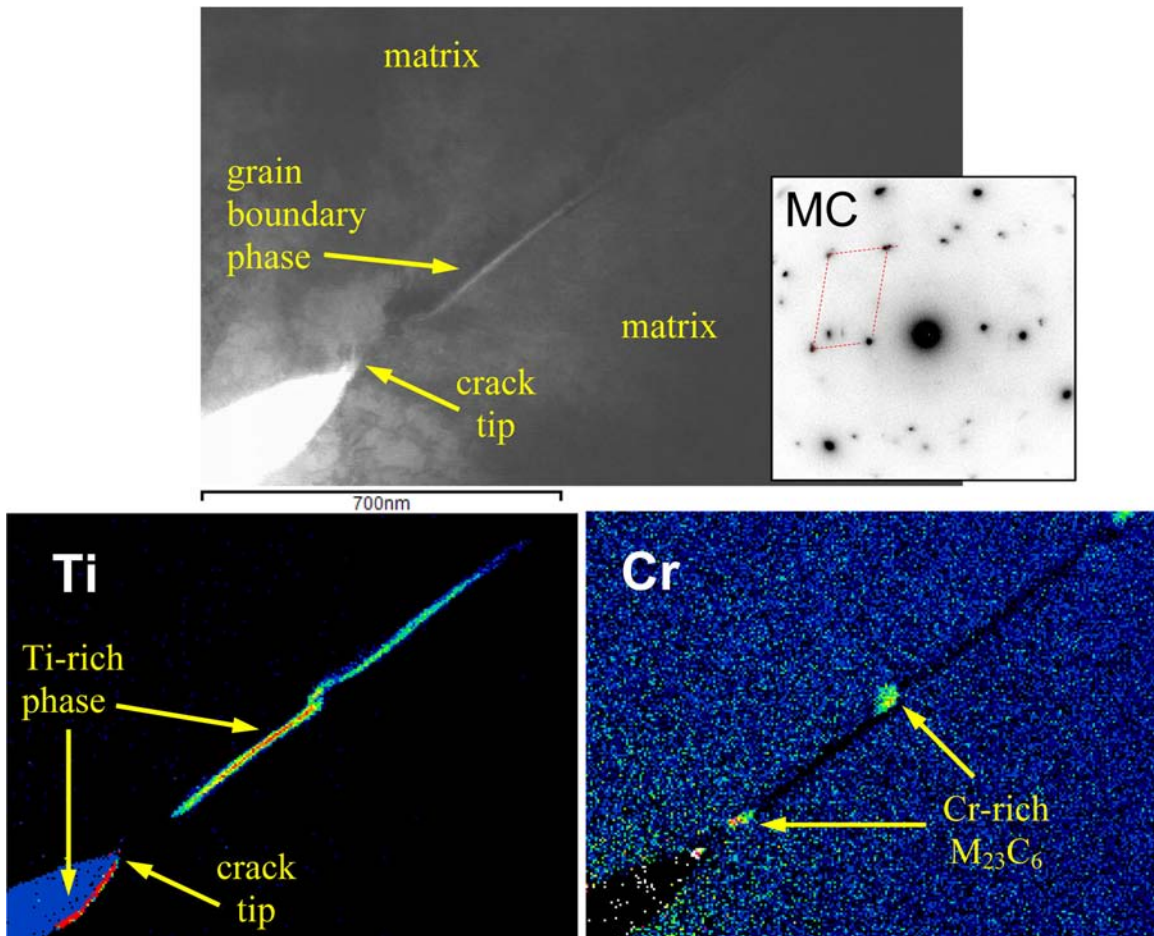
Figure 4.17. Higher Magnification Examination of the Crack-Tip Region Shown in Figure 4.16: (a) TEM bright-field image and selected area diffraction identifying a thin MC-structure second phase; (b) EDS map for Ti demonstrating that the thin phase is highly Ti rich and is located on one side of the crack wall and elongated along the grain boundary; and (c) EDS map for Cr highlighting several IG Cr-rich carbides.

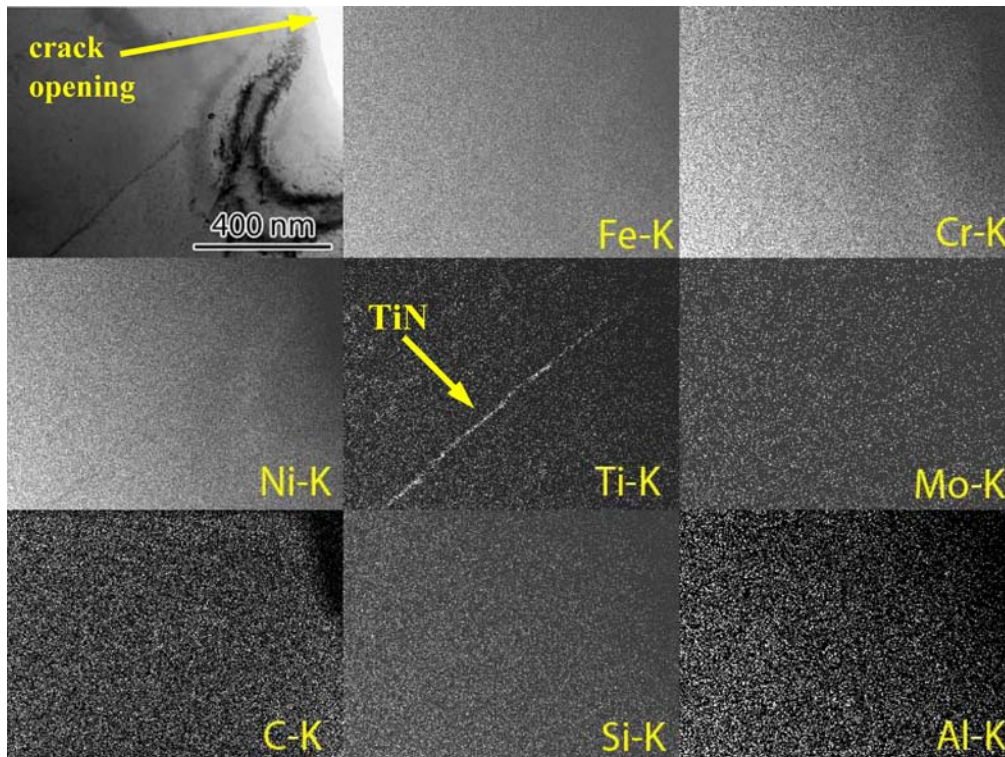
Figure 4.18. Scanning TEM Micrograph and Elemental Maps of a Grain Boundary Leading a Weld Crack in Sample VY3. A nearly continuous TiN phase is observed along the grain boundary in front of the crack. The crack opening appears large and rounded due to repetitive ion milling to thin the grain boundary region in front of the crack.

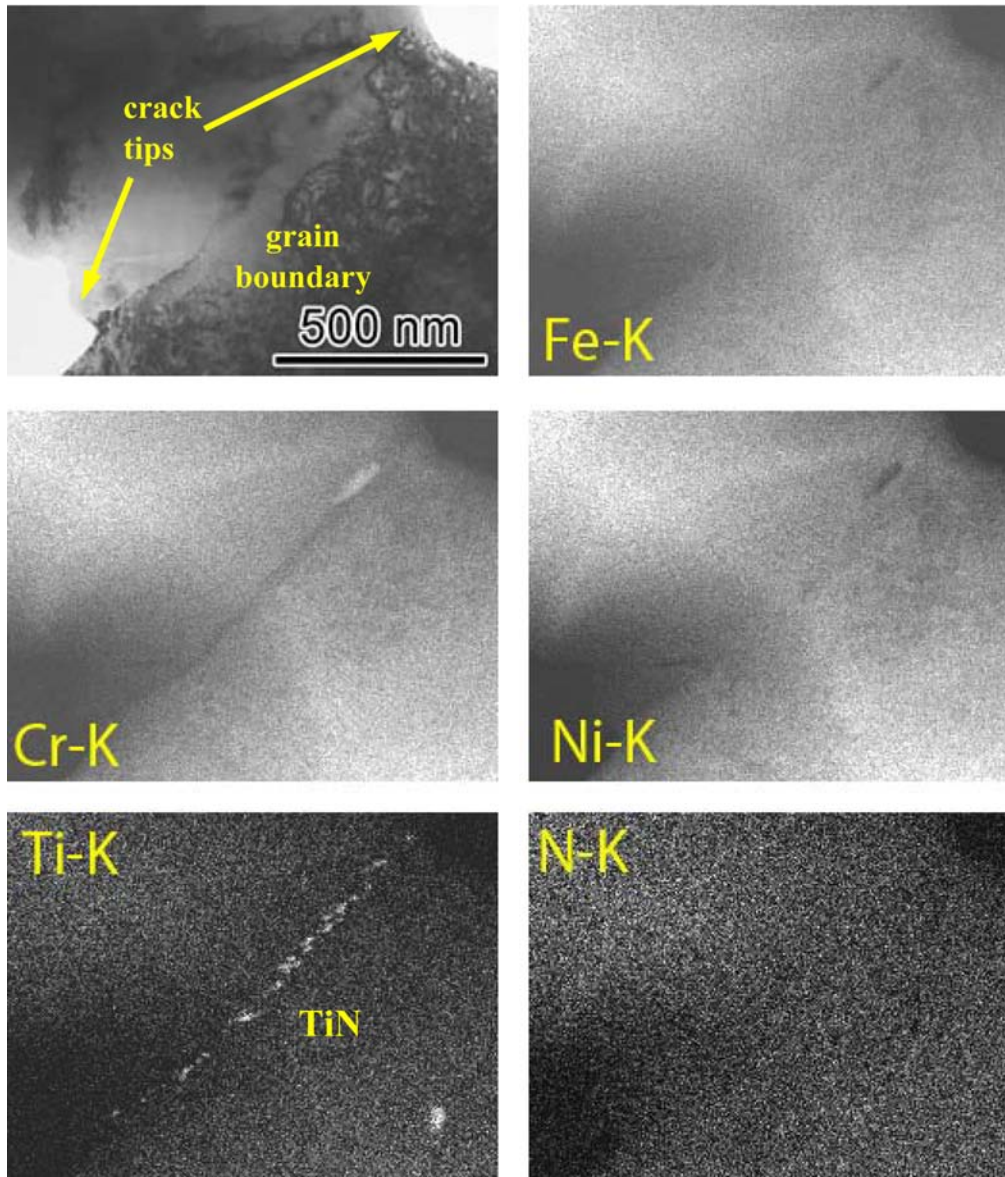
Figure 4.19. EDS Elemental Maps Illustrating Small TiN_2 Particles and One Large M_{23}C_6 Carbide Along a Grain Boundary Along the Path of a Hot Crack. Nitrogen cannot be detected in the TiN particles by EDS mapping because of the weak N-K signal.
