Subject: Duke Energy Carolinas, LLC (Duke)
McGuire Nuclear Station, Unit 1
Docket No. 50-369
Relief Request Serial #09-MN-002
Response to Request for Additional Information

Relief Request 09-MN-002

Response to NRC Request for Additional Information

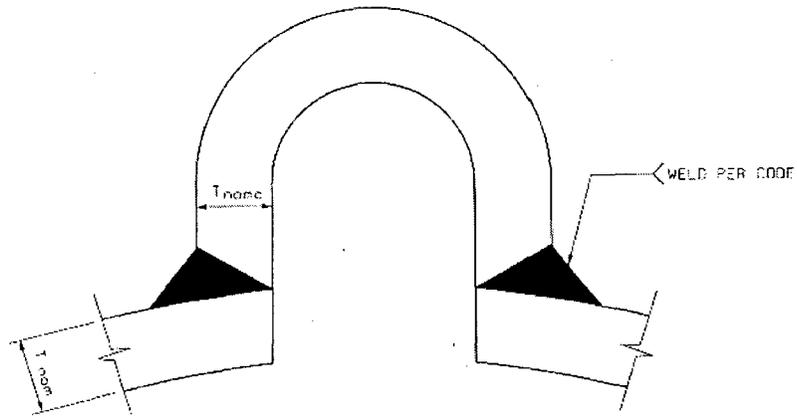
Figure 1 (Example of Code-Compliant Repair)

A code compliant repair can be accomplished by welding a coupling or pipe cap to the exterior surface of the component, provided the defective portion of the component wall has been removed and is not relied on for pressure boundary integrity. For this type of repair, a relief request is not required. Figure 1 shows an example of a code compliant repair of this nature.

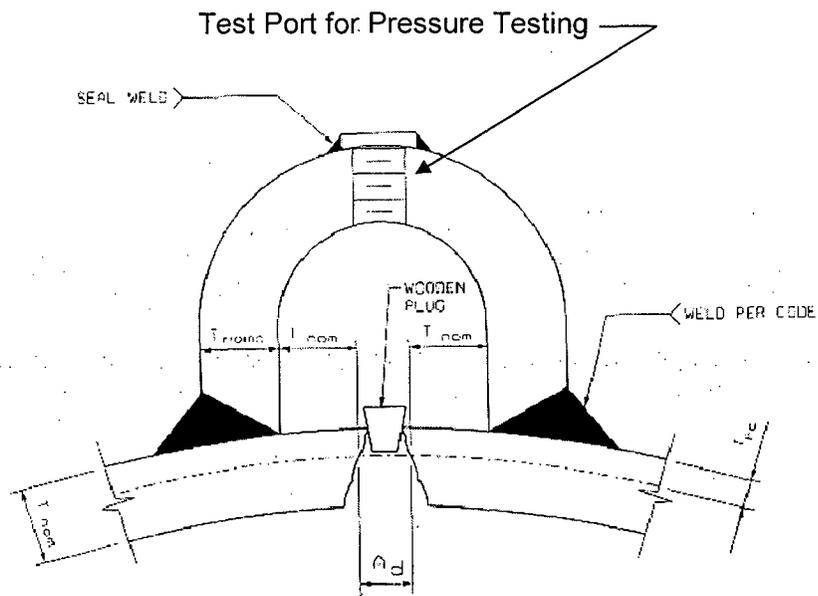
Figure 2 (Example of Repair/Replacement Conforming to Proposed Alternative)

If the defective portion of the component wall has not been removed prior to welding a coupling or pipe cap over the defective area, Duke believes that the requirement of IWA-4400 has not been met and that the repair/replacement activity is not considered to be in compliance with the requirements of the ASME Code, Section XI. Figure 2 shows an example of this type of repair/replacement activity that complies with the proposed alternative in 5.1 and 5.3.c of our request. For the proposed alternative shown in Figure 2, there is actually more material remaining in the component wall within the welded encapsulation than is provided by the code compliant repair shown in Figure 1. Please note that Duke plans to install protective coatings material into the

encapsulation following completion of the repair/replacement activity, system leakage test and VT-2 visual examination, provided the wooden plug (or other temporary seal) continues to seal the defective area sufficiently to allow for installation of the protective coatings material. Installation of protective coatings will eliminate concern that the interior surfaces of the encapsulation and its attachment weld will be subject to conditions that could cause continued corrosion. For these reasons, Duke believes that the proposed alternative provides an acceptable level of quality and safety as that afforded by the code compliant repair/replacement activity shown in Figure 1.
