LICENSEE EVENT REPORT (LER)

FACILITY NAME (1) Indian Point, Unit 3	DOCKET NUMBER (2) 0 5 0 0 0 2 8 16	PAGE (3) 1 OF 10
---	---------------------------------------	---------------------

TITLE (4)  
Unit Trip Initiated By Loss of Auto Stop Oil Pressure in Main Turbine Generator

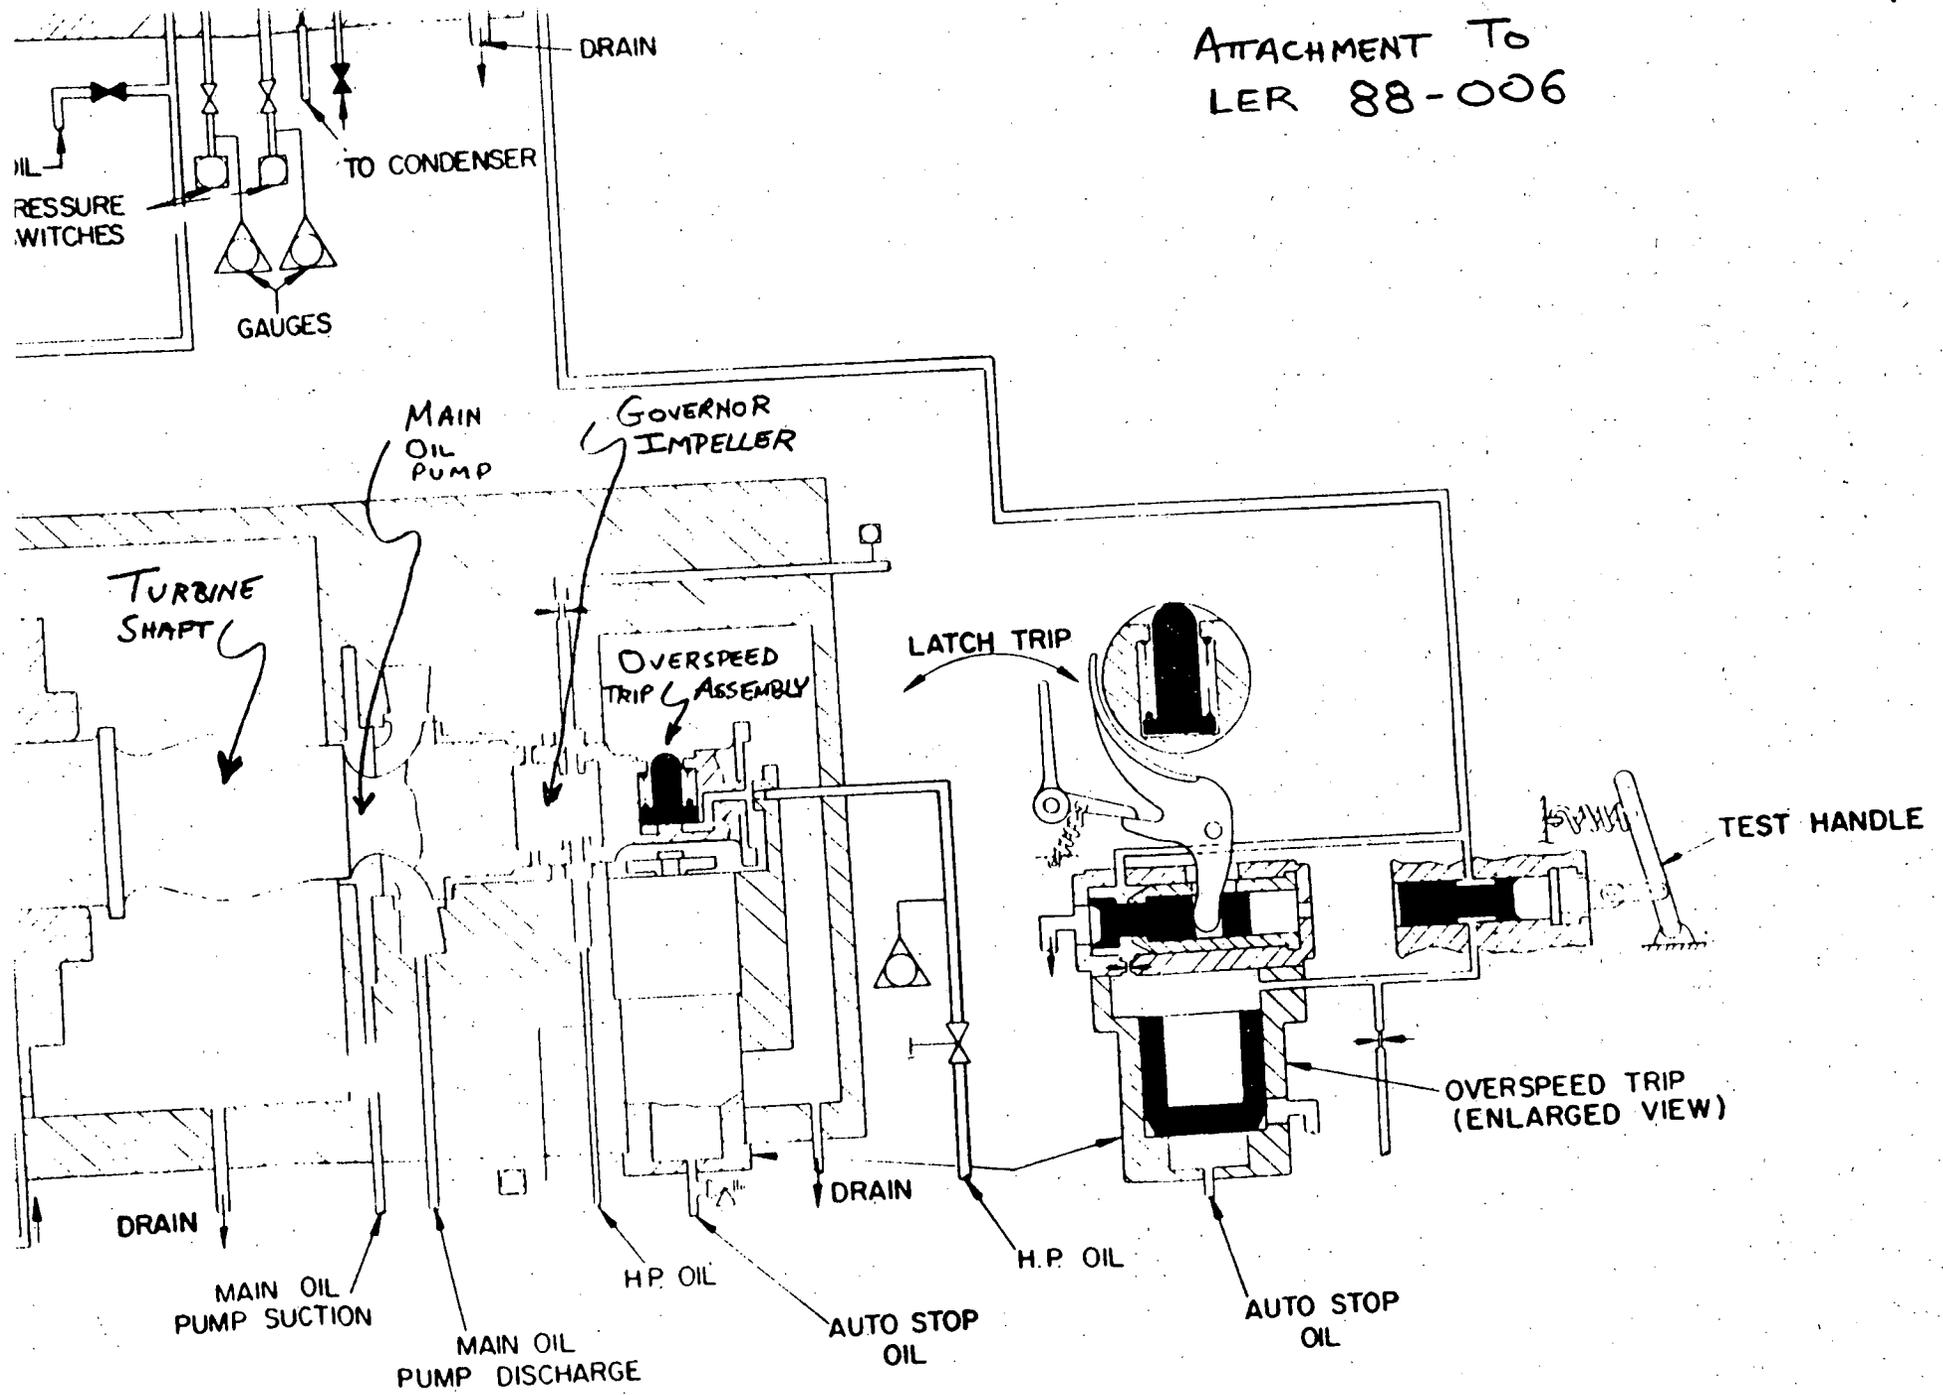
Figure 2  
I.L. 1250-3686

The trip of the main turbine generator was initiated by a loss of auto stop oil pressure resulting from the shifting of the governor impeller assembly (see attached schematic). This had occurred due to the fatigue failure of a retaining pin that restrains the governor impeller shaft in proper alignment with the MTG main oil pump.

The locking pin failure allowed the governor impeller shaft assembly to be displaced approximately three quarters of an inch, which in turn moved and actuated the overspeed trip mechanism lever. This allowed a mechanical drain valve to bleed-off the auto stop oil pressure.

The failure of the retaining pin that restricts movement of the governor impeller assembly led to the displacement of the governor impeller assembly, which actuated the overspeed trip mechanism lever.

- 1) The MTG governor was refurbished with a new impeller, sleeve, and stub shaft. As recommended by Westinghouse the governor impeller was torqued to 1,000 foot-pounds instead of the nominal 500 foot-pounds. Proper performance of the governor was operationally verified.

- 2) The MTG overspeed trip mechanism was reassembled, adjusted, and tested.
- 3) The retaining pin for the governor impeller assembly was modified to provide additional strength needed for the application.
