Subject: Indian Point 3 Nuclear Power Plant
NRC Bulletin No. 88-09: "Thimble Tube
Thinning in Westinghouse Reactors"

**ATTACHMENT I
RESPONSE TO NRC BULLETIN 88-09
THIMBLE INSPECTION RESULTS**

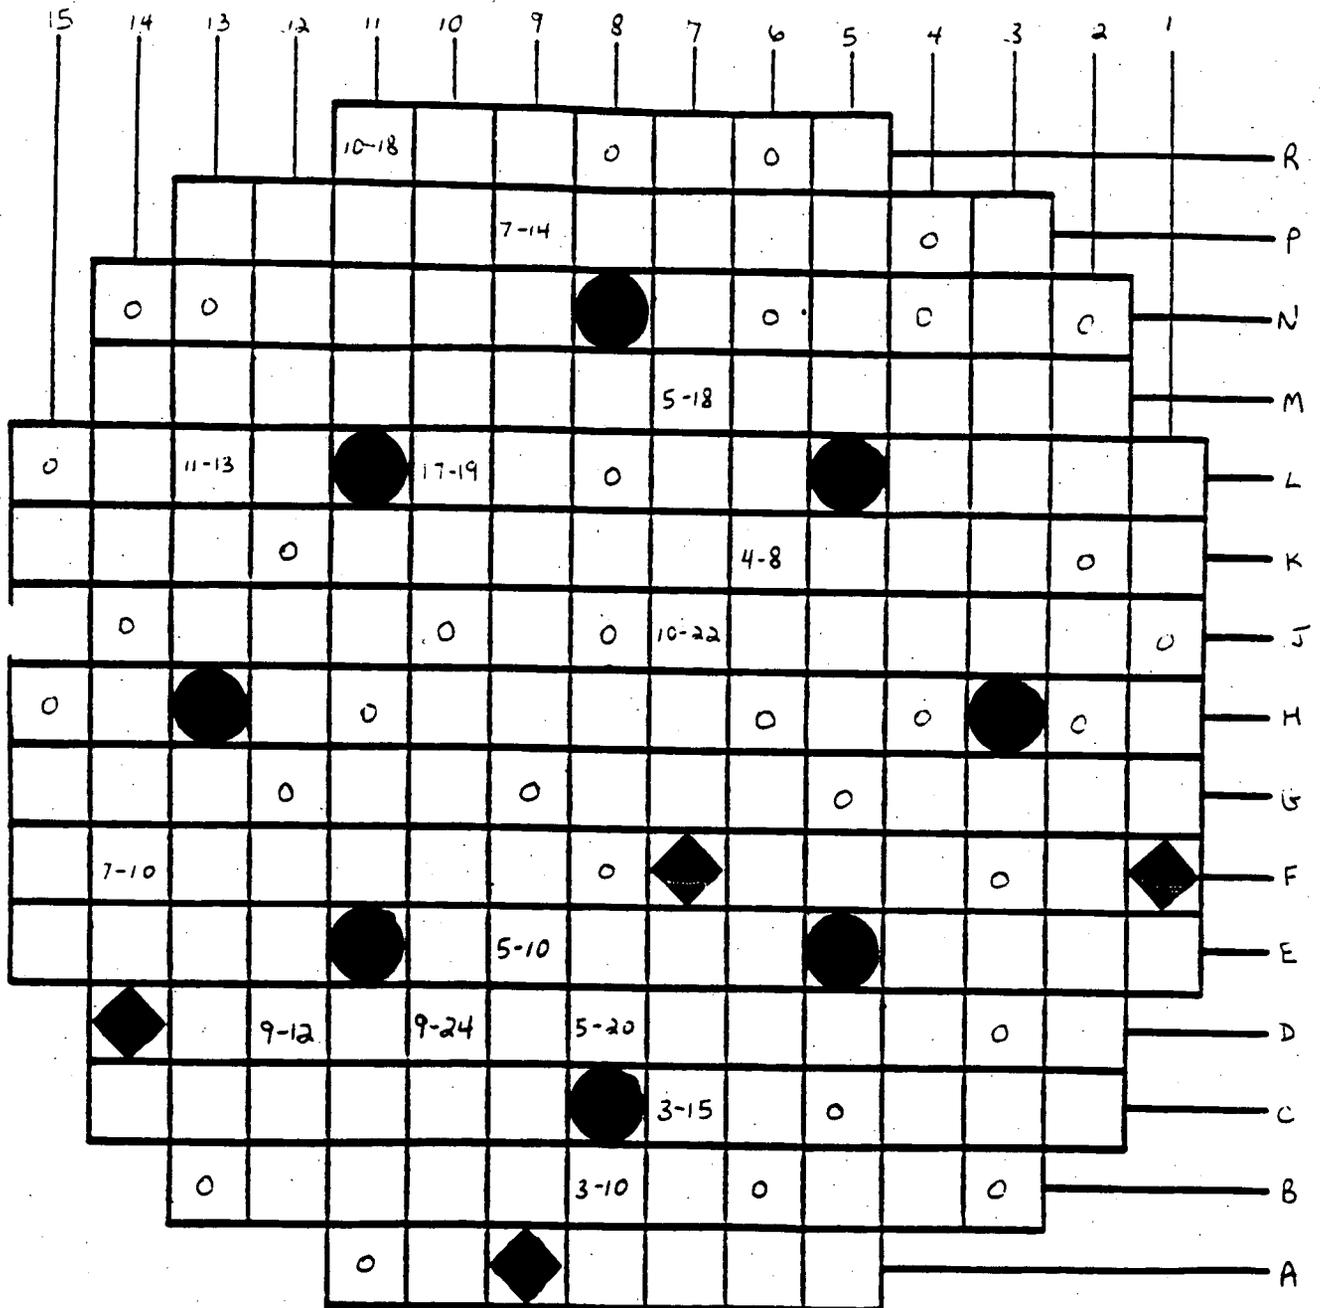
Figure 1

Upon inspection completion the data was submitted to Westinghouse Electric Corporation for analysis. Westinghouse's analysis which provides the basis for acceptable thimble tube wear indicated that all 46 thimble tubes inspected were in good condition with wall losses well within Westinghouse's recommended maximum allowable wear criterion of 60%. Results of the thimble inspection are summarized in Attachment I.

** Damage was below the lower core plate due to previous thimble relocation.

Measured Thimble Wall Loss by Core Location
