Indian Point 3
Nuclear Power Plant
P.O. Box 215
Buchanan, New York 10511

SUBJECT: Indian Point 3 Nuclear Power Plant
Docket No. 50-286
Licensee Event Report # 93-045-01
"A Failure Mode of The Central Control Room
Ventilation System Damper Actuators With The
Loss Of Instrument Air Resulted In A
Condition Prohibited By Technical
Specifications Due To Personnel Error"

LICENSEE EVENT REPORT (LER)

TITLE (4) A Failure Mode of The Central Control Room Ventilation System Damper Actuators With The Loss Of Instrument Air Resulted In A Condition Prohibited By Technical Specifications Due To Personnel Error

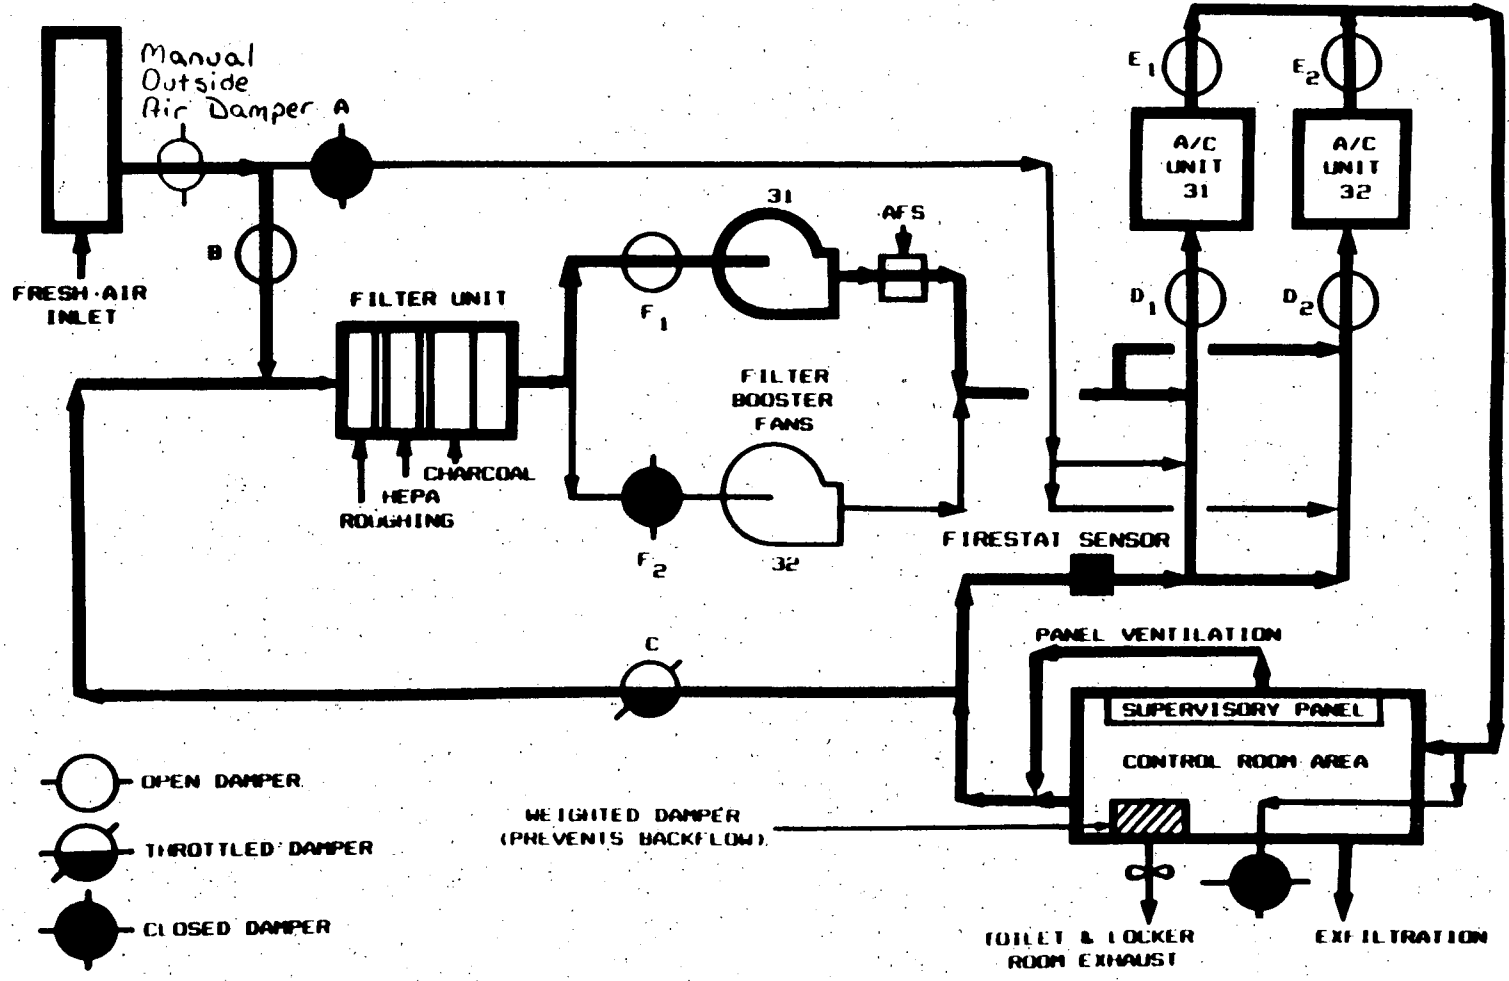
FIGURE 1
**CONTROL ROOM VENTILATION SYSTEM
 PARTIAL RECIRCULATION
 (CONTROL ROOM PRESSURIZED)**

The CCR HVAC has 7 pneumatically operated dampers (see attached Figure 1). The function of these dampers, their position in the 10% incident mode and their failure position following loss of IA are as follows:

- Dampers A and B direct the flow of air from the outside air intake into the system. The B damper, normally closed, opens to direct outside air to the filtration unit. The A damper, normally open, closes to isolate the system fans from the outside air intake. These dampers fail closed on loss of IA.

- Damper C directs CCR return air to the filtration unit. The C damper is normally closed and opens in the 10% incident mode. It fails open.
- Dampers D1 and D2 open or close the air flow path returning to the associated HVAC unit. These dampers are normally open if the corresponding HVAC unit fan is running. Closure of a damper stops the corresponding HVAC unit fan resulting in a loss of a CCR cooling unit. These dampers both fail closed.

- The F1 or F2 dampers are each on the inlet to a filter booster fan and isolate the filtration unit. These dampers are normally closed and open in the 10% incident mode. These dampers fail closed.

The failure modes identified above isolate outdoor air from the system and result in a loss of pressurization, filtration and cooling in the CCR. This prevents the CCR HVAC system from performing its required function in any of its modes.

The event was caused by personnel error of an indeterminate origin during the system design. The architect engineer did not evaluate this failure mode during initial design or when upgrading the system from a non safety system to a safety system prior to initial operation.

- Prior to startup the Authority will install a backup gas supply to operate the damper actuators, for a minimum of 24 hours, in the event of a loss of Instrument Air to the Control Room Ventilation System's Damper Actuators.

- Prior to startup, the Authority will revise the System Operating Procedures (SOPs) and Emergency Operating Procedures (EOPs) related to the Control Room Ventilation System to guide the operator on the failure position of the damper actuator and the possible corrective actions (manual damper positioning) that they can perform.
