SUBJECT: Indian Point 3 Nuclear Power Plant
Docket No. 50-286
Licensee Event Report # 94-001-00
"Pressurizer Liquid Sampling Line Support Discrepancies Place
the Plant Outside its Design Basis Due to Personnel Error"

FACILITY NAME (1) Indian Point Unit 3	DOCKET NUMBER (2) 05000286	PAGE (3) 1 OF 6
---	--------------------------------------	---------------------------

TITLE (4) Pressurizer Liquid Sampling Line Support Discrepancies Place the Plant Outside its Design Basis Due to Personnel Error

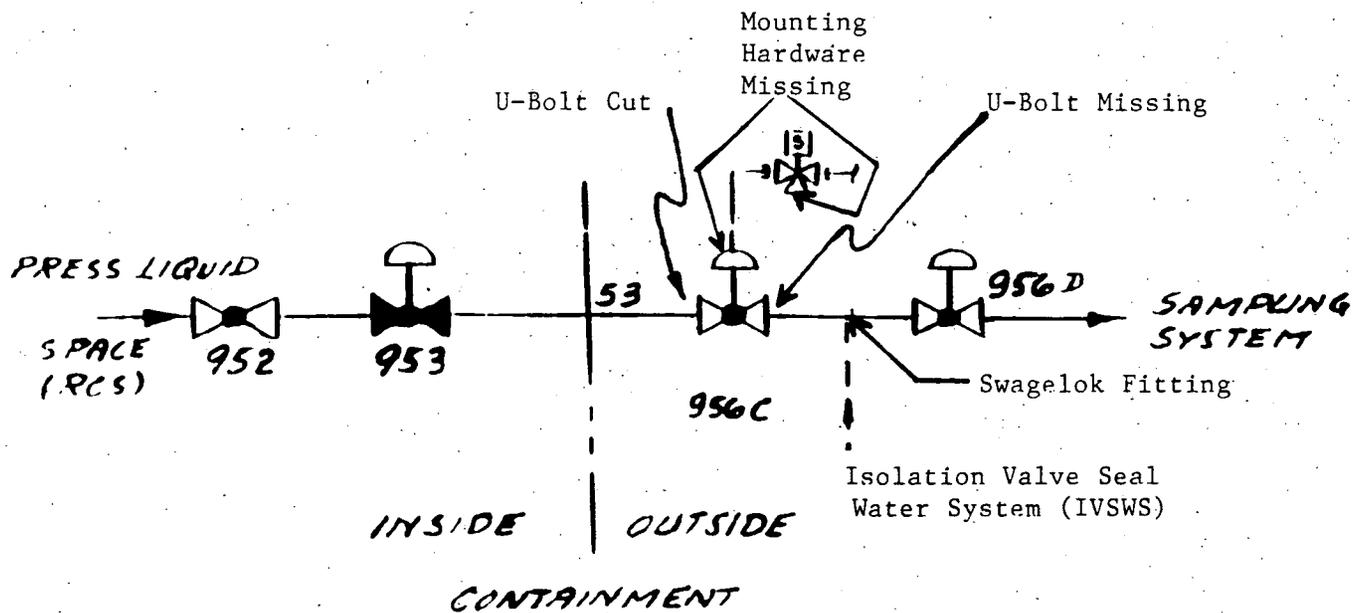
On January 28, 1994, at approximately 1100 hours with the plant in a cold shutdown condition (reactor power level at 6 cps, reactor coolant temperature at 108 degrees F, reactor coolant pressure at atmospheric and pressurizer level at 29%), a Maintenance Engineer identified that one of two valve support mounting bolts for Sampling System valve SP-AOV-956C were missing and that a tubing U-bolt restraint downstream of this valve was missing (see Figure 1). This event, which occurred prior to November 14, 1992, is a result of poor work practices and attitudes that previously existed. Investigation into the event revealed further discrepancies as described below. Stress analysis of the as found condition indicates that the tubing does not meet USAS B31.1 design basis stress limits indicated in the Final Safety Analysis Report for sampling system piping.

The Maintenance Department investigated the work history on the sampling line and related Problem Identifications (PIDs) and concluded that this event probably occurred on November 13, 1992. On November 13, 1992 maintenance personnel replaced a leaking Swagelok compression fitting used as the tee connection between the Isolation Valve Seal Water System (IVSWS) (BD) and the sampling system line for pressurizer liquid space sampling. The IVSWS line is connected to the pressurizer liquid space sampling line between containment isolation valves SP-AOV-956C and SP-AOV-956D. Maintenance concluded that when the tubing was cut on both sides of the Swagelok to remove the fitting, the resulting gap between tubing ends was too wide for the new Swagelok to be installed. The maintenance crew attempted to make up this gap in the tubing by pulling together the tubing which was held fast by various restraints. To accomplish this, the maintenance investigation concluded that the following actions were taken outside of the scope of the work request: (1) one of two SP-AOV-956C actuator mounting bolts was removed; (2) the U-bolt tubing restraint on the downstream side of valve SP-AOV-956C was removed; (3) the U-bolt tubing restraint on the upstream side of valve SP-AOV-956C was cut in half (this also resulted in the marring of the primary sample tubing); and (4) the two bolts which mounted the SP-AOV-956C air operator solenoid valve were removed. A PID was written on November 14, 1992 reporting the cut U-bolt. However, this condition was not identified as potentially reportable until January 28, 1994 when additional support discrepancies were identified.

The Maintenance Department investigation concluded that this event was caused by personnel error during a maintenance activity performed on November 13, 1992. The error on the part of the maintenance personnel is that they applied poor work practices and worked outside of established work control practices (procedures) during the performance of a work request.

Figure 1
As Found Condition of
Pressurizer Liquid Space Sample Line

4. To correct the discrepancies, the supports to SP-AOV-956C and its accompanying solenoid valve will be reworked/reinstalled. The marred section of primary sample tubing upstream of SP-AOV-956C will be replaced. These actions will be completed prior to startup from the current outage.
