April 29 1994  
IPN-94-053

SUBJECT: Indian Point 3 Nuclear Power Plant  
Docket No. 50-286  
Licensee Event Report # 94-001-01  
"Pressurizer Liquid Sampling Line Support Discrepancies Place  
the Plant Outside its Design Basis Due to Personnel Error"

**TITLE (4)** Pressurizer Liquid Sampling Line Support Discrepancies Place the Plant Outside its Design Basis Due to Personnel Error

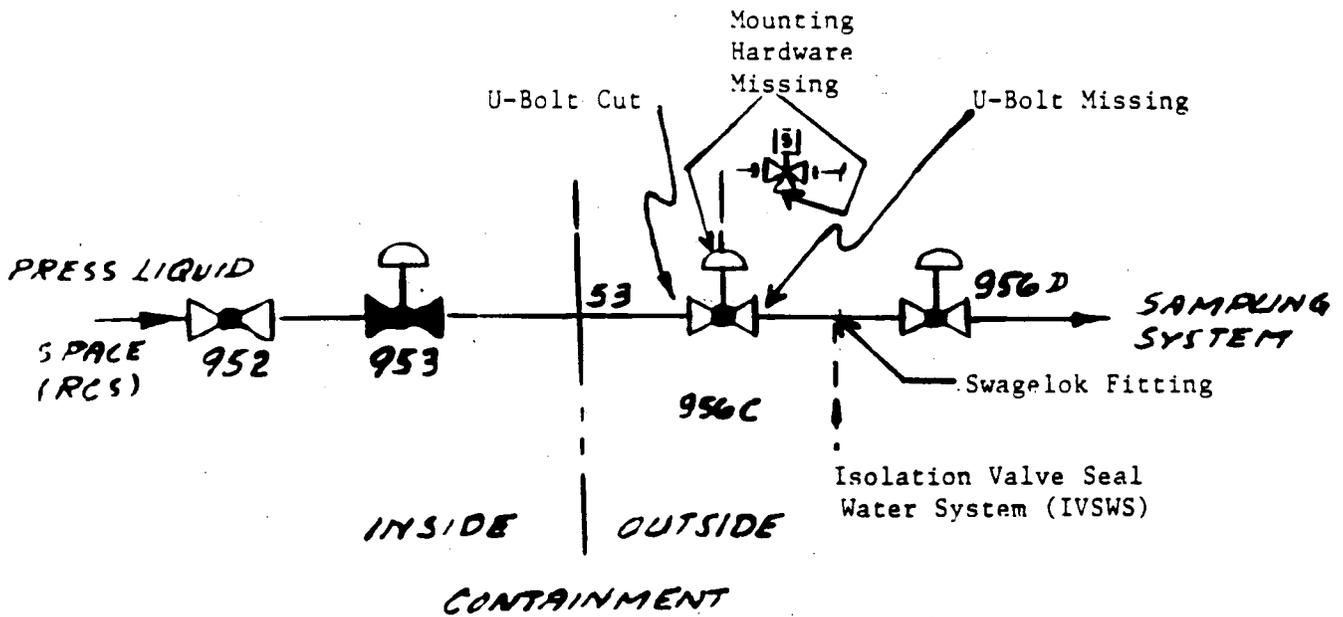
On January 28, 1994, at approximately 1100 hours with the plant in a cold shutdown condition (reactor power level at 6 cps, reactor coolant temperature at 108 degrees F, reactor coolant pressure at atmospheric and pressurizer level at 29%), a Maintenance Engineer identified that one of two valve support mounting bolts for Sampling System valve SP-AOV-956C were missing and that a tubing U-bolt restraint downstream of this valve was missing (see Figure 1). This event, which occurred prior to November 14, 1992, is a result of poor work practices and attitudes that previously existed. Investigation into the event revealed further discrepancies as described below. Stress analysis of the as found condition indicates that the tubing does not meet USAS B31.1 design basis stress limits indicated in the Final Safety Analysis Report for sampling system piping.

A second investigation reached a different conclusion than the investigation reported in LER 94-001-00. The second investigation concluded that the damage discussed earlier most probably occurred on May 6, 1992 when contractor personnel replaced a body to bonnet gasket on valve SP-AOV-956C. This conclusion was reached considering the following:

The error on the part of the contractor personnel is that they applied poor work practices and worked outside of established work control practices (procedures) during the performance of a work request.

Figure 1  
As Found Condition of  
Pressurizer Liquid Space Sample Line

4. To correct the discrepancies, the supports to SP-AOV-956C and its accompanying solenoid valve will be reworked/reinstalled. The marred section of primary sample tubing upstream of SP-AOV-956C will be replaced via work request WR 94-00364. These actions will be completed prior to startup from the current outage.
