Indian Point 3
Nuclear Power Plant
P.O. Box 215
Buchanan, New York 10511
914 736.8001

May 6, 1994
IPN-94-057

SUBJECT: Indian Point 3 Nuclear Power Plant
Docket No. 50-286
Licensee Event Report # 93-036-01
"Improper Seismic Mounting of Damper Actuators in the Central
Control Room Ventilation System Resulted in a Condition
Prohibited by Technical Specifications Due to Personnel Error"

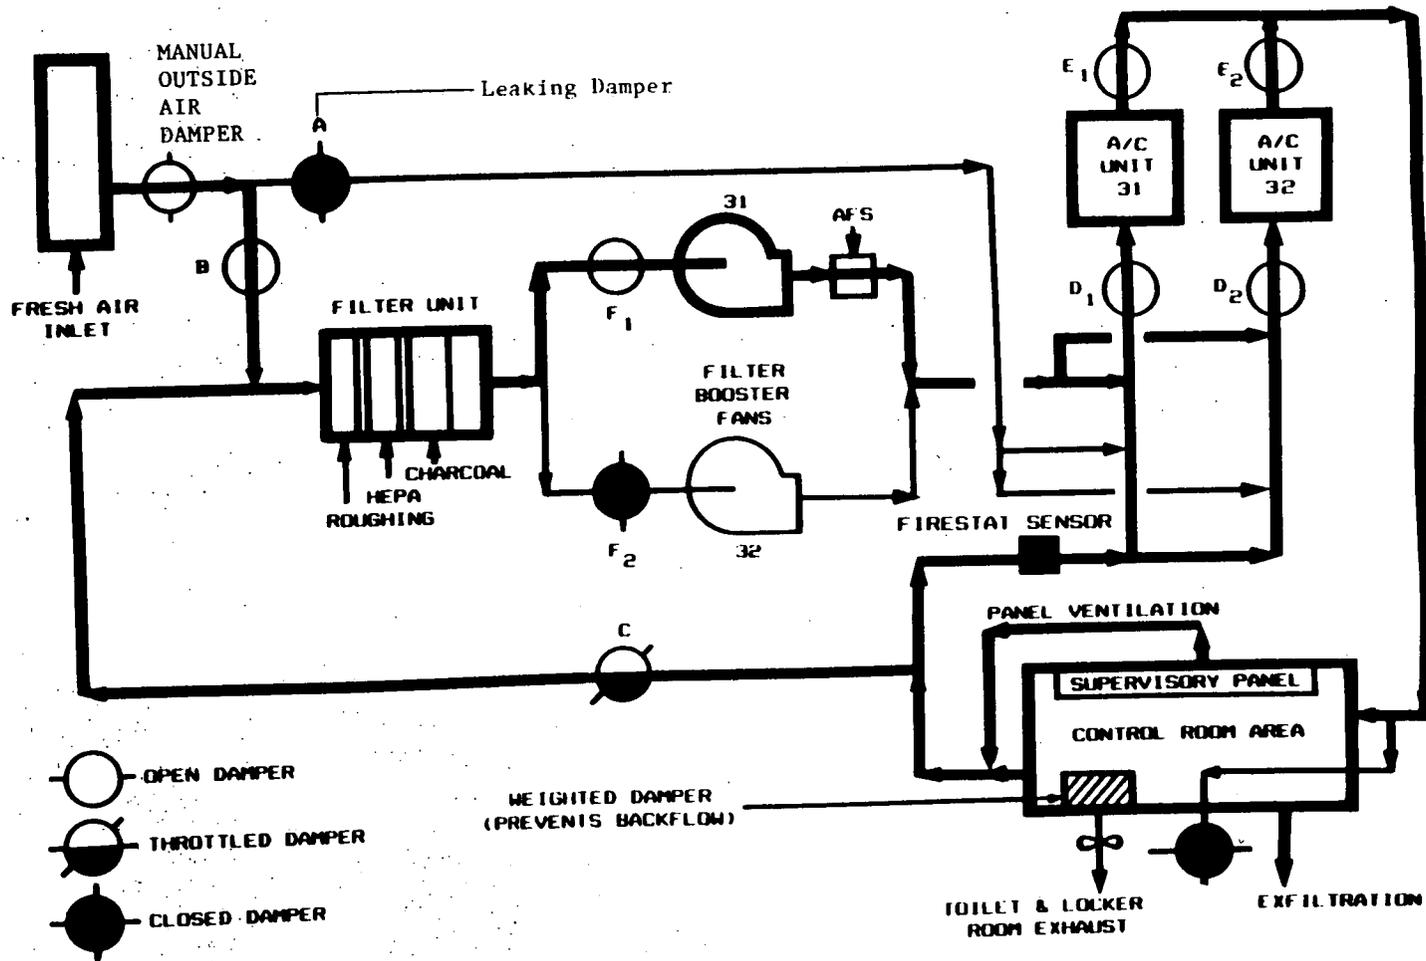
FIGURE 1
CONTROL ROOM VENTILATION SYSTEM
PARTIAL RECIRCULATION
(CONTROL ROOM PRESSURIZED)

The system engineer and seismic engineer inspected the mounting of the damper actuators and the setting of the stop nuts on the actuators in the CCR Ventilation System. The stop nuts on damper actuators B, C, D2, F1 and F2 (see attached figure) were found to be loose. The engineers determined that the mounting of damper actuators A, B, C, D1, D2, F1 and F2 appeared not to be seismically mounted and required detailed evaluation.

A detailed evaluation was performed for the A, B, C, D1, D2, F1 and F2 damper actuator mountings. This evaluation concluded that damper actuators A, B, D1 and D2 were adequately mounted so that the damper actuators would have been operable following a seismic event. This conclusion is based on the assumption that the damper actuators are seismically qualified. An ongoing search is being conducted to locate the documentation showing the seismic qualification of the actuators. If this search is unsuccessful the seismic qualification of the actuator will be evaluated through testing. If the conclusions presented here are invalidated by the results of these efforts, the Authority will provide a supplement to this LER. Although damper actuators A and D2 would have been operable following a seismic event, the mounting of the damper actuators are going to be improved. Damper actuators B and D1 are not going to be modified in any way. Damper actuators C, F1 and F2 require mounting improvements.

On September 16, 1993 technicians tested the flows controlled by the B and C dampers and determined no adjustments were necessary. The B and C damper actuator stop nuts positions were acceptable as found. The stop nuts on damper actuators B and C were tightened into place. On September 17, 1993 mechanics were sent out to adjust and tighten, as necessary, the stop nuts on damper actuators D2, F1 and F2. All dampers were capable of opening and closing fully in the as found conditions. The stop nuts were found to be in a position which would have allowed the actuator to stroke further than necessary. However, this condition would have caused the dampers to close tightly without damage to the damper. The stop nuts on damper actuators D2, F1 and F2 were adjusted and tightened into place.
