UNITED STATES  
NUCLEAR REGULATORY COMMISSION  
OFFICE OF INSPECTION AND ENFORCEMENT  
WASHINGTON, D.C. 20555

IE Circular No. 79-24  
Date: November 26, 1979  
Page 1 of 3

PROPER INSTALLATION AND CALIBRATION OF CORE SPRAY PIPE BREAK DETECTION EQUIPMENT  
ON BWRs

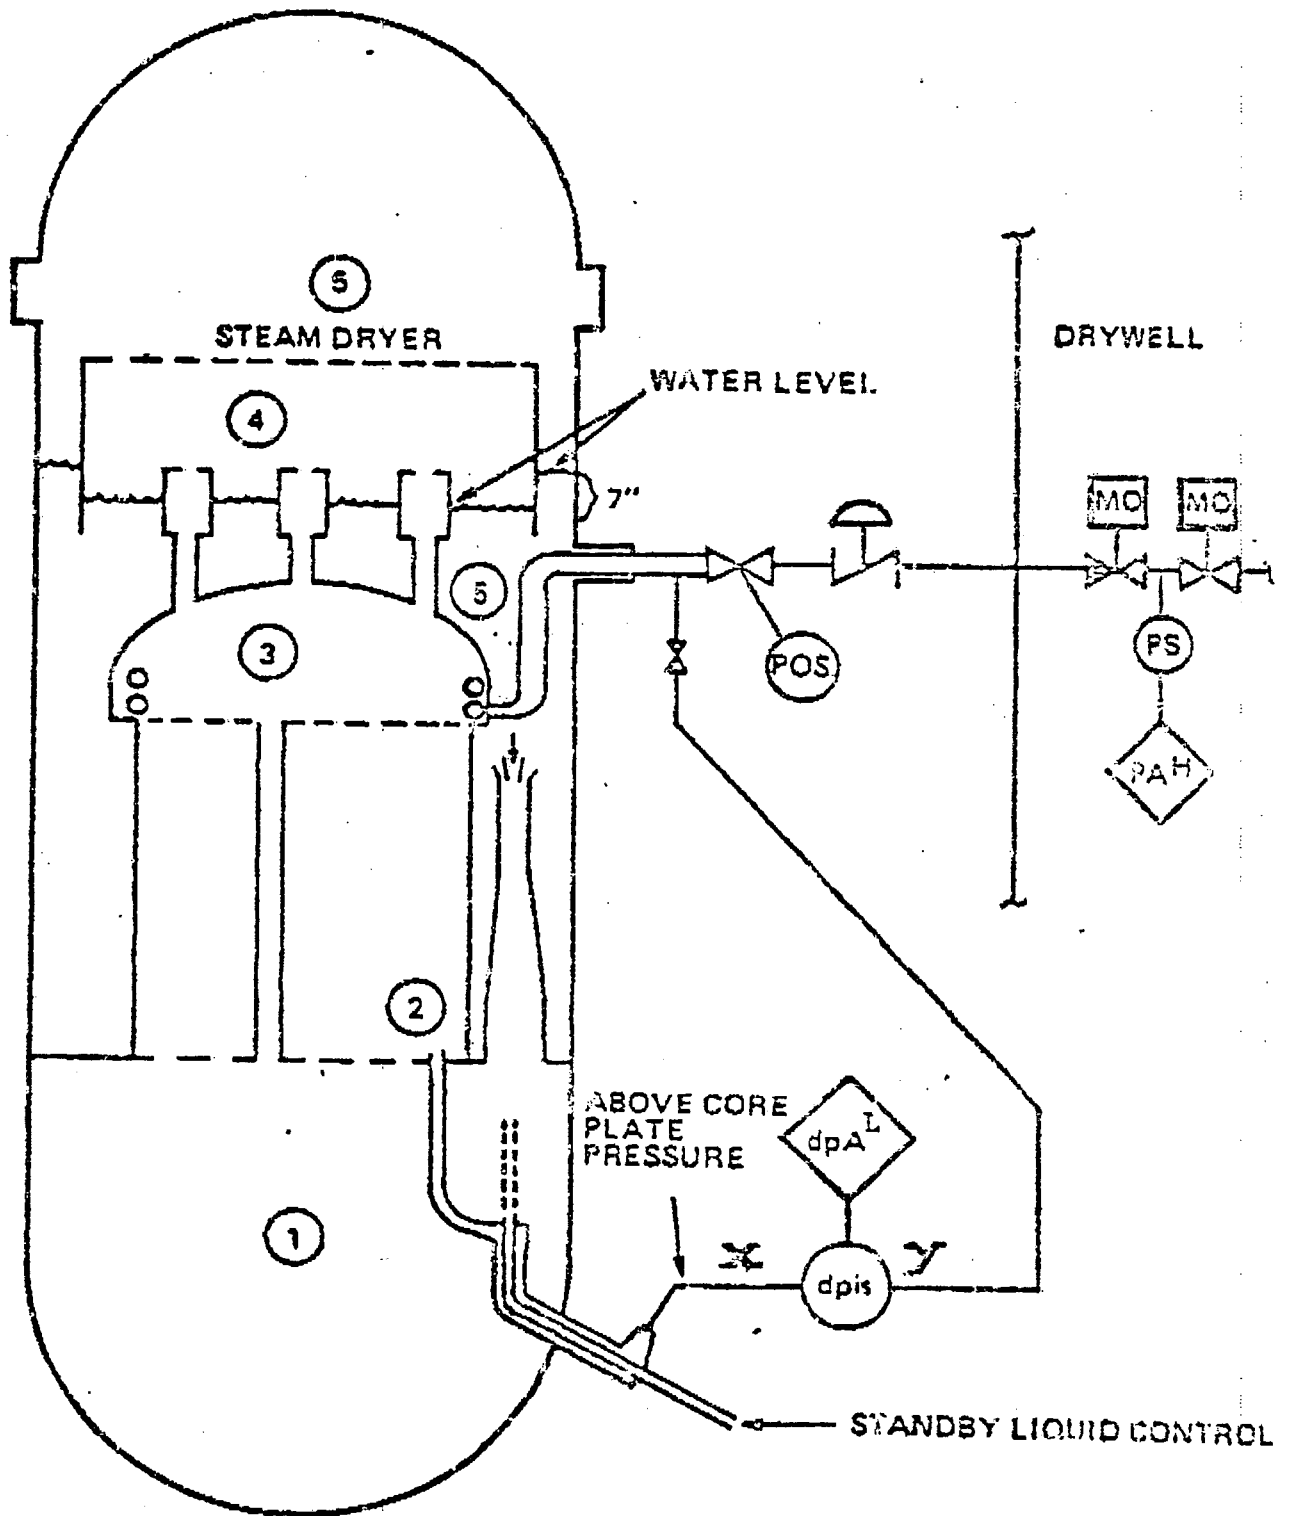
Figure 1 Core Spray System Pipe Break Detection Instrumentation

The licensee's investigation of the downscale deflection revealed that the original piping arrangement and calibration did not adequately take into account the effect of density changes of the water in the pressure leg connections. The original installation had the high pressure side of the dp instrument (see attached Figure 1) connected to the reference leg in the vessel (Figure 1 Connection X) and the low pressure side to the core spray piping outside the vessel but inside the drywell (Figure 1 Connection Y). With the piping intact, this arrangement senses the pressure difference between bottom and top of core. With a break in CS piping in the annulus area the instrument then senses the additional pressure drop across the separators (dp  $\sim$  7 psi additional) and dryers (dp  $\sim$  7-inches water). This installation was in accordance with GE design requirements.

Also in accordance with GE instructions the calibration of the dp instrument was performed with the reactor in the cold condition and the alarm was set to trip at 5 psid increasing. Because of this cold calibration the dp instrument then indicated full downscale negative during operation. This negative dp was due to the heat up of the reference leg (Figure 1 Connection X) which caused the fluid density to decrease as the plant reached hot conditions. The magnitude of this dp was determined to be about 3.5 psid following completion of the modification discussed below.

Adding the 3.5 psi downscale deflection to the 5 psi alarm setpoint results in a total required deflection of 8.5 psi to initiate the alarm at the setpoint. Since the total dp available across the separators and dryer is only 7 psi

(1.5 psi less than the total required deflection), the alarm would not be actuated by a CS pipe break in the annulus. Therefore, the original installation, including calibration procedure, was deficient.

To correct the problem, Iowa Electric modified the installation by interchanging the pressure leg connections and resetting the alarm to trip at 2 psid decreasing. In this orientation it was found that going from cold to hot produced a 3.5 psid positive deflection. The technical specifications were changed to reflect the revised alarm setpoint.

- "1. BWR operators, who have differential pressure ( $\Delta P$ ) instrumentation which reads only positive values, interchange their core spray line break instrument connections so that the high side connection is to the core spray sparger sensing line and the low side connection is to the above the core plate sensing line. This instrumentation should be calibrated for a zero  $\Delta P$  reading during cold shutdown; it will then give a positive  $\Delta P$  reading during normal rated power operation and a pegged zero reading for a line break indication during normal rated power operation.

Also, when this change is made, the recommended alarm setpoint (on decreasing  $\Delta P$ ) setting is  $0.5 \pm 0.25$  PSID; and for those plants that have a value in their technical specifications,  $> 0$  PSID is recommended as a limit.
