AREAS OF RESIDUAL CONTAMINATION
AT THE
• UCC-MARIETTA, OH, SITE

June 11, 1984

Building 77

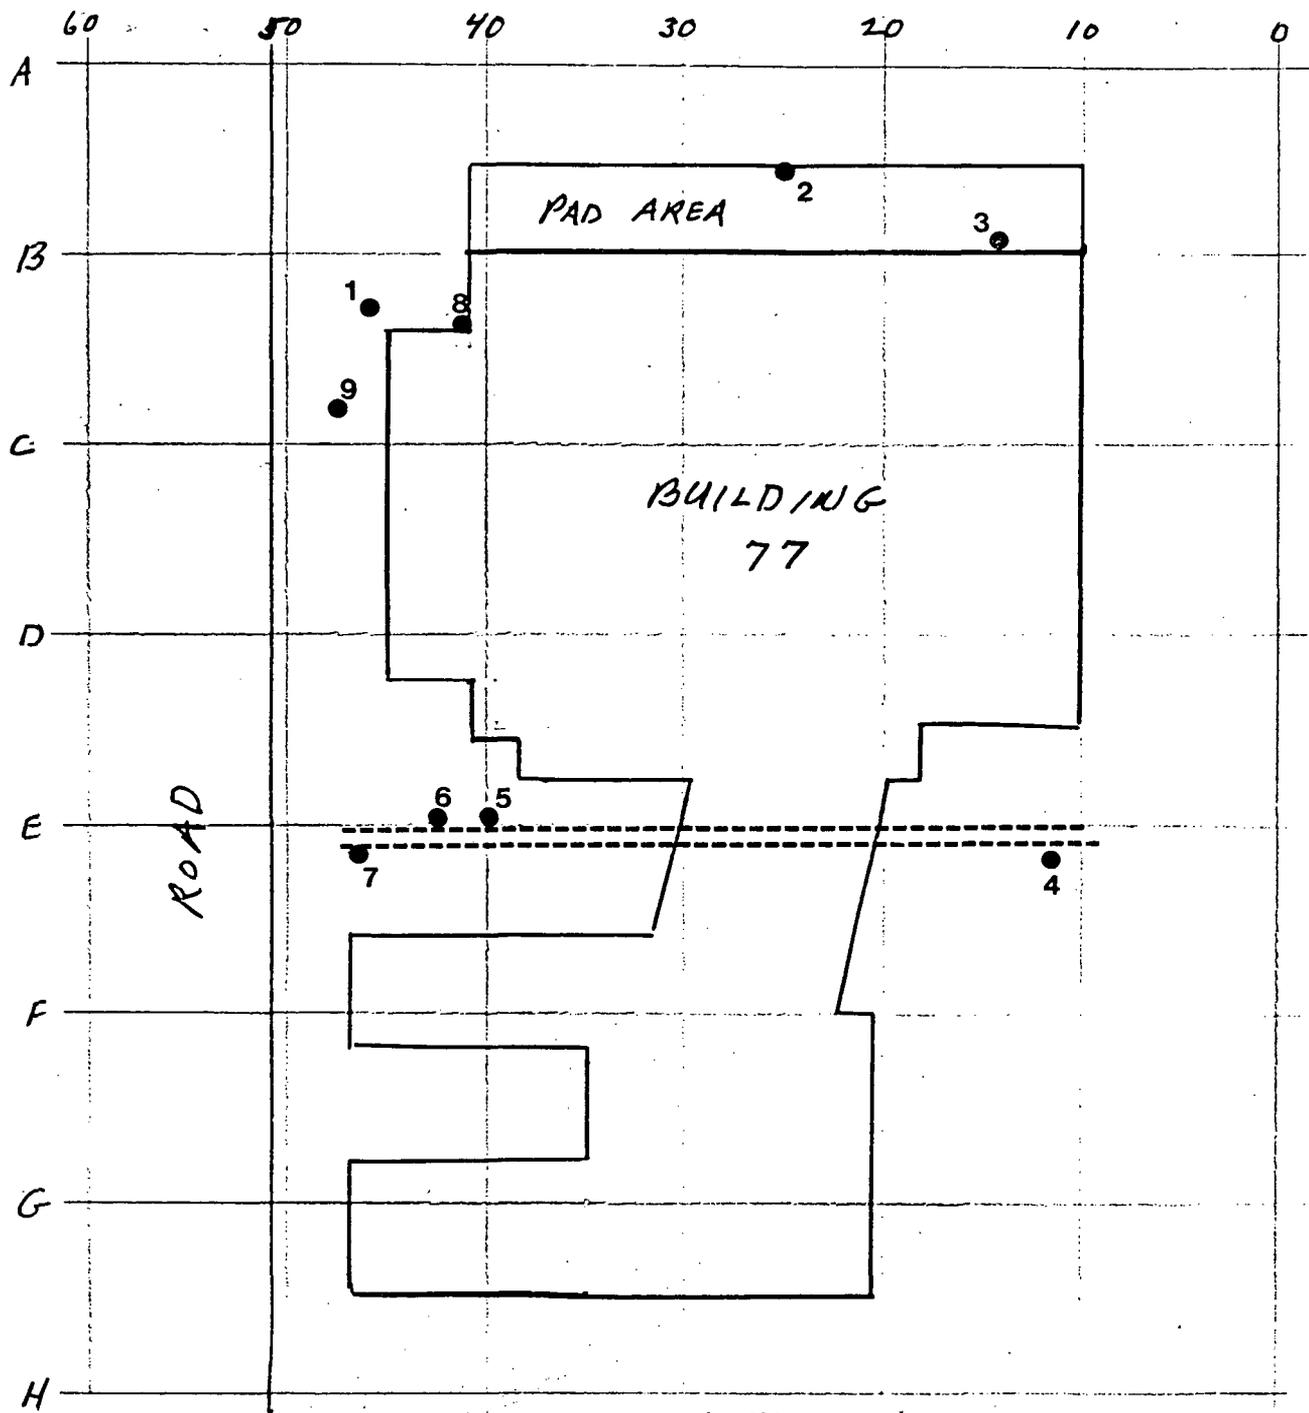
Elevated direct radiation levels indicating possible surface or subsurface contamination were noted at nine locations, identified on the

attached drawing. Surface sampling at most of these locations revealed white and/or yellow residues as the source of the direct radiation readings. After sampling, most of the radiation levels increased, particularly at location #9, suggesting additional material below 15 cm deep.

As we discussed by telephone, there are also some small isolated spots of elevated direct radiation in the vicinity of the previous residue storage area. Until the samples from these locations can be analyzed and the levels and extent of contamination evaluated, it is suggested that no further remedial action be undertaken in this area.
