UNITED STATES  
NUCLEAR REGULATORY COMMISSION

Subject: DIABLO CANYON POWER PLANT - NRC SPECIAL INSPECTION  
REPORT 05000323/2009009

NRC Inspection Report 0500323/2009009

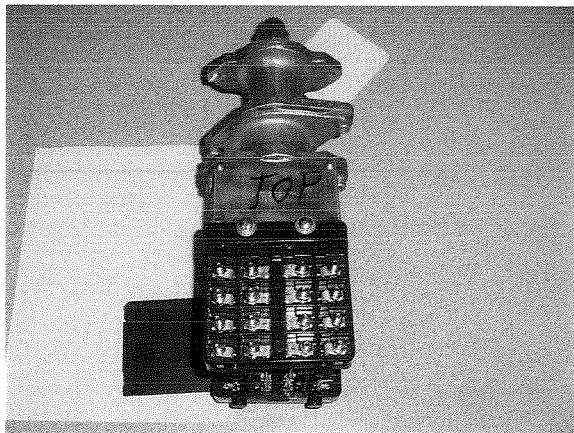
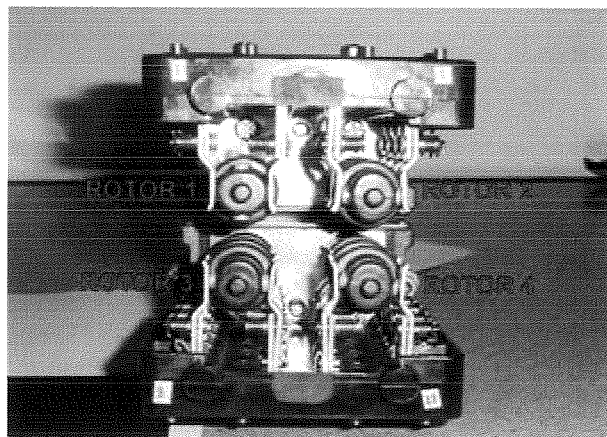
Attachment 6: Limit Switches

On October 22, 2009, the licensee identified that the RHR containment sump suction valve interlock switches (Valves SI-2-8982A/B) were misaligned on both Unit 2 trains, that this misalignment occurred on February 16, 2008, and that the equipment had been returned to service on February 21, 2008. The misaligned interlock switches would have prevented remote manual operation of the motor operated valves supplying RHR discharge to the suction of the safety injection and centrifugal changing pumps (Valves SI-2-8804A/B) and containment spray pumps (Valves CS-2-9003A/B). The loss of capability to operate Valves SI-2-8804A/B remotely rendered both trains of the emergency core cooling system inoperable. The loss of capability to operate Valves CS-2-9003A/B rendered both trains of containment spray inoperable (see drawing in attachment 5), though the loss of this capability had minimal impact on risk because the containment spray system would not be needed for the size of loss of coolant accidents that would render Valves CS-2-9003A/B inoperable from the control room.

Improper coordination of limit switches on Unit 2 residual heat removal (RHR) sump suction Valves SI-2-8982A/B resulted in the disablement of interlocks which permit operators to open the valves that provide RHR flow to the suction of the safety injection and charging pumps (SI-2-8804A/B). This resulted in a loss of the capability for operators to initiate cold leg recirculation from the control room for loss of coolant accidents that do not depressurize the reactor coolant system below the shutoff head of the RHR pumps. The valves were accessible and could have been re-positioned locally.
