**Subject: January 2010 Inspection Report, Cameco Resources, Permits 603 and 633**

## **JANUARY 2010 INSPECTION REPORT DISTRICT 1/LAND QUALITY DIVISION**

**COMPANY:** Cameco Resources (CR), Highland Ranch, Permit #603  
& Smith Ranch, Permit 633

**DATE OF INPECTION:** January 29, 2010

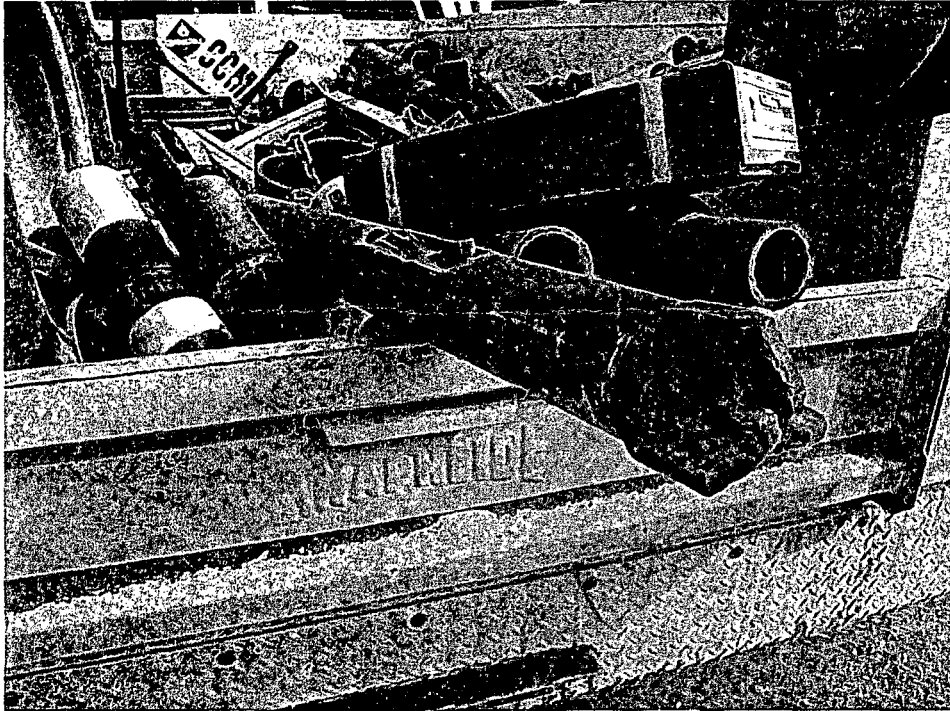
The inspectors observed partial completion activities in Wellfield 15A. Under-reaming was completed at the first drill site observed. The driller was running casing and placing spacers at 40 feet intervals. The next step for this well is cementing the hole around the pipe, followed by running a cutter into the pipe to open up the production zone followed by installation of the screen. A cutter tool was observed (**Figure 1**). A second drill site was on lunch break with the screen/packer ready to be installed (**Figure 2**).

**Figure 1** Cutting tool used to open poly pipe production zones where screen will be installed.

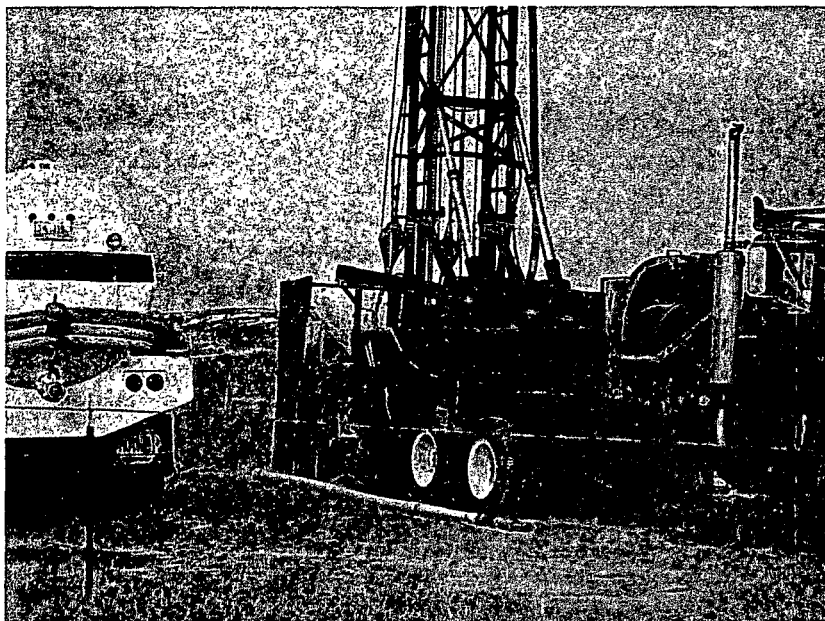
**Figure 2** View of drill rig with next strand including the screen interval and packer ready for installation.

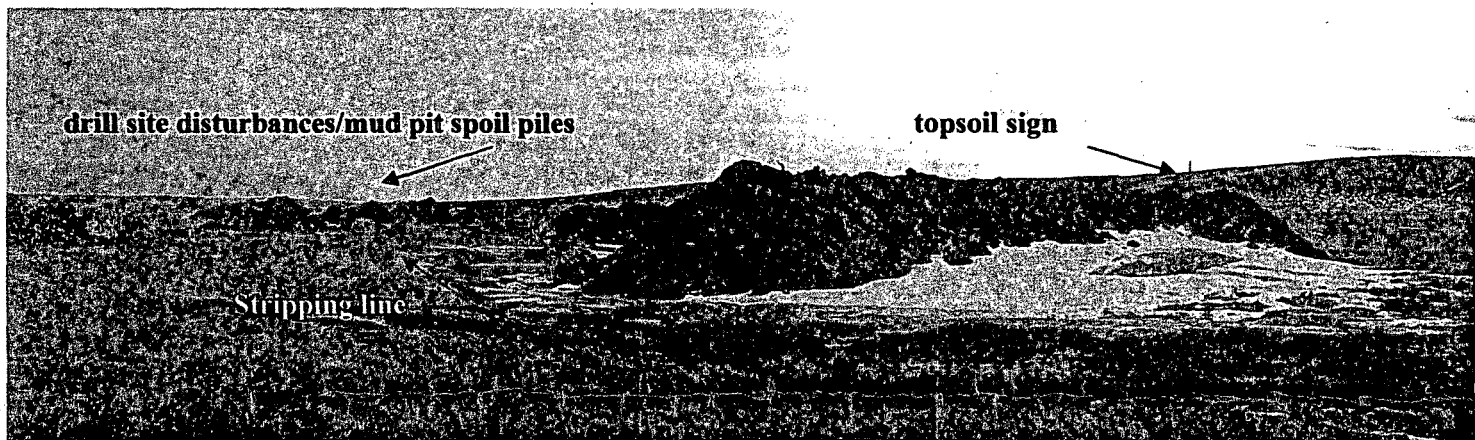
It was noted that topsoil is no longer being placed in piles adjacent to the drill locations where it had previously been subject to contamination from the spoil material and often run over by drill traffic. The topsoil is now salvaged for localized areas of drilling into larger stockpiles (**Figure 3**). The topsoil pile had the required sign, however was not seeded or protected with a toe ditch. The salvaged topsoil appears to be bladed to remove the vegetation. The depth of salvageable soil for the area was not known.

**Figure 3 Topsoil salvaged from localized disturbance area of wellfield development**

- 1 The savaged topsoil appears to be bladed to remove the vegetation. The inspector verified the depth of topsoil for the area inspected (Permit 633, Appendix D-7). The soils survey indicates soil depths in Section 11 T35N R74 are generally 3-5 inches. CR should ensure all topsoil is being salvaged.
- 2 Topsoil stockpiles constructed for local disturbances occurring during wellfield development require protection measures according to Noncoal Rule and Regulations Chapter 3, Section 2(c)(i)(B). CR is not providing a quick growing cover of vegetation as the piles are typically reapplied within a year. However, to minimize loss of soil during heavy runoff events and to keep mine traffic from encroaching onto the piles a perimeter toe ditch is required to contain the soil. **Please construct a toe ditch around the topsoil stockpiles during construction of all new topsoil stockpiles.**
