Subject: February 2010 Inspection Report, Cameco Resources, Permits 603 and 633

**FEBRUARY 2010 INSPECTION REPORT
DISTRICT 1/LAND QUALITY DIVISION**

COMPANY: Cameco Resources (CR), Highland Ranch, Permit #603
& Smith Ranch, Permit 633

DATE OF INPECTION: February 24, 2010

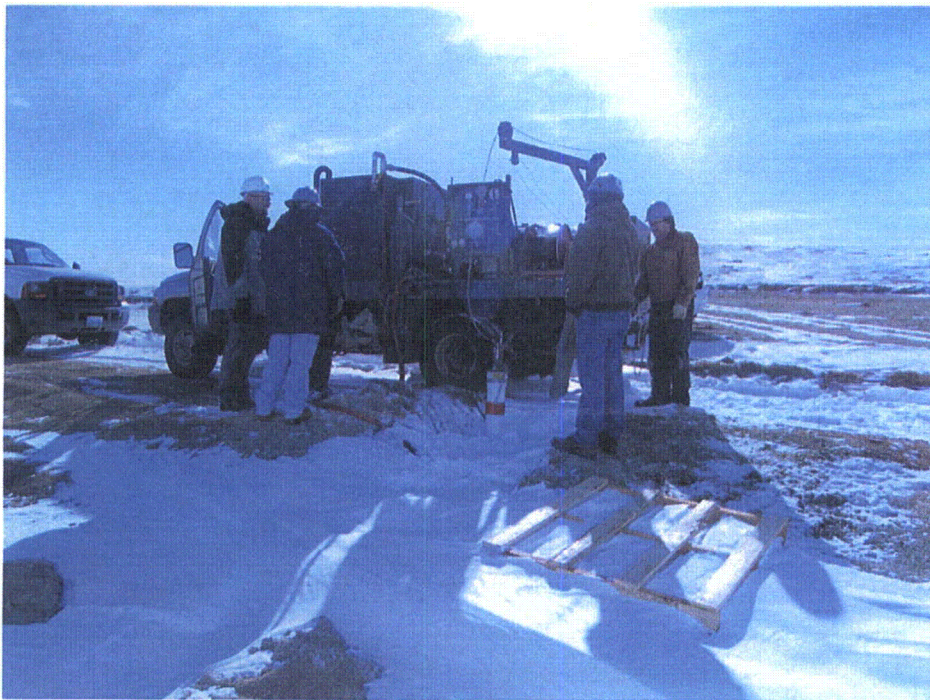
The inspector observed the mechanical integrity test (MIT) at injection well 15I-763 in MU-15A along with two NRC inspectors (**Figure 1**). The test resulted in a confirmed positive integrity of the well. It was noted that topsoil was stripped in stockpiled for the wells in the area. A down-slope toe-ditch should be constructed around the pile (**Figure 2**).

Figure 1 MIT observed at well 15I-763

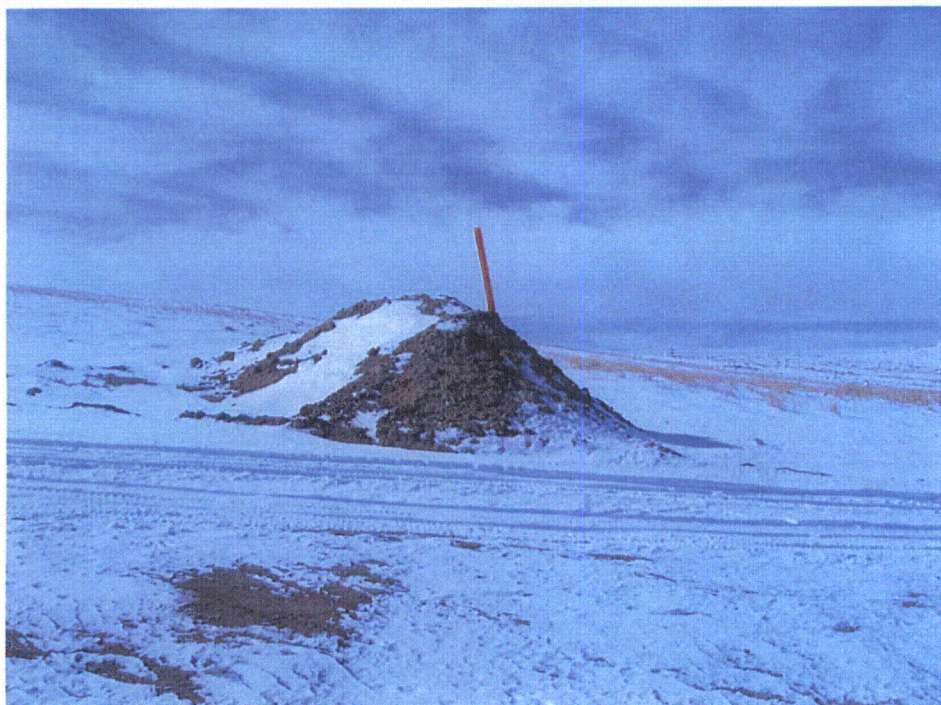
Development drilling was ongoing in Header House 9-13 area. Topsoil was found to be salvaged and segregated into stockpiles away from the drill sites. Signs were in place on the piles. Toe ditches are not found to protect the loss of soil around the base of the pile. Development drilling was observed on the western edge of the wellfield. New red well caps were observed.

Figure 2 Topsoil stockpile with sign

- 2 Topsoil stockpiles constructed for local disturbances occurring during wellfield development require protection measures according to Noncoal Rule and Regulations Chapter 3, Section 2(c)(i)(B). CR is not providing a quick growing cover of vegetation as the piles are typically reapplied within a year. However, to minimize loss of soil during heavy runoff events and to keep mine traffic from encroaching onto the piles a perimeter toe ditch is required to contain the soil. **Please construct a toe ditch around the topsoil stockpiles during construction of all new topsoil stockpiles.**

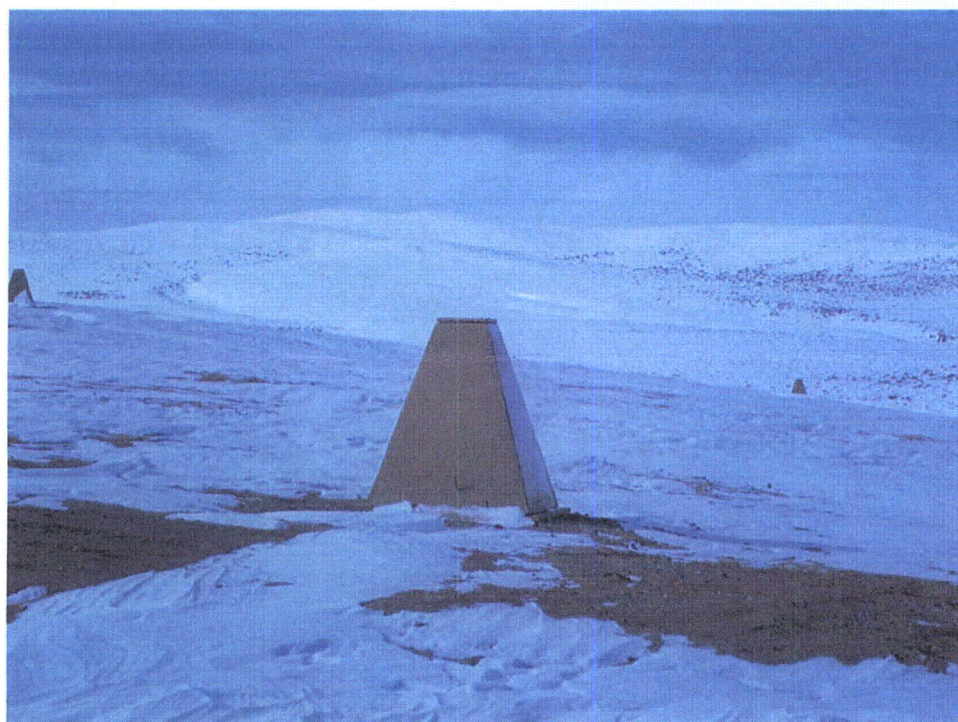
A new well cover design is being utilized that is supported by BLM as better suited to the terrain and aesthetically less noticeable than the white boxes found in other wellfields. The new design is shaped like a pyramid, tan is color and made of a synthetic material (**Figure 3**). The covers fit snugly over the concrete basin surrounding the wellhead. Leak detection was observed in a random well check and found to be functioning (**Figure 4**).

Figure 3 View of new well covers in MU-9

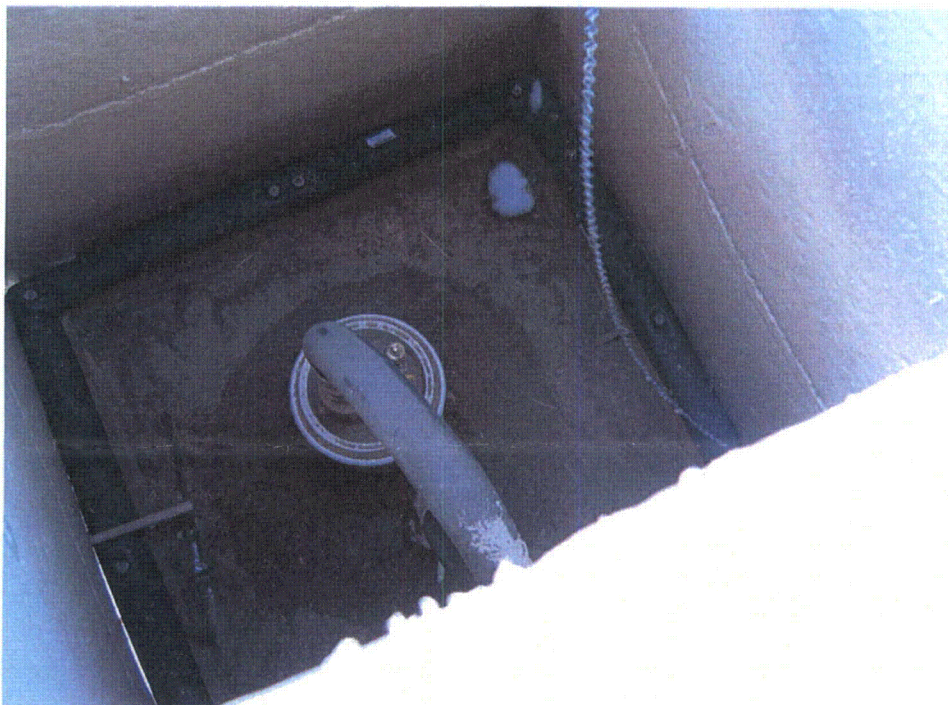
Figure 4 View of inside of well in Figure 3

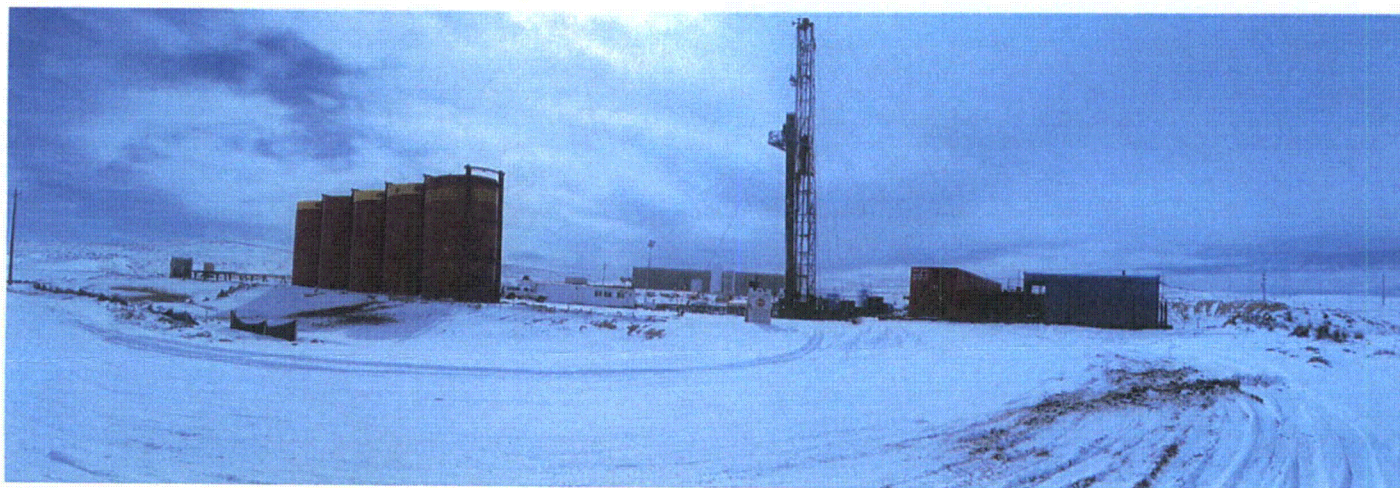
DDW #6 is located immediately south of Satellite SR-2. It has been drilled and completed with flow testing ongoing (**Figure 5**).

Figure 5 DDW#6 flow test activities

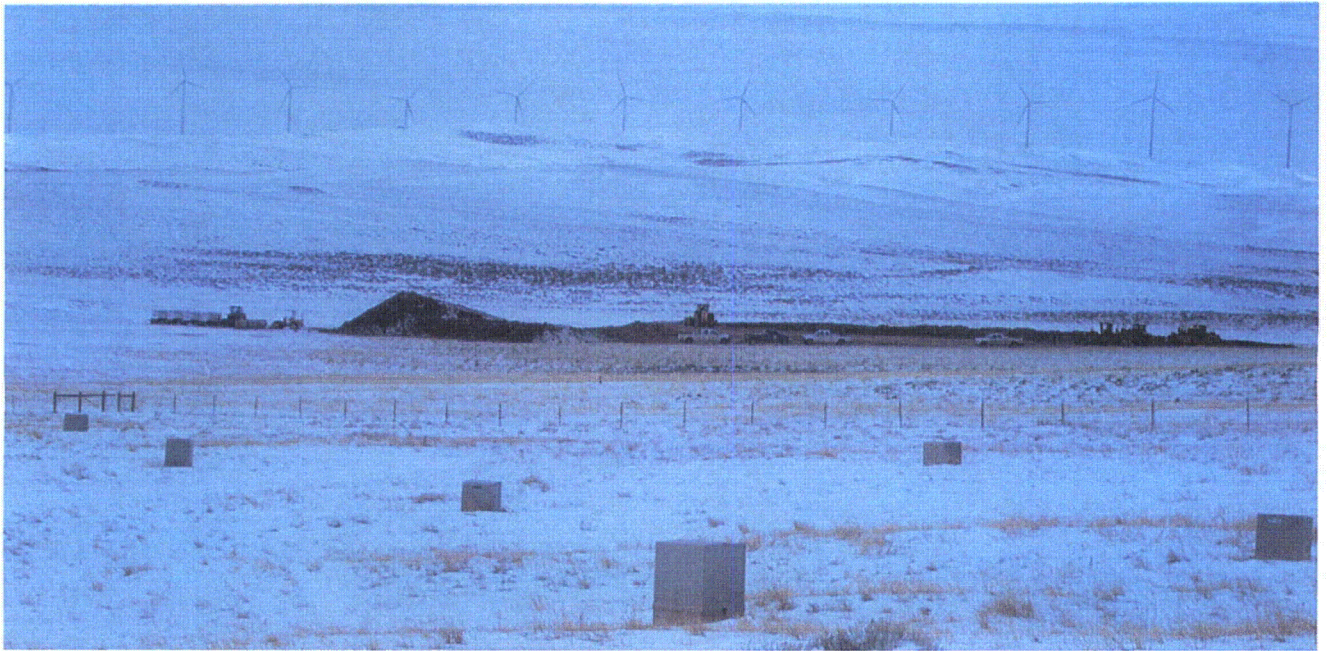
New disturbance was discovered west of MU-4 including several loaders and other construction equipment and multiple pick-up trucks indicating contractor work. A large stockpile was noted from the distance and presumed to be topsoil stripped from the area (**Figure 6**). It appeared the dozers were excavating from a depression and pushing the material upslope. Upon return to the office to inquire what the disturbance was related to, CR explained it was the development of the Deep Disposal Well Pad #10.

Figure 6 View of new disturbance for DDW#10
