Exelon Generation Company, LLC
Dresden Nuclear Power Station
6500 North Dresden Road
Morris, IL 60450-9765

Subject: Licensee Event Report 237/2009-002-01, "Unit 2 High Pressure Coolant Injection Suction Valve Fails to Close"

4. TITLE
Unit 2 High Pressure Coolant Injection Suction Valve Fails to Close

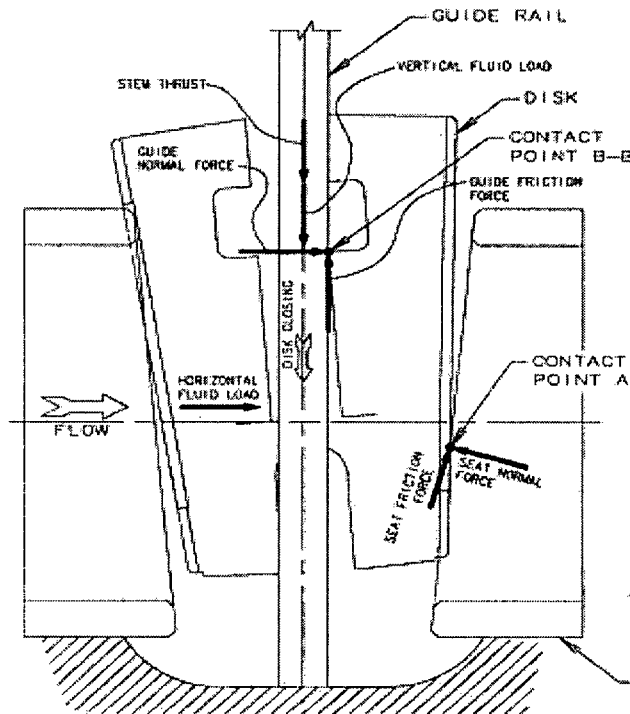
The Root Cause of this event was that when the valve was in the full open position, the center of gravity of the solid gate valve disc extending past the end of the in-body valve guides, which caused the disc to tip and bind with the in-body guides. Industry operating experience found similar events that were caused by either friction between disc and guide or disc alignment issues known as "tipping", however their root cause was attributed to excessive in-body guide wear which was not evident during D2R21 internal valve inspections.

Figure 1. This is a typical example of valve disc tipping.

The in-body valve guides were lengthened into bonnet to ensure the valve disc's center of gravity is supported by guides when the valve is in the Open position. Preventative maintenance activities for motor operated valve stem lubrication were revised, as needed, to ensure that the frequency does not exceed two-years for the motor operated valve program valves with horizontal disc/stem orientation that exhibit internal binding.
