Point Beach Nuclear Plant, Unit 1
Docket 50-266
Renewed License No. DPR-24

Unit 1 Refueling 32 Analytical Evaluation Report for the Reactor Vessel
Point Beach Nuclear Plant

**SECTION XI FLAW EVALUATION OF
INDICATION RECORDED ON RC-32-MRCL-AIII-03
OF THE REACTOR VESSEL
INLET NOZZLE-TO-PIPE WELD**

LTR-PAFM-10-50-NP
Revision 0

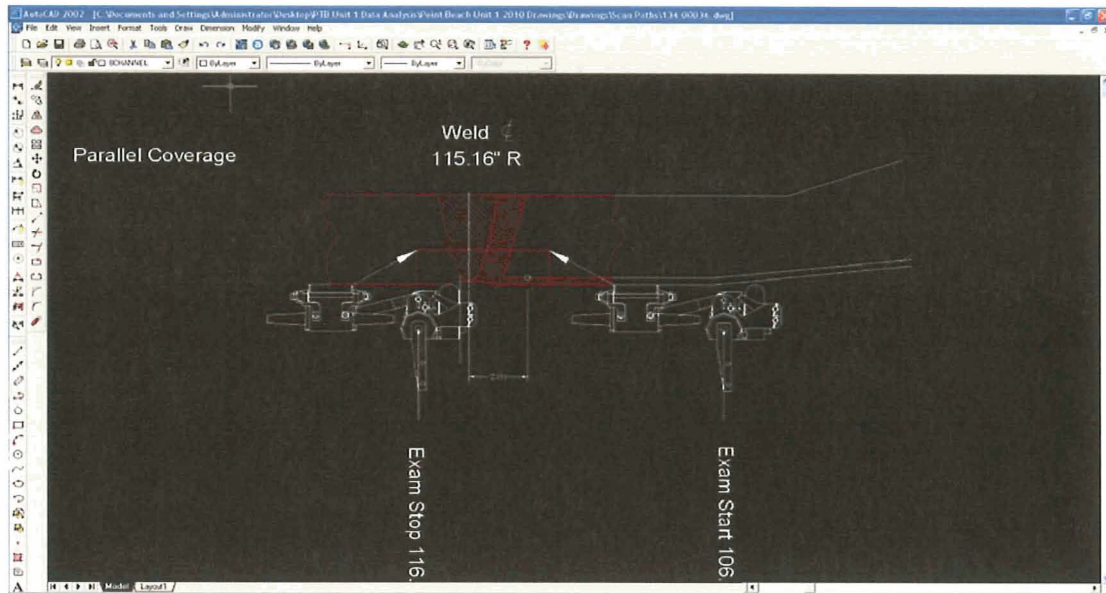
Figure 1: Inspection Volume of the Region of Interest, and Location of the Indication

Sizing scans were performed with the specified PA search unit, which assisted with the characterization of the indication. The sizing scans characterized the indication as being 0.71 inches long and 0.505 inches in through-wall dimension (18.10% a/t). The cladding thickness (not counted) is 0.25 inches, and the nominal pipe thickness (minus clad) is 3.27 inches. The surface "S" dimension was conservatively considered to be zero (0) to account for near-surface uncertainties.

With RMSE applied, the indication size is considered conservatively to be 0.592 inches through wall. The maximum allowable flaw depth, per the flaw acceptance standards of IWB-3500, would be 12.5% of the wall thickness (approximately 0.41 inches through-wall).

Based on current findings, it is considered that this indication or group of indications is most likely to be embedded fabrication flaws; however, it is being evaluated as a surface-connected flaw due to the proximity to the inside surface. The location is actually near to the buttering of the nozzle, and also near to the clad-to-base metal interface, as shown in the sketch of Figure 1.

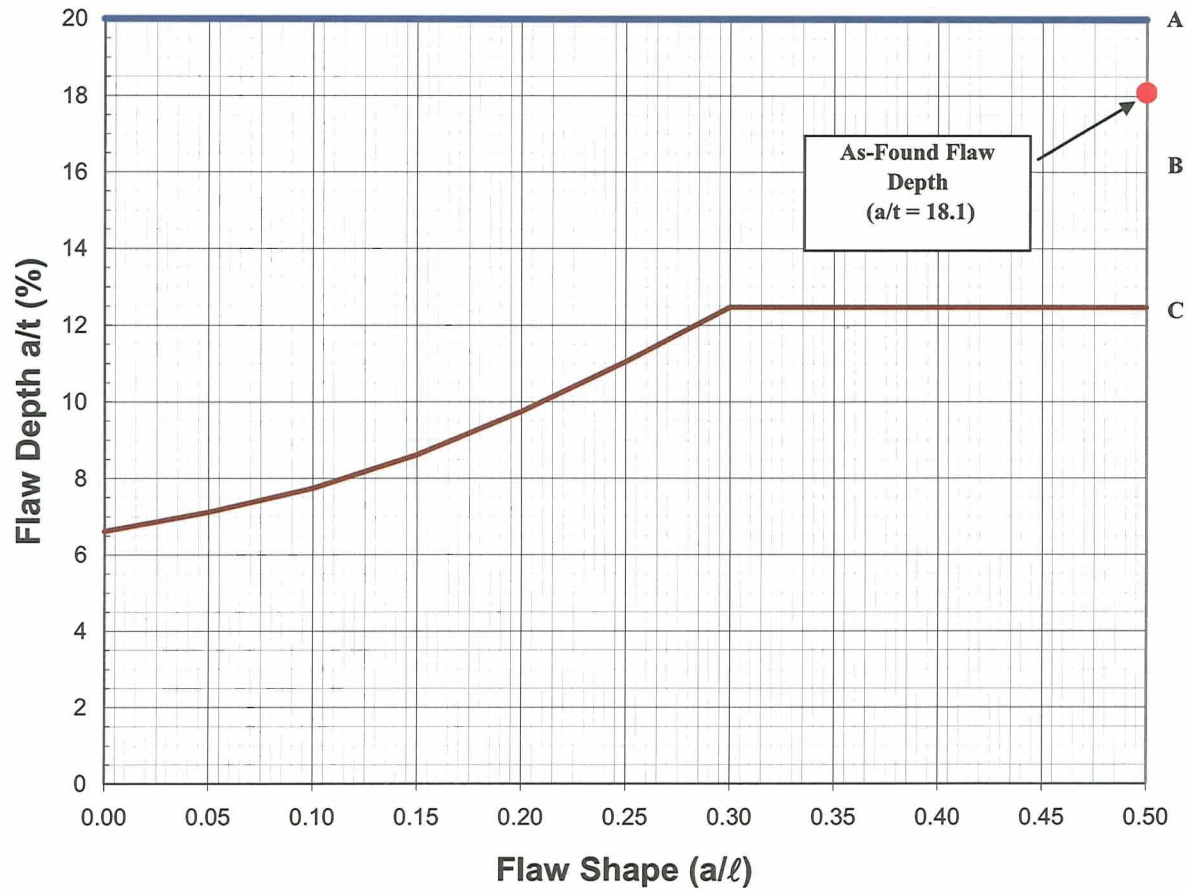
Figure 2 (Figure A-6.3) Evaluation Chart for Inlet Nozzle Safe-end to Nozzle Weld [1]

In preparation for the reactor vessel inspections, a set of flaw evaluation charts had been prepared for the reactor vessel weld regions [1,2], and the indication was compared with these flaw evaluation results, and found to be acceptable for further service without repair. The flaw evaluation chart of interest is Figure A-6.3 of reference 1, which is provided in an updated version as the last figure of this technical note, with the indication plotted.

Therefore, we see that the allowable flaw depth is very large, regardless of the flaw shape for this location. For conservatism the allowable flaw depth in the chart of Figure 2 has been cut off at $a/t = 0.2$.

The evaluation chart for surface flaws is shown in Figure 2, for circumferential flaws. Note that there are three lines in the chart, representing the acceptable length of service, 10, 20, and 30 years.

The crack growth during service is negligible. Fatigue crack growth was calculated in WCAP-11477 [1] for several flaws of similar depth to the location of interest. The flaws in the table below had a length of 6 times the depth and were open to the surface and exposed to the water environment. The flaws in the table show no appreciable flaw growth from service. The indication of interest is not nearly as elongated as the six to one flaw whose results are shown here, and is not exposed to the water environment, so the growth will be even less than predicted here. Therefore, there is no difference in the allowable depth as a function of service time for this location, and the allowable depths for 10, 20 and 30 years of service are the same.
