ULNRC-05695

**DOCKET NUMBER 50-483
CALLAWAY PLANT UNIT 1
UNION ELECTRIC CO.
FACILITY OPERATING LICENSE NPF-30
LICENSEE EVENT REPORT 2010-003-00
SAFETY SYSTEM ACTUATION AFTER LOSS OF A SWITCHYARD BUS**

1. FACILITY NAME Callaway Plant Unit 1					2. DOCKET NUMBER 05000483			3. PAGE 1 OF 6											
4. TITLE Safety System Actuation After Loss of a Switchyard Bus

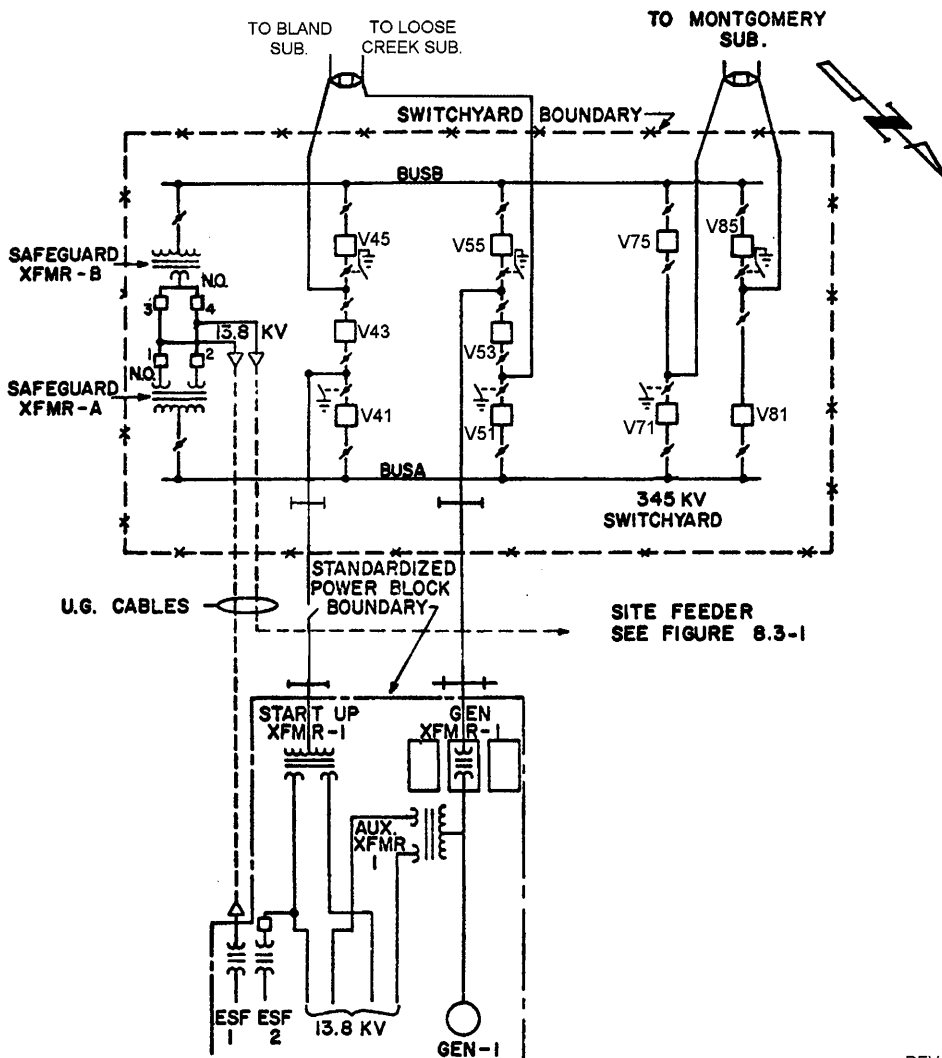
FIGURE 8.2-5
345 KV ONE LINE AND
GENERAL ARRANGEMENT
CALLAWAY PLANT

The 345-kV Callaway switchyard [EIIS system FK] consists of circuit breakers [EIIS component BKR], disconnect switches [EIIS component MOD], buses [EIIS component BU], transformers [EIIS component XFMR], and associated equipment. The switchyard is arranged in a breaker-and-a-half configuration as shown in Callaway FSAR Site Addendum (SA) Figure 8.2-5, "345 KV One Line and General Arrangement Callaway Plant." The figure is shown on the last page of this LER. The switchyard breakers mentioned in this LER are designated as MDV## where ## is the specific breaker number. On the figure, they are shown as V##.

On February 19, 2010, at 2145, the "A" Safeguard Transformer was lost which resulted in switchyard breakers MDV41, MDV51, MDV71 and MDV81 tripping open and subsequent loss of the "A" switchyard bus. Electricians in the switchyard reported hearing a loud boom and saw what looked like an arc off of one of the ends of the "A" Safeguard Transformer, and then saw sparks cascading down.

The loss of the "A" switchyard bus and the "A" Safeguard Transformer were self-revealing. The cause for the loss of the "A" Safeguard Transformer was a low side phase-to-phase fault external to the 'A' Safeguard Transformer. The most probable cause of the fault was a conductive foreign material or that an animal bridged the air gap between transformer low voltage bushing terminals. No evidence of the fault initiator was found and therefore a root cause could not be verified.
